# **Shop Front Investigations**

**Prisco's, Harral Building, 32 Eldon Street,  
Barnsley**

**Ref: Y24**

**March 2022**

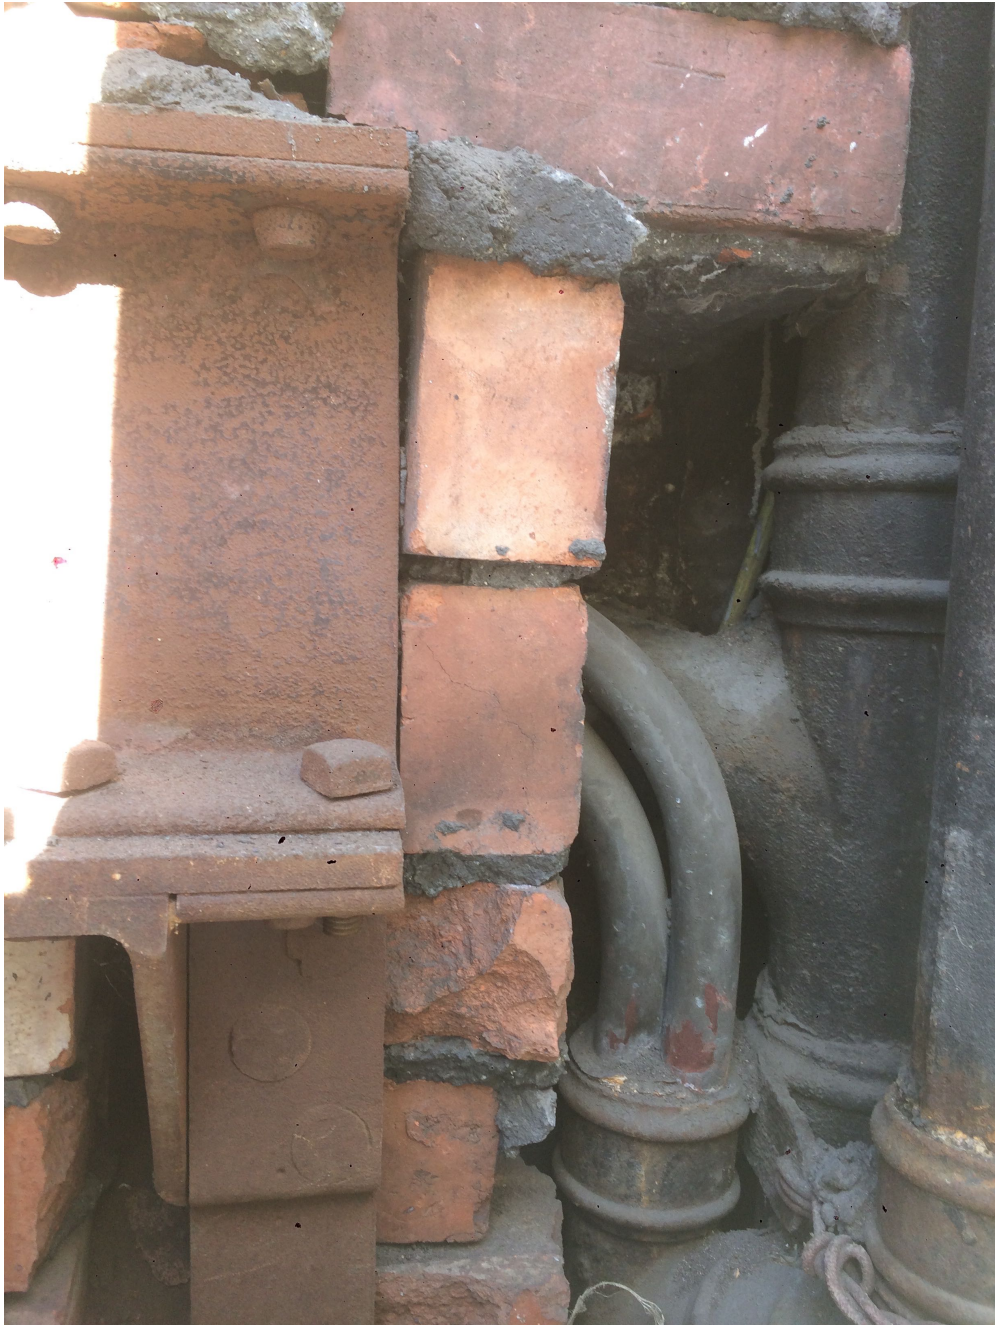
At the right-hand end there is a vertical steel channel carrying the beam end, and there are three intermediate supports, boxed in, but presumably also steel channel or columns. The shop front forms a slight angle on plan near the entrance so the beams are presumably not continuous at this point.

Right-hand end of bressumer beam

The steelwork appeared to be in good condition, but it would be prudent to paint any areas of steel that are accessible.

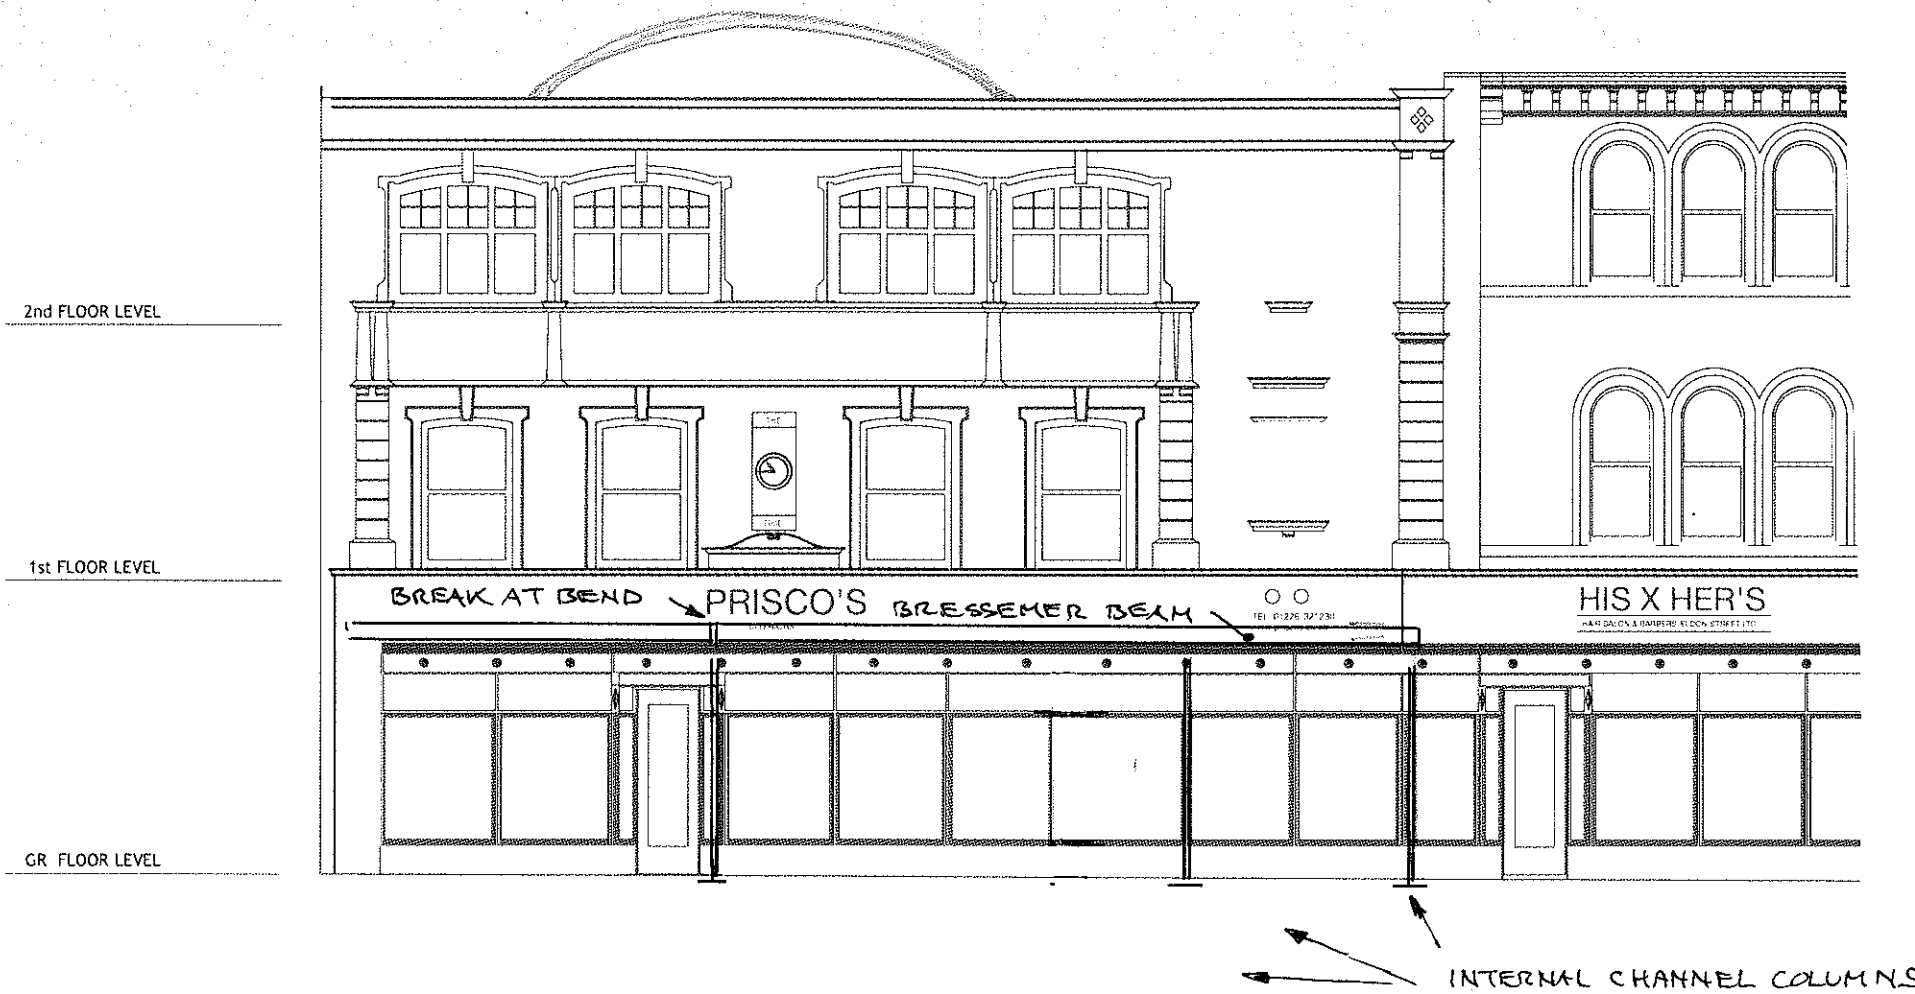
The bressumer beam above the shop front window is composed of two 9" x 4" beams with top and bottom plates, making a composite 12" x 9.75" beam (Reference B313 at the date of construction).

The longest span is around 5.5 metres. This is longer than was recommended by design guides at the time for beams of the type, which has resulted in excessive deflection and this we believe, is the cause of the buckling in the window.

BRESSEMER BEAM  
 COMPOSITE B313 12" x 9 3/4" : 2 No 9" x 4"  
 TOP + BOTTOM PLATES 12" x 3/8"

In order to provide additional restraint to the bronze window framing it would be possible to insert a horizontal steel channel at transom level spanning between the vertical columns.

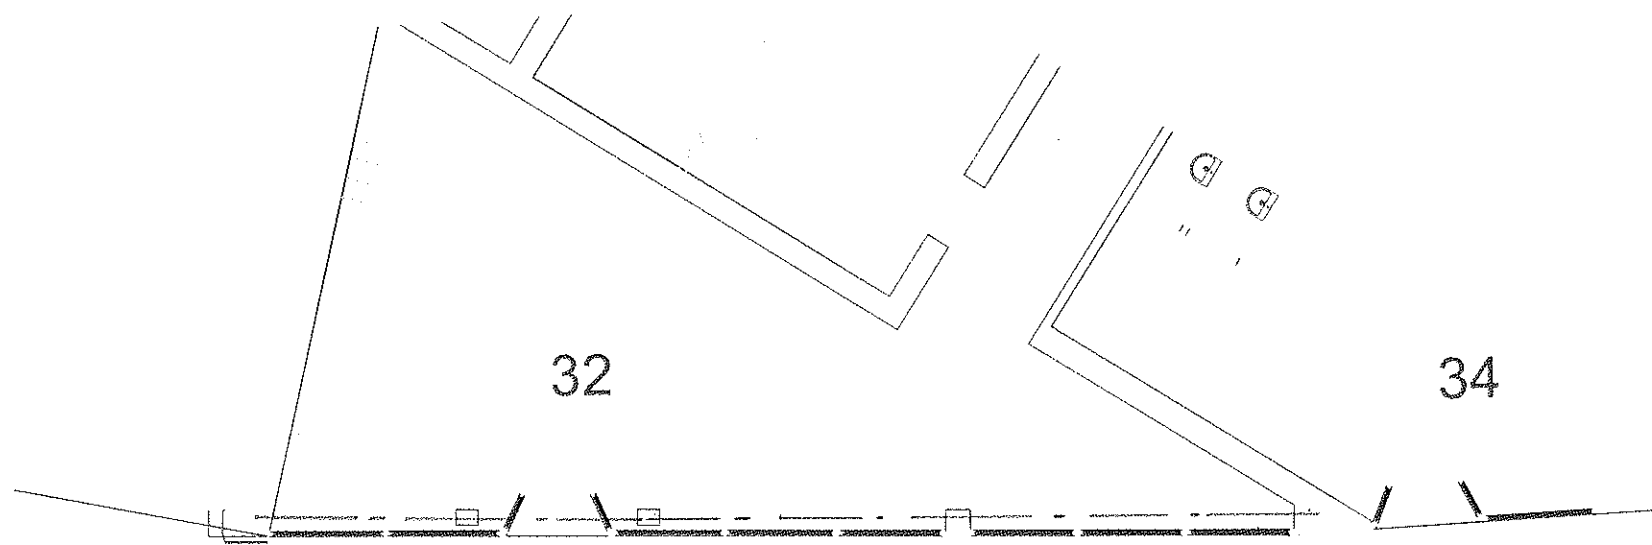
PRISCOS - HARRAL BUILDING  
 SHOP FRONT BRESSEMER BEAM  
 MARCH 2022 Y24/01

The bronze glazing has buckled near the centre, although the framing and glass are intact. The investigation was an attempt to identify the cause of the buckling.
