Project: 21_VTA_03_54
Site: Pindar Oaks Hospital, Upper Sheffield Road,
Barnsley, South Yorkshire, S70 4PX.
Client: Nichola Taylor - Countrywide.

Document Title:	Tree Safety Survey - 3 year time cycle.
Document Author:	Matt Harmsworth
Project Manager:	Matt Harmsworth
Project Title:	Pindar Oaks Hospital, Upper Sheffield Road, Barnsley, South Yorkshire, S70 4PX.

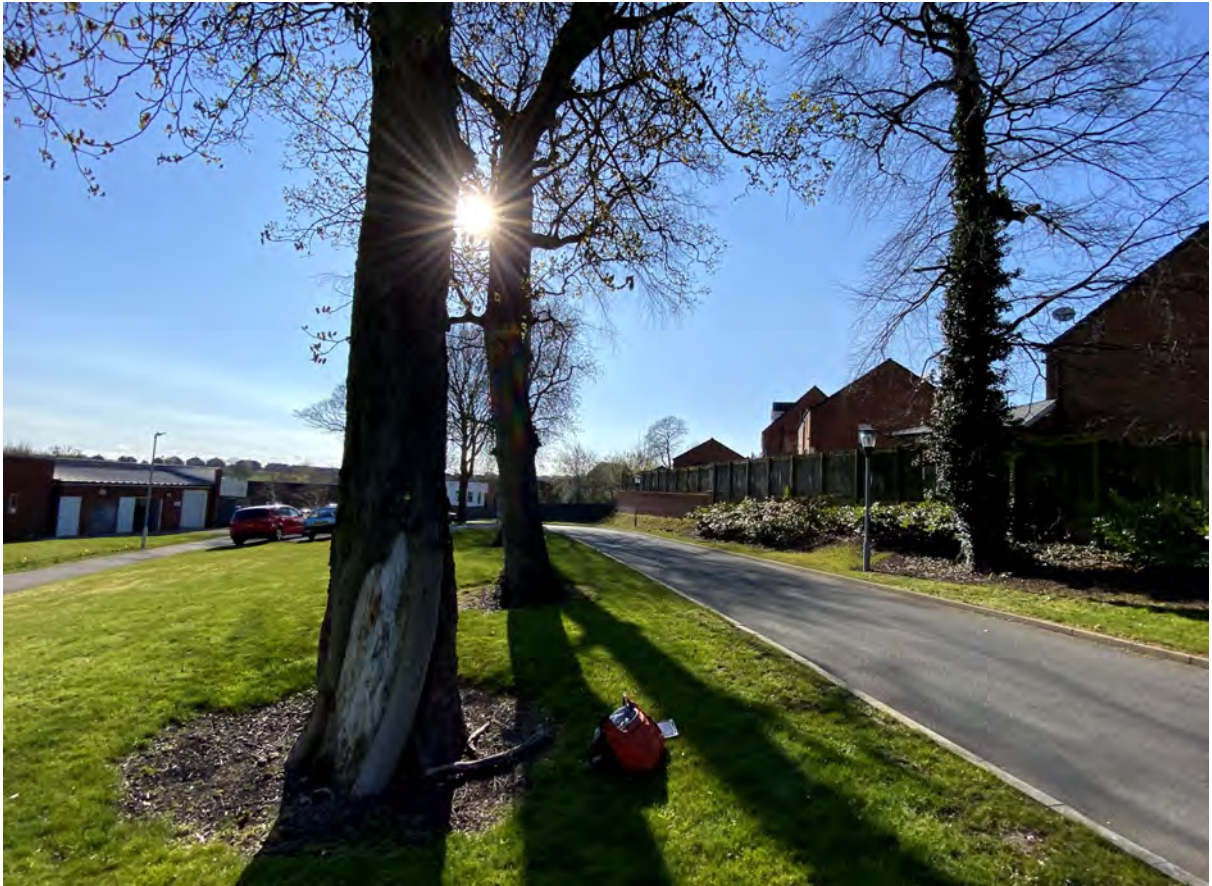
Photographic plate showing the surveyed trees with tree 1881 in the foreground.

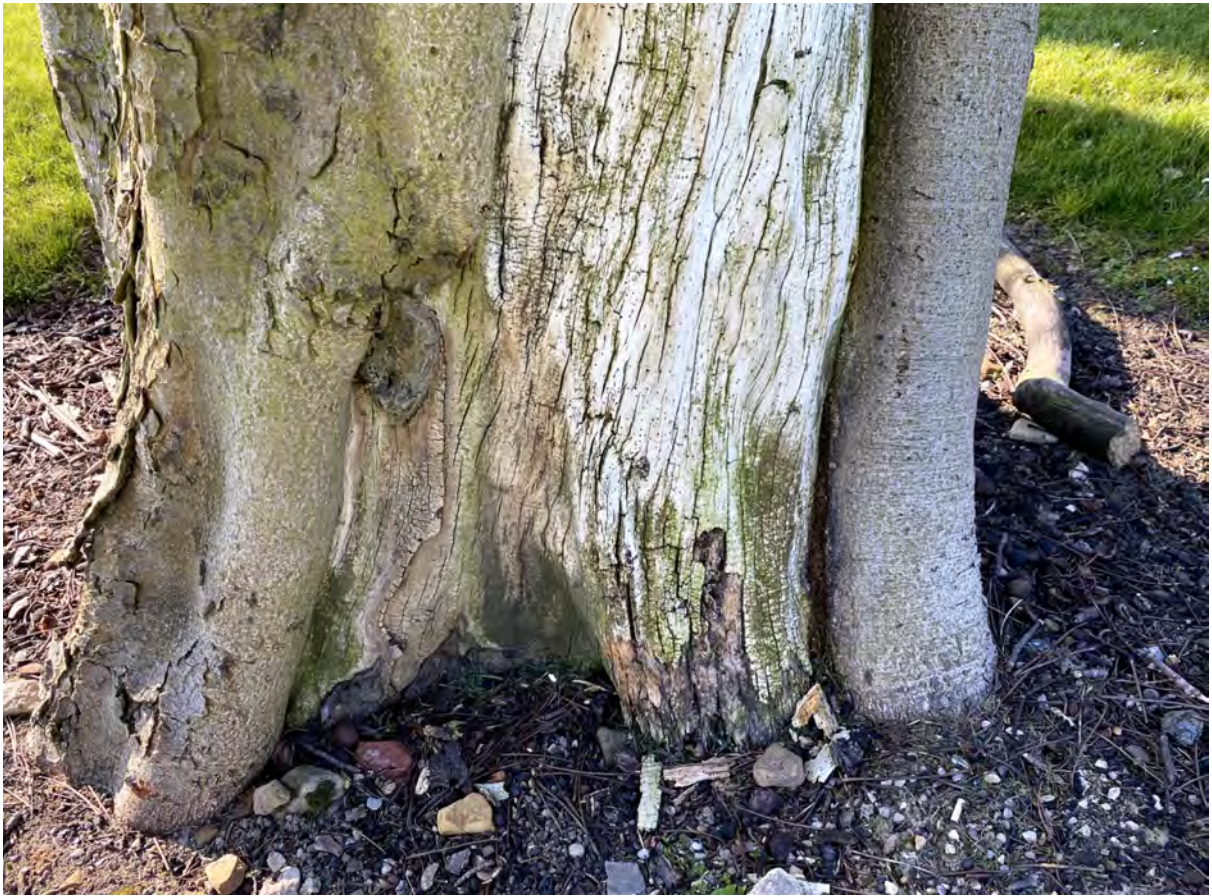
Photographic plate showing the basal damage to 1881.

Tree Tag	Species	Height	Age Class	DBH	Life Expectancy	Condition	Physical Description	Works Required	Timescale	Budget
1881	Horse Chestnut	14	M	600	<10	Poor	Located in a grass matrix adjacent to the entrance road; large mechanical wound at the base of the stem that has not fully occluded; decay present; thin crown and stunted form.	Dismantle and fell	<1 year	3 men 1 day
1882	Beech	13	M	500	20+	Good	Located on site boundary; dense ivy cover; good vitality; crown under pressure for unsympathetic pruning due to the proximity to the neighbours houses.	Strip ivy	<2 years	2 men 2 hours
1833	Horse Chestnut	14	M	800	20+	Fair	Mechanical damage to stem from construction works; road within rooting area	Monitor	<1 year	N/A
1834	Sycamore	15	M	600	20+	Fair	Mechanical damage to upper crown, looks like a lorry strike; lack of trunk flare; tree is in decline	Monitor	<1 year	N/A
Notes:	There are a number of mature trees on site that appear to be remnants of the previous land use. Most have been damaged by construction works and will require staged removal over the next ten years.

- 4.1 Recommendations for safety works are included within the data tables, with additional recommendations in the paragraphs below.
- 4.2 The site will require annual monitoring visits due to the large number of declining trees on the periphery of the site.
- 4.3 There is scope for some new higher quality tree planting but any planting must be robust, sustainable and protected to climate change.
- 4.4 If the grass is allowed to grow longer beneath the drip line of the trees on the field, this may lead to an improvement in condition and vitality.
- 4.5 The removal of tree 1881 will require written approval from the local planning authority due to its protected status.

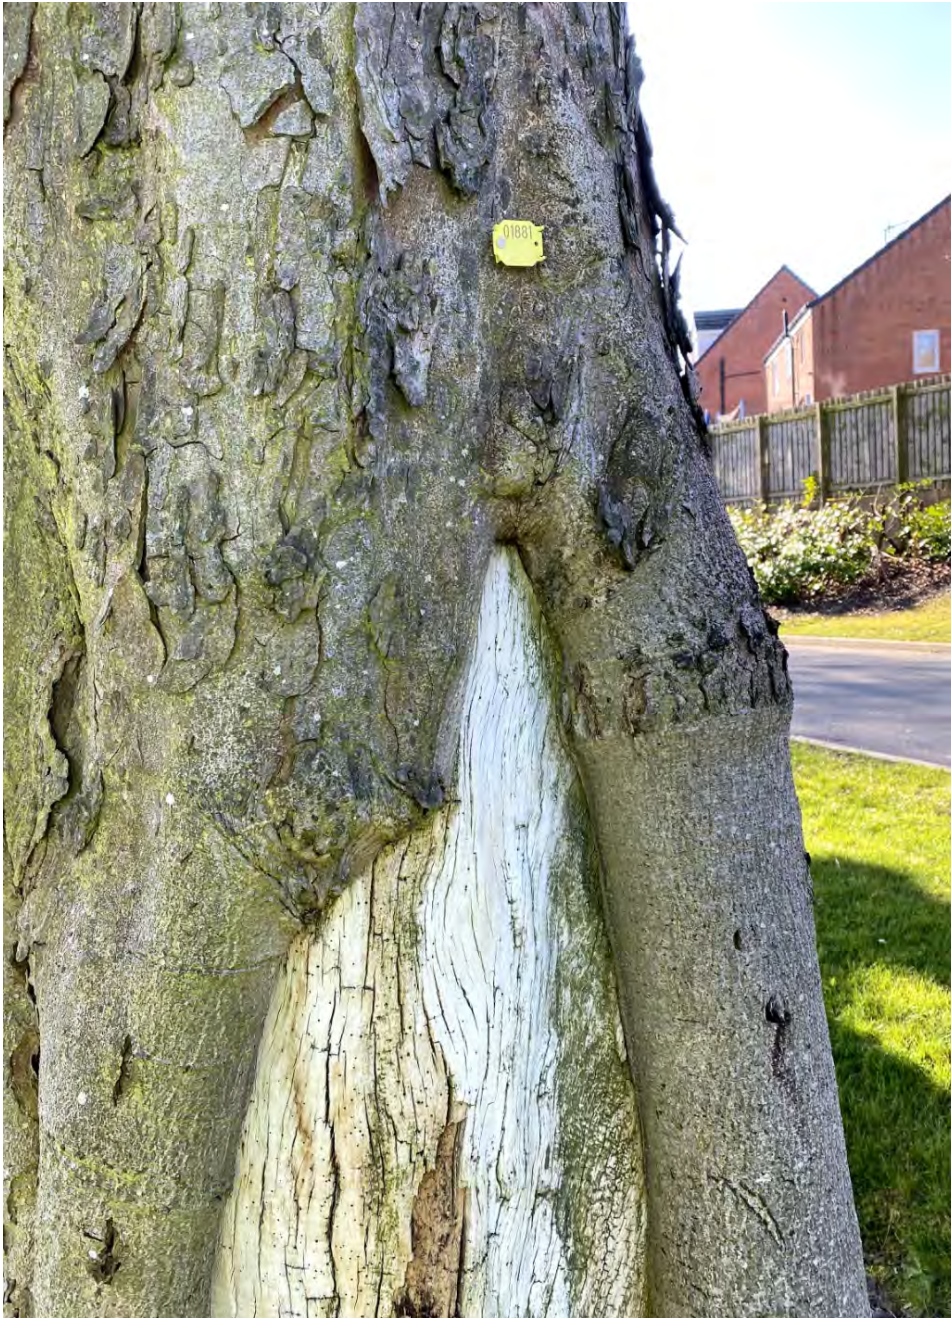
Photographic plate showing the basal damage to 1881, note the tree tag for identification.

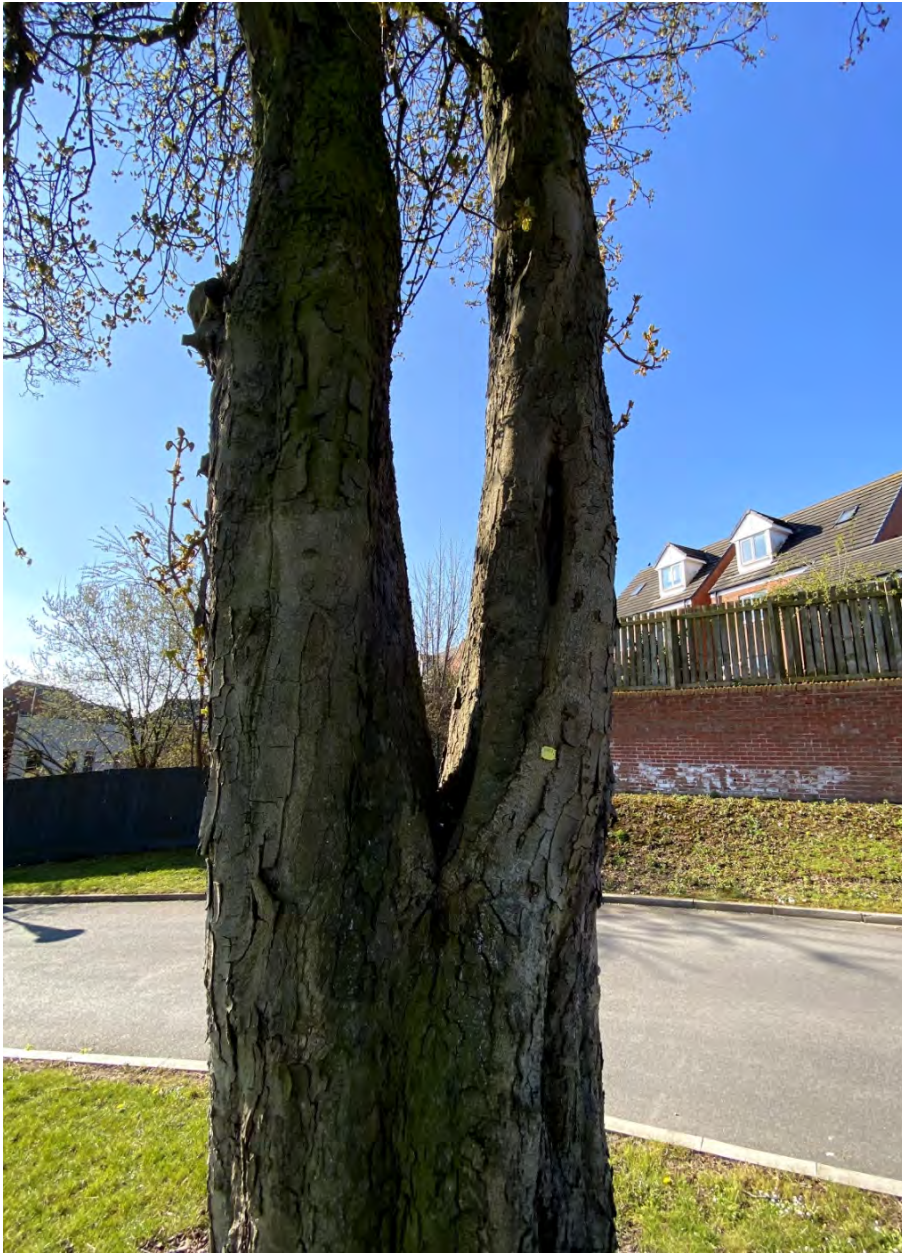
Photographic plate showing the tree 1833 with mechanical damage in the Lower stem..

- 3.6 A number of trees have suffered mechanical damage to the crowns and stems most likely due to a lack of protection during the construction phase. These will require monitoring moving forwards.

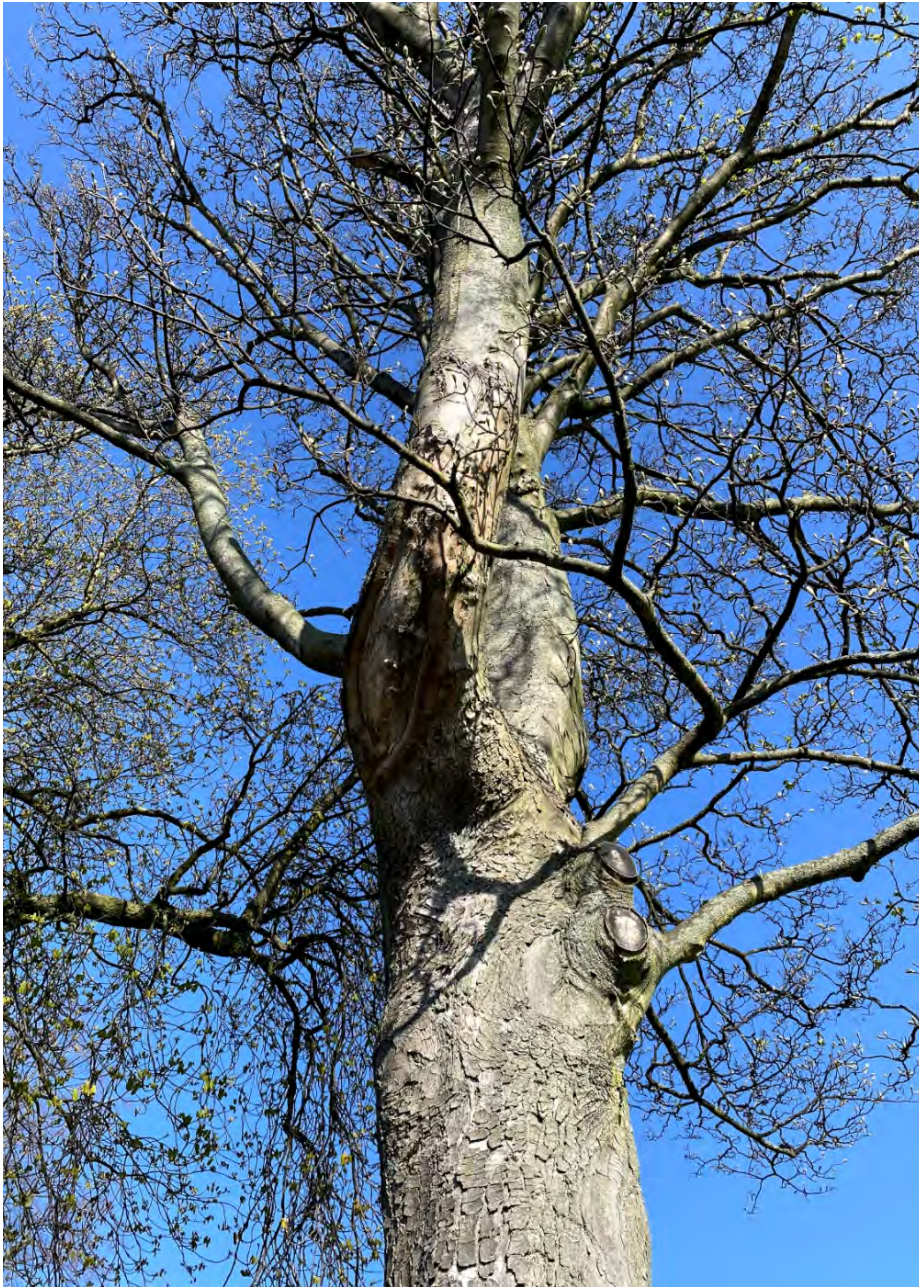
It is clear from our assessment that the trees were damaged by mechanical strikes most likely during the construction of the site. There is also evidence of ground levels being changed which is leading to the decline of the sycamore 1834.

Photographic plate showing the tree 1834 with mechanical damage in the Upper crown.

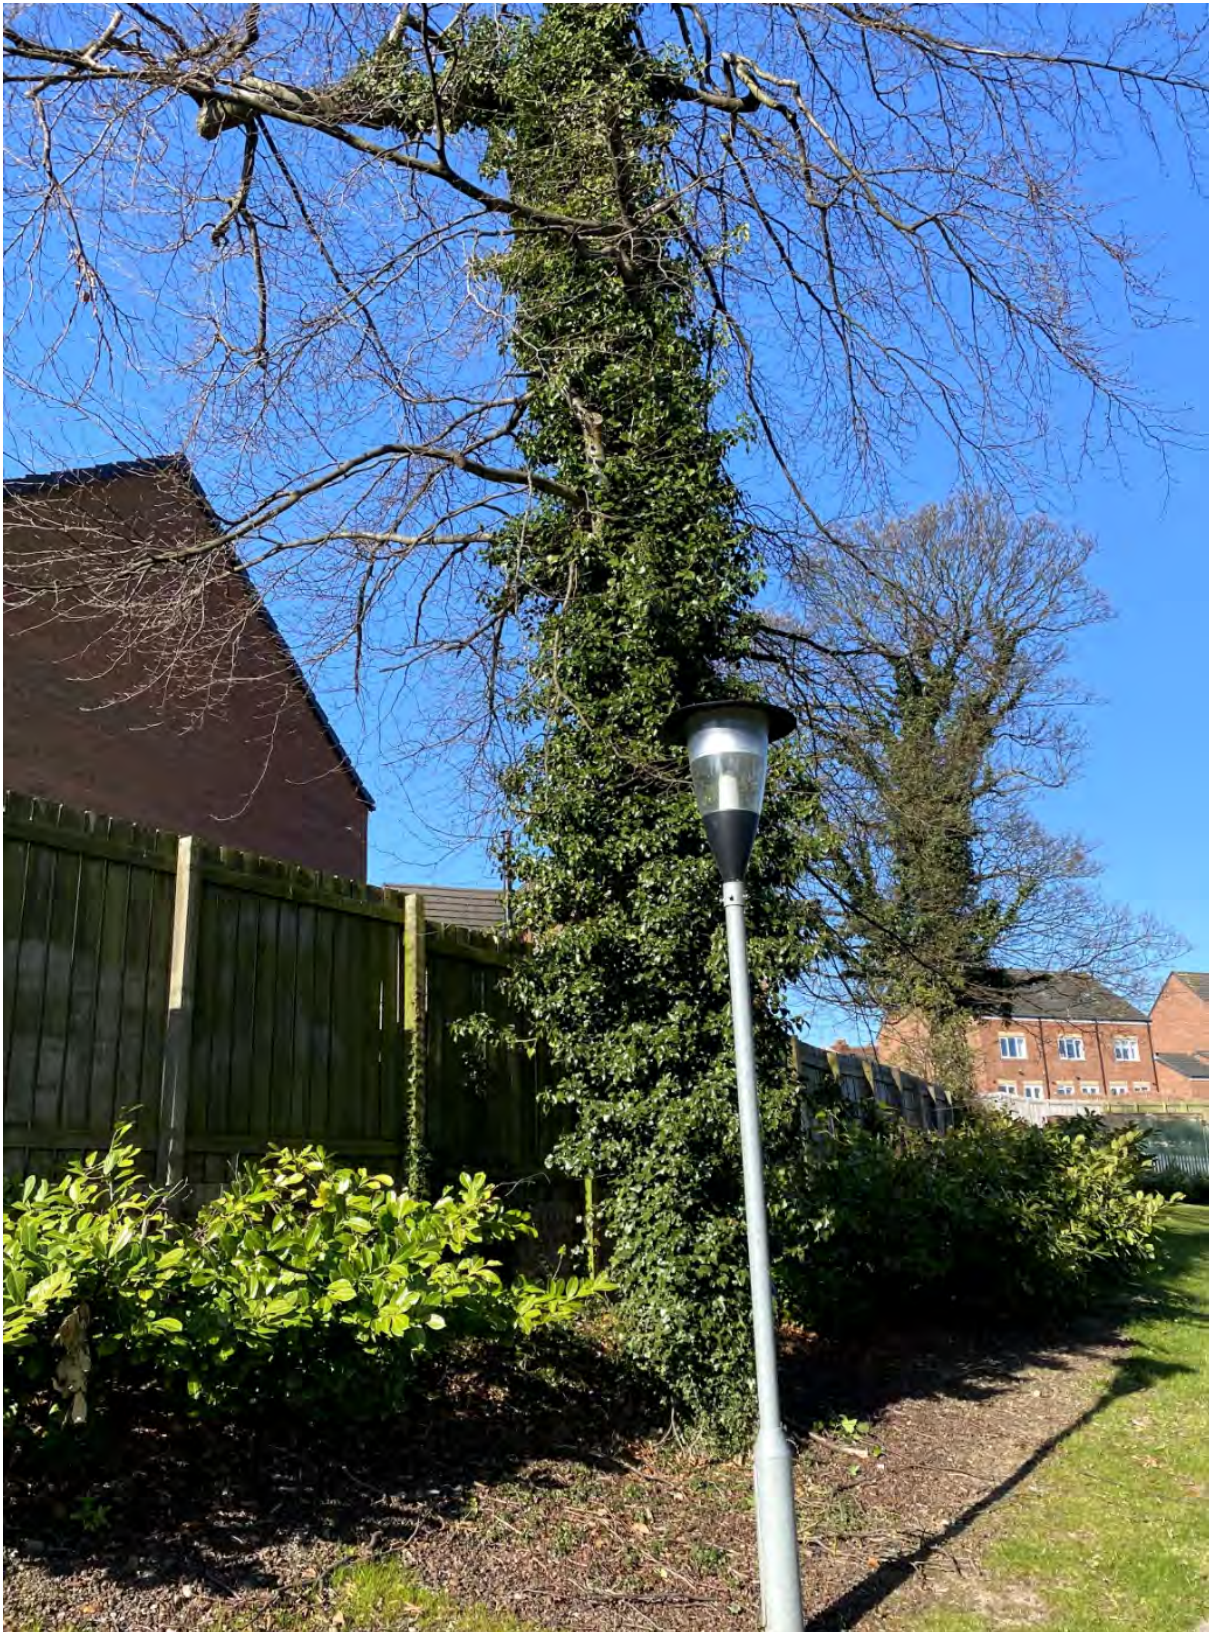
Photographic plate showing the beech tree - 1882.
