**Tree Hazard Assessment  
St Edwards Church  
Racecommon Road  
Barnsley  
S70 6JY**

Report Reference: TCC-1462-1  
30 October 2021

| Report Title: | Tree Hazard Assessment |

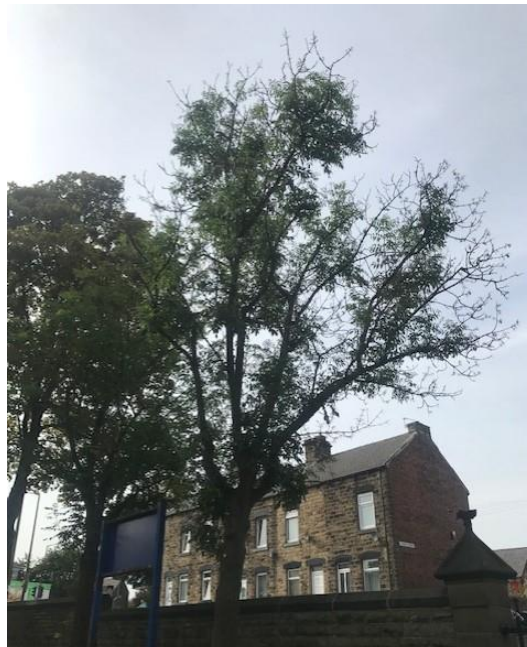
14. T2612 has been recommended for removal due to its impaired physiological condition and location. The tree has been severely infected by Ash Dieback disease, a fungus which enters the tree through the branch tips. The tree exhibits a declining canopy has can be viewed in Figure 2 below. It is unlikely the tree will recover from the infection and in view of its location adjacent the public footpath removal is considered the preferred course of action.

**Figure 2: T2612 is unlikely to recover from the effects of Ash dieback disease.**

| Tree No | Species, Botanical Name | Target | Age | Height (m) | Structural Condition | Vitality | Life Expectancy | Observations & Defect Assessment | Recommendations | Priority |
|---|---|---|---|---|---|---|---|---|---|---|
| T2612 | Common Ash, <i>Fraxinus excelsior</i> | Footpath;<br>Highway | Early-mature | 10-15 | Fair | Early-decline | >5 | Single stemmed tree with sparse overall appearance and moderate deadwood, probably due to Ash dieback ( <i>Hymenoscyphus fraxineus</i> ) infection. Appears to be more severely impacted by infection of Ash dieback ( <i>Hymenoscyphus fraxineus</i> ) than T2609 and T2611. Unlikely to recover from the infection sufficient to provide a viable specimen. | Fell to ground level. Replant with suitable alternative genus and species of tree. | 2 |

18. It is recommended that the tree recommended for removal be replaced with suitable species. Advice on suitable species, establishment and management can be provided on request.
