ARBORICULTURAL REPORT

to BS 5837:2012 at:

***25-27 Millhouses Street,
Hoyland,
Barnsley,
South Yorkshire,
S74 9BQ***

Reference: AWA4401

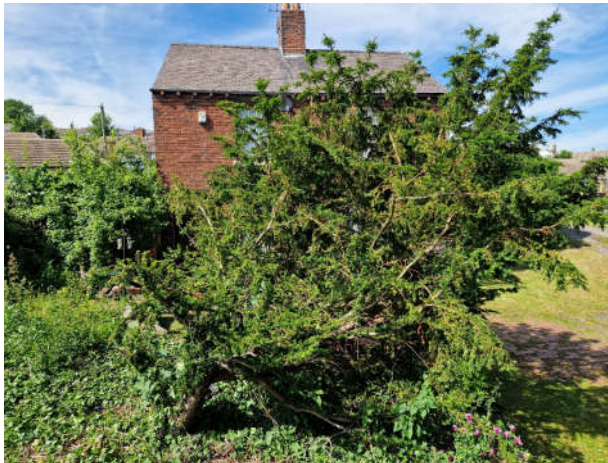
- 3.2.4 Yew T1 is situated on raised land to the west of the main property and overhangs a parking area. It is unbalanced to the east and has likely been suppressed by adjacent vegetation that has been removed before the survey was undertaken. T1 provides limited amenity and is low value.

Photo 3: T1 with unbalanced form, likely as a result of suppression by vegetation that has since been removed, looking north

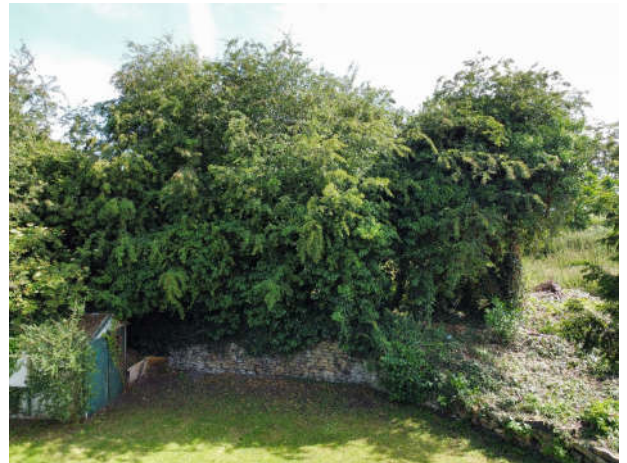
- 3.2.6 Dense group G3 primarily consists of Hawthorn trees in similar condition. The stems run along the top of a retaining wall and overhangs the parking area and small shed to the north. It provides effective screening, but the trees are low value and amenity. T4 is a self-seeded Sycamore growing within the southern aspect of G3. It has a significant southerly lean and has limited amenity prospects long-term.

Photo 4: Shrubby group G3 growing along the top of a retaining wall, looking south

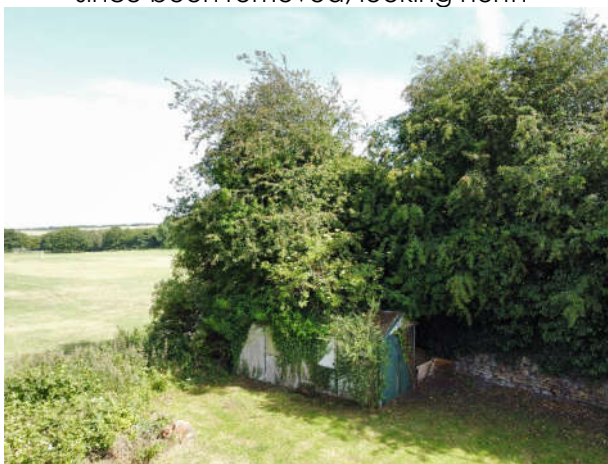
Photo 5: G3 overhangs a small shed to the north, looking south

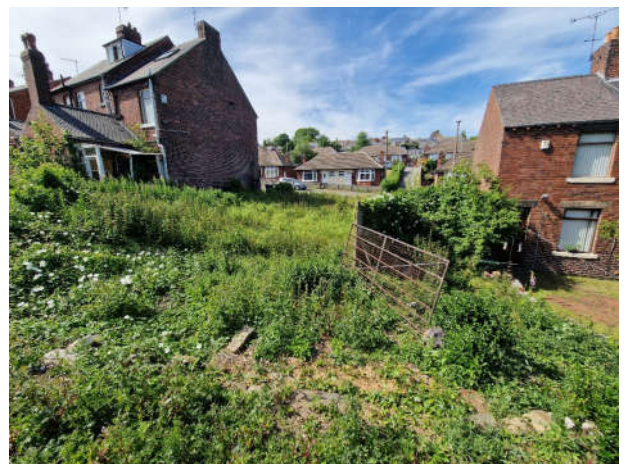
- 3.2.8 The majority of the western area of the site contains dense low-level vegetation making it largely inaccessible. A cursory inspection of the area revealed occasional stumps but nothing of arboricultural interest.

Photo 6: The western area of the site mainly consisted of low vegetation and occasional stumps, looking north
