Proposed Roundabout: A635 Goldthorpe

Road Safety Audit: Stage 1

Report Produced for:	Barnsley MBC
Report Produced by:	Jonathan Birkett
Report Dated:	18 October 2021
Report Reference:	MAL/A635GRSA1Rev1
Road Safety Audit Team Leader:	Jonathan Birkett

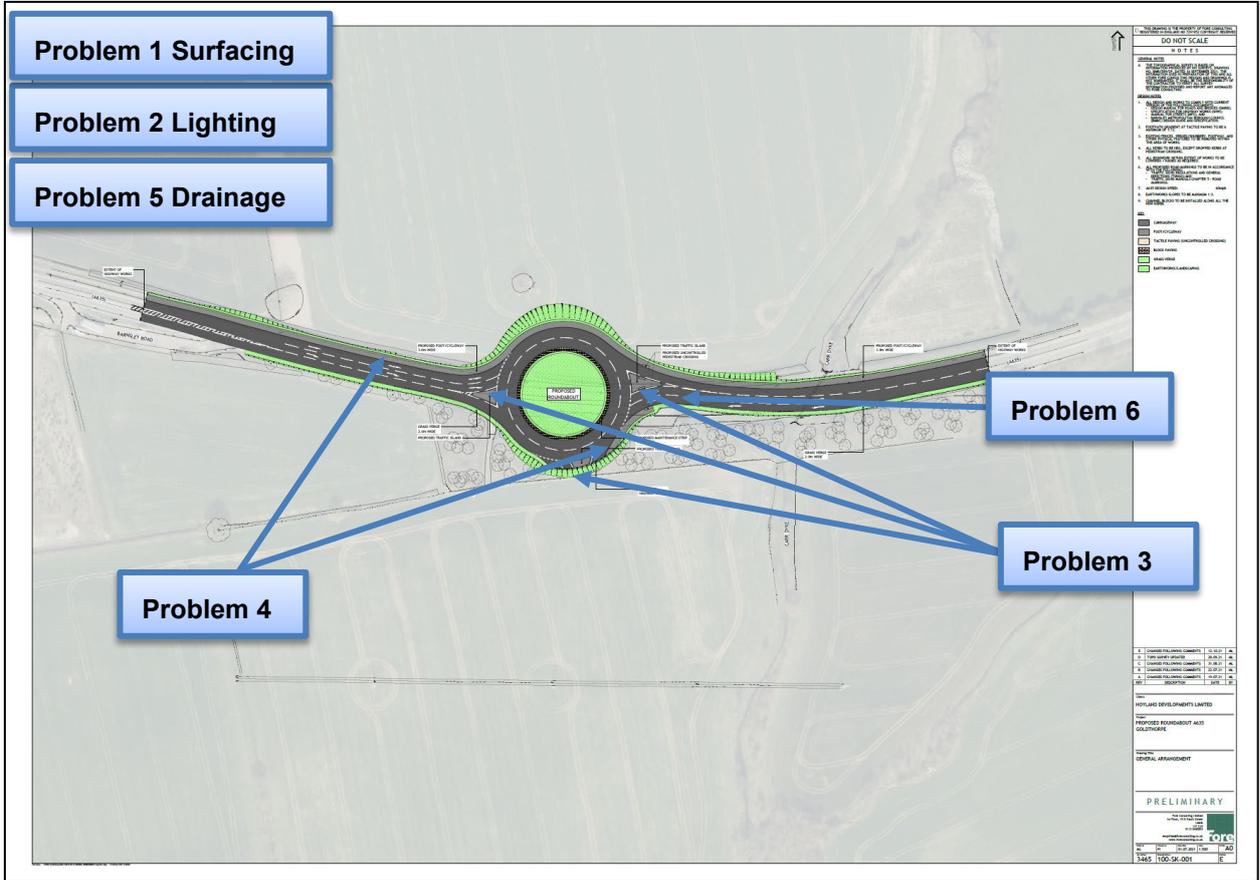
Appendix 2 – Problem Location Plans

PROBLEM		1
Location:	Surfacing	
Summary:	Unsuitable surfacing material can increase the risk of shunt and loss of control type collisions	
<p>No surfacing drawings have been provided to the Road Safety Audit Team, the scheme will include a new roundabout and significant changes to the existing road layout. Surfacing material that does not provide suitable skid resistance in locations where there will be heavy braking and vehicles circulating the roundabout can increase the risk of shunt and loss of control type collisions.</p>		
RECOMMENDATION		
Provide details of all surfacing materials proposed as part of the detailed design.

PROBLEM		2
Location:	Throughout the roundabout	
Summary:	Inappropriate levels of lighting can lead to an increased collision risk.	
<p>The drawings provided do not clearly show if street lighting is proposed. The Audit Team note that other roundabouts on the A635 within the National Speed Limit are street lit.</p> <p>The scheme will include significant changes with carriageway widening and new layouts. This may result in the carriageway and NMU crossing points being in shadow leading to possible conflicts during the hours of darkness.</p>		
RECOMMENDATION		
Ensure that suitable lighting provision is provided.

PROBLEM		3
Location:	All splitter islands and approaches.	
Summary:	Lack of suitable signing on the splitter islands and approaches can increase the risk of vehicle loss of control as well as NMU/vehicle collisions.	
<p>A new roundabout and splitter islands will be constructed as part of the proposed works, two of which will include uncontrolled shared use crossings. The drawings do not show any "Keep Left" bollards which should be located on the islands. There is also no advanced warning signs shown on the approaches.</p> <p>A lack of suitable signing on the islands and approaches to the roundabout could lead to vehicle loss of control and NMU/vehicle collisions.</p>		
RECOMMENDATION		
Provide suitable signing on all the splitter islands and approaches to the roundabout at detailed design.

PROBLEM		4
Location:	Shared cycle facilities.	
Summary:	A lack of separation between the shared facility and carriageway can increase the risk of cycle/vehicle collisions.	
<p>The A635 is national speed limit (albeit speeds may well be lower due to the construction of the new roundabout).</p> <p>The drawings show that there will be no separation between the edge of cycleway and carriageway. DMRB CD195 Table E3.26 gives minimum levels of separation based on the speed limit and for a 60mph speed limit the absolute minimum separation is 2m.</p> <p>A lack of separation between the shared facility and carriageway can increase the risk of cycle/vehicle collisions.</p>		
RECOMMENDATION		
Provide suitable levels of separation between the edge of shared facility and carriageway throughout its length.

PROBLEM		5
Location:	Proposed works.	
Summary:	Inappropriate drainage may lead to ponding water resulting in loss of control type collisions as well as NMU slips, trips and falls.	
<p>A new roundabout will be constructed as part of the development with localised changes to the A635. Ponding water can result in an increased risk of loss of control type collisions and at certain times of year standing water will freeze resulting in ice, vehicles manoeuvring in the turning could lose control resulting in an increased risk of collisions as well as NMU slips, trips and falls.</p>		
RECOMMENDATION		
Provide appropriate drainage at all locations where changes to the existing road layout are proposed.

PROBLEM		6
Location:	A635	
Summary:	Lack of suitable signing and or warning paving will increase the risk of NMU collisions.	
<p>It is proposed to construct as part of the scheme a new 2m footway along the south-eastern side of the A635, this will link into the new 3m shared use route from the development site. The drawings do not show any warning paving or shared use signing giving blind/partially sighted pedestrians adequate notice that they are entering a shared facility.</p> <p>Lack of suitable signing and warning paving can increase the risk of NMU collisions.</p>		
RECOMMENDATION		
Provide suitable signing and/or warning paving on the new footway where it meets the new shared route.
