RISK ASSESSMENT,  
SSSI, STAIRFOOT  
AT  
PROPOSED CULLET RECYCLING FACILITY  
WOMBWELL LANE, BARNSELY, S70 3NS  
FOR  
POTTERS-BALLOTINI LTD  
REPORT REF: PB 3505/SSSI

REPORT REF: PB 3505/SSSI

November 2022

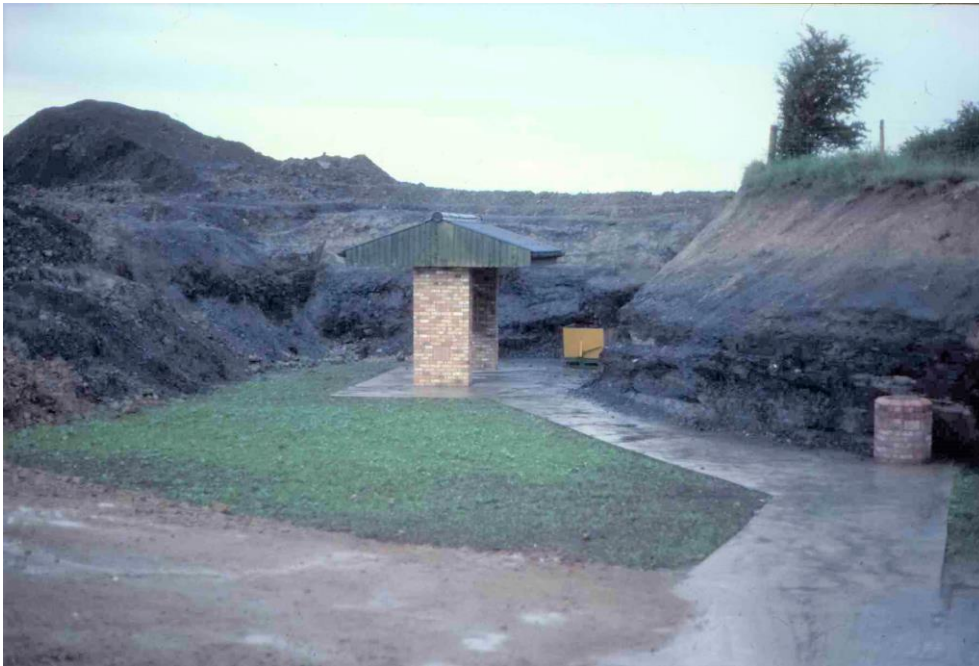
**Figure 3A      Former Display Adjacent SSSI  
(supplied by SAGT)**

Under the management of the Manager of Yorkshire Brick, the SSSI was made available for school visits and for sample collecting, with any resulting spoil being used in the brickmaking process. The brickworks liaised with the British Geological Survey for a display panel, which was housed in a specially built brick housing. A plaque was installed alongside the Trans Pennine Trail, as shown in Figures 3A and 3B, which has since been vandalised.

After the closure of the brickworks, the display was demolished and the ground in front of the SSSI is now partially flooded. The shale bank is overgrown with birch and brambles and there is very little exposure of the marine band.

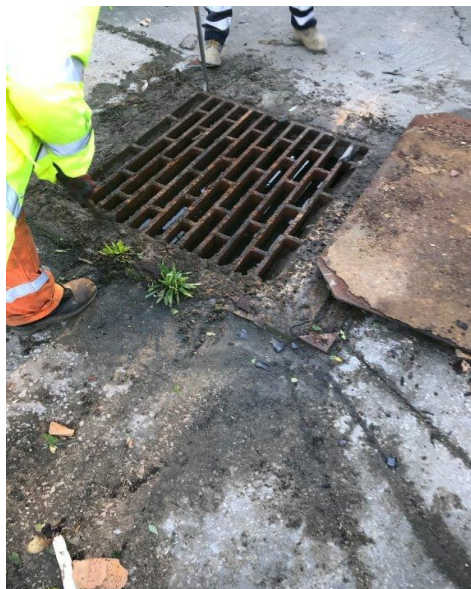
**Figure 11 Chamber 1 within Potters Site**

On occasions, the lower part of the development site just within the site boundary adjacent to this point on the Trans Pennine Trail has also been observed to flood. It subsequently appears to drain away either via soakaway into soft ground located adjacent the site boundary itself, or via a square chamber fitted with a grille and a slightly raised makeshift metal cover bolted to the concrete hardstanding a short distance inside the site depending on the amount of rainfall. An open gully is present just to the west of the metal cover which collects surface water from the concrete hardstanding and drains into this chamber.

The metal drain cover was temporarily removed by Potters during the first phase of CCTV investigation of the site drainage by a specialist contractor during October 2021. It was noted that there were three inlets to the drain in total and that the fourth leaves the chamber in a south-easterly direction towards the Trans-Pennine Trail.

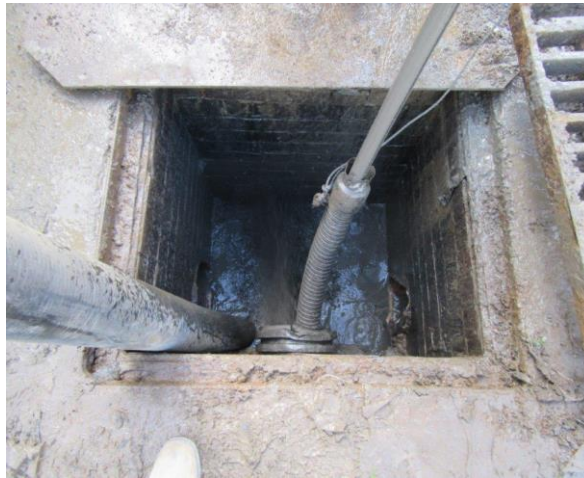
**Figure 12 Chamber 1 within Potters' Site**

A few metres to the south-east, the camera identified a blockage or collapse in the drain. Potters responded by appointing a drainage contractor to carry out an emergency repair.

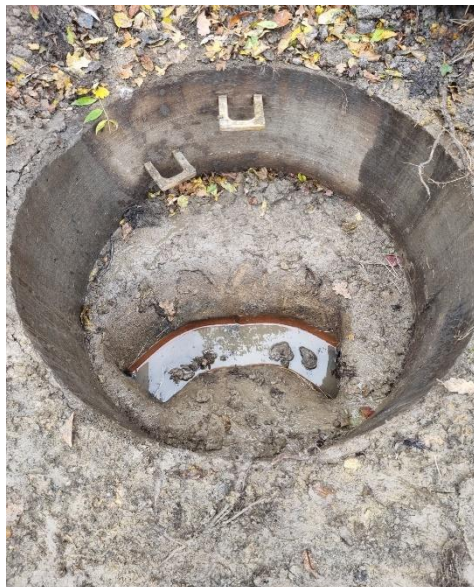
**Figure 13 Chamber 2 on the Site Boundary**

During the repair works, it became apparent that this drain turned through 90° within a second circular chamber, and into a third circular chamber, both located on the site boundary in the south-easternmost corner. This was not initially apparent due to the chamber lids being obscured beneath vegetation and several inches of mud and sediment. The third chamber was observed to drain via pipework to a fourth rectangular chamber on the Trans Pennine Trail, on its eastern side just beyond the SSSI. The third chamber is just outwith the land now in Potters' ownership.

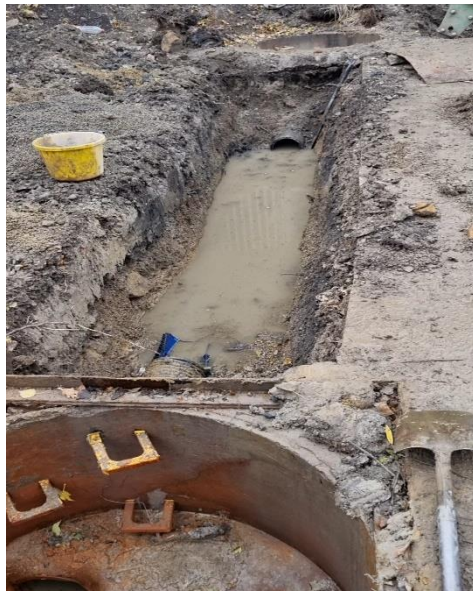
**Figure 15**      **Drainage Run Between Chamber 2 and Chamber 3**

Despite the repairs, it is proving difficult to maintain the flow within this part of the drainage system. Within the first chamber (with the metal cover and grille), a 300mm black plastic field drain was noted to enter from the east as identified by the CCTV Contractors. The field drain was blocked with compacted soil and silt.

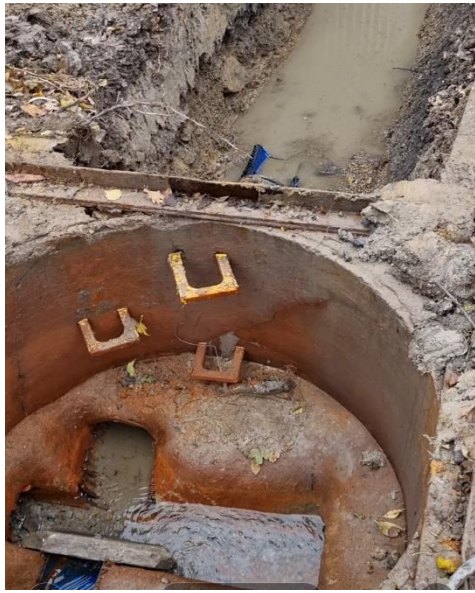
**Figure 16 Chamber 3 with blue field drain visible at the bottom of the picture**

During the jetting process it became apparent that the field drain was partially exposed at the surface within the adjacent field and there was no cover fitted to the end of the drain. Mud and sediment has since been observed to enter the drainage system from the field. The functional part of the field drain is not on land in the ownership of Potters.

Also, within the third chamber, a 150mm blue plastic field drain enters from the east which was also unblocked during a later phase of jetting. This pipe was identified as having root damage. It would appear logical that this drain was installed to drain the area behind the SSSI and does not cross any land in the ownership of Potters.

It is concluded that if repairs to the field drainage were to be carried out by the third party responsible for its upkeep, then the drainage system would be more likely to remain clear and free of sedimentation for longer. It could require some additional works within the field and on the Trans Pennine Trail itself to prevent the ponding of water in the vicinity of the SSSI. Potters will have to maintain their part of the drainage system as part of their Management System for the site, and, are willing to co-operate with BMBC and the owner to assist in the resolution of the immediate and ongoing drainage issues.

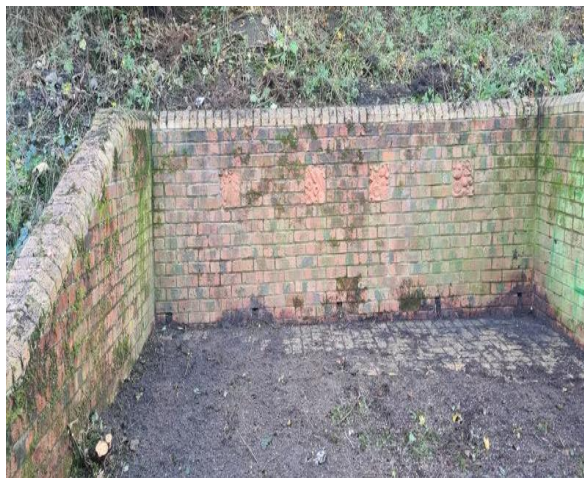
**Figure 17      Brick Enclosure on West side of Trans Pennine Trail**

There is a brick enclosure associated with the Marine Band SSSI located on the west side of the Trans Pennine Trail just beyond the site boundary. This was almost completely obscured by vegetation but was cleaned off and re-exposed by Potters Contractor during the course of preparing for the CCTV survey during November 2021. Potters would like to offer to carry out repairs to the enclosure by removing roots, improving the floor, cleaning up the brickwork and sponsoring a suitable bench and / or signage that could be put up inside the enclosure to provide information about the Marine Band located opposite along with a practicable element of ongoing maintenance. A further suggestion is to carry out a small amount of vegetation removal to a limited section of the embankment within the SSSI to re-expose the Marine Band for the benefit of interested parties.
