# Weddle Landscape Design

## GYPSY LANE, WOMBWELL

### Tree Survey, Arboricultural Impact Assessment and Method Statement

February 2019 (Revision A - May 2019)

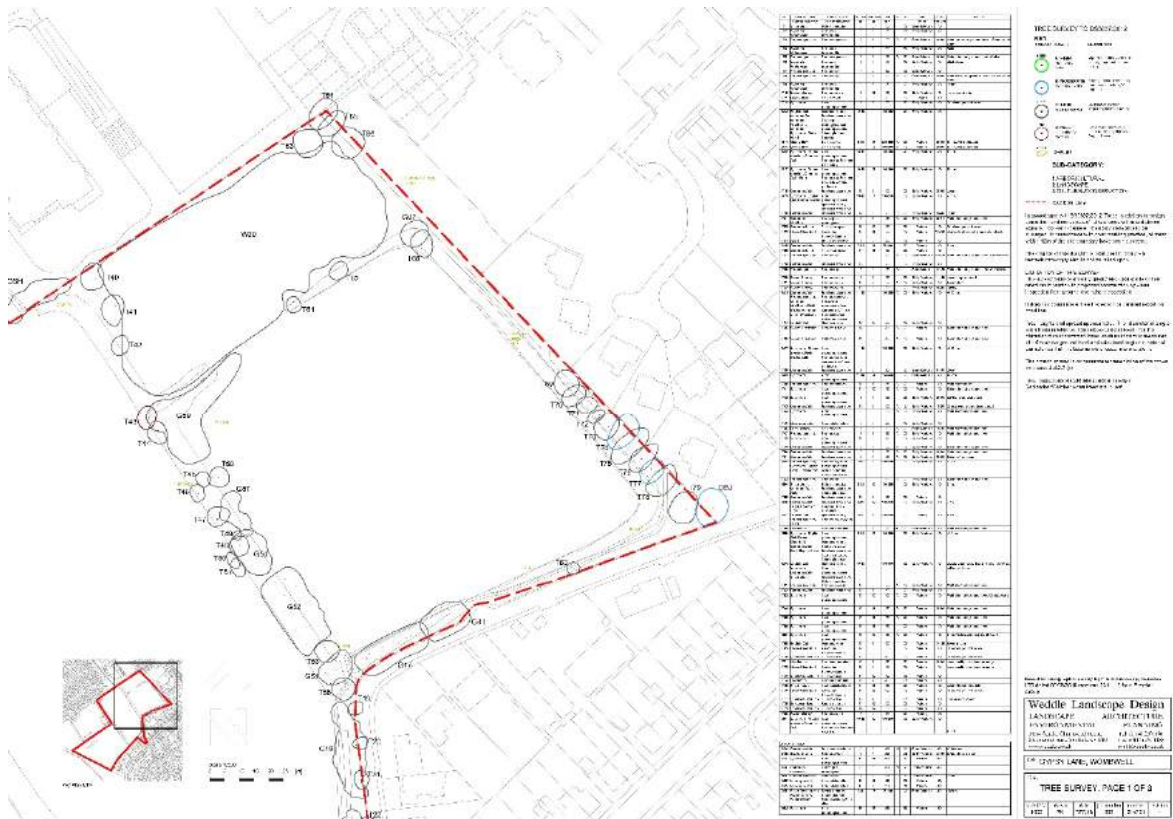
Tree Survey GLW 01A

The tree survey includes an assessment of life stage, life expectancy, general observations on condition and categorisation in accordance with BS 5837:2012 'Trees in Relation to Design, Demolition and Construction – Recommendations' Section 4.5 and Table 1. Specific This information is presented in the tree schedule on drawing GLW 01A.

The majority of the trees on the site were planted as part of the school and sports field in the mid 1990's. There appears to have been very little management of trees throughout the site, particularly within the sports field shelterbelts which has resulted in suppressed and leaning stems.

The majority of the trees are low quality and unremarkable, with the best arboricultural features being the woodland block at the north of the site and the belt of mature trees on the eastern boundary.

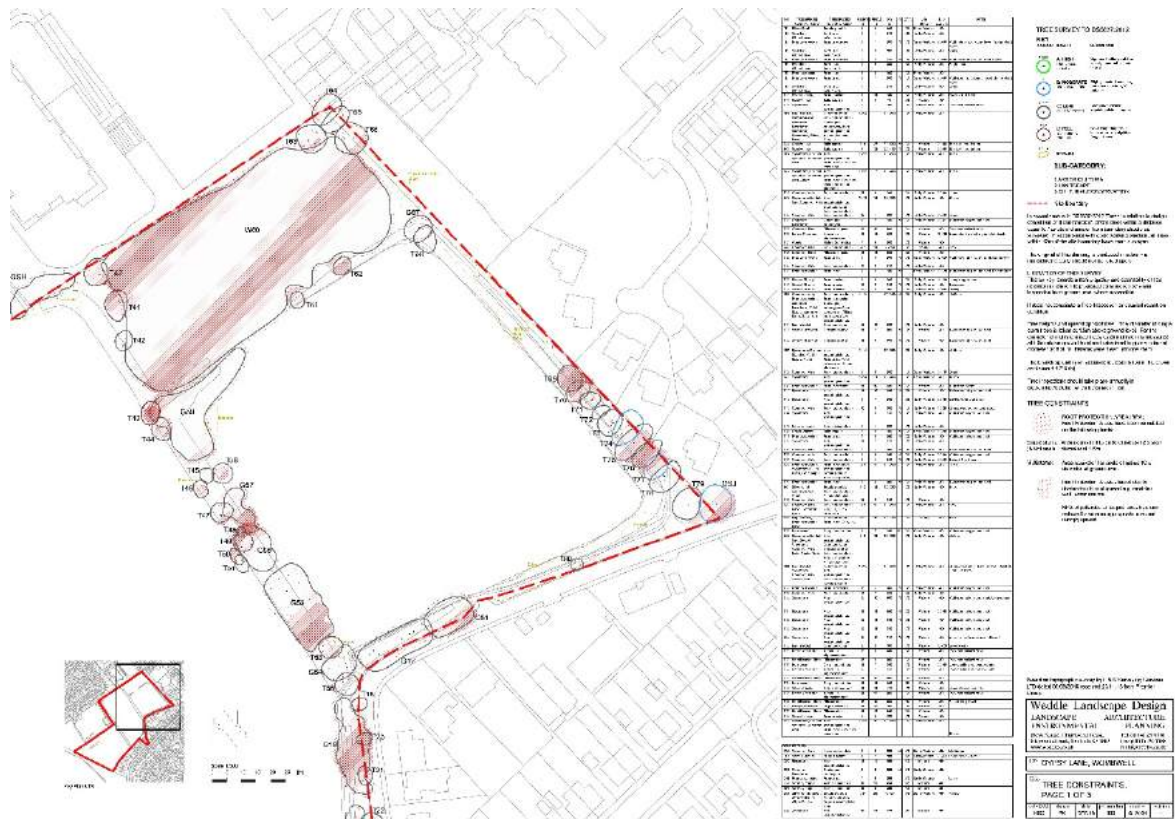
Tree Constraints GLW 04A

The Root Protection Area (RPA) as defined by BS 5837:2012 'Trees in Relation to Design, Demolition and Construction – Recommendations' has been identified and shown on the Tree Constraints Plans (see drawings GLW 04A, GLW 05A and GLW 06A). This is the zone of roots which should be protected against damage during construction.

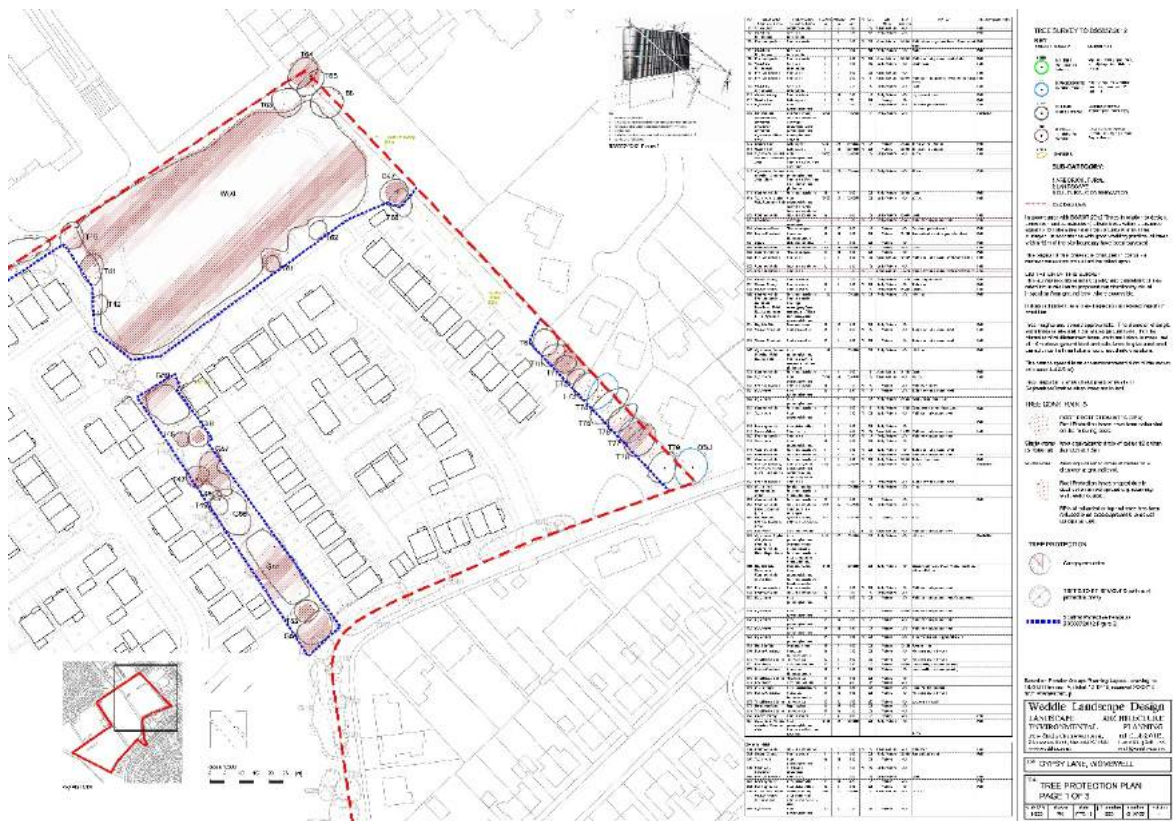
Tree Protection Plan GLW 07A

The proposed layout is shown on drawings GLW 07A, GLW 08A and GLW 09A Tree Protection Plan. The Tree Protecting Plan also indicates the position for protective barriers.

All other trees will be retained. The proposed development has the potential to impact on the retained trees and protective fencing will be erected to surround all retained trees. The location of protective fencing is shown on drawings GLW 07A, GLW 08A and GLW 09A Tree Protection Plan.
