## Oak Close, Barnsley Tree Survey

June 2010

Report to: Pollard Thomas Edwards Architects  
UNIT S204  
2nd Floor  
Merchants Court  
Liverpool  
L21TS  
Report Title: Oak Tree Close – Tree Survey  
Revision: Draft  
Date: June 2010  
Report Ref: 2697

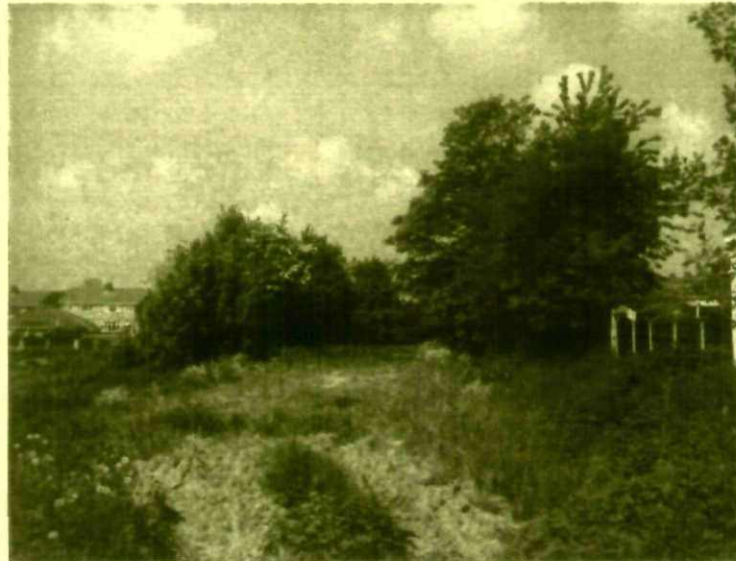
Photograph 1 – General Overview of the site being surveyed

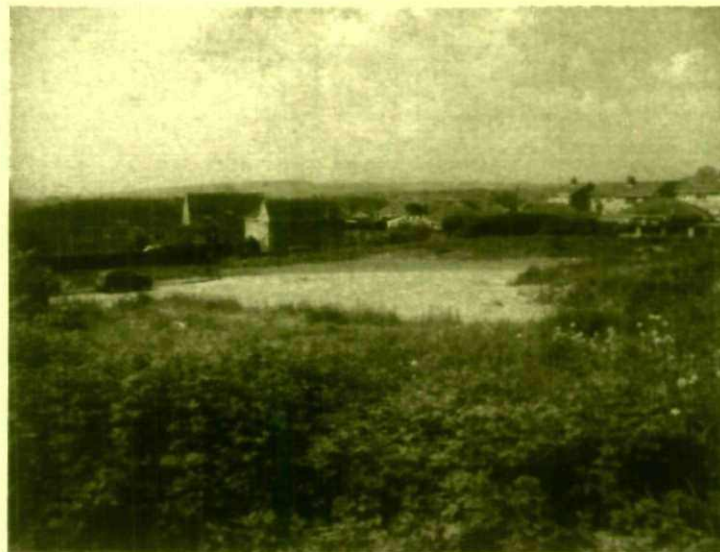
Photograph 2 – General overview of the site being surveyed

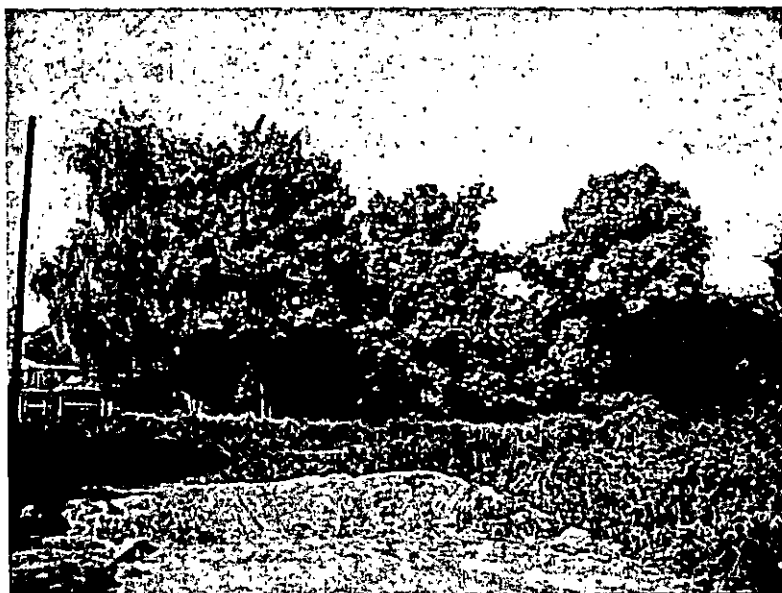
3.2.1 Tree T1 is a mature Birch located very close to the north perimeter of the site. This tree provides the properties to the north with a well established canopy screen. The single upright trunk supports an open, evenly balanced canopy with pendulous habit common to the species. Minor dead wood is visible to the lower branches but there are no nests or potential bat roost opportunities visible. The tree is included within Photograph 3. This tree is recommended for retention and placed in category B2. An RPA of 3.6m is required to protect the root zone of this tree.

3.2.2 Tree T2 is a Norway Maple, possibly a hybrid with Sycamore which is not uncommon to the area. It is multi-stemmed from the base with two major well balanced trunks supporting an openly irregular canopy that is heavy to the South side. Minor dead wood is visible in the canopy and basal regeneration is evident. Ash and Maple saplings are providing low canopy cover. The tree is pictured in Photograph 3. There is no indication from ground level of nesting birds or suitable bat roost opportunities at the time of the survey. This tree is recommended for retention and placed in category B2. An RPA of 4.2m is required to protect the root zone of this tree.

3.2.3 Tree T3 is also a Norway Maple, (possibly also a hybrid with Sycamore). It is multi-stemmed from the base with two major trunks favoring slightly to the south and supporting an openly irregular canopy that is not well balanced. Structurally this tree has some significant dead wood, poor canopy shape and is partly overshadowed by adjacent trees. Basal regeneration is evident. A Cypress hedge in the neighboring property is partially screening and dominating the north aspect of this tree. The tree is shown in Photograph 3. There is no indication from ground level of nesting birds or suitable bat roost opportunities at the time of the survey. This tree may be retained or could be removed as it is placed in category C2. If retained, an RPA of 3.3m will be required to protect the root zone of this tree.

3.2.4 Tree T4 is another potentially hybrid Norway Maple located close to the site boundary. It has a single trunk supporting a well balanced, openly irregular canopy with minor dead wood. The lower branches have been removed. The established Cypress hedge is once again present to the rear (north) side reducing the canopy on this side. The tree is shown in Photograph 3. There is no indication from ground level of nesting birds and little obvious sign of suitable bat roost opportunities at the time of the survey. This tree

may be retained or could be removed as it is placed in category C2. If retained, an RPA of 3.7m will be required to protect the root zone of this tree.

Photograph 3 – Left to right T1 (Birch) T2, T3 and T4 (Maples)

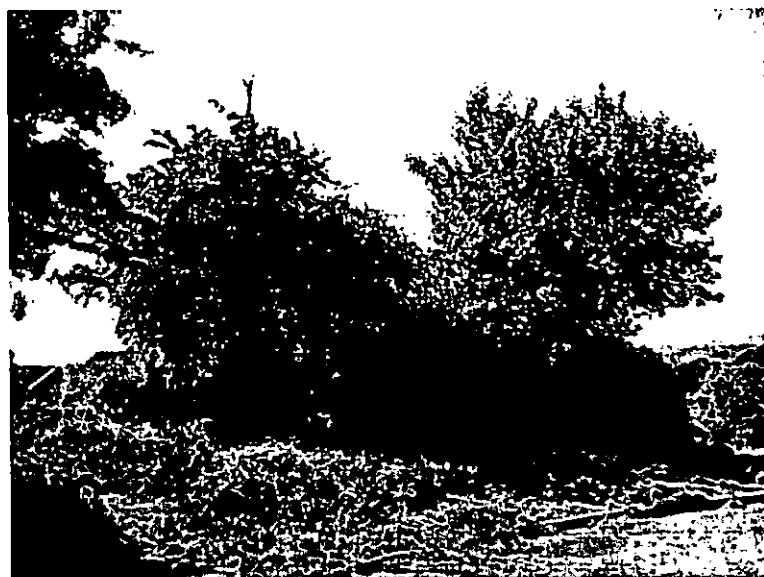
- 3.2.5 Tree T5 is another potentially hybrid Norway Maple located a short distance from the other. It has a single trunk supporting a broadly ascending canopy, irregular in places, that is unevenly balanced favoring the west. There is significant Laurel undergrowth around the base of the tree. A major wound on the trunk is in the process of healing over. There is, however, significant dead wood visible in canopy. The tree is shown in Photograph 4. There is no indication from ground level of nesting birds or suitable bat roost opportunities at the time of the survey. This tree may be retained or could be removed as it is placed in category C2. If retained, an RPA of 3.9m will be required to protect the root zone of this tree.

| Tree No | Species | Ht (m) | Stem Diam cm@ 1.5m (mm) | Canopy Spread (m) | Height of Crown Clearance | Age Class | Overall Condition | Structural condition | Recommendations | BS 5837 Category | RPA (m <sup>2</sup> ) | RPA Radius (m) |
|---|---|---|---|---|---|---|---|---|---|---|---|---|
| T5 | MAPLE ( <i>Acer platinoides</i> – Norway Maple) | 7 | 330 | 4 | 3 | M | F/P | A single trunk supporting a broadly ascending canopy, irregular in places, that is unevenly balanced favoring the west. Significant Laurel undergrowth. Major wound on the trunk is healing. Significant dead wood visible in canopy. <b>Photograph 4.</b> No indication from ground level of nesting birds or suitable bat roost opportunities at the time of the survey. | <b>This tree is not in good condition and is one three with interlocked canopies. It provides minimal landscape screening effect. Consider REMOVAL or REDUCTION to improve shape and health.</b> | C2 | 49 | 3.9 |

Photograph 4 – T7 (left) and T5 (right)

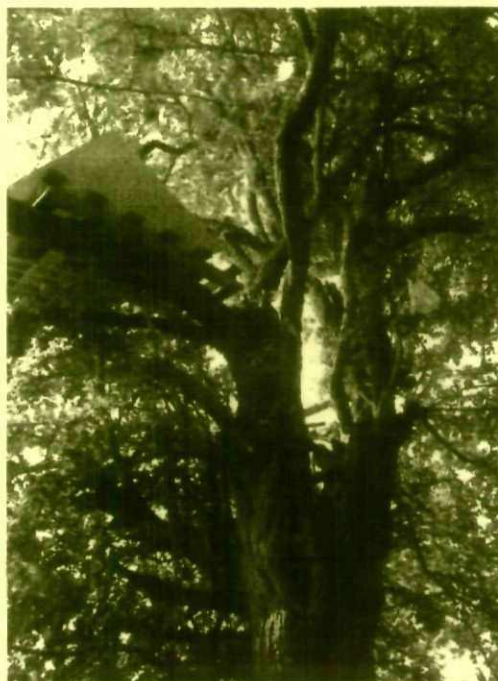
- 3.2.6 Tree T6 is an over mature Hawthorn, possible a residual of an original hedgerow in this location. It has poor canopy structure with a tree house apparently being constructed within the lower branch divisions. There are major bark wounds on trunk and major dead wood visible in the canopy. The canopy is twisted (strangled) and has become irregular due to age and damage. It is shown in Photograph 5. No nests are visible but this tree has potential to provide bat roosting opportunities. This tree is classed in category R and should be removed after being inspected for roosting bats.

| Tree No | Species | Ht (m) | Stem Diam cm@ 1.5m (mm) | Canopy Spread (m) | Height of Crown Clearance | Age Class | Overall Condition | Structural condition | Recommendations | BS 5837 Category | RPA (m <sup>2</sup> ) | RPA Radius (m) |
|---|---|---|---|---|---|---|---|---|---|---|---|---|
| T6 | HAWTHORN ( <i>Crataegus monogyna</i> ) | 6 | 420 | 3.5 | 3 | OM | P | An over mature Hawthorn, possible a residual of an original hedgerow. Poor canopy structure with a tree house being constructed. Major bark wounds on trunk and major dead wood visible in canopy. Canopy is twisted (strangled) and has become irregular due to age and damage. <b>Photograph 5.</b> No nests visible but has potential to provide bat roost opportunities. | <b>REMOVE. Consider inspecting for roosting bats and nesting birds prior to felling. (WCA 1981 rev.)</b> | R | N/A | N/A |

Photograph 5 – T6: Over mature Hawthorn (*Crataegus monogyna*)

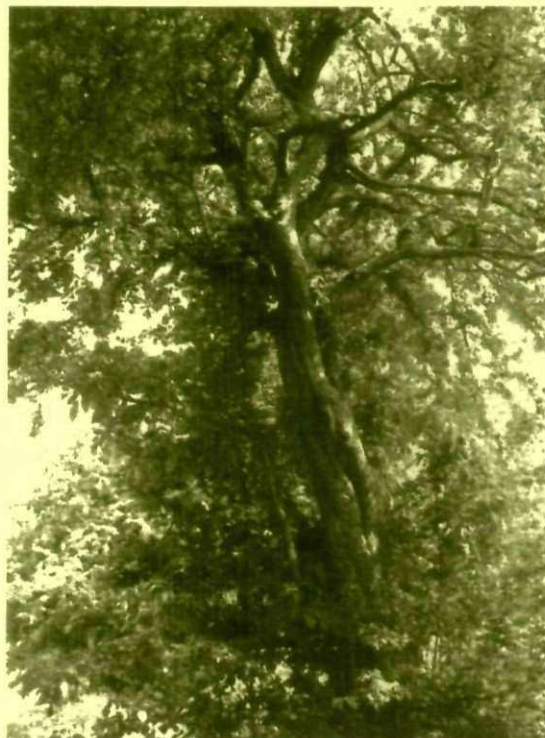
- 3.2.7 Tree T7 is an over mature Hawthorn located close to T6 and therefore possibly also a residual of an original hedgerow. It has a poor, interlocked canopy structure. Major bark wounds are visible on the trunk and major dead wood is visible in canopy. The canopy has become irregular due to age, over-shadowing and damage. Photographs 4 and 6 show this tree. No nests are visible but this tree has the potential to provide bat roost opportunities. This tree is classed in category R and should be removed after being inspected for roosting bats.

| Tree No | Species | Ht (m) | Stem Diam cm@ 1.5m (mm) | Canopy Spread (m) | Height of Crown Clearance | Age Class | Overall Condition | Structural condition | Recommendations | BS 5837 Category | RPA (m <sup>2</sup> ) | RPA Radius (m) |
|---|---|---|---|---|---|---|---|---|---|---|---|---|
| T7 | HAWTHORN (Crataegus monogyna) | 5-6 | 380 | 3 | 3 | YNG | P | An over mature Hawthorn, possible a residual of an original hedgerow. Poor canopy structure. Major bark wounds on trunk and major dead wood visible in canopy. Canopy is twisted (strangled) and has become irregular due to age and damage. <b>Photographs 4 and 6.</b> No nests visible but has potential to provide bat roost opportunities. | <b>REMOVE. Consider inspecting for roosting bats and nesting birds prior to felling. (WCA 1981 rev.)</b> | R | N/A | N/A |

Photograph 6 – T7: Close up of over mature Hawthorn.

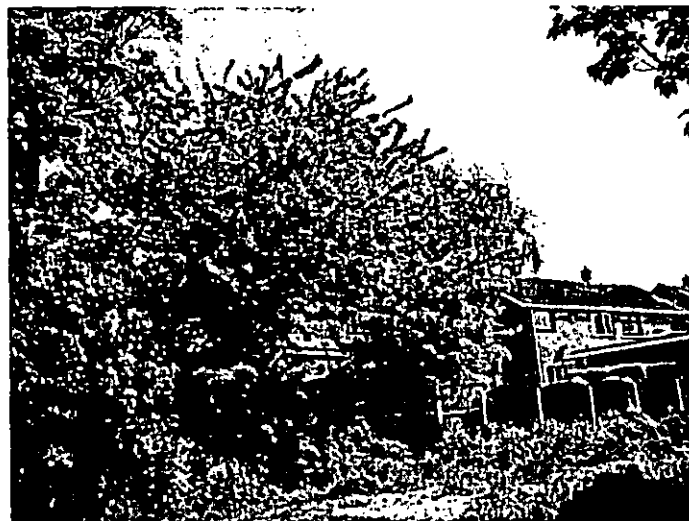
- 3.2.11 Tree T11 is a Cherry. Located close to the east boundary of the site, this tree has a single trunk supporting an ascending even canopy that provides good landscape

screening. There is some moderate dead wood visible in lower canopy but this is not significant. This tree is shown in Photograph 8 and 9. This tree may be retained or could be removed as it is placed in category C2. If retained, an RPA of 4.2m will be required to protect the root zone of this tree.

3.2.12 Tree T12 is a young, upright, single trunk Birch tree located 1m from boundary fence that has a light, open, narrowly headed canopy. A Beech tree is growing through the Birch canopy and competing with the Birch. The tree is shown in Photographs 8 and 9. The Birch may be retained or could be removed as it is placed in category C2. If retained, the Birch will RPA of 2.2m to protect the root zone of this tree. The Beech tree should be removed.

Photograph 8: Cherry T11 with Birch T12 to rear.

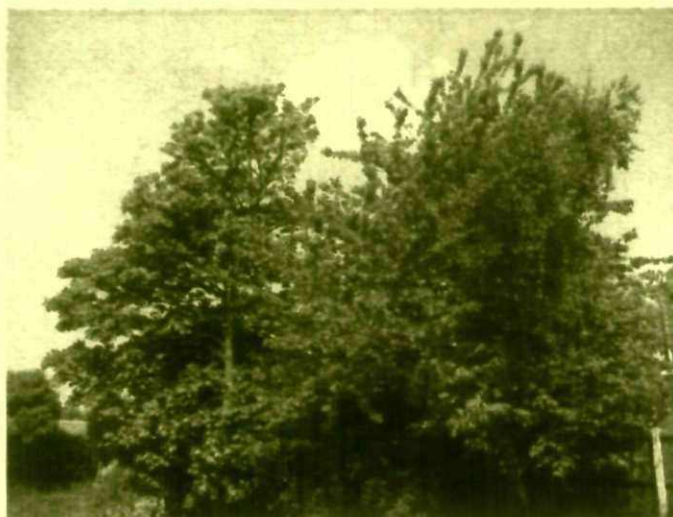
Photograph 9: Reverse view of Birch T12, Cherry T11 and Maple T10
