# ARBORICULTURAL REPORT

*Land Off*  
***Wakefield Road,  
Mapplewell,  
Barnsley,  
South Yorkshire  
S75 6FZ***

Date: *June 2017*

Reference: *AWA1887*

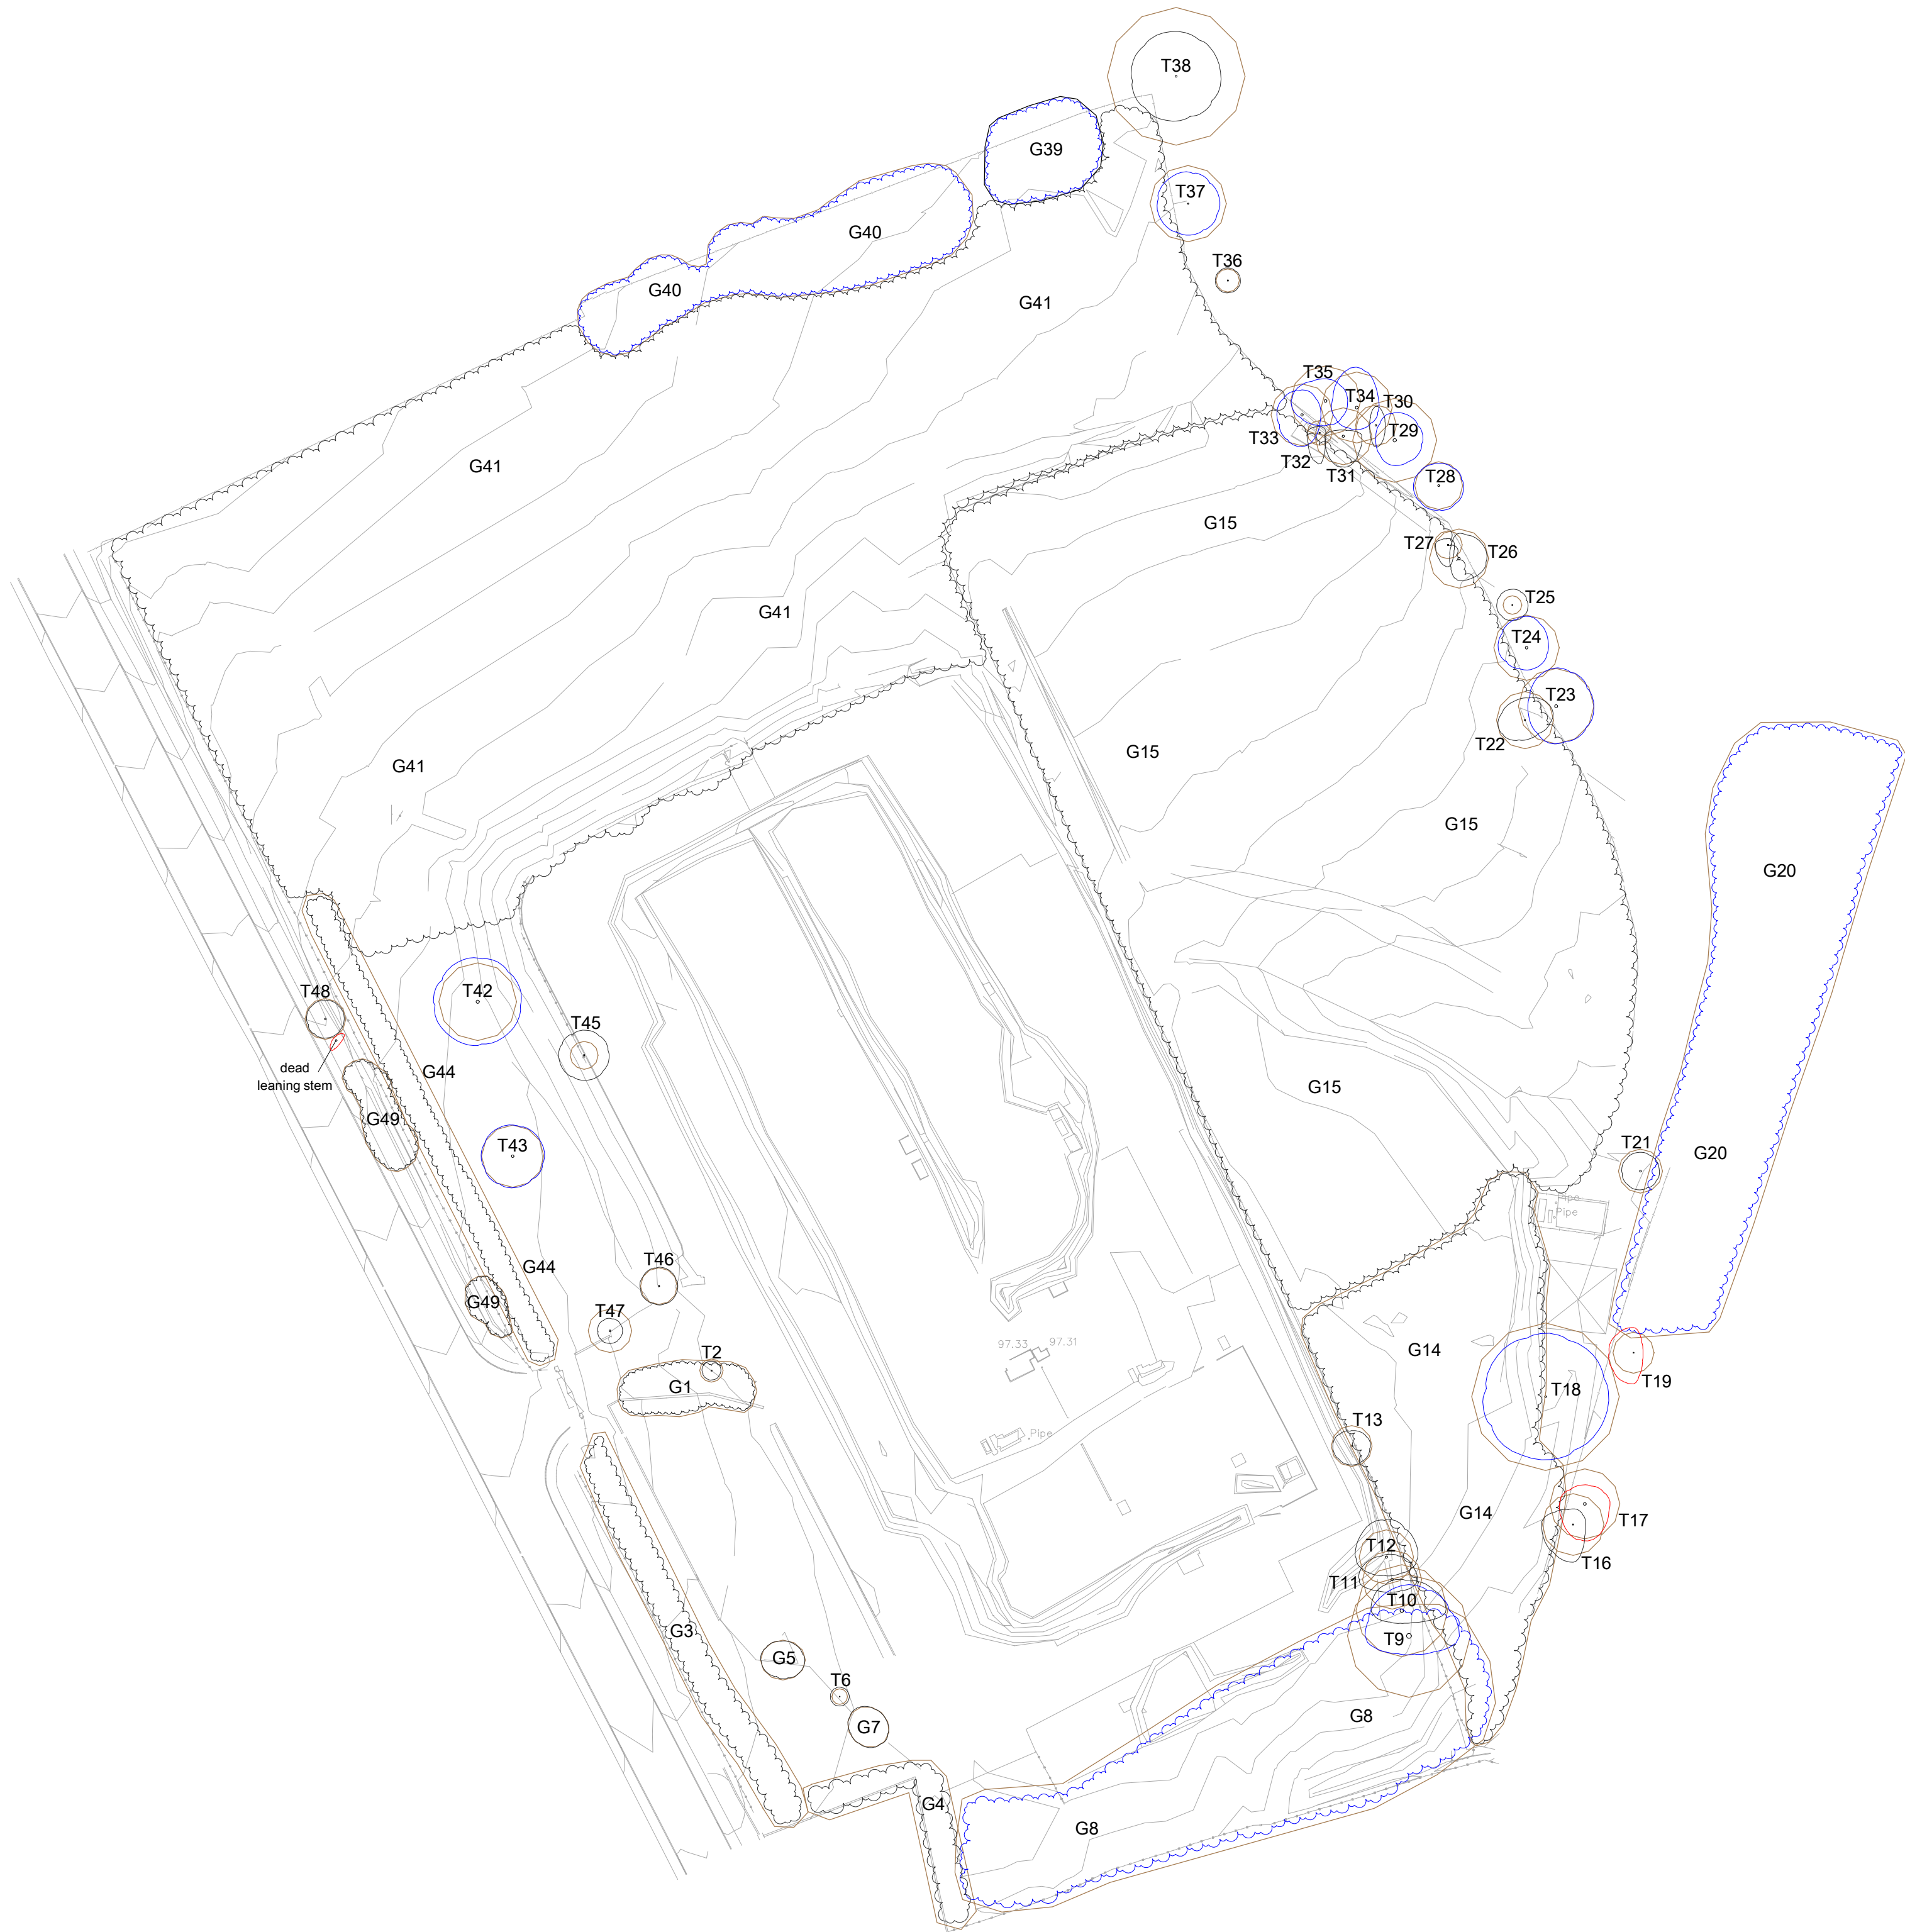
**Appendix 5:**  
**Tree Constraints Plan**  
Wakefield Road, Mapplewell, S75 6FZ  
Ref: AWA1887

- 3.2.15 The tree Root Protection Area (RPA) detailed on the Tree Constraints Plan at Appendix 5, has been used as a layout design tool, to inform on the area around a tree where the protection of the roots and soil structure is treated as a priority.

- 3.3.4 The tree Root Protection Area (RPA) detailed on the Tree Constraints Plan at Appendix 5, should be used as a layout design tool, to inform on the area around a tree where the protection of the roots and soil structure is treated as a priority.
