ARBORICULTURAL REPORT & Impact Assessment to BS 5837:2012 at:

***Clover Cottage,
Common Road,
Brierley
Barnsley
S72 9EA***

Reference: *AWA5914*

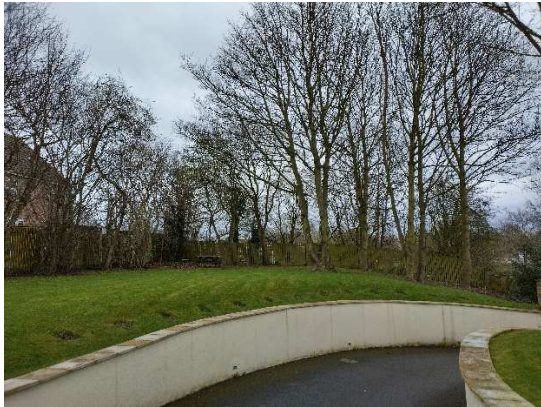
- 3.2.13 Two tree groups border the property on the northwestern boundary. These are G8, a linear group of Hazel, and G59 and linear group of Hawthorn. These both provide screening between the site and adjacent properties as well as good wildlife habitat.

Photo 1: T1 to G8 from west

G8	Hazel	<i>Corylus avellana</i>	Early-mature	9	10+	150 avg	Yes	0.5	See plans				Limited access around base	Multiple stemmed at base. Epicormic growths. Ivy covered	Minor deadwood	Ivy prevented detailed inspection of base and stems. Overhanging adjacent property to northwest. Pruned back from neighbouring property leaving stubs. 1 moderate sized dead stem within falling distance of adjacent garden	Fair	Fair	20 to 40 yrs	Moderate	C	No works required
T9	Oak	<i>Quercus sp.</i>	Mature	16	1	880	No	5	6	7	6	7	No visual defects	Single stemmed Old pruning wounds	Minor deadwood. Stubs. Old pruning wounds	Overhanging adjacent property. Timber fence in contact with stem at 2m to northwest. Access prevented detailed inspection and accurate measurements of northwestern crown.	Good	Good	>40 yrs	Moderate	A	No works required

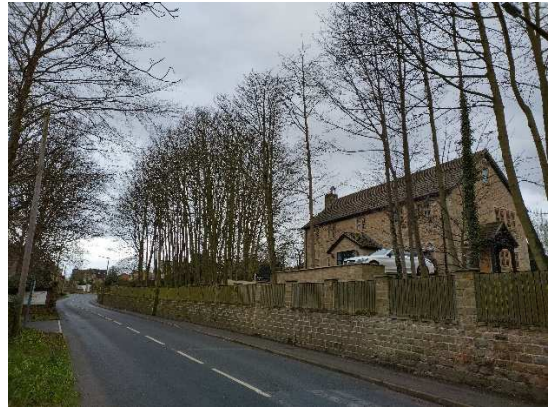
- 3.2.9 The Sycamores that grow along the southeastern edge of the site were likely part of a more densely wooded area that was thinned to retain the existing trees. As a result of this many of them have tall slender stems with little crown growth. In addition, many along the roadside have been crown raised to between 8 to 10m. Whilst these trees collectively have moderate amenity and provide good screening between the road and the dwelling, many of them have a reduced life-expectancy due to their poor form.

- 3.2.10 Ash tree T12 and Sycamores T29, T39, T40, T41 and T45 all show signs of poor physiological and structural health and are within falling distance of the road. As such it is advised that they are removed regardless of the development.

Photo 2: view of southeastern boundary from east

4.2.5 The following 6 trees are unsuitable for retention and need to be removed regardless of development: T12, T29, T39, T40, T41 and T45.

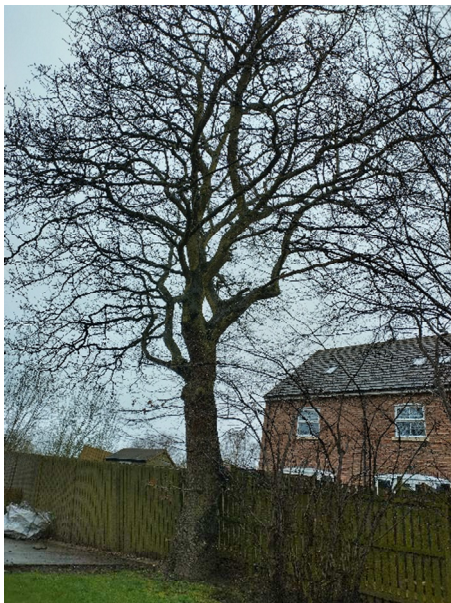
- 3.2.7 Most of the trees are semi-mature with some early-mature. There are occasional young and mature trees.
- 3.2.8 The site's most significant tree is T9, a mature Oak. This is situated on the northwestern boundary of the site. This tree is prominent throughout the

northeastern area of the site and the surrounding area and provides a moderate level of amenity value. It is in good physiological and structural health and is retention category A.

Photo 3: T9 from east

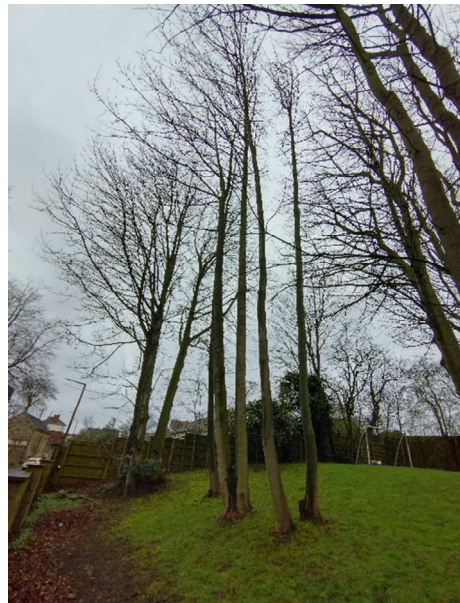
Photo 4: T46, T47, T48, T49 and T50 from east

T46	Sycamore	<i>Acer pseudoplatanus</i>	Semi-mature	18	1	220	No	10	1	1.5	1	1.5	No visual defects	Single stemmed Vertical. Stubs. Old pruning wounds	Small / sparse. Minor dieback. Minor deadwood	Very little crown. Tall slender stem	Fair	Poor	10 to 20 yrs	Low	C	No works required
T47	Sycamore	<i>Acer pseudoplatanus</i>	Semi-mature	18	1	200	No	12	0.5	2	3	0.5	No visual defects	Single stemmed Vertical	Minor dieback. Minor deadwood. Small / sparse	Tall slender stem within falling distance of road	Fair	Poor	10 to 20 yrs	Low	C	No works required

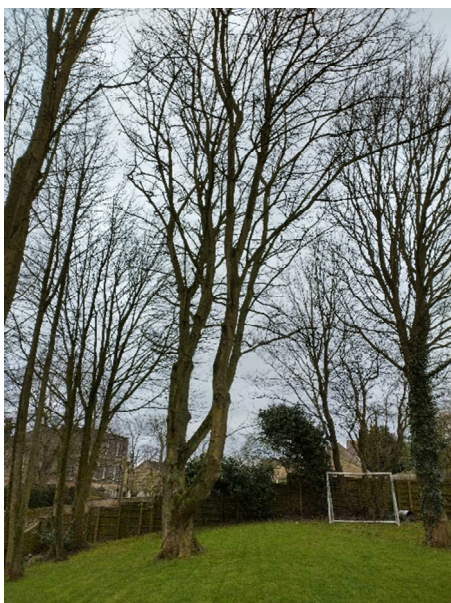
- 3.2.11 T51 is a mature Sycamore in a more central position in the southwestern lawned area. This is in good structural and physiological health and has good long-term prospects. It is retention category B.

Photo 5: T51 from northeast

4.2.4 Sycamore T51 is retention category B, however it has only low amenity value due to being surrounded by trees to the north, south and west which screen it from the road and the neighbouring properties. As such, the removal of T51 removal will have only a minor negative impact in terms of visual amenity. The removal will largely be mitigated by the retention of most of the boundary Sycamores at the site.

T51	Sycamore	<i>Acer pseudoplatanus</i>	Mature	18	2	520, 790	No	6	9.5	5	5	8.5	No visual defects	Multiple stemmed at 2m. Old pruning wounds. Tight union. Cup-like union collecting dirt/water. Minor cavities. Stubs	Old pruning wounds. Minor deadwood. Tight union	Minor deadwood in southeastern crown likely from pruning. Pruning wounds on stem up to 6m. Tight union at 7m in northern crown	Good	Good	>40 yrs	Low	B	Removal required to facilitate development

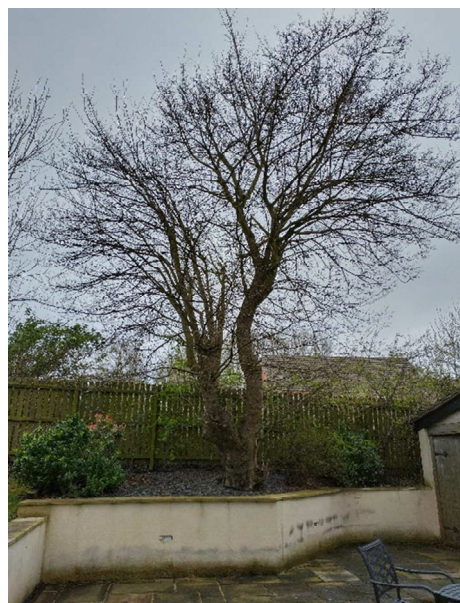
- 3.2.12 Field Maple T62 is a good example of its species providing good wildlife resources and arboricultural interest. This is also retention category B.

Photo 6: T62 from south

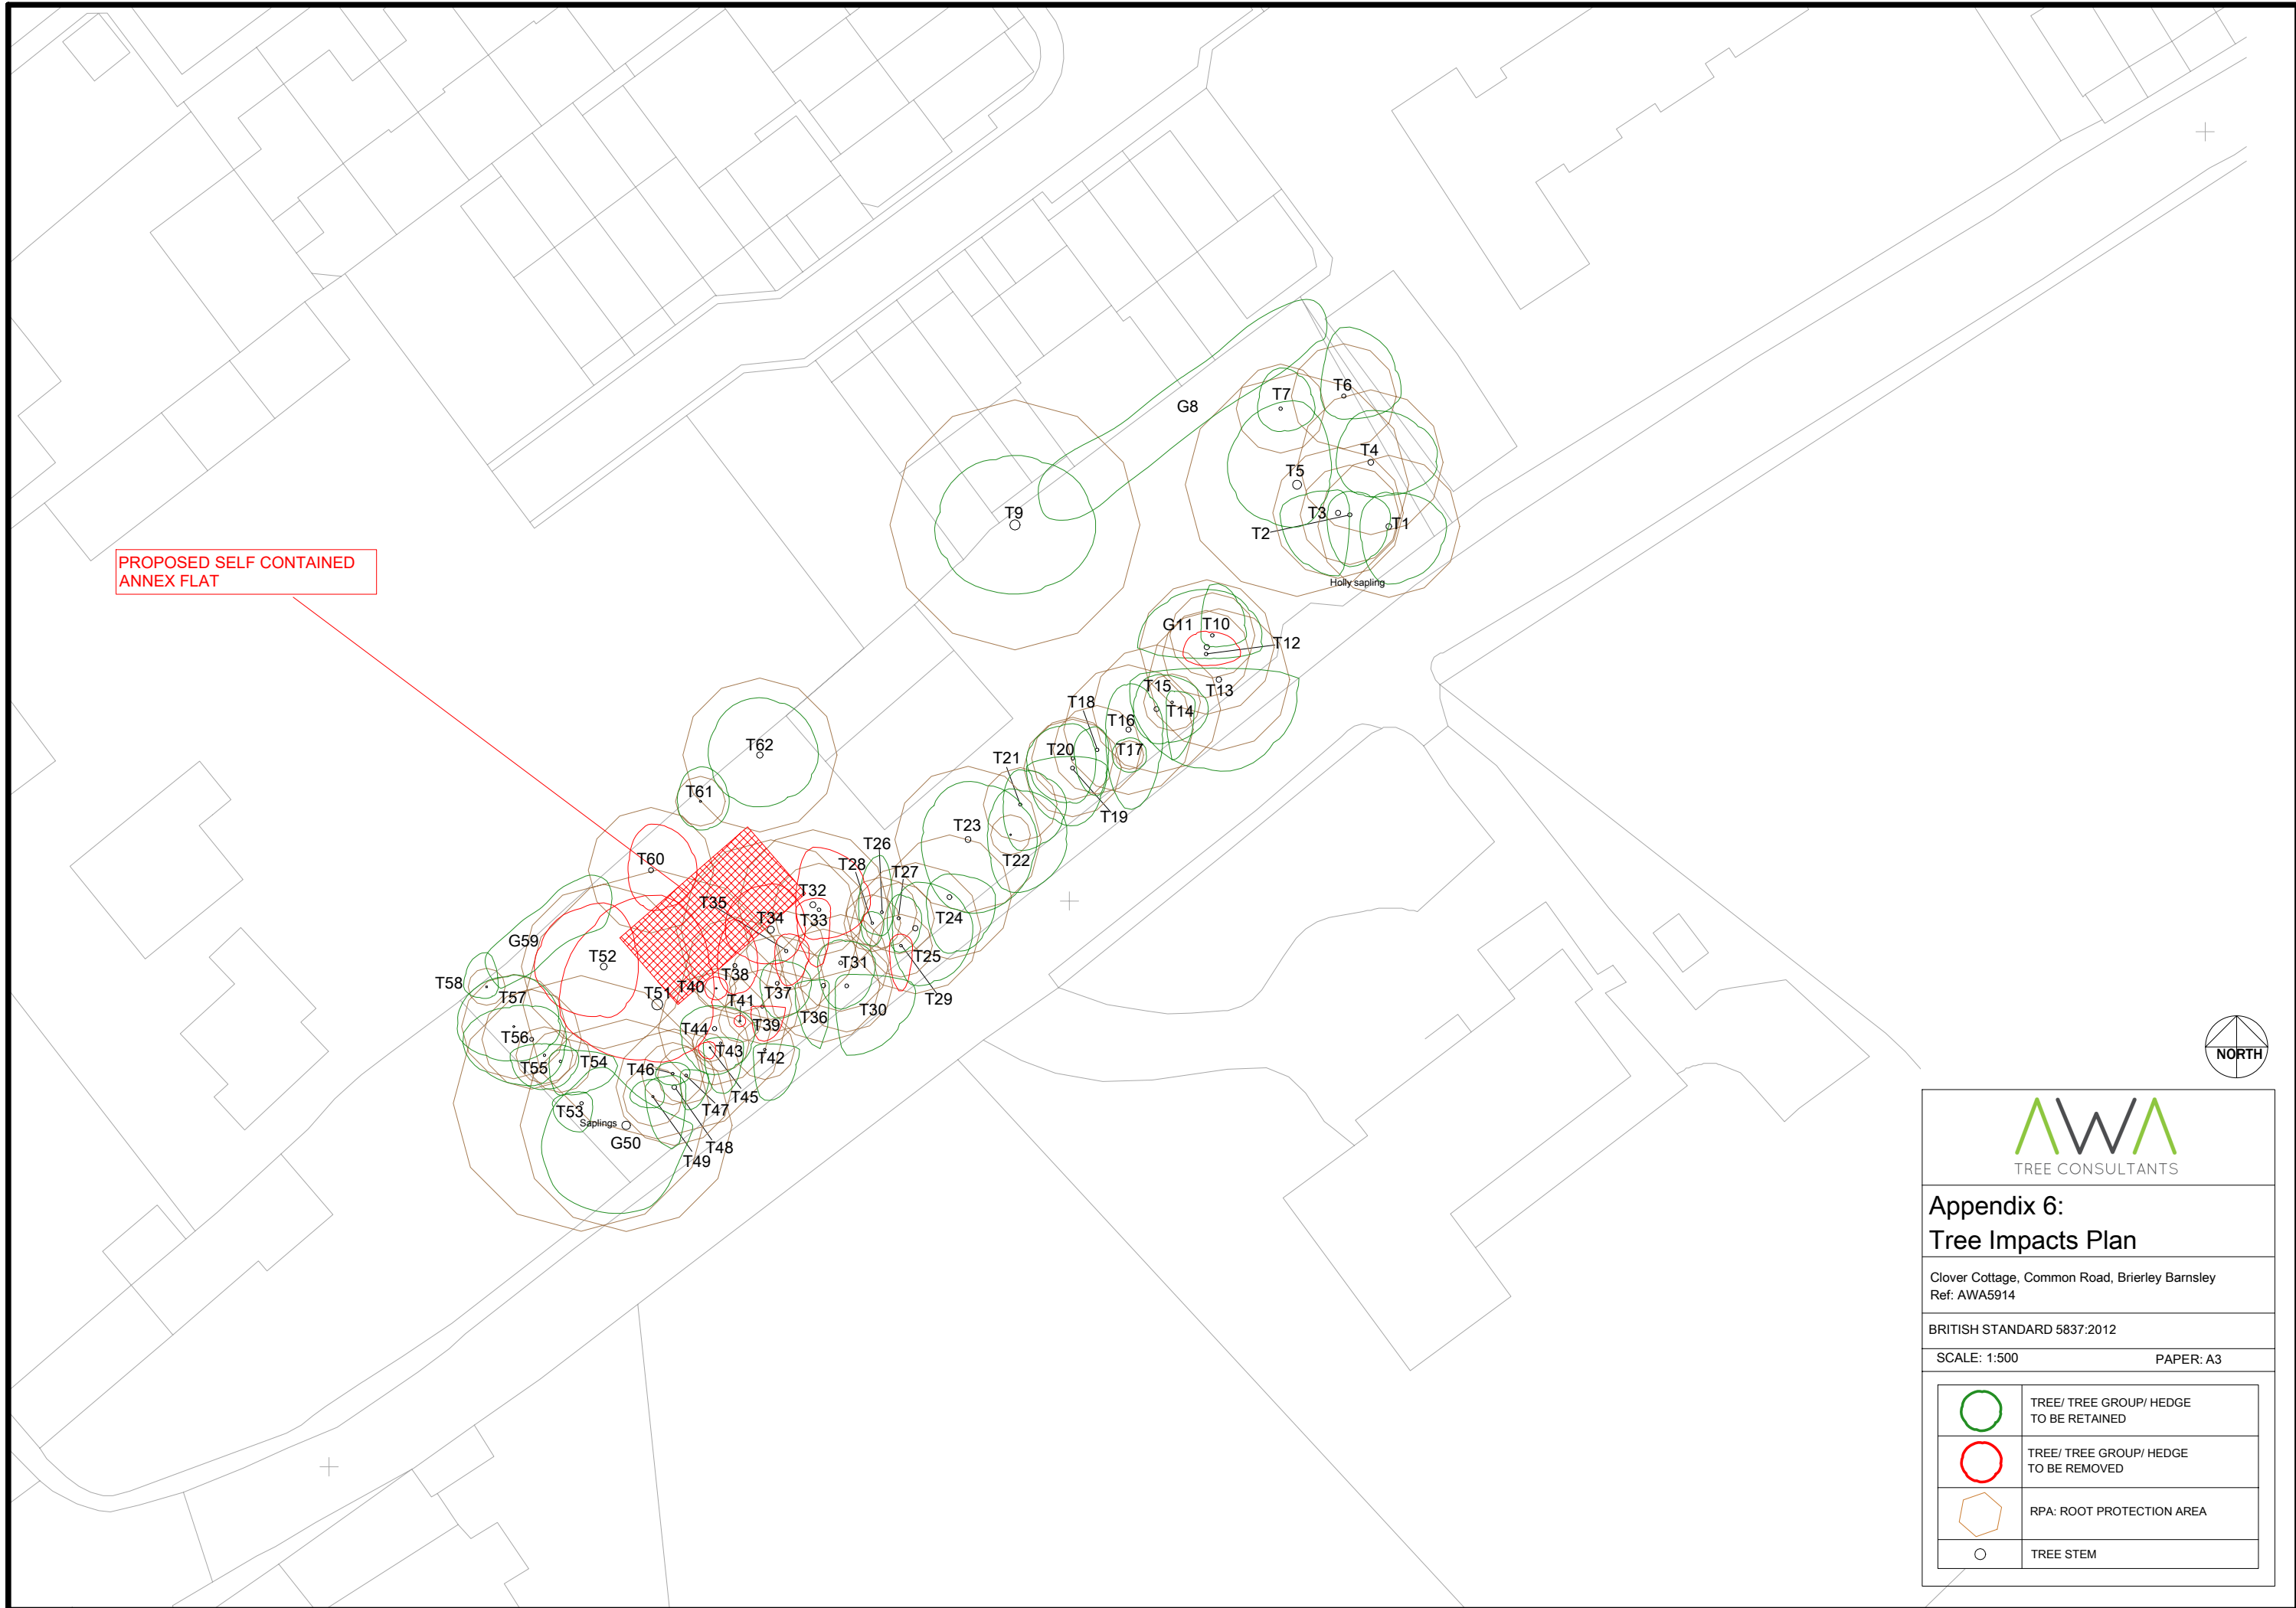
4.2.1 From assessing the new development proposals, 8 trees will require removal to facilitate the development as they are situated in the footprint of the development or their retention and protection throughout the development is not suitable.

4.2.2 The trees that require removal to facilitate the development are T32, T33, T34, T35, T38, T51, T52 and T60.

4.3.2 Potentially damaging activities are proposed in the vicinity of retained trees. The new development encroaches close to and into the edge of the RPA of T44. Construction within the RPA can have negative impacts on tree roots. However, the encroachment is very minor, and the detailed RPA for these trees is likely to be a slightly exaggerated representation of the trees actual rooting area. As such, it is unlikely that significant roots will be within these areas and the retained tree should remain largely unaffected by the

- 4.5.1 The retained trees will require protection by fencing in accordance with BS 5837: 2012, during the development phase.
- 4.5.2 If required by the Local Planning Authority, an associated Arboricultural Method Statement, detailing protective fencing specifications and construction methods close to the retained trees can be provided.
