Project:	Barnsley Children's Hospital		
Our reference:	BCAU-MMD-00-XX-TN-D-0001		
Prepared by:	J Lea-Wilson	Date:	05/02/2020
Approved by:	A Precious	Checked by:	A Precious
Subject:	Surface Water Planning Conditions

1 Project Background

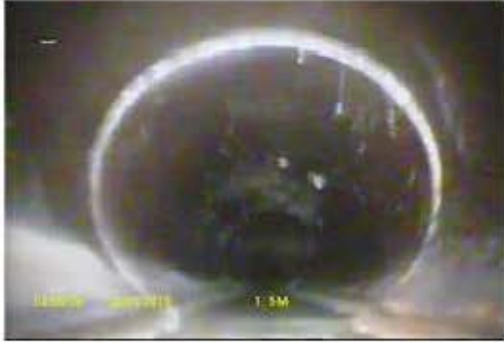
Pos	Video Ref	Code	Description	Image
00.00m		MH	Start node type, manhole MH01	
00.00m	0:00:00	WL	Water level: 0% Height/Diameter	
01.60m	0:00:27	JDM	Joint displaced medium - Severity 3	<p>Image Provided - Ref: 0_2</p>

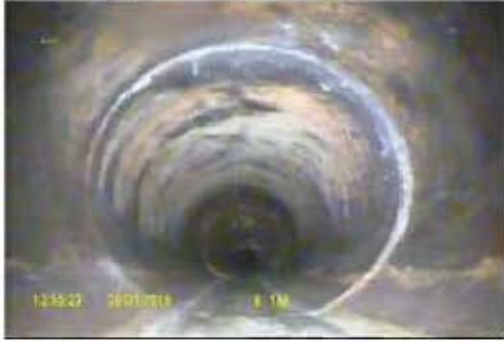
08.10m	0:00:42	JDM	Joint displaced medium - Severity 3	<p>Image Provided - Ref: 0_3</p>

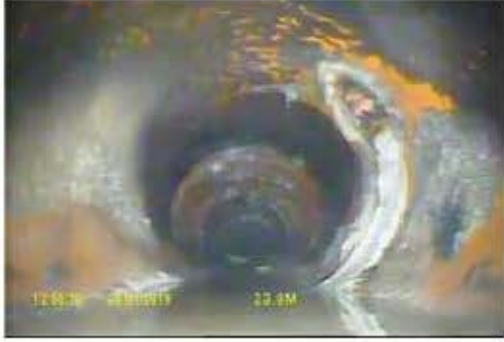
23.80m	0:01:38	DEE	Attached deposits, encrustation from 12 o'clock to 06 o'clock: 10% Cross sectional area loss - Severity 3	<p>Image Provided - Ref: 0_4</p>

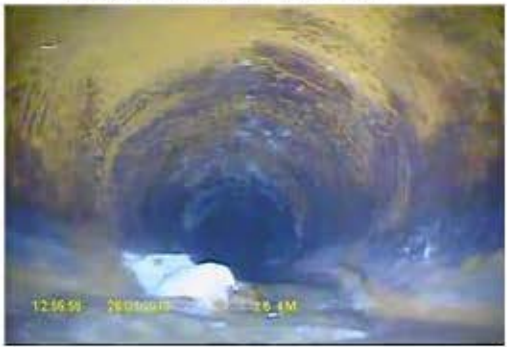
26.40m	0:02:14	D	Deformed drain/sewer: 10% Height/Diameter - Severity 4	Image Provided - Ref: 0_6

26.40m		SA	Survey abandoned Unable to pass deformed pipe.

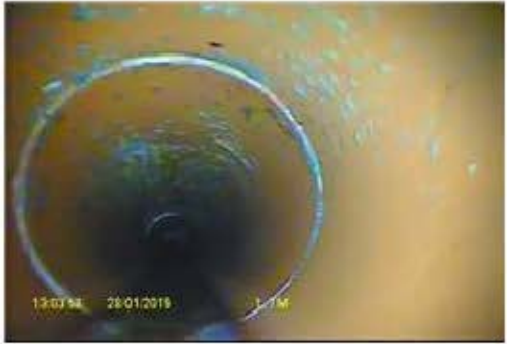
Pos	Video Ref	Code	Description	Image
00.00m		MH	Start node type, manhole MH01	
00.00m	0:00:00	WL	Water level: 0% Height/Diameter	
01.70m	0:00:18	JDM	Joint displaced medium - Severity 3	<p>Image Provided - Ref: 1_2</p>

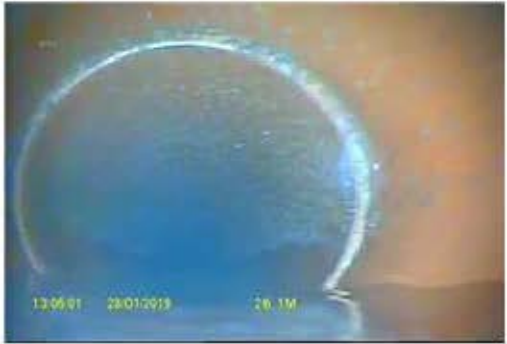
Pos	Video Ref	Code	Description	Image
26.10m	0:01:25	JDM	Joint displaced medium - Severity 3	Image Provided - Ref: 1_5

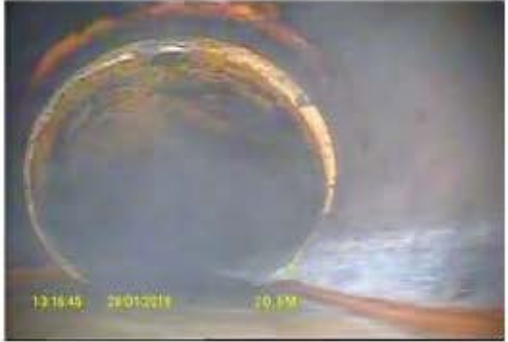
Pos	Video Ref	Code	Description	Image
20.50m	0:02:17	JDM	Joint displaced medium - Severity 3	Image Provided - Ref: 2_6

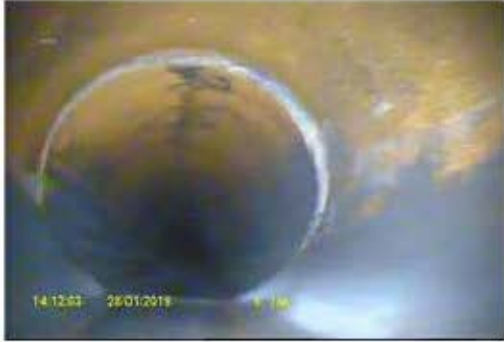
Pos	Video Ref	Code	Description	Image
00.00m		MH	Start node type, manhole MH02	
00.00m	0:00:00	WL	Water level: 0% Height/Diameter	
06.70m	0:00:33	JDM	Joint displaced medium - Severity 3	<p>Image Provided - Ref: 3_2</p>

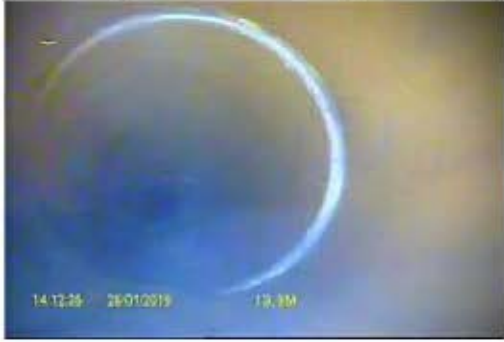
13.90m	0:01:04	JDM	Joint displaced medium - Severity 3	<p>Image Provided - Ref: 3_3</p>

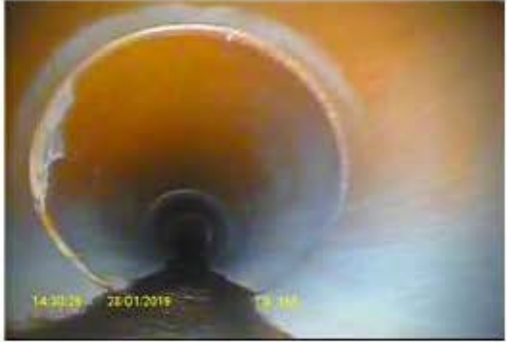
Pos	Video Ref	Code	Description	Image
00.00m		MH	Start node type, manhole MH02	
00.00m	0:00:00	WL	Water level: 0% Height/Diameter	
18.10m	0:00:41	JDM	Joint displaced medium - Severity 3	Image Provided - Ref: 4_2

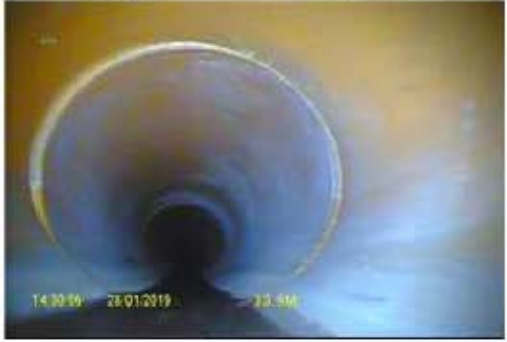
33.90m	0:01:11	JDM	Joint displaced medium - Severity 3	Image Provided - Ref: 4_3

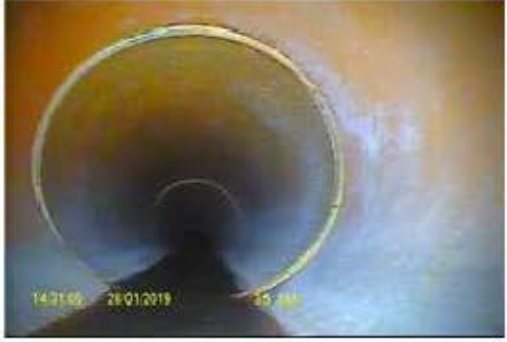
35.30m	0:01:20	JDM	Joint displaced medium - Severity 3	Image Provided - Ref: 4_4

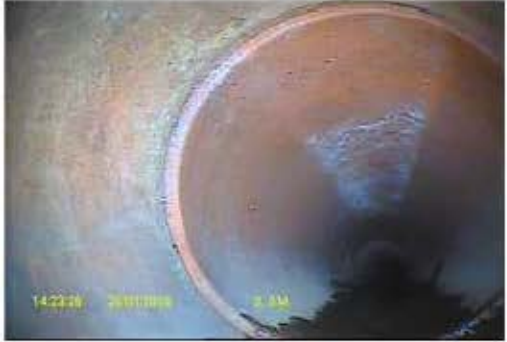
Pos	Video Ref	Code	Description	Image
00.00m		MH	Start node type, manhole MH02	
00.00m	0:00:00	WL	Water level: 0% Height/Diameter	
00.10m	0:00:15	JDM	Joint displaced medium - Severity 3	Image Provided - Ref: 5_2

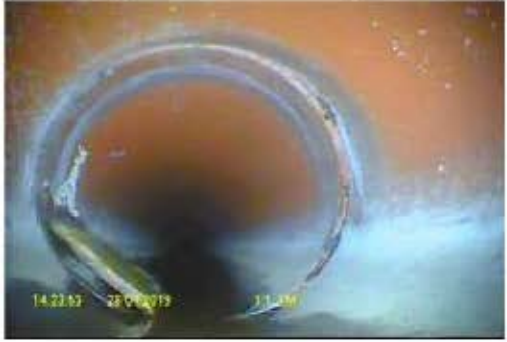
11.30m	0:00:42	JDM	Joint displaced medium - Severity 3	Image Provided - Ref: 5_3

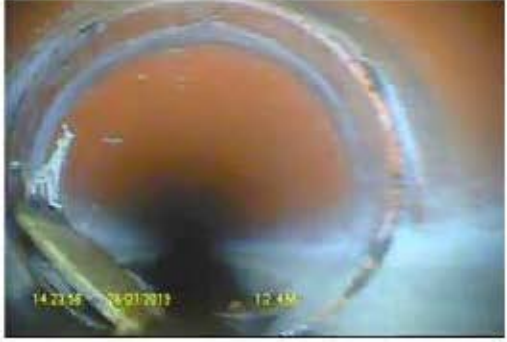
11.30m	0:00:47	OB	Other obstacles: 30% Cross sectional area loss - Severity 3	Image Provided - Ref: 5_4

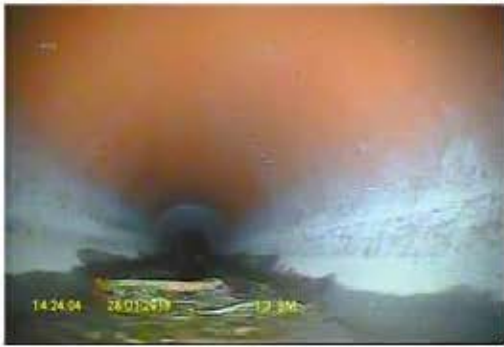
Pos	Video Ref	Code	Description	Image
11.30m	0:00:53	DER	Settled deposits coarse: 20% Cross sectional area loss - Severity 3	Image Provided - Ref: 5_5

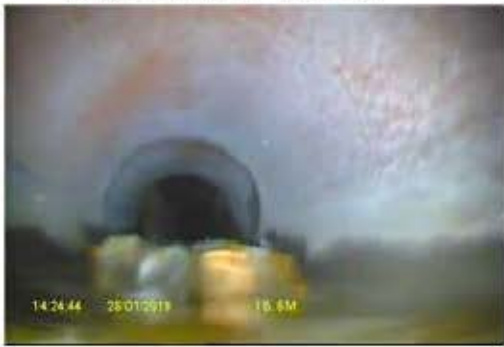
15.60m	0:01:33	OB	Other obstacles: 30% Cross sectional area loss - Severity 3	Image Provided - Ref: 5_6

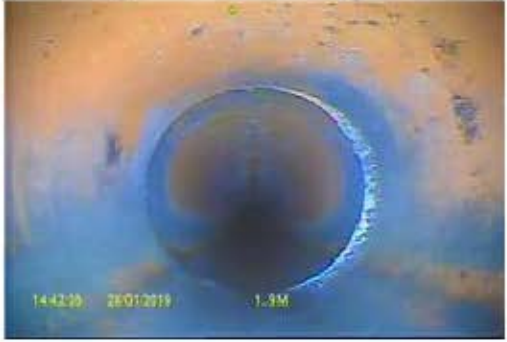
02.20m	0:00:27	JDM	Joint displaced medium - Severity 3	Image Provided - Ref: 6_3

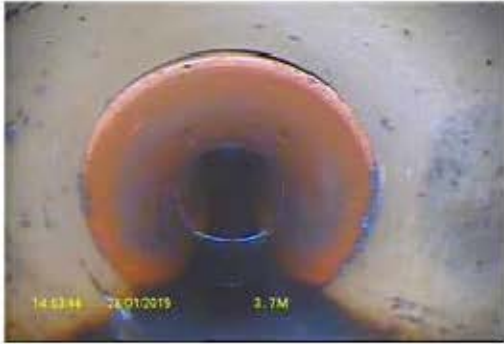
Pos	Video Ref	Code	Description	Image
00.00m		MH	Start node type, manhole MH02	
00.00m	0:00:00	WL	Water level: 0% Height/Diameter	
03.70m	0:00:27	JDM	Joint displaced medium - Severity 3	Image Provided - Ref: 7_2

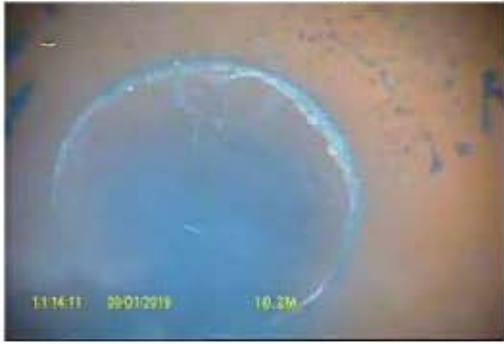
10.20m	0:00:28	JDM	Joint displaced medium - Severity 3	Image Provided - Ref: 8_3

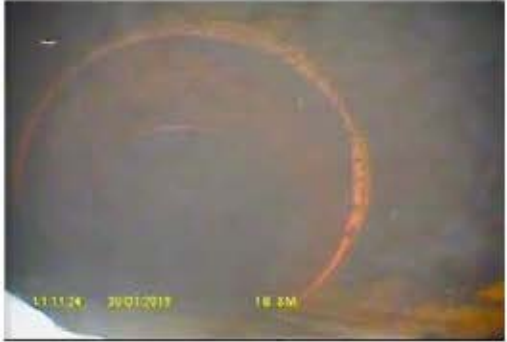
Pos	Video Ref	Code	Description	Image
18.80m	0:01:33	JDM	Joint displaced medium - Severity 3	Image Provided - Ref: 9_5

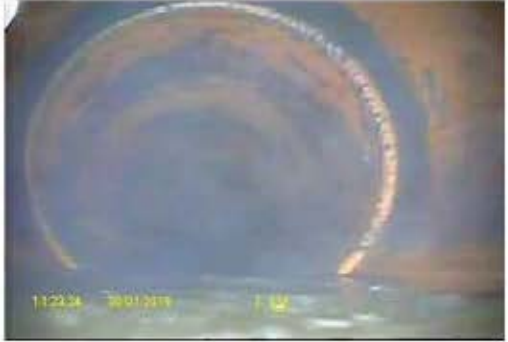
Pos	Video Ref	Code	Description	Image
00.00m		MH	Start node type, manhole MH03	
00.00m	0:00:00	WL	Water level: 0% Height/Diameter	
03.90m	0:00:19	JDM	Joint displaced medium - Severity 3	Image Provided - Ref: 10_2

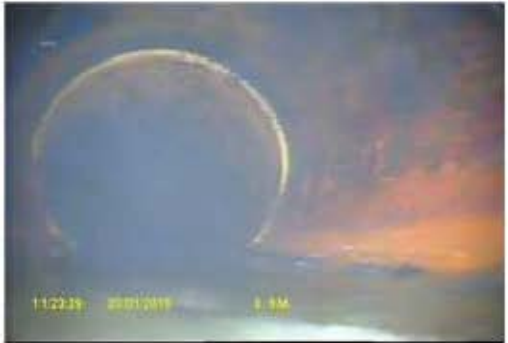
07.00m	0:00:25	CU	Loss of vision	
09.00m	0:00:34	JDM	Joint displaced medium - Severity 3	Image Provided - Ref: 10_4

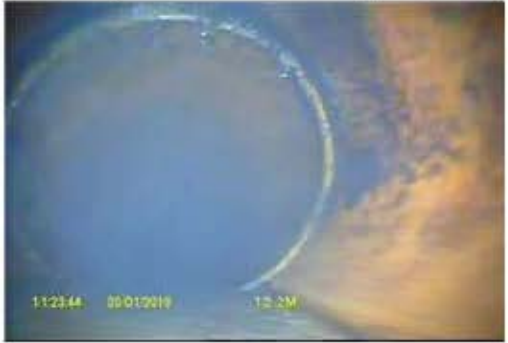
12.20m	0:00:39	JDM	Joint displaced medium - Severity 3	Image Provided - Ref: 10_5

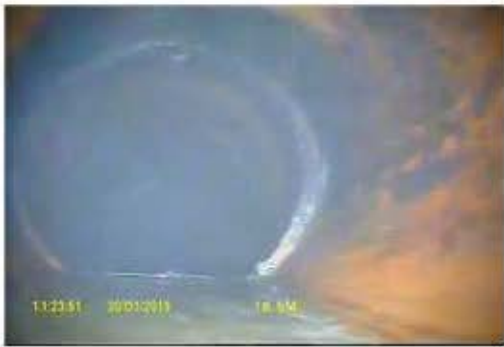
Pos	Video Ref	Code	Description	Image
16.60m	0:00:46	JDM	Joint displaced medium - Severity 3	Image Provided - Ref: 10_6

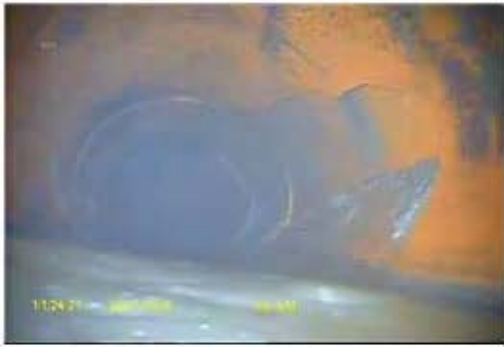
18.60m	0:00:54	S1 WL	Water level 18.6m - 30m: 40% Height/Diameter	
26.40m	0:01:04	CM	Cracks, multiple from 12 o'clock to 06 o'clock - Severity 2	Image Provided - Ref: 10_8

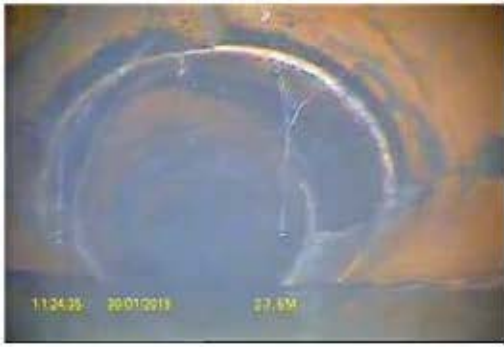
27.60m	0:01:31	CM	Cracks, multiple from 09 o'clock to 03 o'clock - Severity 2	Image Provided - Ref: 10_9

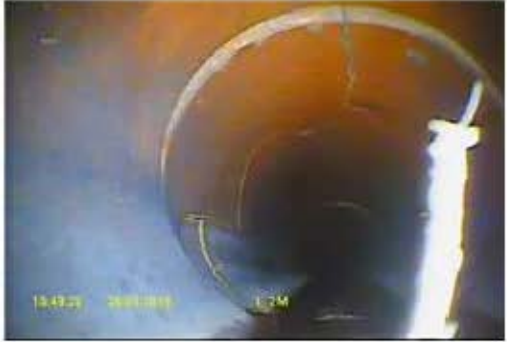
Pos	Video Ref	Code	Description	Image
00.00m		MH	Start node type, manhole MH04	
00.00m	0:00:00	WL	Water level: 0% Height/Diameter	
01.20m	0:00:14	JDM	Joint displaced medium - Severity 3	Image Provided - Ref: 12_2

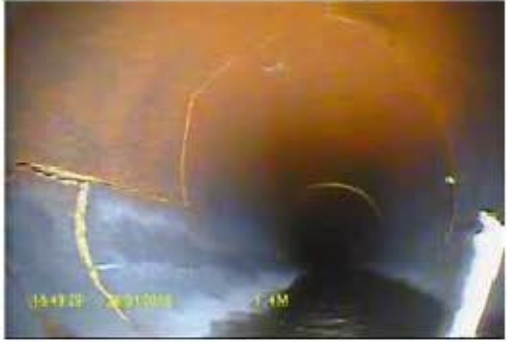
01.40m	0:00:15	CC	Crack, circumferential from 06 o'clock to 12 o'clock - Severity 1	Image Provided - Ref: 12_3

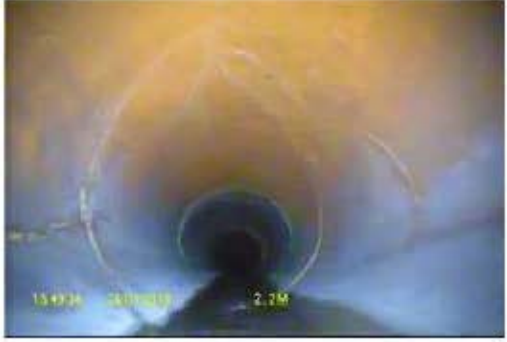
02.20m	0:00:20	CC	Crack, circumferential from 03 o'clock to 09 o'clock - Severity 1	Image Provided - Ref: 12_4

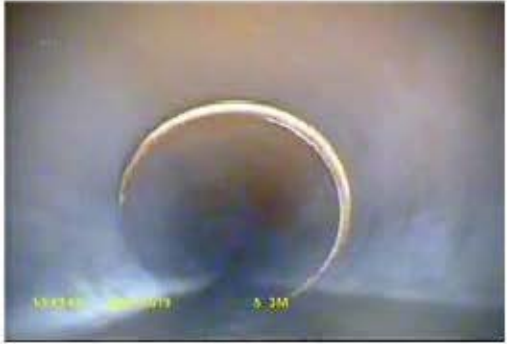
Pos	Video Ref	Code	Description	Image
05.30m	0:00:29	JDM	Joint displaced medium - Severity 3	Image Provided - Ref: 12_5

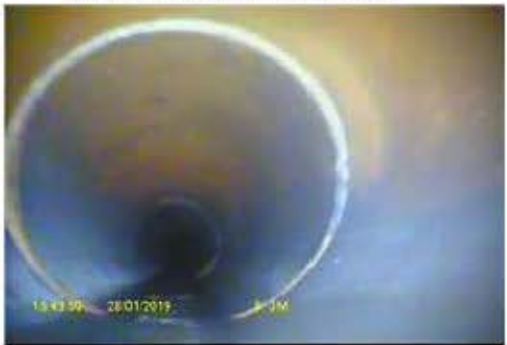
08.30m	0:00:36	JDM	Joint displaced medium - Severity 3	Image Provided - Ref: 12_6

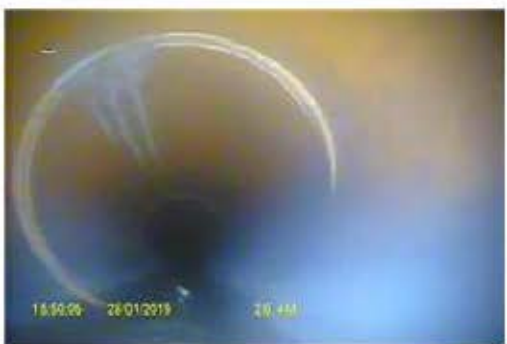
20.40m	0:00:53	JDM	Joint displaced medium - Severity 3	Image Provided - Ref: 12_7
