**Hartcliff Road, Penistone
Proposed Residential Development
Designers Response to Stage 1 Road Safety
Audit for the Proposed Highway Works
At Hartcliff Road/Chapel Lane**

August 2014 (Initial Issue)

STAGE 1 ROAD SAFETY AUDIT

14088 / August 2014

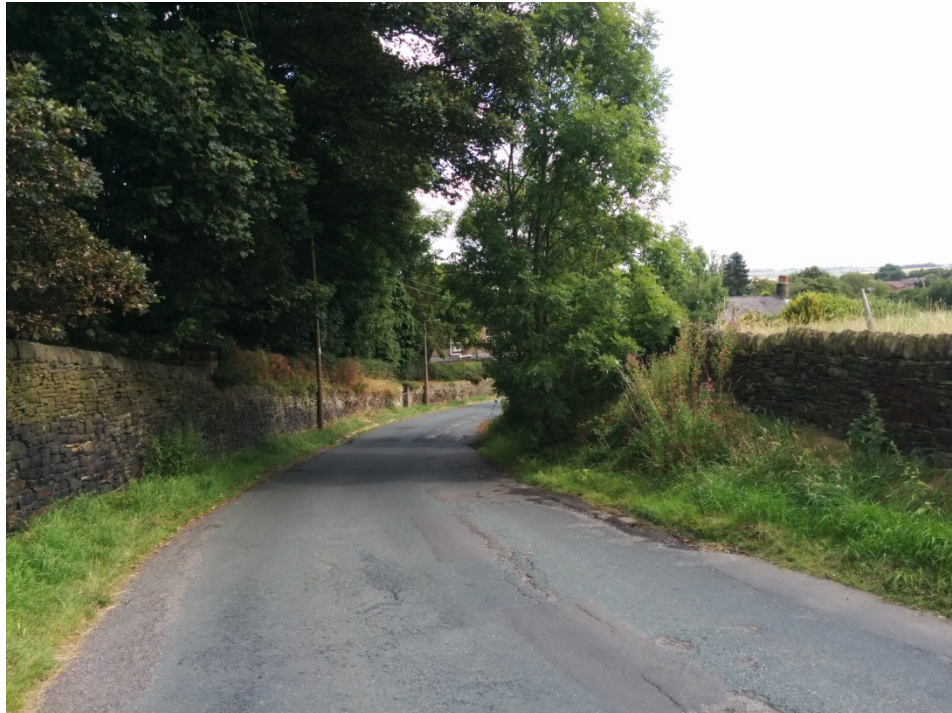
Summary: *The presence of vegetation will obscure visibility of proposed signals and queuing traffic.*

The Audit Team noted that alignment of Hartcliff Road approaching the proposed signals will result in the vegetation in the southern verge obscuring the required forward visibility afforded to drivers of the traffic signal heads and potentially of any queuing traffic.

Failure to provide adequate forward visibility of a stationary vehicle / traffic signal heads could result in shunt type incidents.

The Highway Authority should be asked to serve notice on the owner of the vegetation to arrange for it to be cut back / removed as necessary.

Noted. The Highway Authority will be supplied with a copy of the Safety Audit and Designers response and are requested to take appropriate action.

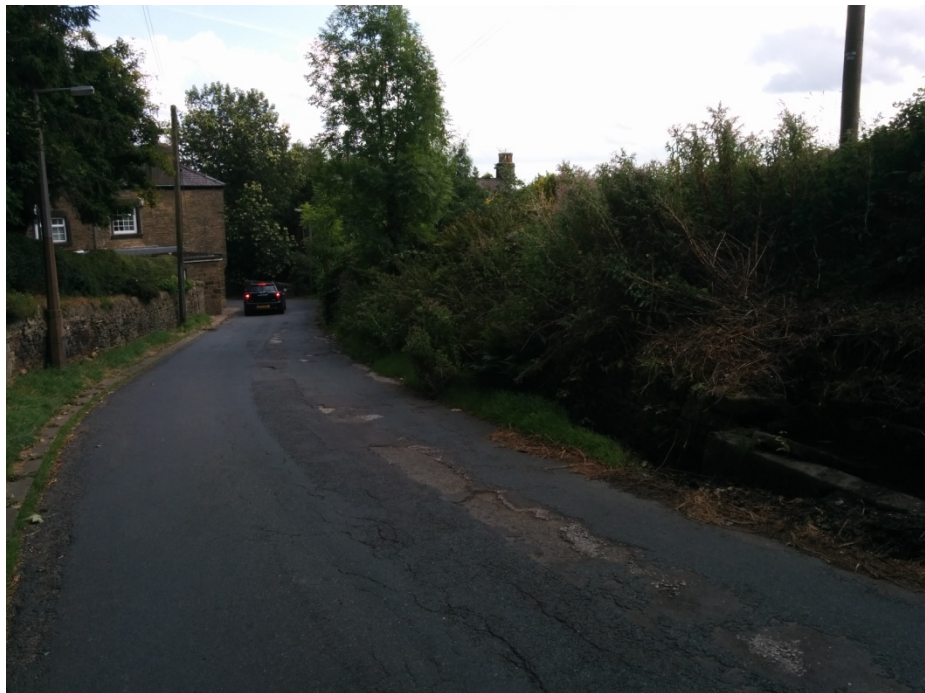
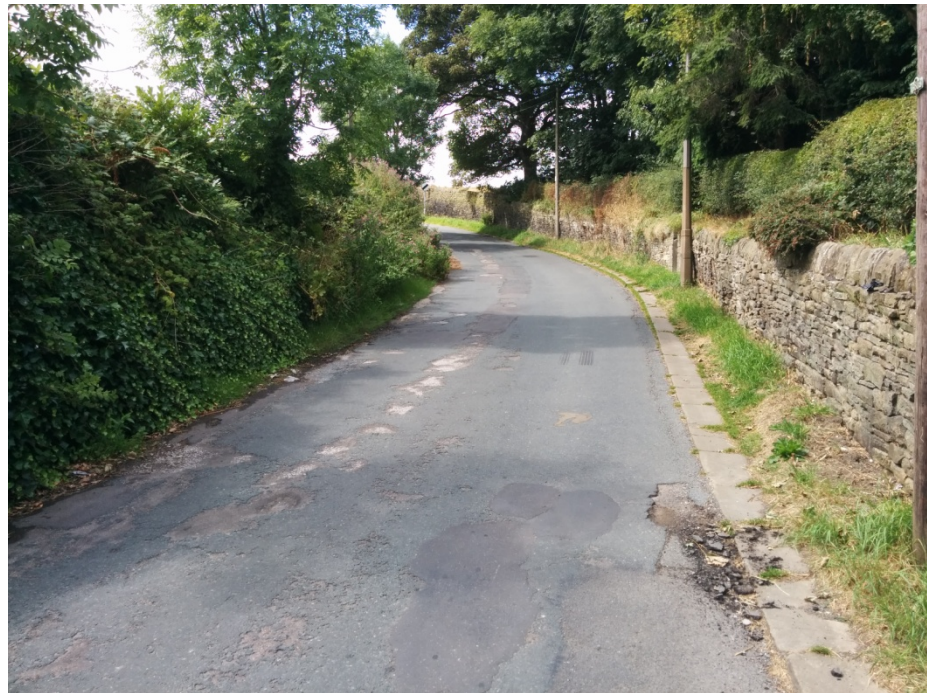
Summary: *Existing road surface is in poor state of repair and may lead to skidding / shunt type incidents.*

The Audit Team noted that the carriageway surface on Hartcliff Road on the approach to the proposed signals is in a poor state of repair and is badly potholed in places. The introduction of the signals will tend to concentrate where drivers will brake to a halt leading to further deterioration of the road surface. The narrow width of Hartcliff Road may also result in some braking taking place over the centre line of the road.

Failure to provide adequate skid resistance on the approach to a potential hazard could lead to increased braking, skidding and shunt type incidents.

The carriageway of Hartcliff Road shall be resurfaced over its full width for at least 50m from the proposed stop line using high PSV chippings / materials as appropriate / approved by the Highway Authority.

High friction surfacing will be provided, the full extent of which will be considered at the Detailed Design Stage.

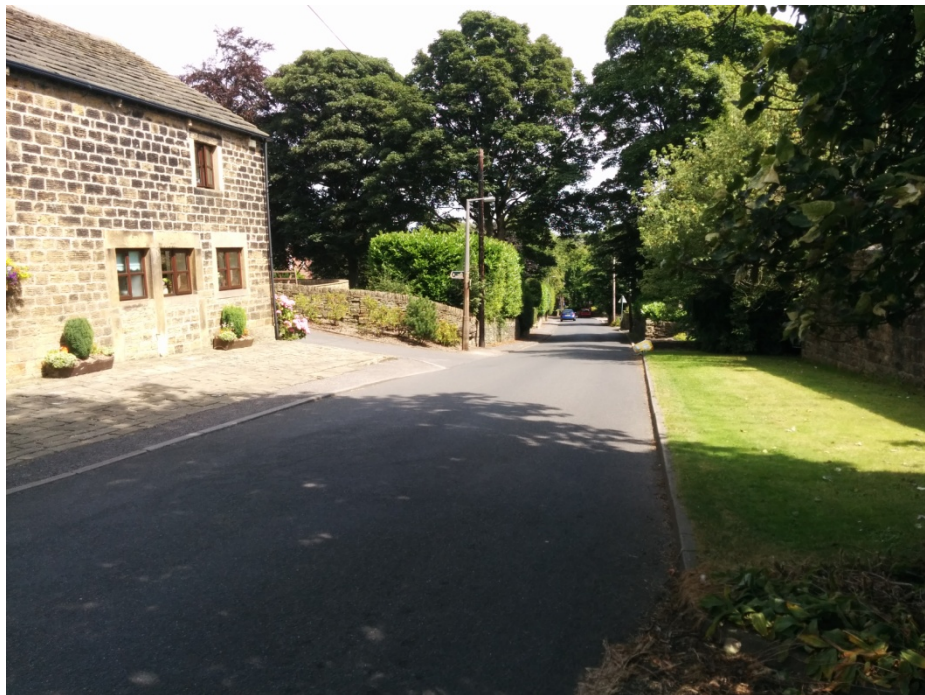
Summary: *The proposed build out is close to a private drive serving several properties. Vehicles using this drive may be obstructed by the new feature and mount the footway placing pedestrians at risk.*

The proposed build out on the Chapel Lane approach to the signals is located almost opposite a private drive serving several residential properties. Whilst some vehicle

swept path information was provided to the Audit Team for a vehicle turning left in to the drive this appears to be very tight with no margin for driver error and there was no swept path shown for a vehicle turning right out of the drive. It is therefore unclear whether a vehicle will be able to turn left in to or right out of the drive without either over running the northern footway or mounting the build out and be in conflict with pedestrians and the new signal equipment placed in these areas.

The Design Team shall carry out swept path analyses to demonstrate how the vehicles anticipated to use the private drive will be able to do so without over running existing or proposed footway / build out areas or colliding with signal equipment.

Drawing 12006-ATR-05 Rev B attached in Appendix B illustrates a swept path analysis including all manoeuvres. The swept path analysis confirms that the largest expected vehicle (car and caravan) can be accommodated accessing and egressing the private residential dwellings. Notwithstanding this it should be noted that the vast majority

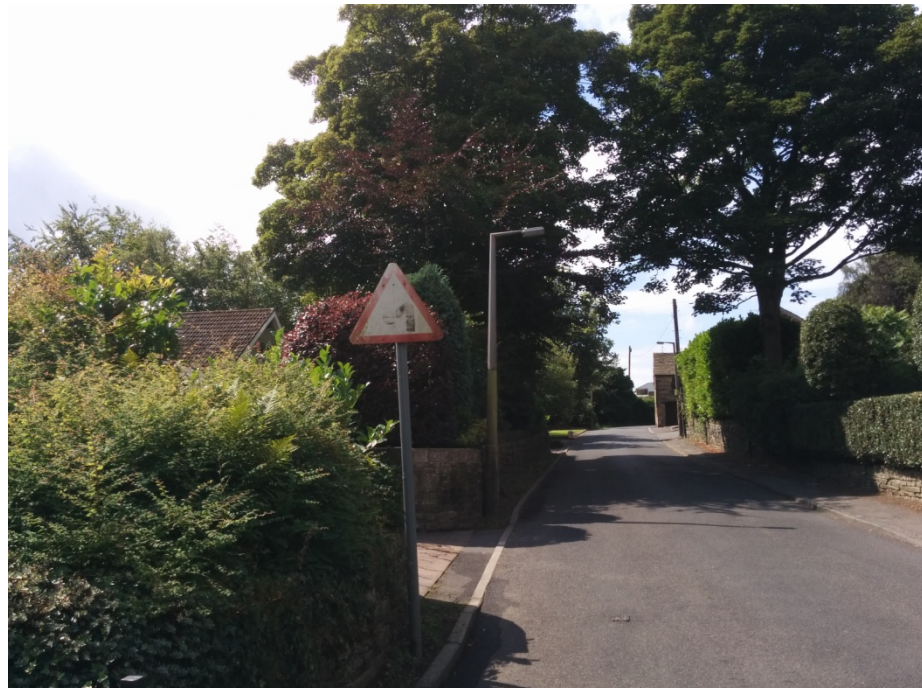
There is an existing sign to Diagram 513 located on Chapel Lane in a poor state of repair and would appear to be handed incorrectly. There is no similar sign on the Hartcliff Road approach.

Failure to adequately sign a hazard such as an “S” bend could lead to loss of control type incidents.

The details and locations of the proposed signs should be made clearer on the drawings and be located at least 35m in advance of the end of the footway provision. The sign to Diagram 513 on Chapel Lane should be replaced (and corrected as necessary) and a new one provided on Hartcliff Road.

Appropriate signage will be included at the Detailed Design Stage. The Highway Authority will be furnished with a copy of the Safety Audit informing them of the existing signage issue.

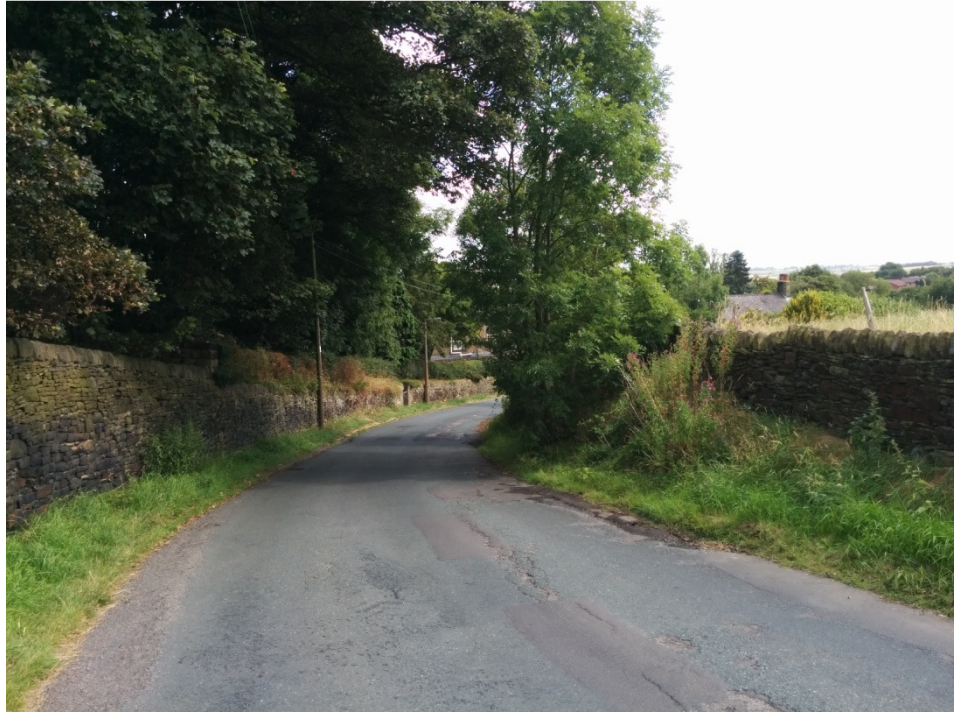
Summary: *The presence of vegetation will obscure visibility of proposed signals and queuing traffic.*

The Audit Team noted that alignment of Hartcliff Road approaching the proposed signals will result in the vegetation in the southern verge obscuring the required forward visibility afforded to drivers of the traffic signal heads and potentially of any queuing traffic.

Failure to provide adequate forward visibility of a stationary vehicle / traffic signal heads could result in shunt type incidents.

The Highway Authority should be asked to serve notice on the owner of the vegetation to arrange for it to be cut back / removed as necessary.

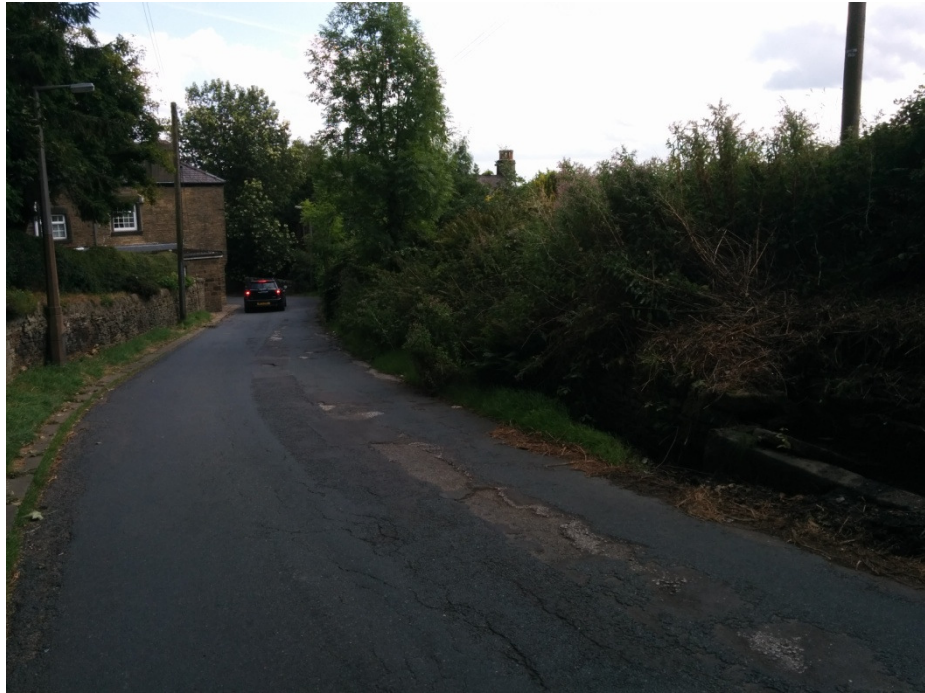
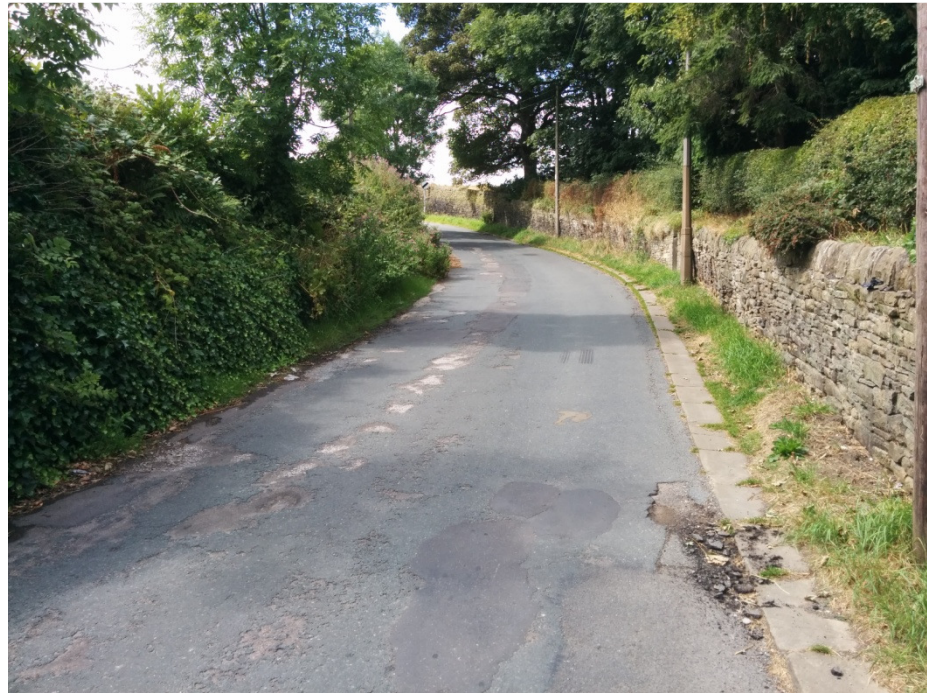
Summary: *Existing road surface is in poor state of repair and may lead to skidding / shunt type incidents.*

The Audit Team noted that the carriageway surface on Hartcliff Road on the approach to the proposed signals is in a poor state of repair and is badly potholed in places. The introduction of the signals will tend to concentrate where drivers will brake to a halt leading to further deterioration of the road surface. The narrow width of Hartcliff Road may also result in some braking taking place over the centre line of the road.

Failure to provide adequate skid resistance on the approach to a potential hazard could lead to increased braking, skidding and shunt type incidents.

The carriageway of Hartcliff Road shall be resurfaced over its full width for at least 50m from the proposed stop line using high PSV chippings / materials as appropriate / approved by the Highway Authority.

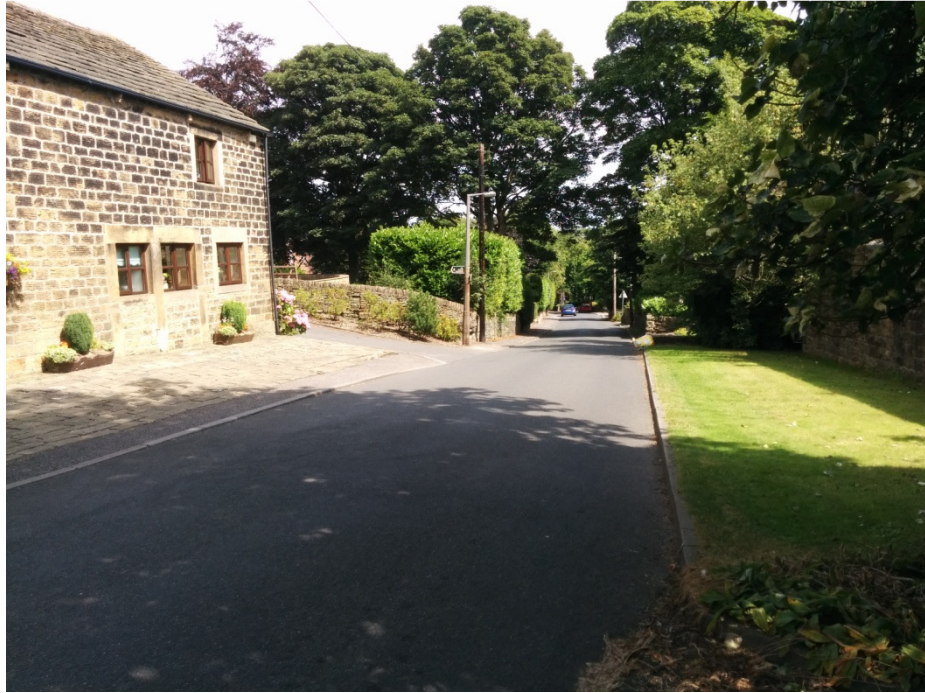
Summary: *The proposed build out is close to a private drive serving several properties. Vehicles using this drive may be obstructed by the new feature and mount the footway placing pedestrians at risk.*

The proposed build out on the Chapel Lane approach to the signals is located almost opposite a private drive serving several residential properties. Whilst some vehicle swept path information was provided to the Audit Team for a vehicle turning left in to the drive this appears to be very tight with no margin for driver error and there was no swept path shown for a vehicle turning right out of the drive. It is therefore unclear whether a vehicle will be able to turn left in to or right out of the drive without either over running the northern footway or mounting the build out and be in conflict with pedestrians and the new signal equipment placed in these areas.

The Design Team shall carry out further swept path analyses to demonstrate how the vehicles anticipated to use the private drive will be able to do so without over running existing or proposed footway / build out areas or colliding with signal equipment.

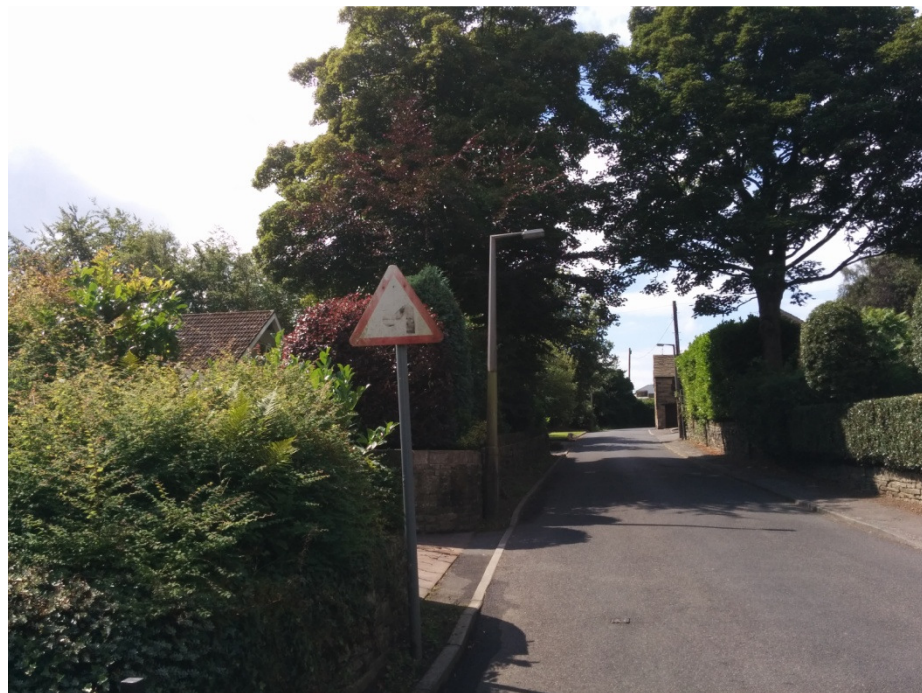
There is an existing sign to Diagram 513 located on Chapel Lane in a poor state of repair and would appear to be handed incorrectly. There is no similar sign on the Hartcliff Road approach.

Failure to adequately sign a hazard such as an “S” bend could lead to loss of control type incidents.

The details and locations of the proposed signs should be made clearer on the drawings and be located at least 35m in advance of the end of the footway provision. The sign to Diagram 513 on Chapel Lane should be replaced (and corrected as necessary) and a new one provided on Hartcliff Road.
