STRUCTURAL REPORT

70, 72, 74 and 76 WATH ROAD, ELSECAR

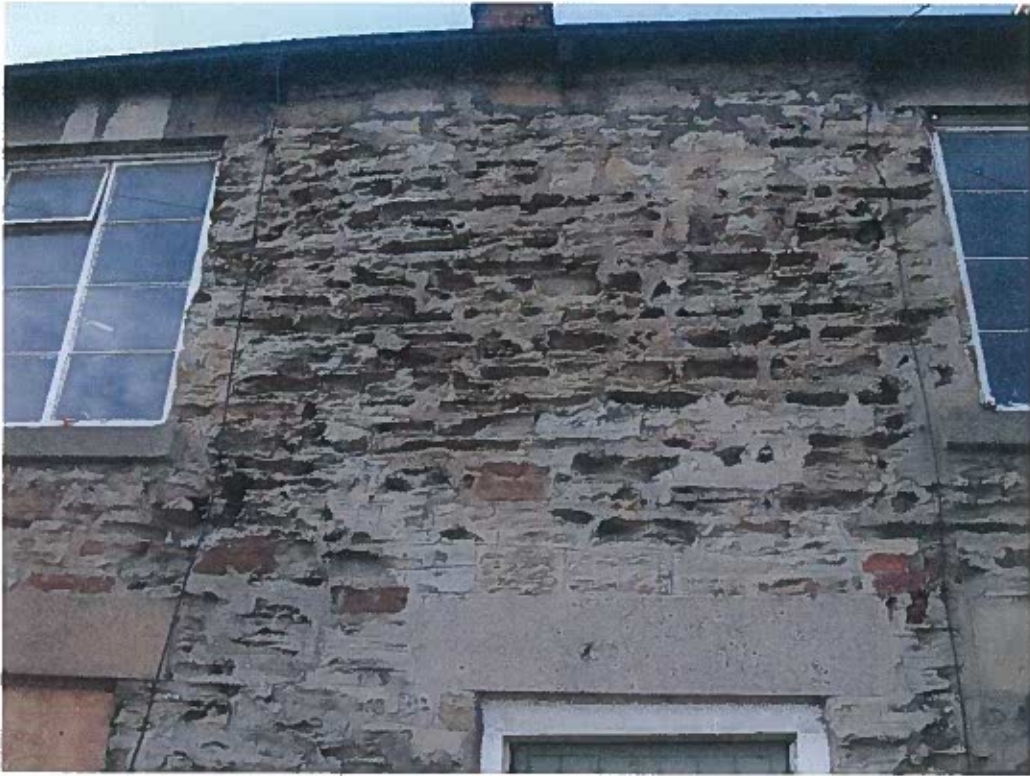
To both the front and rear elevation of all 4 properties, the sandstone facing is very seriously eroded, leaving deep concave holes to many areas. Cementitious render has been applied to many areas to build back the stone, although this appears eroded and loose in places. Eroded joints between the stone walling have also been made up with cement based mortar. The degree of erosion is such that local areas of the wall are considered to be at risk of collapse. This is shown on the attached photographs.

Photo 2 Front Elevation of 72 Wath Road at First Floor level

With regard to replacing the outer leaf of stone, it is proposed to fully prop the first floor and roof, as illustrated on Drawing Nr SL (02) 02. Once fully scaffolded, the outer leaf of stone will be carefully demolished by hand. It is anticipated that most of the rubble core to the wall will be lost. The inner leaf will be made good as necessary. Resin fixed wavy tailed wall ties are to be fixed to the inner leaf. The outer leaf of stone will then be rebuilt, filling the rubble core as work proceeds.

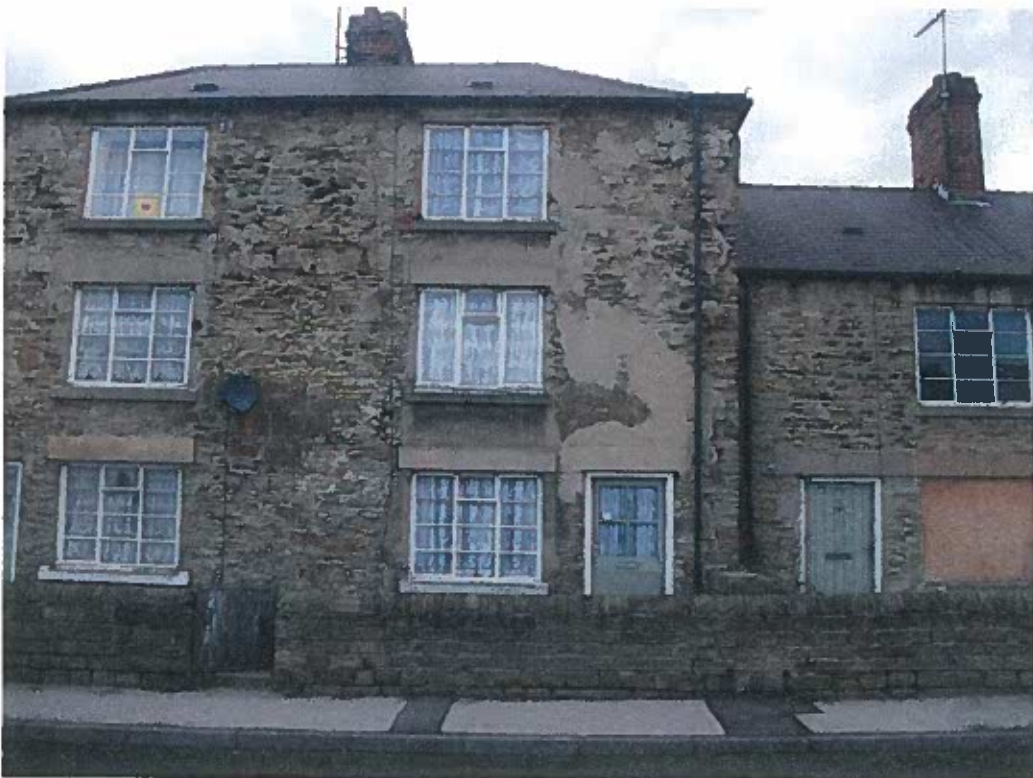
A small gable wall is present between Nrs 70 and 72 to both the front and rear between the 2 storey roof to Nr 72 and the 3 storey roof to Nr 70. To the front, isolated stones appear to require replacement only, although a close inspection will be made when the properties are scaffolded and access is available. To the rear, the gable is fully rendered. It is proposed to fully remove this render and inspect the underlying stonework, which will be replaced as necessary.

Photo 1-Front Elevation 70+72 Wath Road

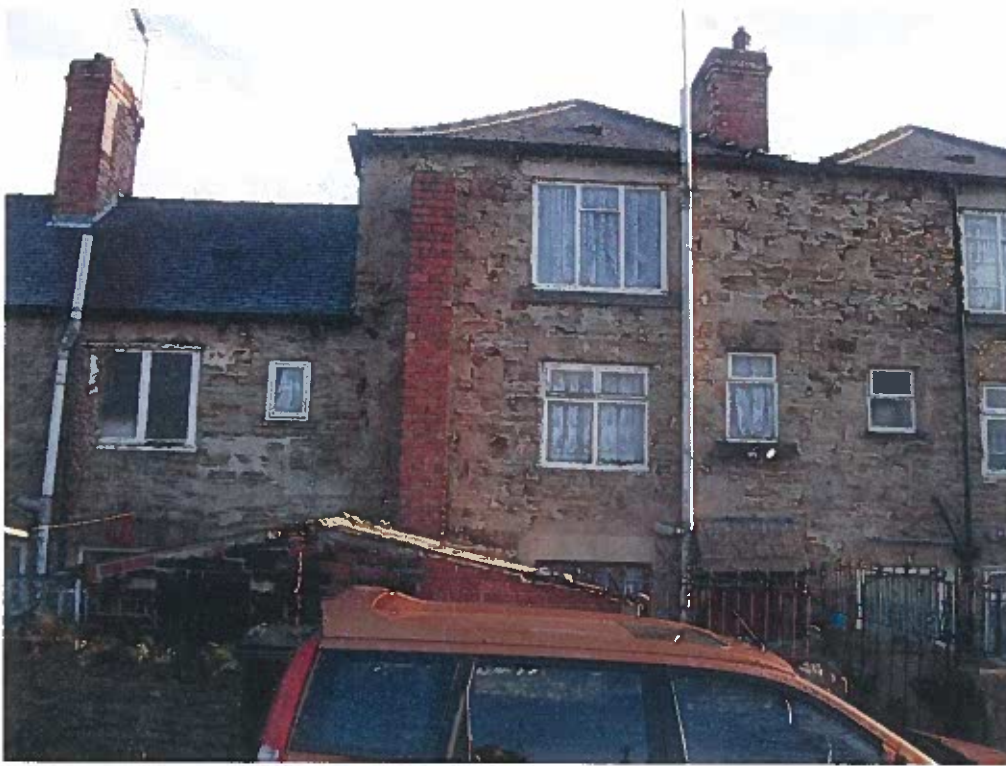
To the rear elevation of Nr 70, a 2 brick square chimney has been added but not bonded to the wall. This extends up to just below the 3 storey eaves. It is intended to demolish the chimney and make good the wall.

Photo 6 Rear Elevation 70+72 Wath Road

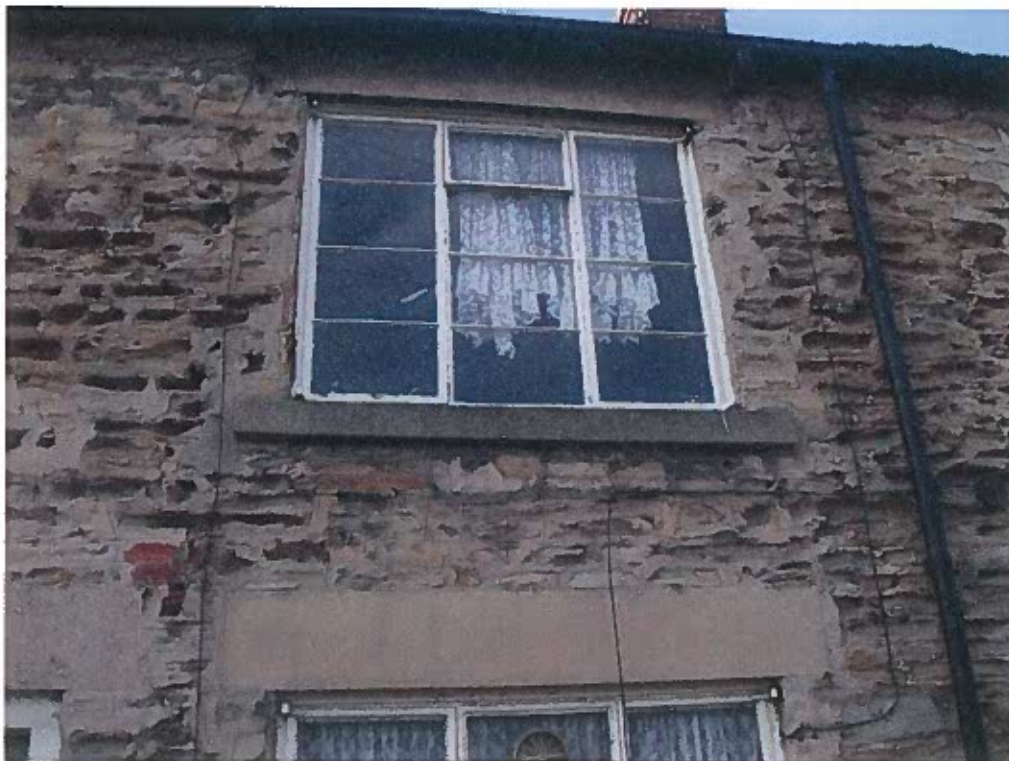
Photo 5 Front Elevation 74 Wath Road

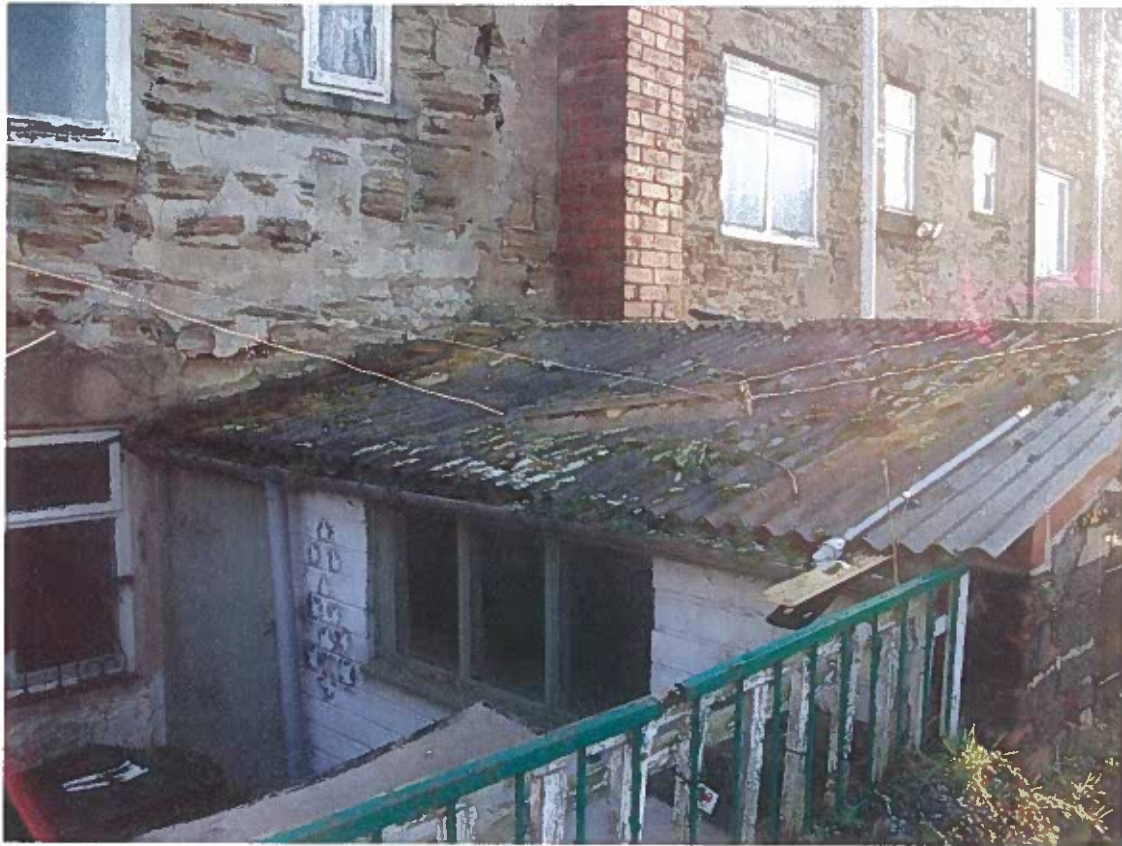
Photo 9- Rear Elevation 70+72 Wath Road
