# Arboricultural Consultancy for Aviva

| Insured | Mr Ian Clifton | Address | Two Oaks, 152 Intake Lane, Barnsley, S75 2HU | | |

**Scope of Report:** To survey the property and determine significant vegetation contributing to subsidence damage, make recommendation for remedial action and assess initial mitigation and recovery prospects. The survey does not make an assessment for decay or hazard evaluation.

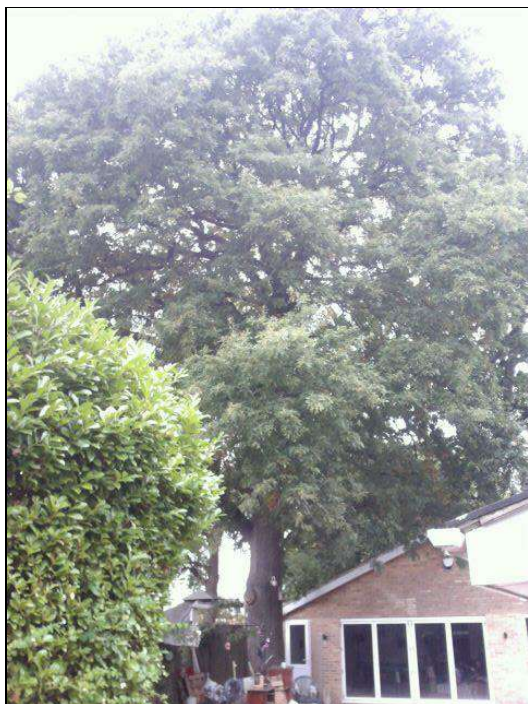
T1 - Oak (Turkey)

With due regards to species profile, size and proximity, T1 (Oak (Turkey)) is considered the dominant feature proximate to the focal area(s) of movement and accordingly, where vegetation is confirmed as being causal, we have identified them as the primary cause of the current subsidence damage.

| Tree No. | Species | Age Cat | Approx. Height (m) | Distance to Building (m) * | Ownership | Action | Requirement |
|---|---|---|---|---|---|---|---|
| T1 | Oak (Turkey) | 3 | 21 | 8.0 | C - Insured | Remove | Remove close to ground level and treat stump to inhibit regrowth. |

Consequently, we have advocated the complete removal of T1, T4 and T5 as it will offer the most certain arboricultural solution likely to restore long-term stability.

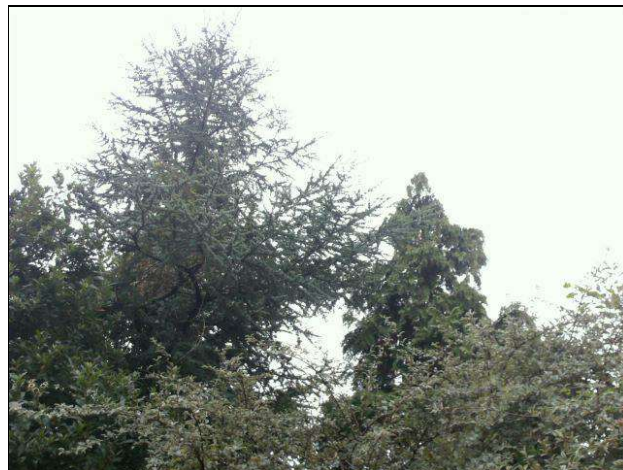
TG2 - Mixed coniferous group

| Tree No. | Species | Age Cat | Approx. Height (m) | Distance to Building (m) * | Ownership | Action | Requirement |
|---|---|---|---|---|---|---|---|
| TG2 | Mixed coniferous group: Cedar & Cypress. | 1 | 8 | 7.0 | A - Third Party | Action to avoid future risk | Maintain at, or below current dimensions by way of regular pruning. |

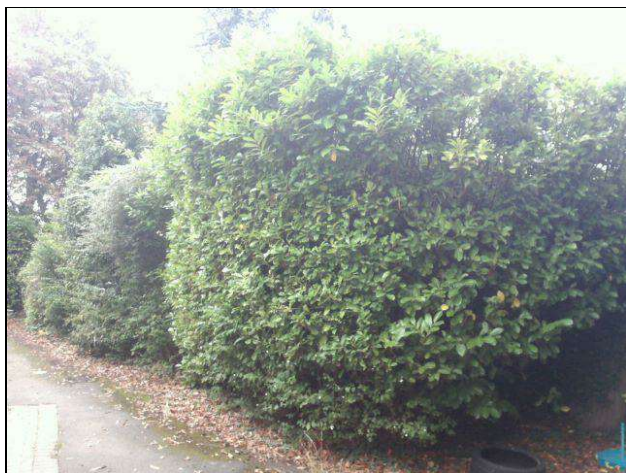
SG1 - Mixed species shrubs

| Tree No. | Species | Age Cat | Approx. Height (m) | Distance to Building (m) * | Ownership | Action | Requirement |
|---|---|---|---|---|---|---|---|
| SG1 | Mixed species shrubs: including Laurel & Cotoneaster | 1 | 4 | 4.2 | C - Insured | Action to avoid future risk | Maintain at, or below current dimensions by way of regular pruning. |

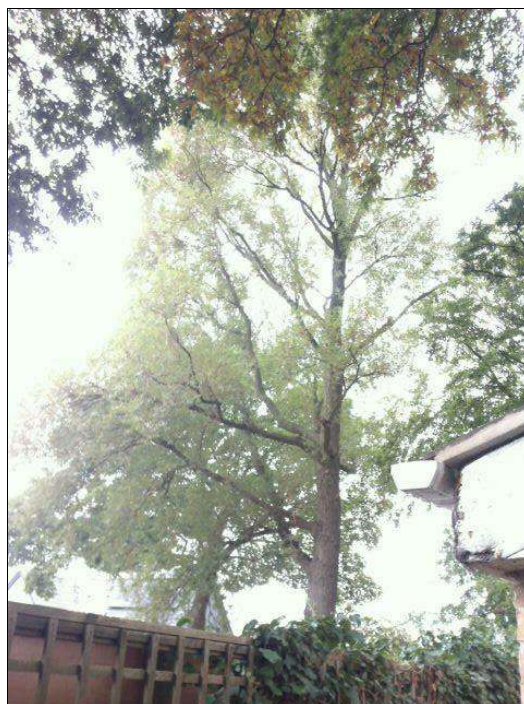
T2 - Willow

| Tree No. | Species | Age Cat | Approx. Height (m) | Distance to Building (m) * | Ownership | Action | Requirement |
|---|---|---|---|---|---|---|---|
| T2 | Willow | 3 | 17 | 7.0 | A - Third Party | Action to avoid future risk | Crown reduce overall canopy by 30% (minimum) to achieve a crown volume reduction in line with BRE IP7/06. Maintain at reduced dimensions by re-pruning back to points of previous reduction on a 3 year cycle. |

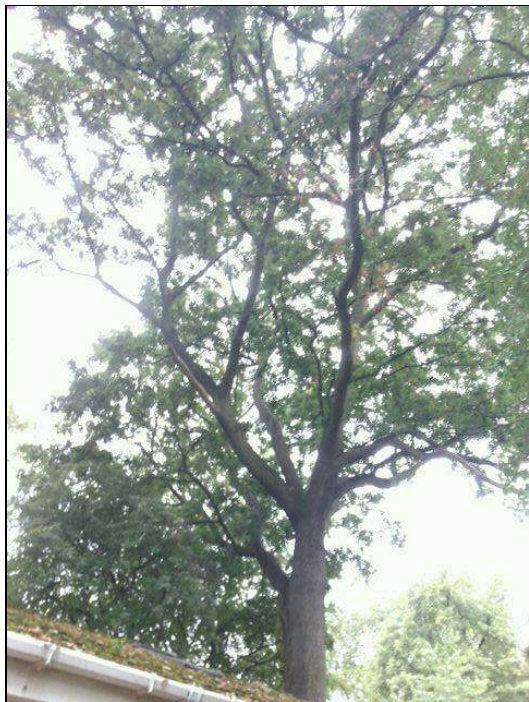
T3 - Oak (Turkey)

| Tree No. | Species | Age Cat | Approx. Height (m) | Distance to Building (m) * | Ownership | Action | Requirement |
|---|---|---|---|---|---|---|---|
| T3 | Oak (Turkey) | 3 | 22 | 2.0 | A - Third Party | Action to avoid future risk | Crown reduce overall canopy by 30% (minimum) to achieve a crown volume reduction in line with BRE IP7/06. Maintain at reduced dimensions by re-pruning back to points of previous reduction on a 3 year cycle.<br>Distance relates to annexe |

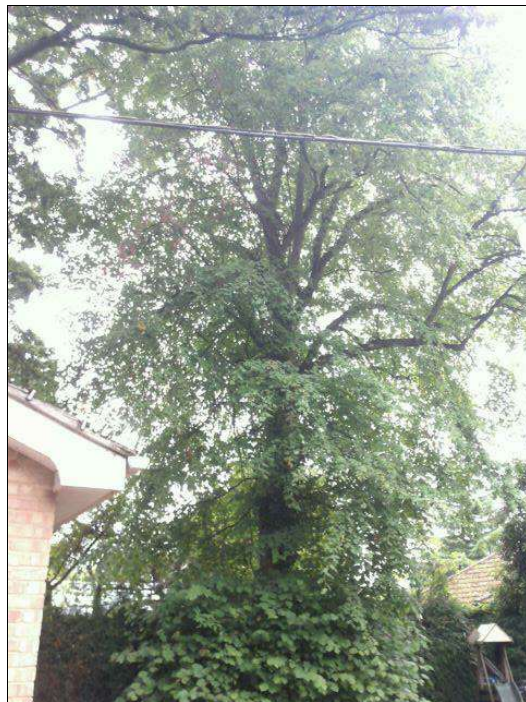
T4 - Lime

T4 (Lime) and T5 (Cedar) are also considered to retain a contributory influence, albeit in a secondary capacity when compared to the above.

| Tree No. | Species | Age Cat | Approx. Height (m) | Distance to Building (m) * | Ownership | Action | Requirement |
|---|---|---|---|---|---|---|---|
| T4 | Lime | 3 | 18 | 10.7 | C - Insured | Remove | Remove close to ground level and treat stump to inhibit regrowth. Distance relates to main house. |

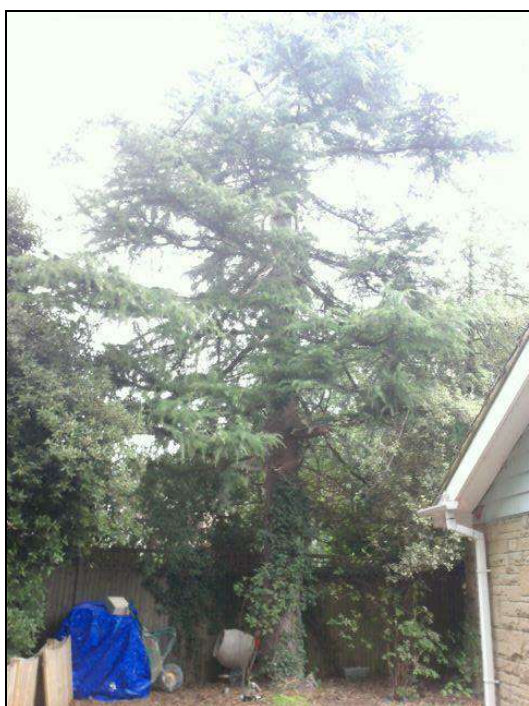
T5 - Cedar

| Tree No. | Species | Age Cat | Approx. Height (m) | Distance to Building (m) * | Ownership | Action | Requirement |
|---|---|---|---|---|---|---|---|
| T5 | Cedar | 3 | 16 | 4.8 | C - Insured | Remove | Remove close to ground level. |

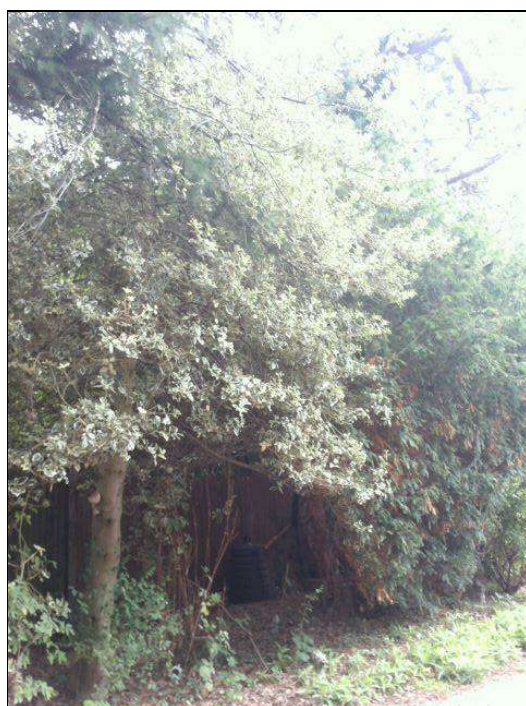
TG1 - Mixed species group

| Tree No. | Species | Age Cat | Approx. Height (m) | Distance to Building (m) * | Ownership | Action | Requirement |
|---|---|---|---|---|---|---|---|
| TG1 | Mixed Species Group: Holly & Yew. | 1 | 8 | 5.1 | C - Insured | Action to avoid future risk | Maintain at, or below current dimensions by way of regular pruning. |

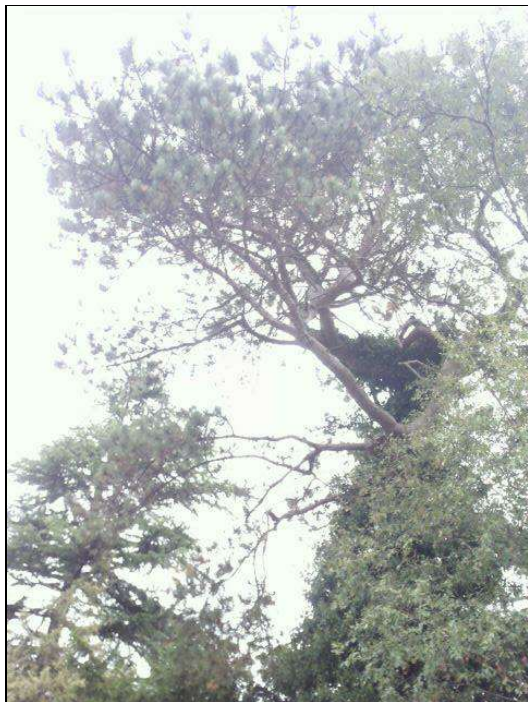
T6 - Pine

| Tree No. | Species | Age Cat | Approx. Height (m) | Distance to Building (m) * | Ownership | Action | Requirement |
|---|---|---|---|---|---|---|---|
| T6 | Pine | 3 | 16 | 7.0 | C - Insured | Action to avoid future risk | Do not allow to exceed current dimensions by way of regular pruning. |

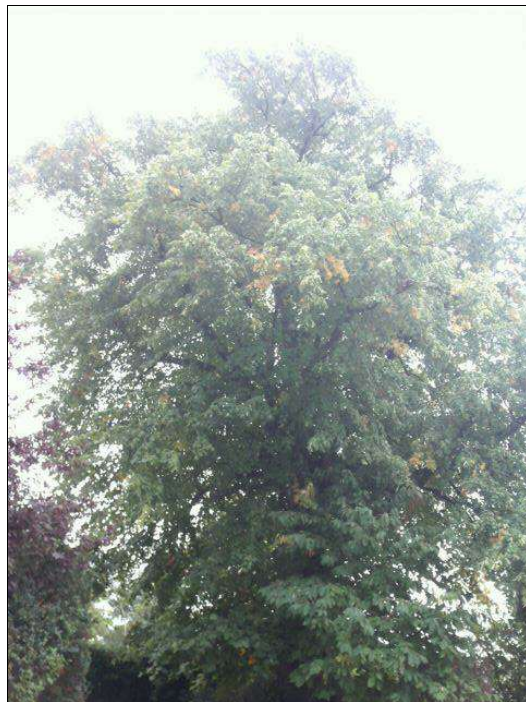
T7 - Lime

| Tree No. | Species | Age Cat | Approx. Height (m) | Distance to Building (m) * | Ownership | Action | Requirement |
|---|---|---|---|---|---|---|---|
| T7 | Lime | 3 | 17 | 15.7 | C - Insured | Action to avoid future risk | Maintain at, or below current dimensions by way of regular pruning. |

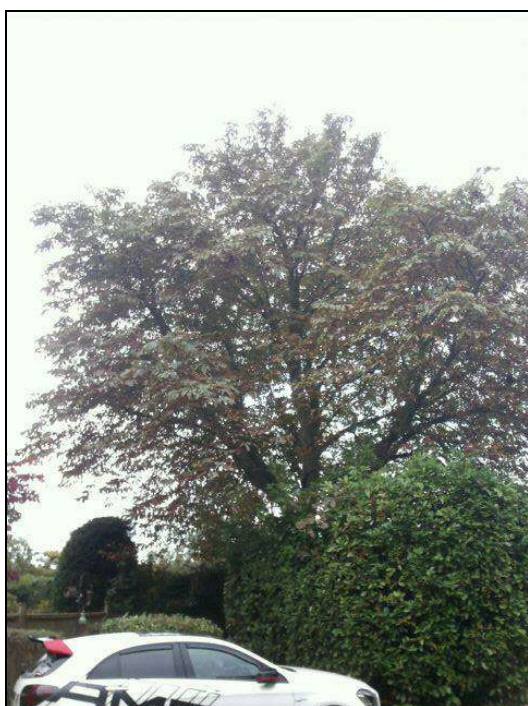
T8 - Horse Chestnut

| Tree No. | Species | Age Cat | Approx. Height (m) | Distance to Building (m) * | Ownership | Action | Requirement |
|---|---|---|---|---|---|---|---|
| T8 | Horse Chestnut | 3 | 13 | 11.6 | C - Insured | Action to avoid future risk | Maintain at, or below current dimensions by way of regular pruning. |
