* inc. architecture ltd		the barn, mock hall farm, 63 leeds road, mirfield, wf14 0da, west yorkshire tel: 07831 275394, e-mail: mail@inc-architecture.co.uk, www.inc-architecture.com		© 2022
project	PARKWAY CINEMA, 62 ELDON STREET, BARNSELY S70 2JL	status	TENDER	
client	ROB YOUNGER, PARKWAY CINEMA	date	JAN 2022	scale 1:50 @ A2
dwg title	PROPOSED ELDON STREET REPAIR ELEVATION	dwg no.	132/P/202	rev.
revision notes:

EXISTING ELDON STREET ELEVATION

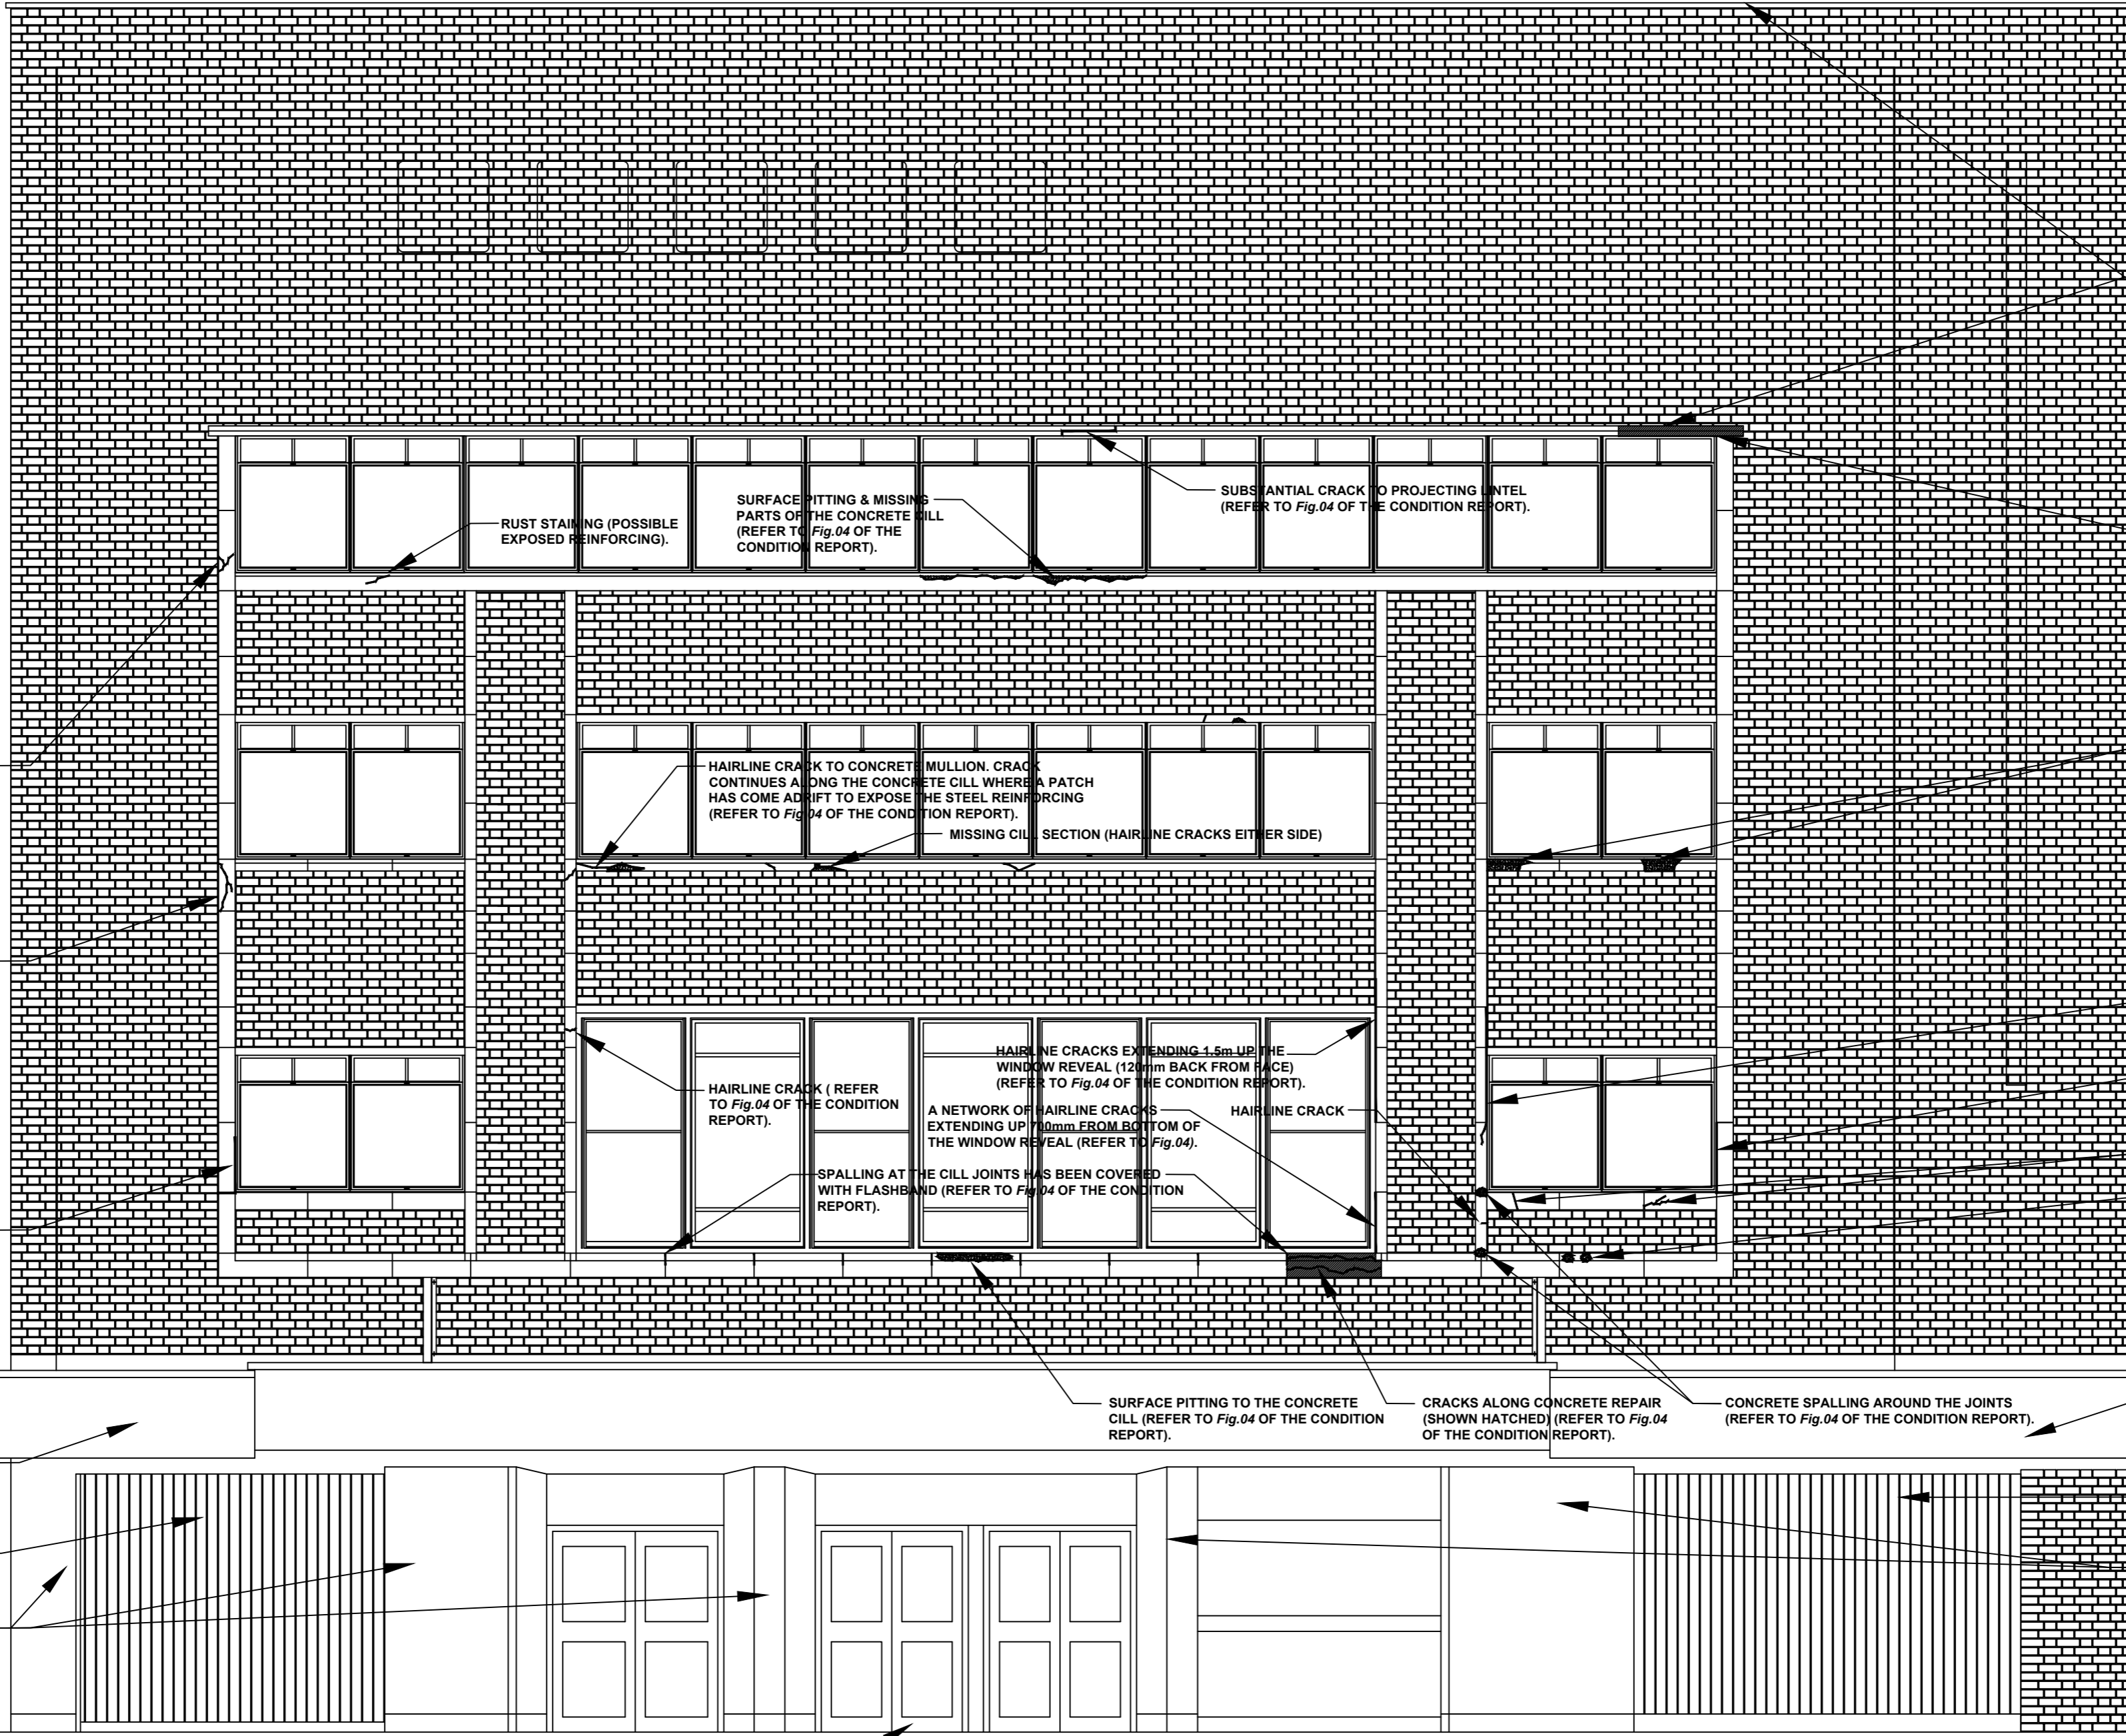
CRACK (300mm) & SPALLING RETURNS AROUND BOTH SIDERS OF THE CONCRETE 'FRAME' (REFER TO Fig.04 OF THE CONDITION REPORT).

CRACK (500mm) & SPALLING RETURNS CONTINUES AROUND LHS OF THE CONCRETE 'FRAME' (REFER TO Fig.04 OF THE CONDITION REPORT).

CRACK ACROSS THE FRONT OF THE CONCRETE 'FRAME' RETURNS AROUND THE WINDOW REVEAL BY 120mm AND RETURNS UPWARDS 450mm (REFER TO Fig.04 OF THE CONDITION REPORT) AND ALSO RETURNS AROUND THE RHS OF THE 'FRAME'.

DRIP AND LEADING FACE OF PROJECTING LINTEL MISSING (REFER TO Fig.04 OF THE CONDITION REPORT). REPLACE THIS SECTION ENTIRELY. ONCE A SCAFFOLD HAS BEEN ERECTED CHECK ALL LINTEL SECTIONS FOR CRACKS AND REPAIR/REPLACE ACCORDINGLY. ALLOW AT THIS STAGE TO REPLACE A FURTHER 2 AND REPAIR.

MISSING CILL SECTIONS (REFER TO Fig.04 OF THE CONDITION REPORT).

HAIRLINE CRACK TO CONCRETE MULLION. CRACK CONTINUES AROUND THE WINDOW REVEAL BY 75mm AND RETURNS UPWARDS 1150mm (REFER TO Fig.04 OF THE CONDITION REPORT).

CRACK AT THE CILL JOINT CONTINUES AROUND THE WINDOW REVEAL BY 120mm THEN RETURN UPWARDS 700mm (REFER TO Fig.04 OF THE CONDITION REPORT).

CRACK (300mm) & SPALLING TO CONCRETE CILL (REFER TO Fig.04 OF THE CONDITION REPORT).

CONCRETE SPALLING ON THE CILL HAS EXPOSED THE STEEL REINFORCING BARS (REFER TO Fig.04 OF THE CONDITION REPORT).

CONCRETE REPAIRS: CORE DRILL (USING A 25mm BIT) THE FOUR CORNERS OF THE REPAIR TO REDUCE THE RISK OF THE REPAIRS SPALLING. CUT OUT TO A MIN. DEPTH OF 40mm (A GREATER DEPTH MAY BE REQUIRED IN SOME LOCATIONS) AND UNDERCUT THE EDGES 2-4mm TO CREATE A JOVETAIL. WIRE BRUSH THE REINFORCING BARS TO REMOVE LOOSE CORROSION AND LEAVE UNCOATED (THE ALKALINITY OF THE NEW CONCRETE WILL RE-PASSIVATE THE CORRODED STEEL).

FIX SHUTTERING BOARDS OVER THE REPAIR AREA (LEAVING A LETTER BOX AT THE TOP TO ALLOW FOR POURING), MATCHING ANY EVIDENCE VISIBLE IN THE ORIGINAL SURFACE AND SEAL THE INTERFACES WITH COTTON WOOL. ENSURE THE CONCRETE, ONCE POURED, IS VIBRATED EXTERNALLY TO ENSURE ALL VOIDS ARE FILLED. REMOVE THE BOARDS AFTER A FEW HOURS AND WASH DOWN THE CEMENTITIOUS SURFACE TO EXPOSE THE AGGREGATE (TO MATCH THE EXISTING FINISH).

IN ORDER TO ACHIEVE AN ACCURATE CEMENT, SAND AND COARSE AGGREGATE MIX, CORE DRILL A SAMPLE AND SEND IT OFF FOR ANALYSIS OR PROVIDE PRELIMINARY SAMPLES FOR APPROVAL. ASSUME AT THE OUTSET A 1:2:4 RATIO OF CEMENT:SAND:COARSE AGGREGATE WITH A 0.4 WATER/CEMENT RATIO.

IN INSTANCES WHERE MORE THAN 50% OF THE ORIGINAL MATERIAL WILL BE LOST IN THE REPAIR PROCESS, REPLACE THE UNIT.

WINDOWS: REMOVE ALL SURFACE RUST USING A WIRE BRUSH. SAND BACK ANY FLAKING PAINT. APPLY RED OXIDE PRIMER TO ANY BARE METAL AND FINISH WITH MATT WHITE HAMMERITE OR INSEED OIL PAINT. ENSURE ALL MECHANISMS AND PIVOTS ARE FREE FROM PAINT, GREASED AND FULLY OPERATIONAL.

FULLY REMOVE THE HARDBOARD FASCIA AND REPAIR THE ORIGINAL FASCIA BENEATH USING LIKE FOR LIKE. REDECORATE WITH 3NO. COATS LINSEED OIL PAINT TO MATCH THE WALL TILING AROUND THE DOORS.

SAND BACK THE PURPLE PAINT TO THE VERTICAL REVEALS AND DOORS AND REDECORATE USING 3NO. COATS LINSEED OIL PAINT TO MATCH THE ADJOINING WALL TILING.

FULLY REMOVE THE PLASTIC PAINT FROM THE WALLS, DOOR REVEALS AND ABOVE THE DOORS USING A STEAM-BASED SYSTEM (OR A POULTICE TYPE PAINT REMOVER) TO EXPOSE THE ORIGINAL TILING. REPAIR CHIPS WITH COLOURED RESIN/ENAMEL TO MATCH THE TILES EXACTLY (UNDERTAKE PRELIMINARY SAMPLES FOR APPROVAL) AND REPLACE CRACKED TILES WITH LIKE FOR LIKE (AGAIN MATCHING THE ORIGINAL TILES EXACTLY).

SAND BACK THE PURPLE PAINT TO THE DOORS AND REDECORATE USING 3 NO. COATS LINSEED OIL PAINT TO MATCH THE ADJOINING WALL TILING.

REPAIR/REPLACE THE LEAD FLASHINGS USING MIN. CODE 6 LEAD SHEET INCORPORATING DRIP (TO HELP SHED RAINWATER AWAY FROM THE BUILDING), WELTS (TO ALLOW FOR EXPANSION OF THE LEAD SHEET) AND FIXINGS (TO SUIT WIND SPEEDS & EXPOSURE BUT ENSURING THEY DO NOT HINDER THERMAL MOVEMENT OF THE LEAD). CONSULT WITH LEAD SHEET ASSOCIATION FOR ADVICE AND GUIDANCE.

CAREFULLY REMOVE THE HARDBOARD FASCIA AND REPAIR THE ORIGINAL FASCIA BENEATH USING LIKE FOR LIKE. REDECORATE WITH 3NO. COATS LINSEED OIL PAINT TO MATCH THE WALL TILING AROUND THE DOORS.

SAND BACK THE PURPLE PAINT TO THE VERTICAL REVEALS AND DOORS AND REDECORATE USING 3 NO. COATS LINSEED OIL PAINT TO MATCH THE ADJOINING WALL TILING.

CAREFULLY REMOVE THE PLASTIC PAINT FROM THE WALLS, DOOR REVEALS AND ABOVE THE DOORS USING A DOFF STEAM-BASED SYSTEM (OR A POULTICE TYPE PAINT REMOVER) TO EXPOSE THE ORIGINAL TILING. REPAIR CHIPS WITH COLOURED RESIN/ENAMEL TO MATCH THE TILES EXACTLY (UNDERTAKE PRELIMINARY SAMPLES FOR APPROVAL) AND REPLACE CRACKED TILES WITH LIKE FOR LIKE (AGAIN MATCHING THE ORIGINAL TILES EXACTLY).
