W L Anderson. Dip.Arb(RFS). M Arbor A.

TREE LOCATION PLAN
CROSS STREET, WORSBOROUGH S70
NOT TO SCALE. JUNE 2026

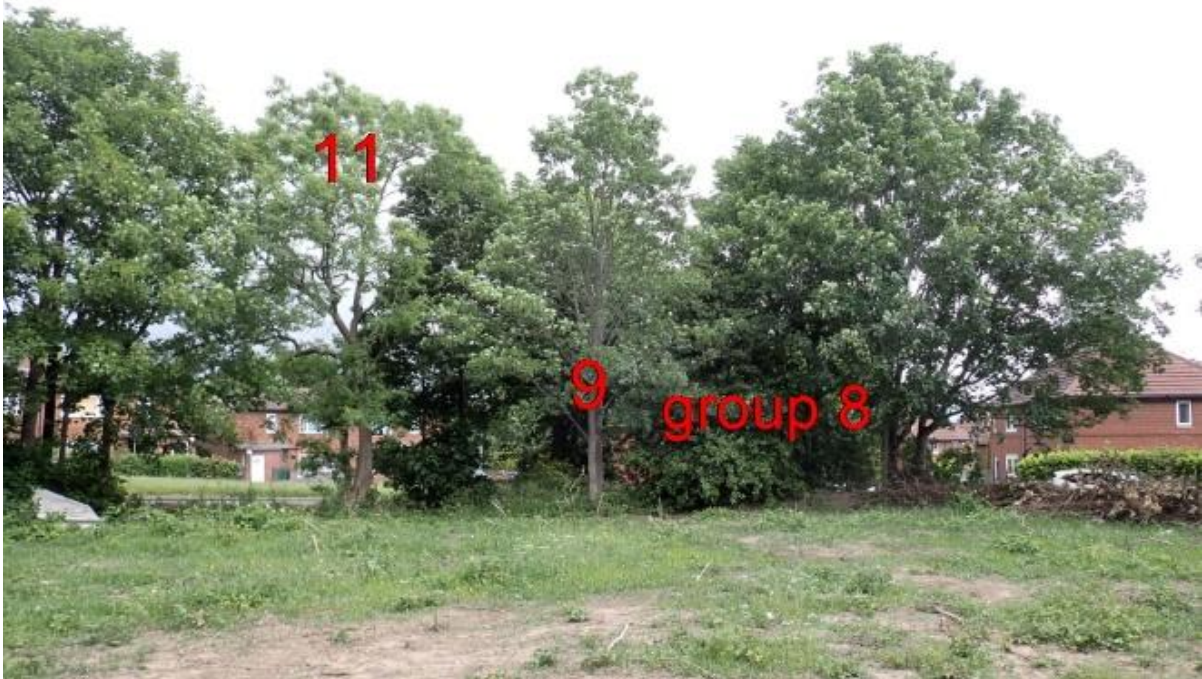
Photograph 1.

The site appears to have suffered a lot of fly tipping over many years. Although it is unlikely that this has greatly affected any single tree, the machine that has scraped off the site has clearly caused damage to the roots of trees.

Photograph 1 is a view of the north east corner of the site, taken looking northeast wards. I've included this photo to try and show the scraped ground. It's not clear here but there were some significant tree roots damaged when this was done. They can be seen in this photo, looking rather like sticks on the ground, but they are in fact roots.

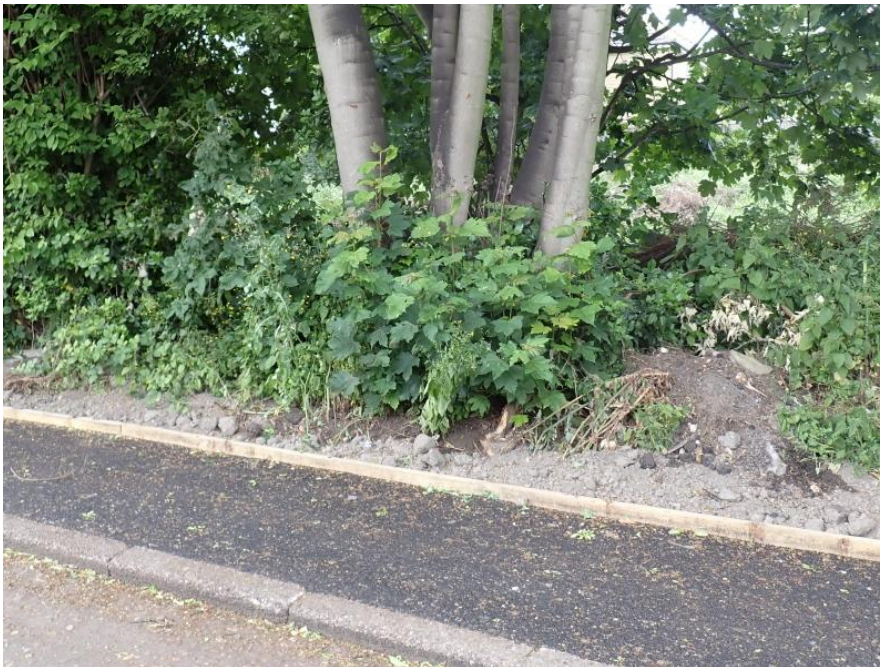
Photograph 2.

6.	Sycamore	Coppice growth, will require a similar RPA to tree 3, and if the garden is paved; as tree 5.
7.	Sycamore	More coppice growth, as tree 6. Additionally, there is a drain inspection chamber at the base of the tree. if this is to be relocated or modified, root damage is inevitable.

Photograph 2 shows the base of tree 6, Sycamore coppice growth. It also shows what appears to be a new pavement. The installation of this pavement must have caused significant damage to nearby trees.

From what I could tell from the photos on Google's street view facility, there might have once been a pavement between the site and the road, but it seems that this was considerably overgrown and the new pavement must have been installed by digging out for a new sub-base.

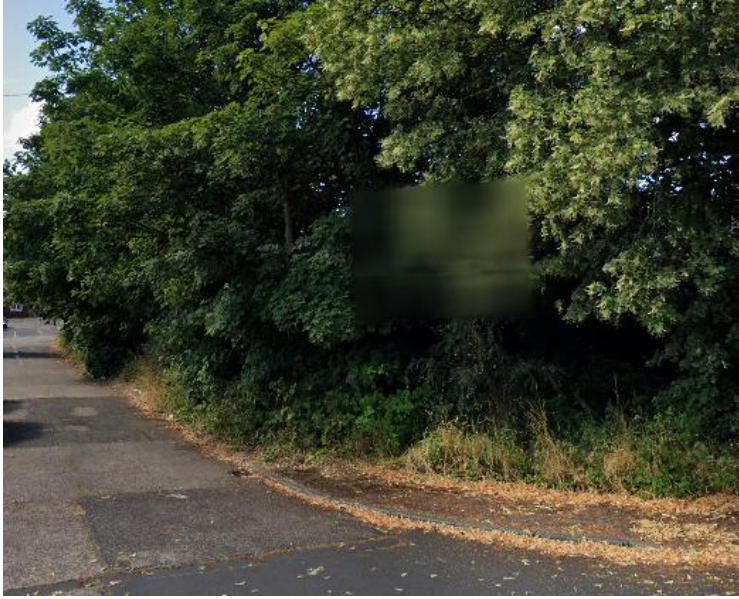
Photograph 3.

Photograph 3 is a screen grab from Google showing the site edge in August 2024. This is looking south down Cross Street.

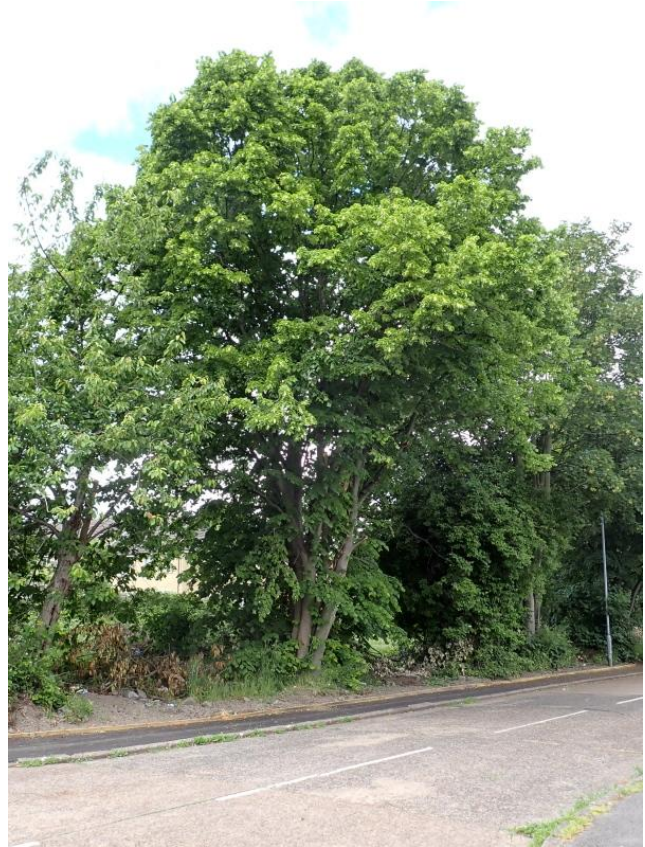
Photograph 4.

5.	Lime	This tree is coppice growth. There are several smaller stems that have grown from the stump of a now removed tree. this tree would require the same RPA as tree 3. There has been some significant soil disturbance at the base of this tree. (And with trees 6 to 8 as well.) It seems a new footpath has been installed alongside the highway and this has almost certainly caused root damage to the road side trees. The plan seems to call for the garden area to be paved, which means almost all of the RPA will be paved.

Photograph 4 is a view looking roughly north west from the end of Cross Street, and showing tree 5. This tree probably suffered root damage from the construction of the pavement.

Tree 5 is coppice growth as with tree 6. It's likely that these trees were cut down and then allowed to regrow from the stump. Coppice management of trees is an underappreciated ability of broad-leaved trees. There are numerous examples of coppiced trees along the UK's highway verges, and even in gardens.

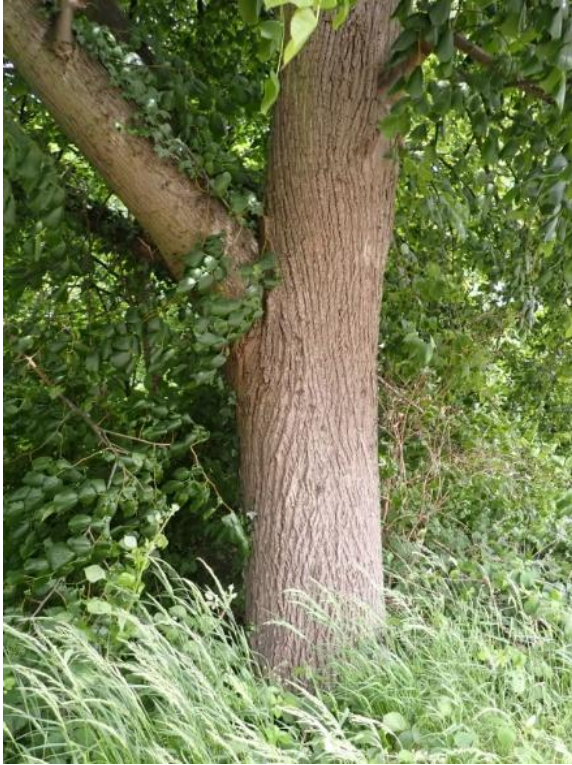
Photograph 5.

3.	Lime	This tree is approximately 13 metres tall and 620 mm diameter, which gives it a root protection area (RPA) radius of 7.5 metres. (See the discussion about Lime cultivars below.)

Photograph 5 shows the trunk of tree 3, a Lime tree. My presumption is that the two Limes on the site are the same cultivar, planted at the same time. There are two species of Lime native to the UK and unsurprisingly, a hybrid between the two. The hybrid is known as Common Lime and as the name suggests, more commonly found than either of the parents. (Broad-leaved Lime and Small-leaved Lime.)

This is a Common Lime and seems to be a selected cultivar, I'm not sure which, but I don't think it is essential to investigate this any further for this report. Tree 3 is a decent specimen but the large branch, to the left in photo 5, seems to be growing with included bark, which is a potential weakness.

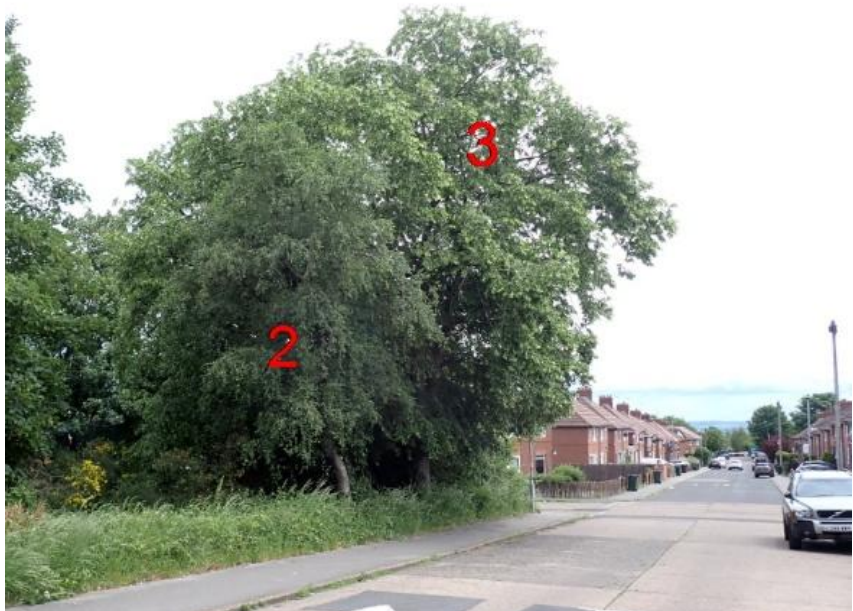
Photograph 6.

Photograph 6 is a view looking east along Overdale Avenue. Tree 2 is the Birch rather dominated by tree 3.

Tree 2 is indicated for removal to create parking spaces. Birch is not a long-lived species and growing in the position it is, even if there was not a development proposal, this tree would probably have only a short future life. The fly-tipping at its base will not have improved its prospects.

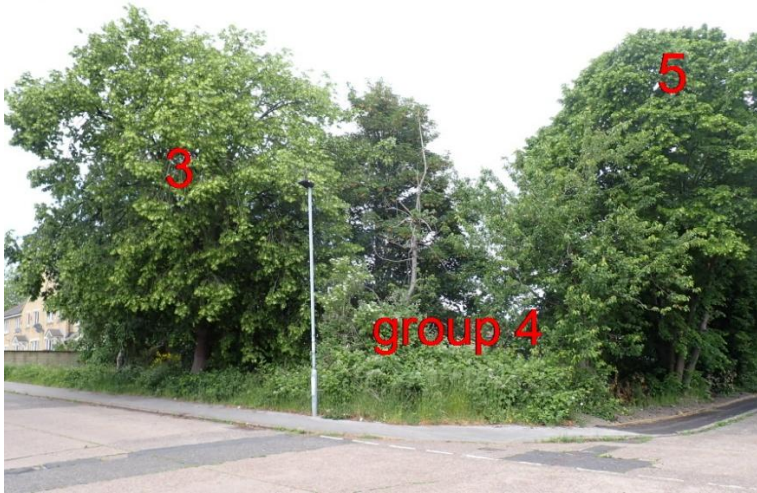
Photograph 7.

Photograph 7 is a view of the south eastern corner of the site, taken from the opposite side of the road.

While the proposal shows all these trees retained, there isn't much that is worth retaining in group 4.

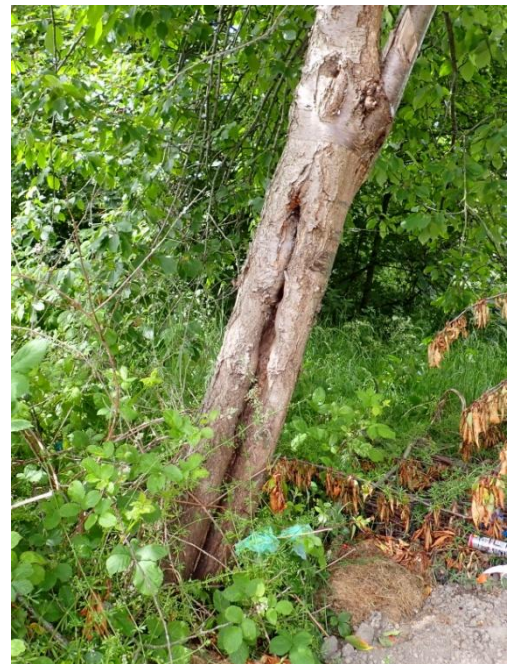
Photograph 8.

4.	Group.	Mainly Sycamore but a nearly-dead Holly and a hollow Cherry can be seen in the midst of the Sycamores. The trees are all considerably smaller than the Lime tree 3. There has been much fly-tipping at the base of the trees.

Photograph 8 is a view of the trunk of the Cherry tree in group 4, which is damaged and decayed. The Holly tree in the group is also almost dead.

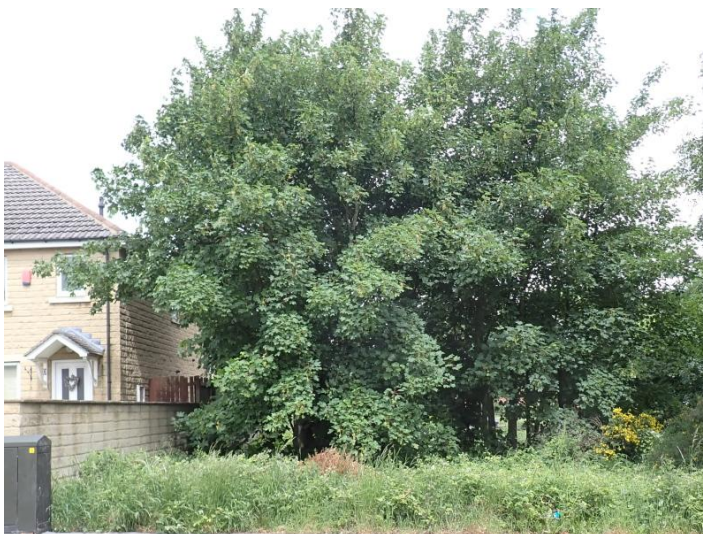
Photograph 9.

Photograph 9 shows tree group 1, taken looking roughly north. Even if these trees were not indicated for removal, it's likely that the occupants of the neighbouring property would be seeking some work to reduce the crowding of their house.

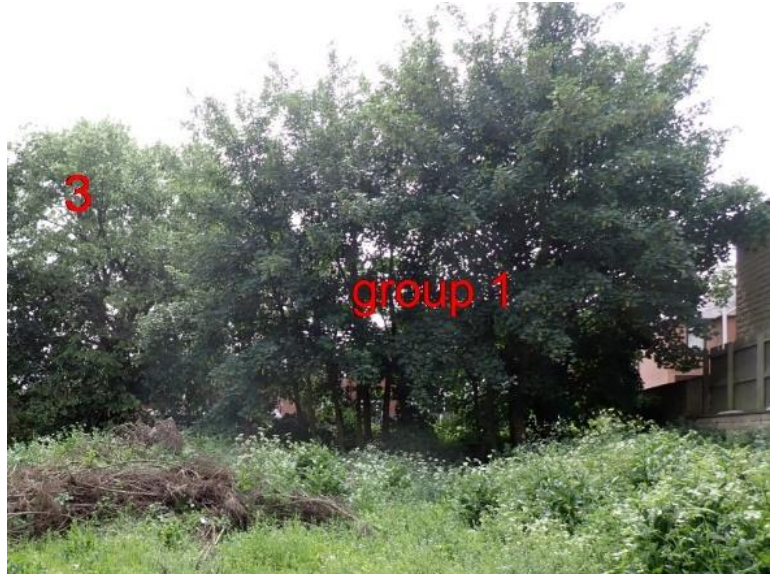
Photograph 10.

Photograph 10 shows group 1, taken from within the site looking south.

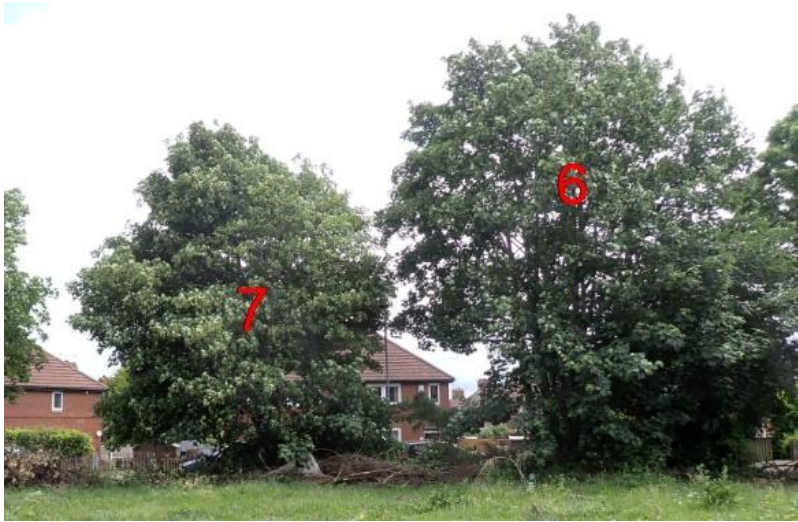
Photograph 11.

Photograph 11 was taken looking east from within the site and shows trees 6 & 7.

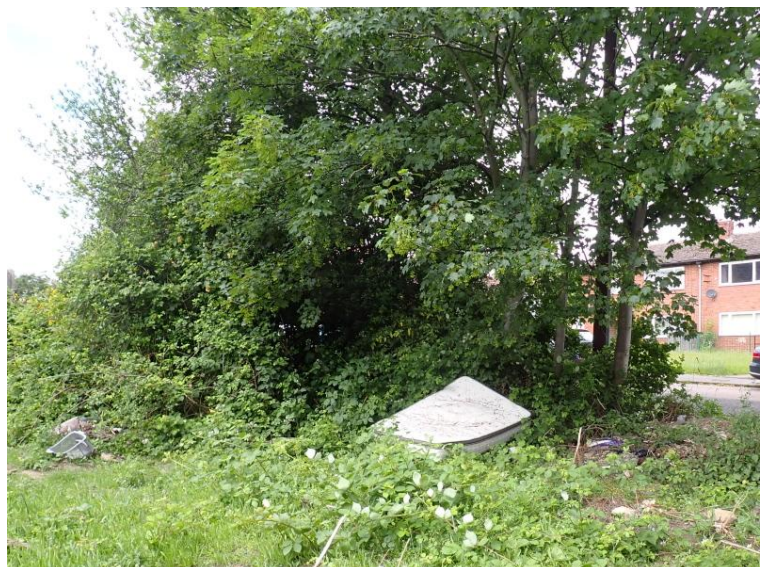
Photograph 12.

12.	Group	Mainly Sycamore with some Holly. The plans call for their removal. Similar to group 1. A Holly tree appears to be dying.

Photograph 12 shows group 12 in the north west corner of the site, with more fly tipping. The proposal calls for these trees to be removed.

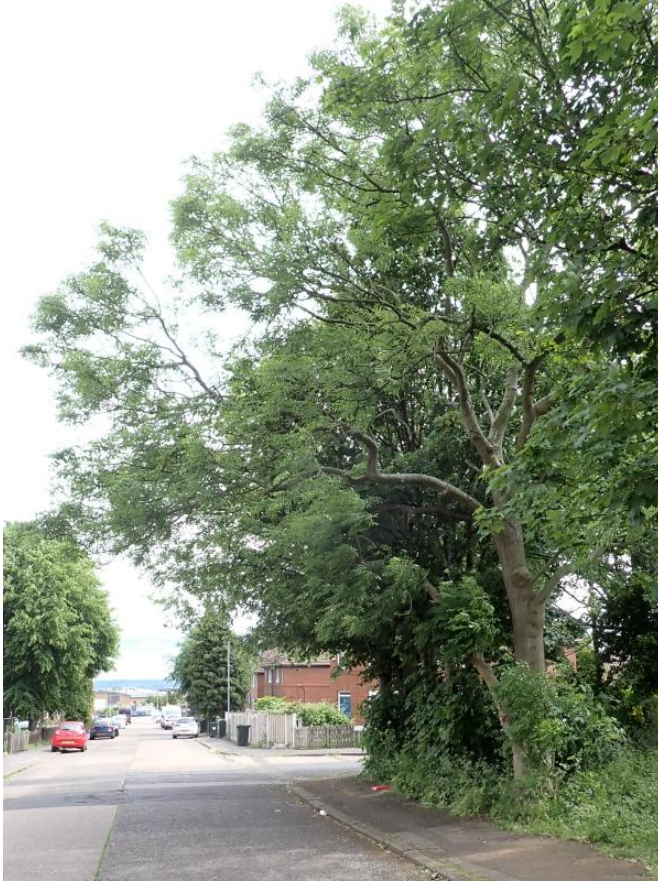
Photograph 13.

10.	Group	Sycamores, smaller than previous trees but will still require a 6 metre radius RPA.
11.	Ash	A decent tree but with some large low branches that will need to be removed. Some signs of Chalara. The plans call for its removal.

Photograph 13 is a view looking east down Underwood Avenue and shows tree 11, the Ash with a long branch reaching over the road. There's another low branch that seems to have been inexpertly pruned. This tree is also indicated for removal.

Chalara Ash Dieback is likely to affect this tree; as mentioned above
