Arboricultural Appraisal Report

Subsidence Damage Investigation at:

9 St Helier Drive
Barnsley
S75 2HD

CLIENT:	B Maule & Co. Ltd
CLIENT REF:	20129573
POLICYHOLDER:	Mr Howe
MWA REF:	S030812.01DM
MWA CONSULTANT:	Stephen Swinburne
REPORT DATE:	14 Aug 2012

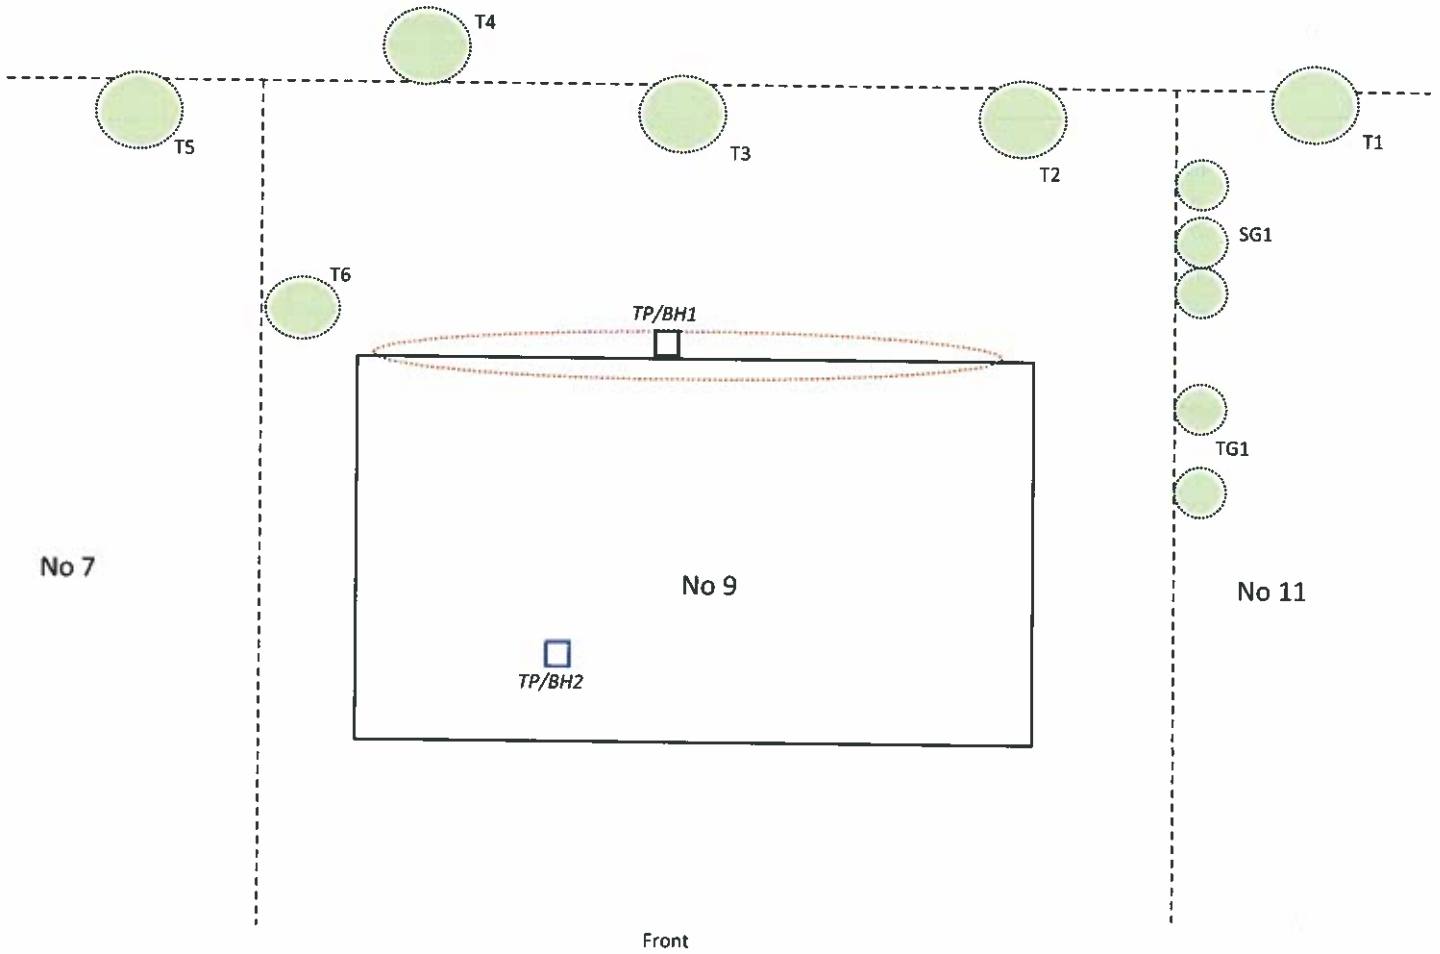
7.0 Site Plan

Approximate areas of damage

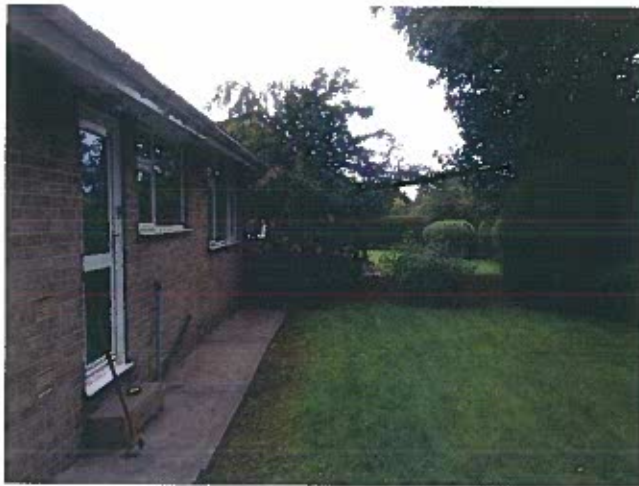
Roots were observed and recovered to a depth of 1800mm in BH1 and 1950mm in BH2 confirming the influence of several elements of vegetation on soil moisture and volumes below much of the property. Our survey did not highlight any trees of the Pomoideae group that would be the likely origin of the Pomoideae roots recovered from TP/BH1. Roots from the laburnum T6 are likely to be present but this tree is of the Leguminosae genus.

Tree No.	Species	Ht (m)	Dia (cm)	Crown Spread (m)	Dist. to building (m)	Age Classification	Ownership
T3	Sycamore	16	56	9	9	Not significantly older than the property	Insured
Recommendation		Remove tree and subsequent regrowth on an annual basis.					
T4	Ash	15.5	45	10	10	Not significantly older than the property	No 11 Oakfield Walk, S75 2LW
Recommendation		Remove and treat stump to inhibit regrowth					
T5	Sycamore	16*	60*	9*	8*	Not significantly older than the property	No 7 St Helier Drive
Recommendation		Remove and treat stump to inhibit regrowth					
T6	Laburnum	6	Ms	5	2	Younger than property	Insured
Recommendation		Remove and treat stump to inhibit regrowth

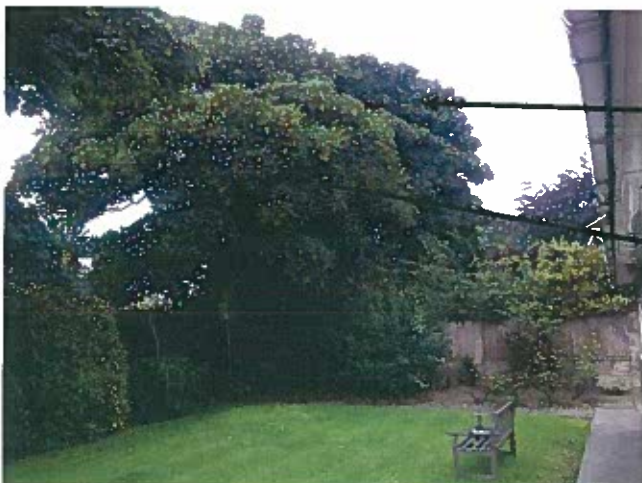
T1

T2

Tree No.	Species	Ht (m)	Dia (cm)	Crown Spread (m)	Dist. to building (m)	Age Classification	Ownership
T1	Sycamore	16*	60*	18*	15	Not significantly older than the property	No 11 St Helier Drive
Recommendation		Do not allow to exceed current dimensions.					
T2	Sycamore	12.5	48	8	10	Not significantly older than the property	Insured
Recommendation		Remove tree and subsequent regrowth on an annual basis.					
TG1	Cypress x 2	6.5	30*	3	2	Younger than property	No 11 St Helier Drive
Recommendation		Do not allow to exceed current dimensions.					
SG1	Mixed species group including holly, pyracantha	4	Ms	4	3	Younger than property	No 11 St Helier Drive
Recommendation		Do not allow to exceed current dimensions.
