Our Ref: 2017/436/TI

11<sup>th</sup> January 2018

**Structural Conditional Report for 319-323 Barnsley Road & 2 Haigh Lane, Hoylandswaine, S36 7HA**

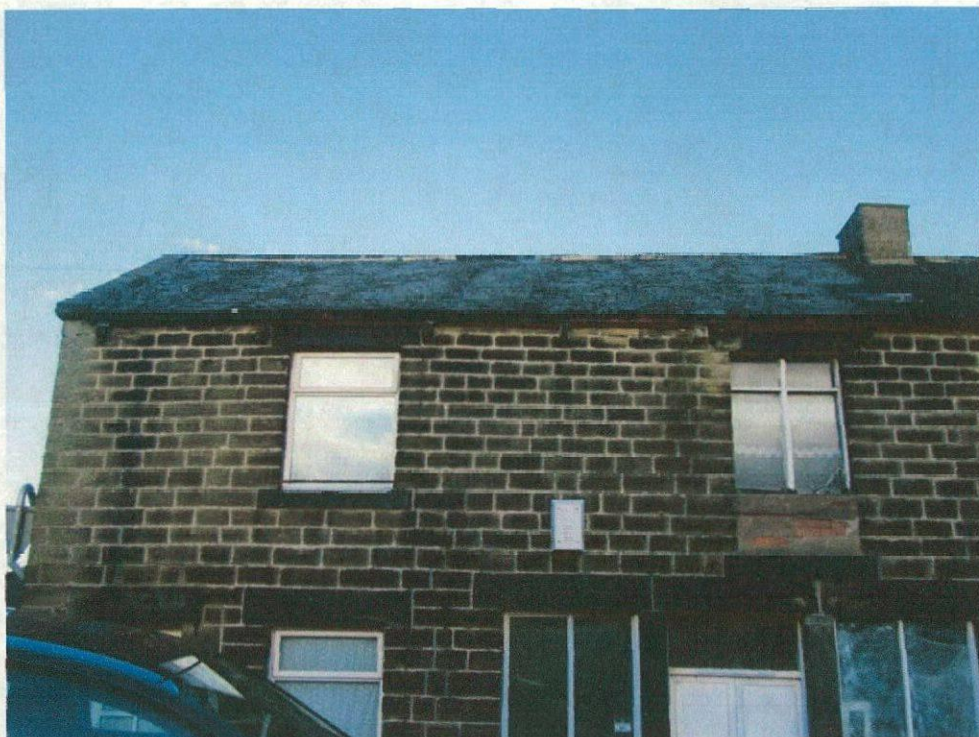
Photo 1 – Extensive weathering of slats to No's 3 on left and 321 in the centre. Bricked up first floor window above old Post Office frontage.

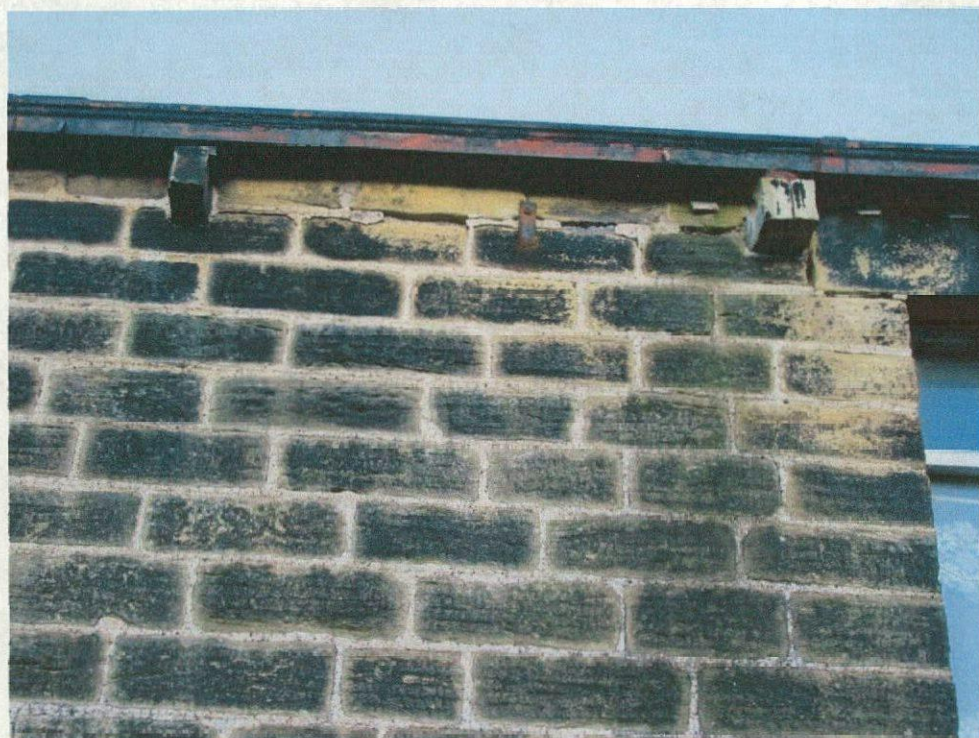
Photo 2 – High level movement to front wall above No 321.

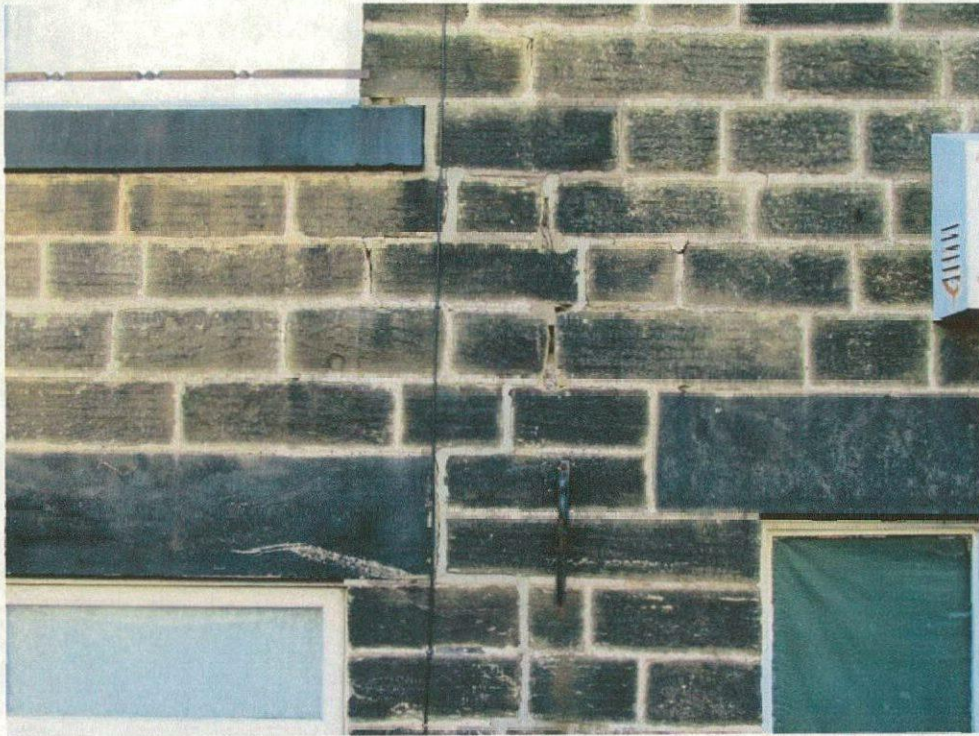
Photo 3 – Vertical cracking between ground floor lintels and first floor sill.

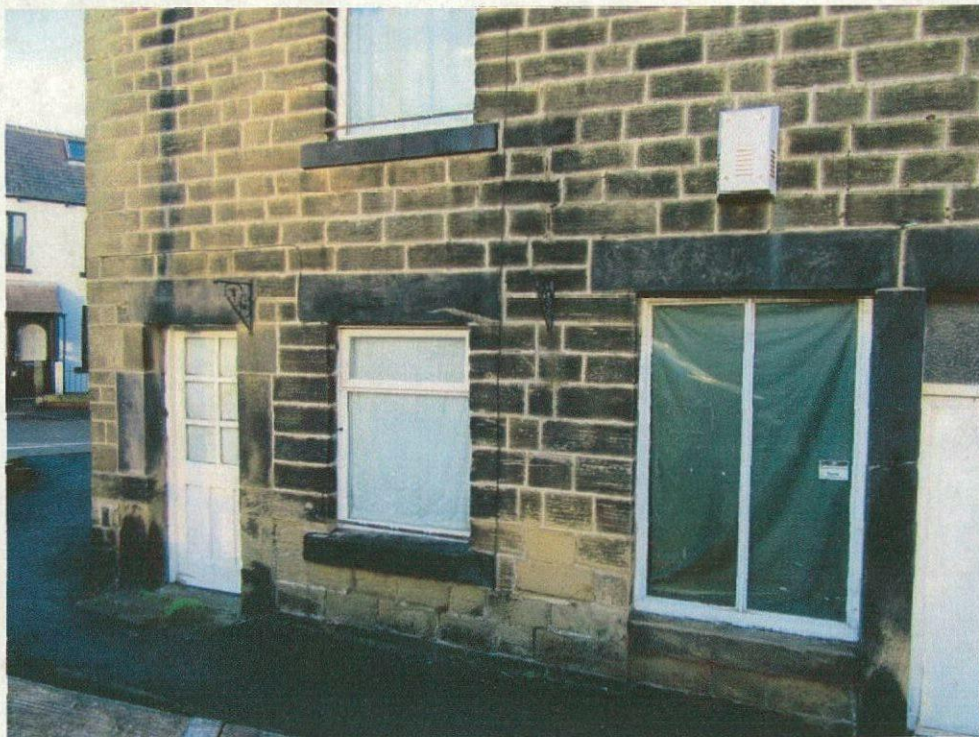
Photo 4 – At junction of No 319 and 321.

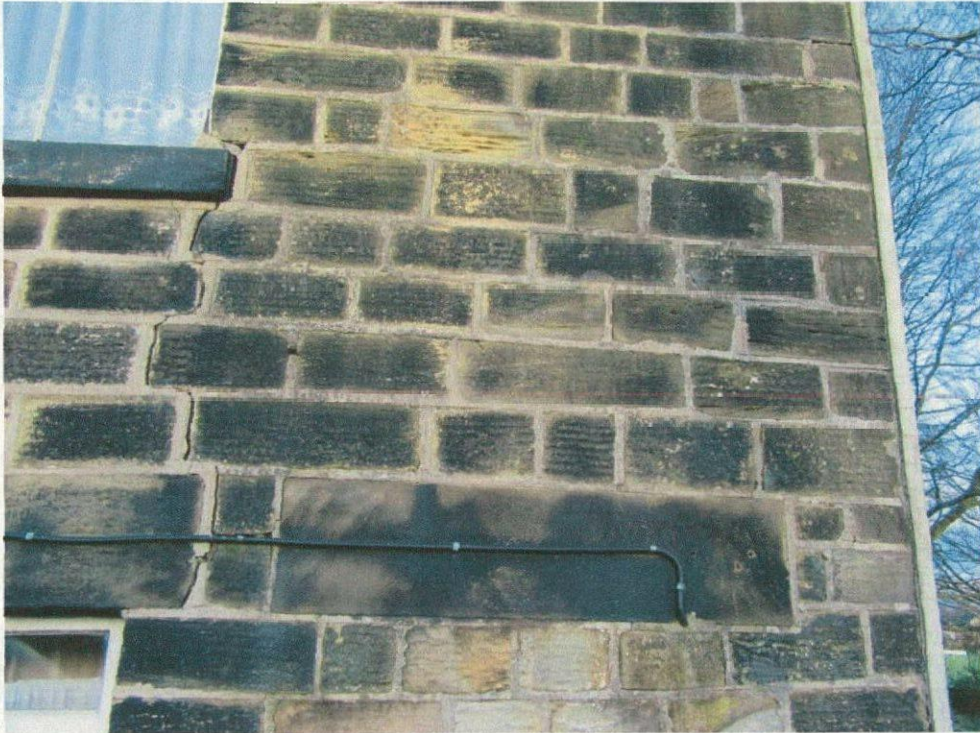
Photo 5 – Right hand gable and end of front wall has severe settlement to No 323. Note – 50mm settlement of old lintel over walled up original doorway and severe crack between lintel and first floor sill stone.

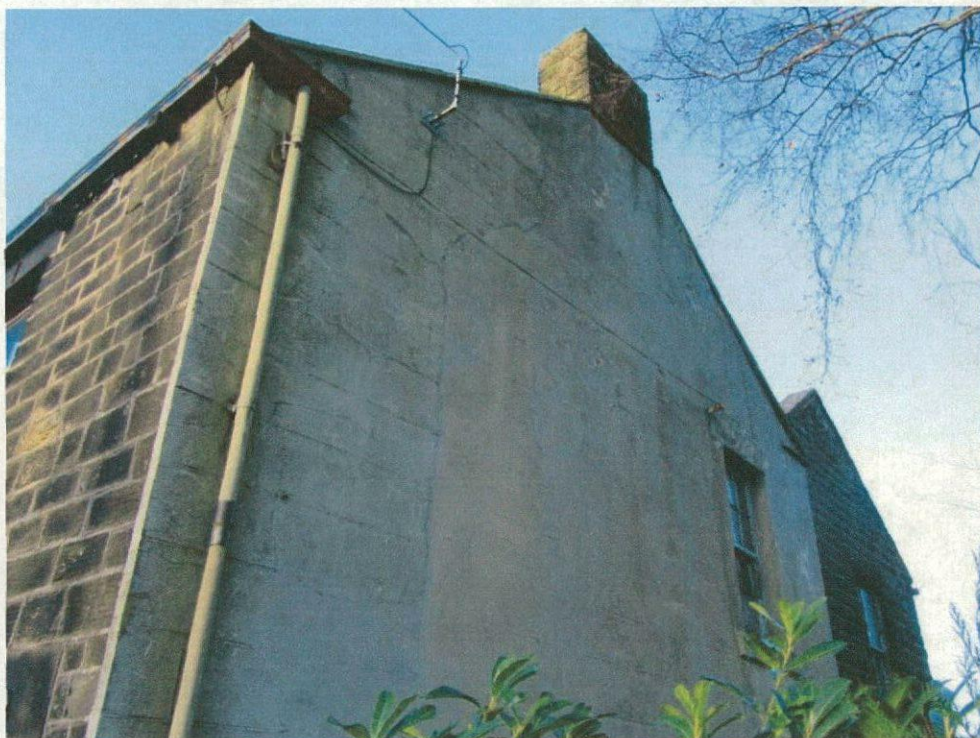
Photo 6 – General view of rendered right hand gable towards the front and stone gable towards rear of No 323.

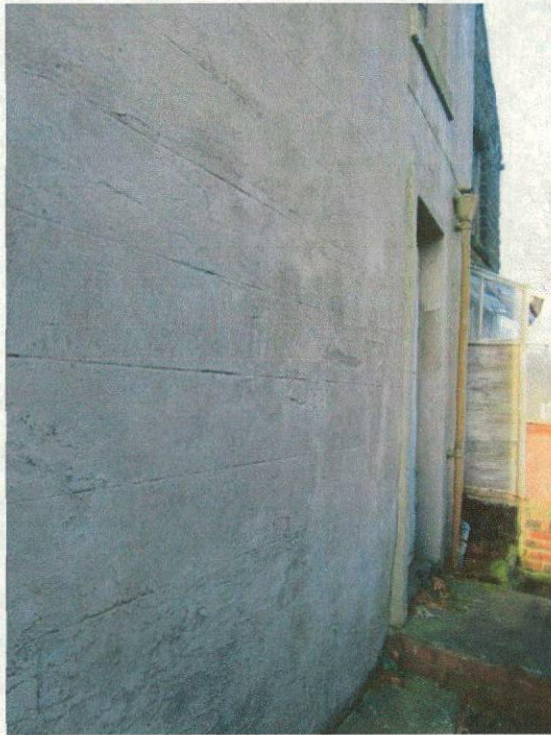
**Photo 7 – General outward bowing of right hand gable wall to No 323 and relocated side door, where jambs were installed vertical. These have now moved out of plumb at the head.**

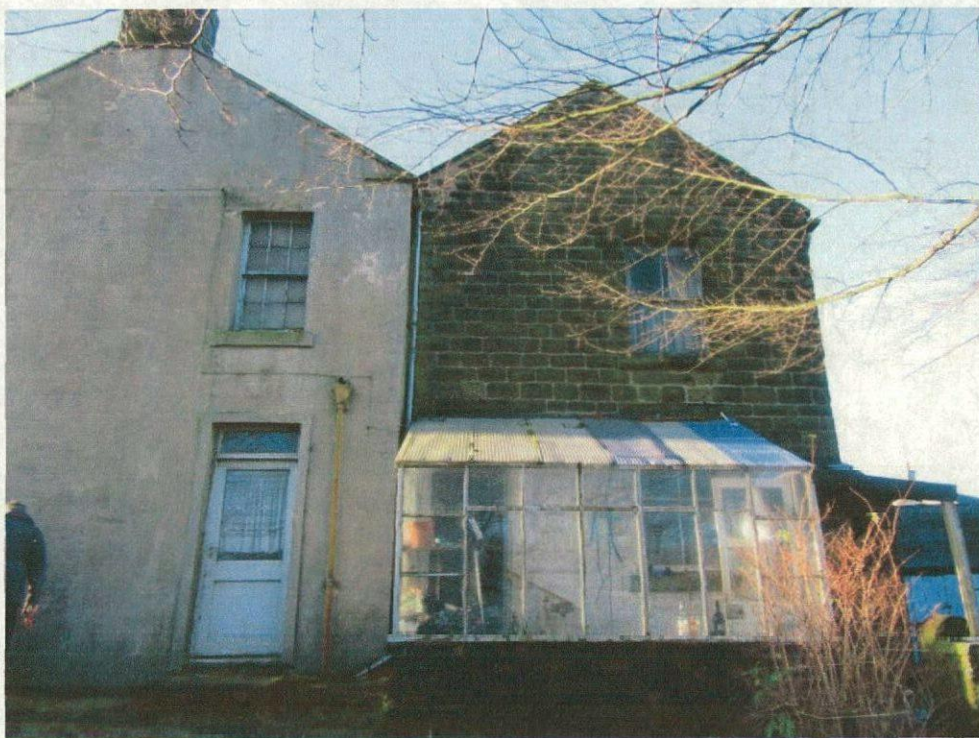
**Photo 8 – Dilapidated timber frame and glass porch to right hand gable.**

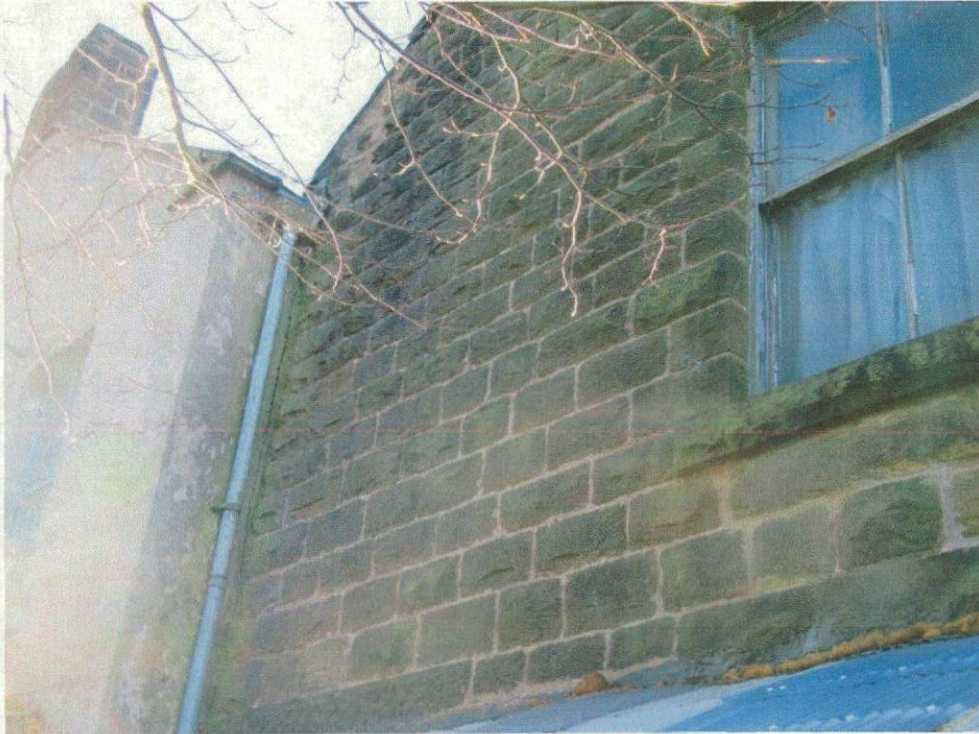
Photo 9 – Crack at junction of rendered front and rear stone work behind rainwater pipe, as the front is moving out more than the rear. Note – poor valley gutter outlet.

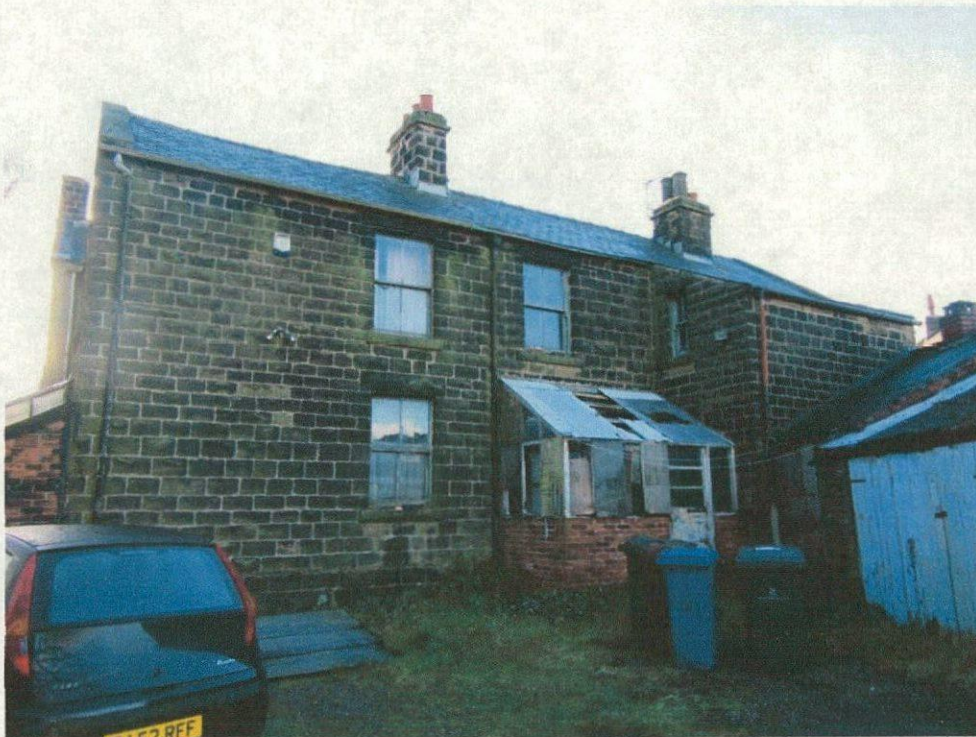
Photo 10 – General view of the rear of No 321 (centre) and No 323 (left of view) and No 2 Haigh Lane. Monopitch to the right of view includes ancillary buildings. Porch to the rear of No 321 is severely dilapidated.

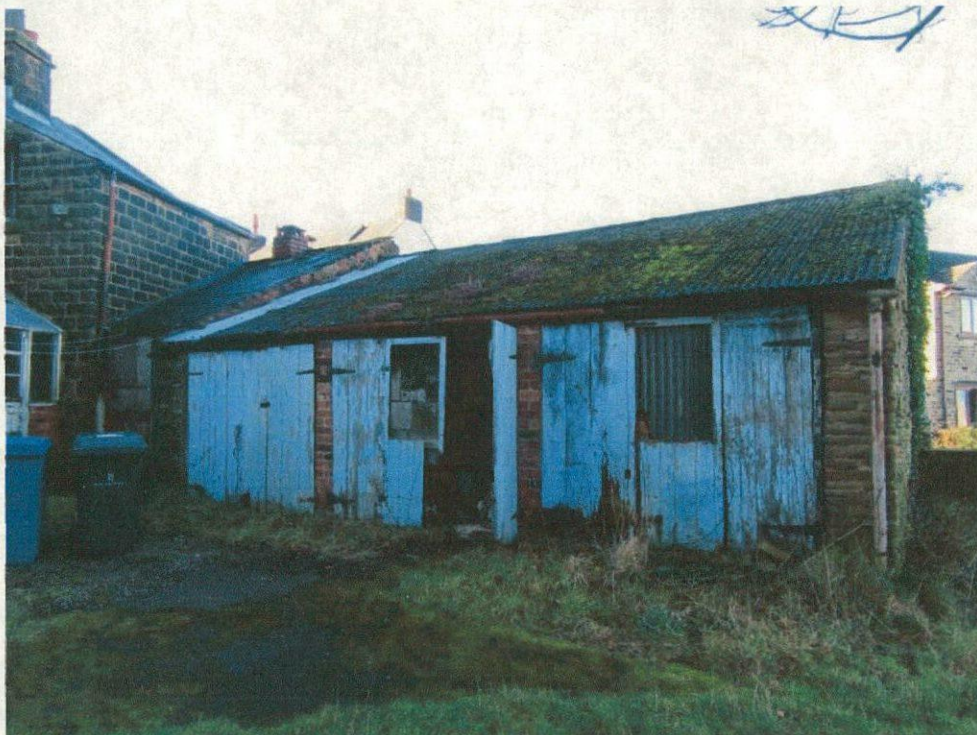
Photo 11 – Outbuildings off 2 Haigh Lane – predominantly asbestos cement roof panels, rotten timber doors and screens and highly weathered stonework.

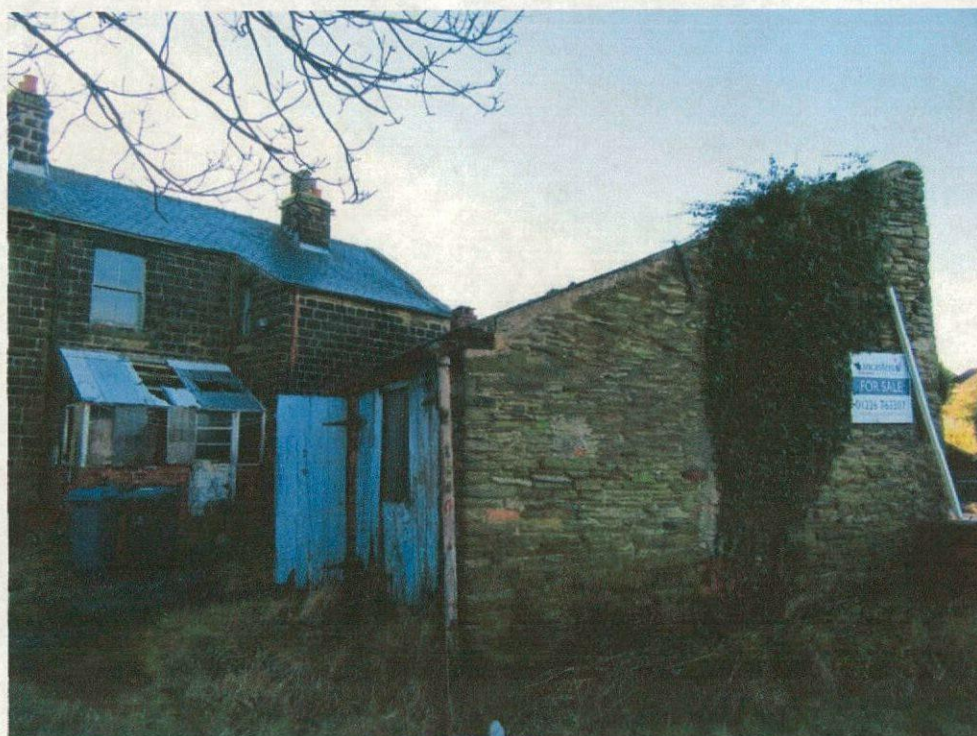
Photo 12 – High weathered stonework to gable of outbuilding.

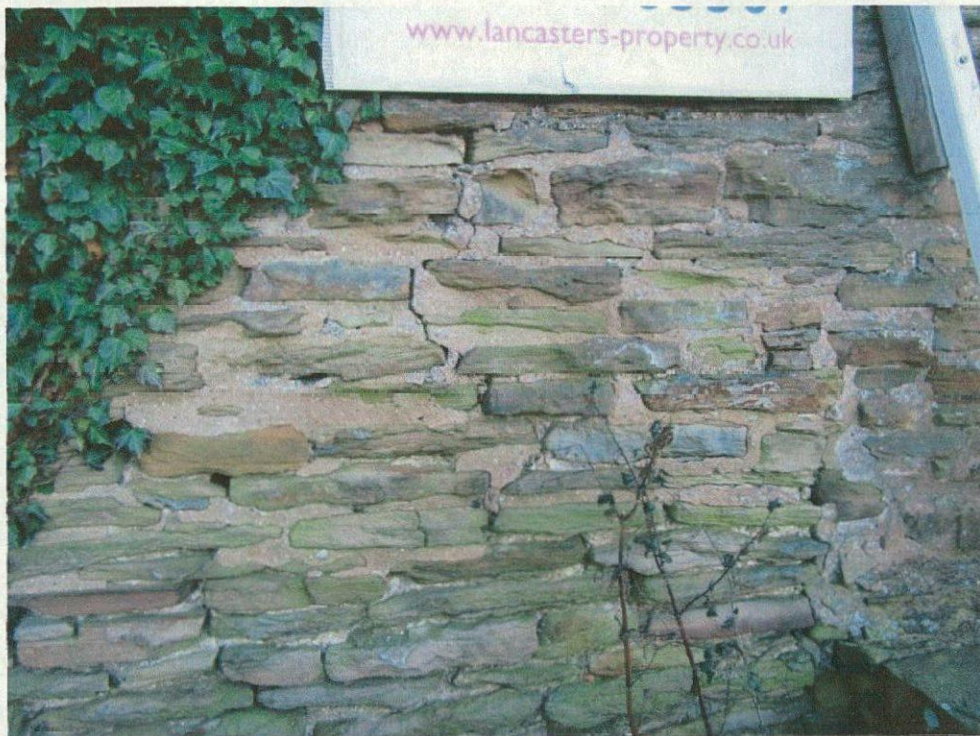
Photo 13 – Movement cracks to gable of outbuilding.

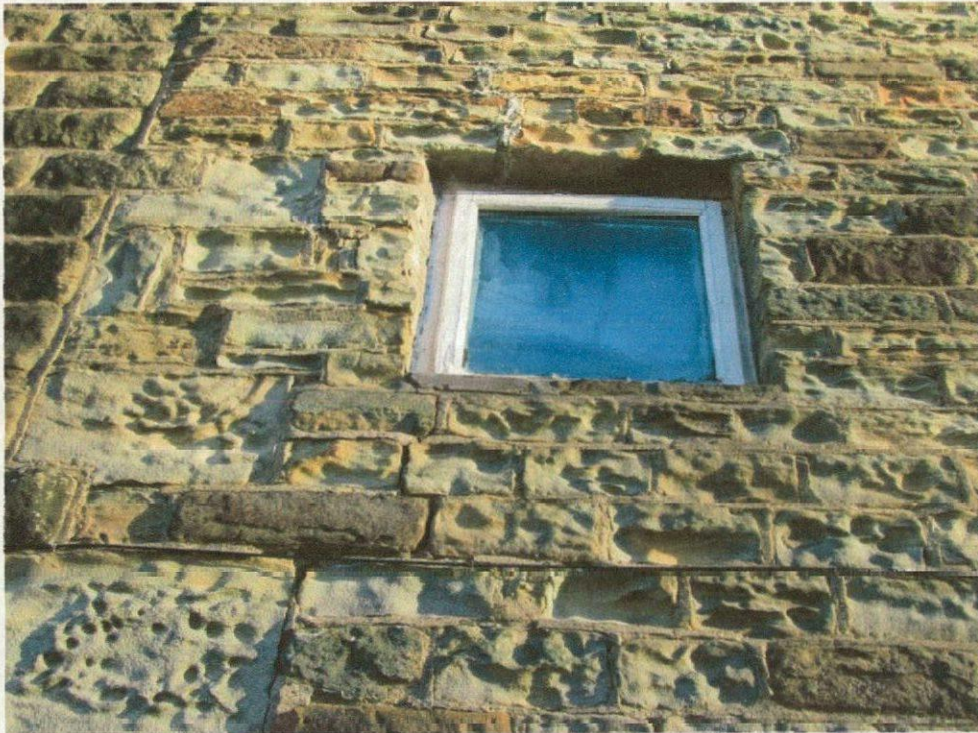
Photo 15 – Cracking between two gable ends below first floor window. Note  
– lack of lintel over window.

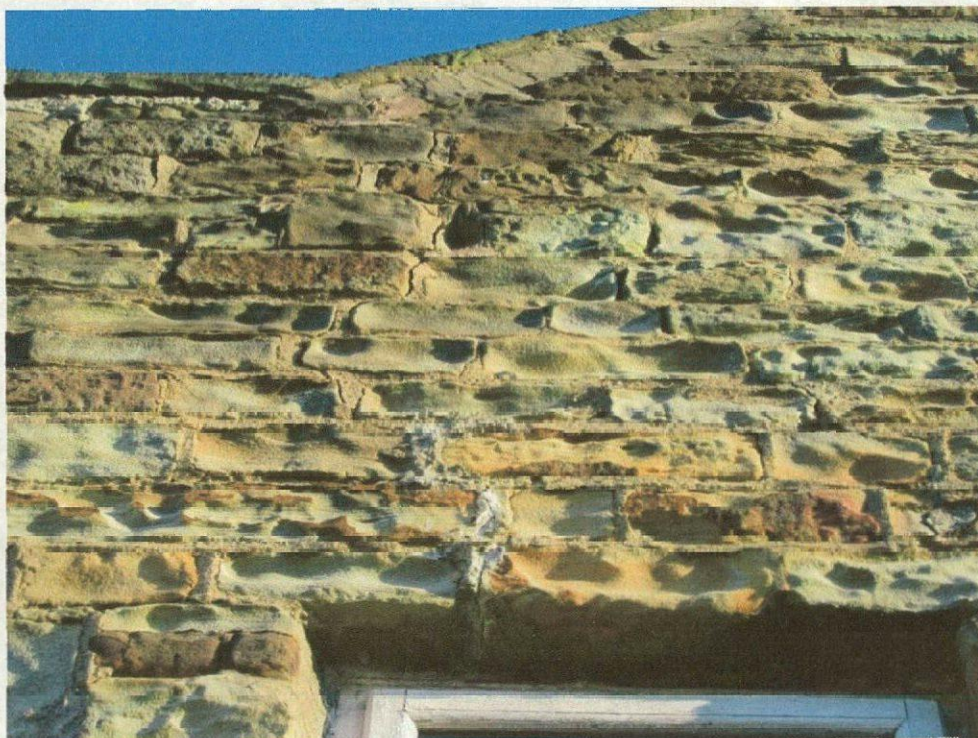
Photo 16 – Vertical crack above same window.

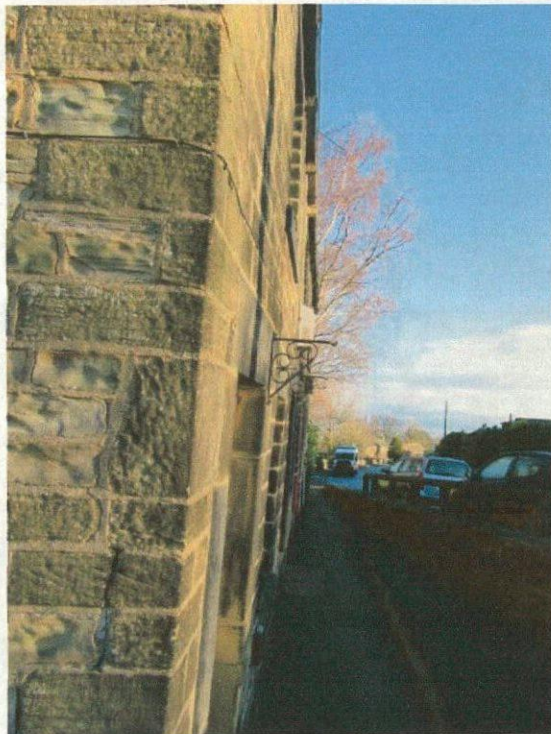
Photo 17 – Front wall along the full length, towards the road is out of plumb.

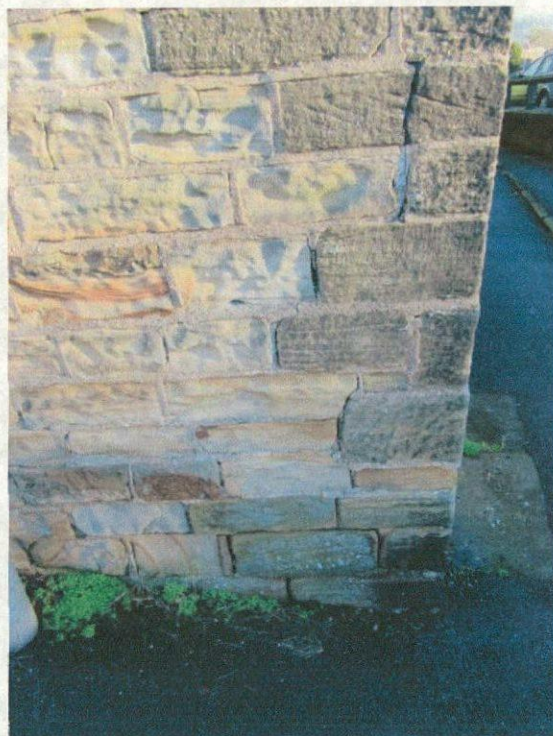
Photo 18 – Crack between front stonework and gable, as the front stone moves away from the gable.

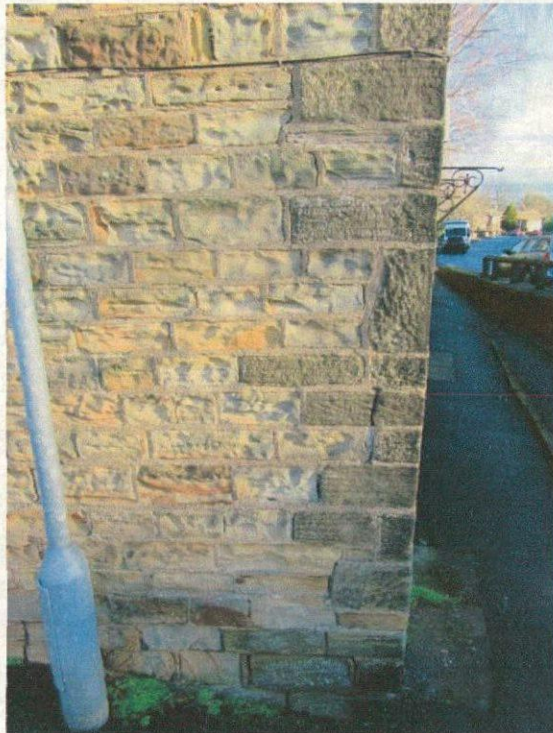
Photo 19 – Cracking extending full height.

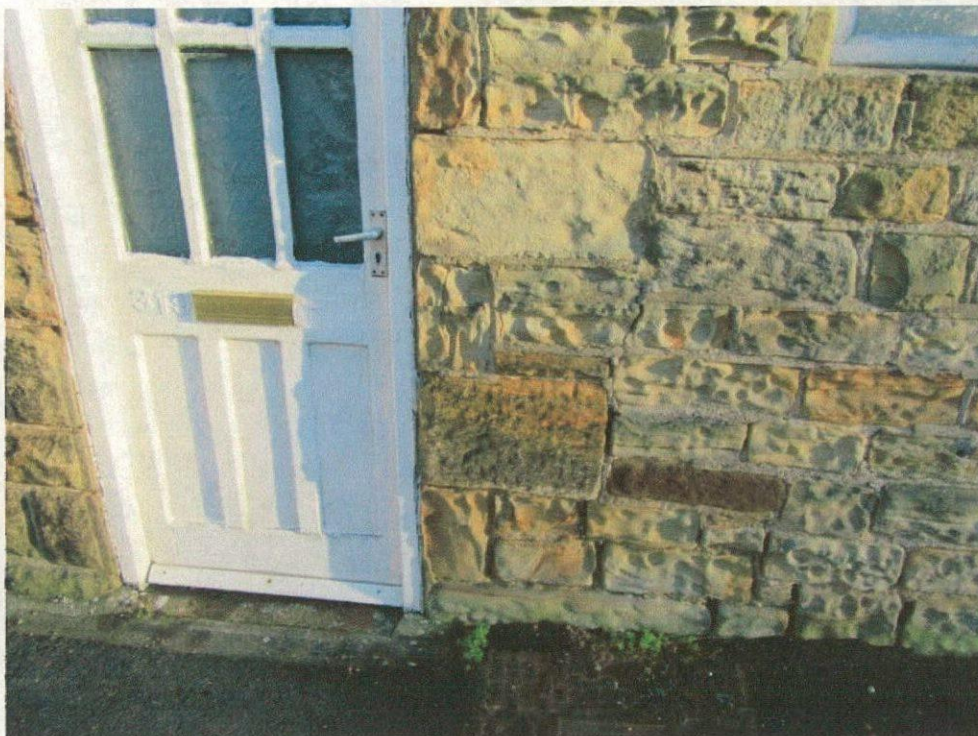
Photo 20 – Cracking to gable of No 319.

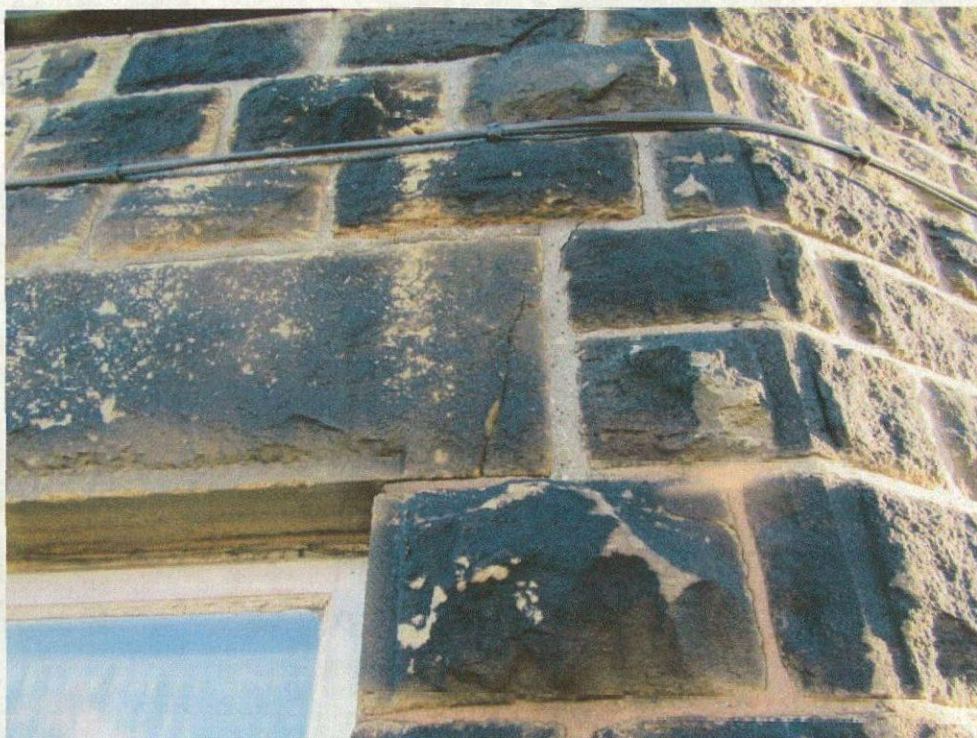
Photo 22 – Failure of lintel bearing.

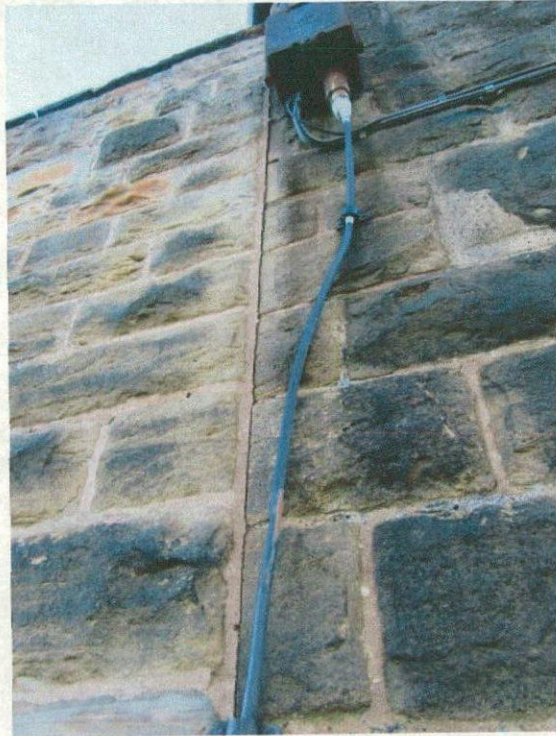
Photo 23 – Cracking at junction of 2 Haigh Lane and outbuildings.

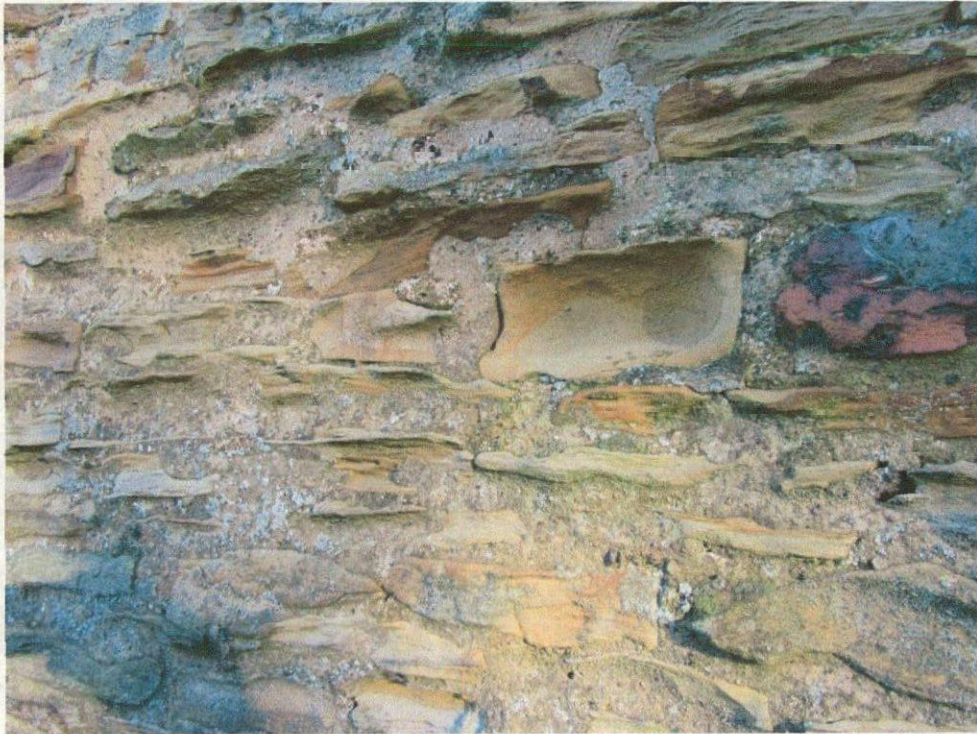
Photo 25 – Enlarged view. Note– severe weathering of poor quality stone.

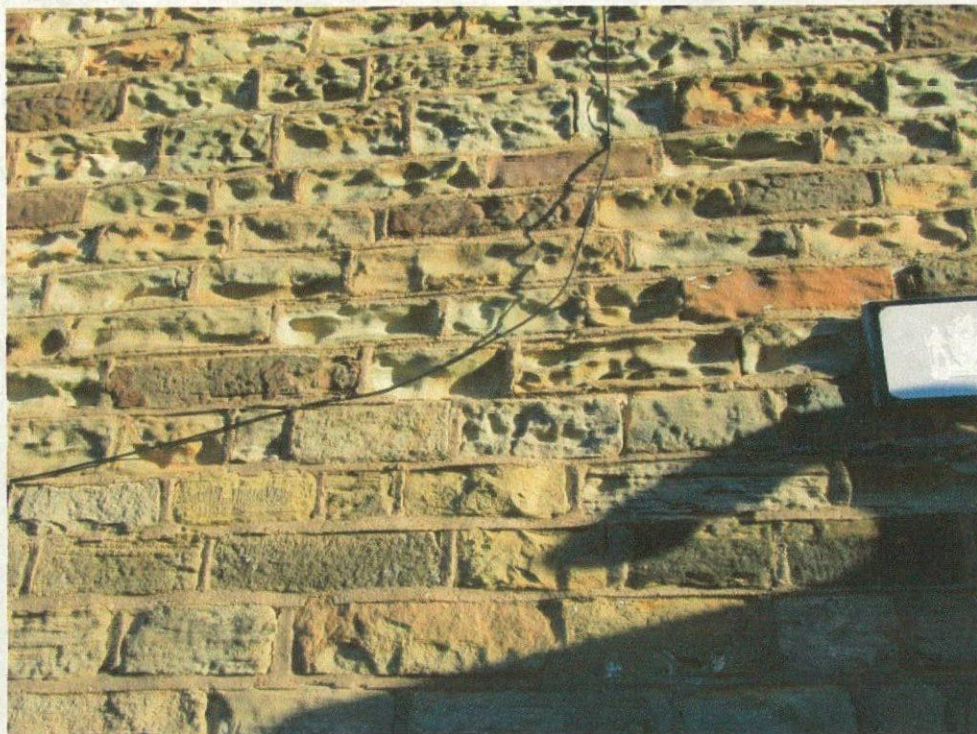
Photo 26 – Severe weathering to whole of gable stonework to No 319.

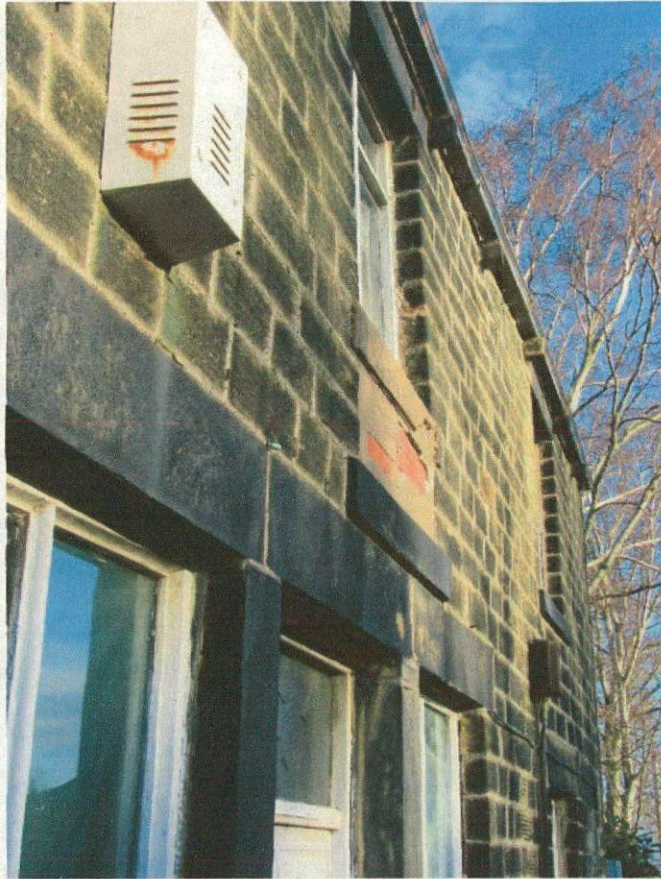
**Photo 27 – Excessive outward bowing to first floor stonework to panel between No 321 and 323.**

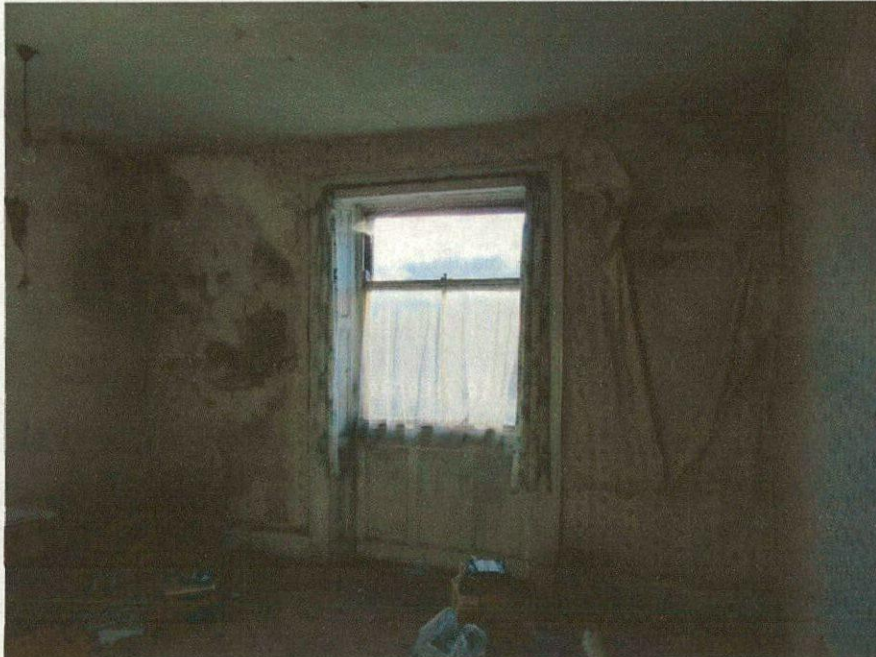
**Photo 28 – Internal view of first floor front wall to No 323. Severe water ingress from gutters.**

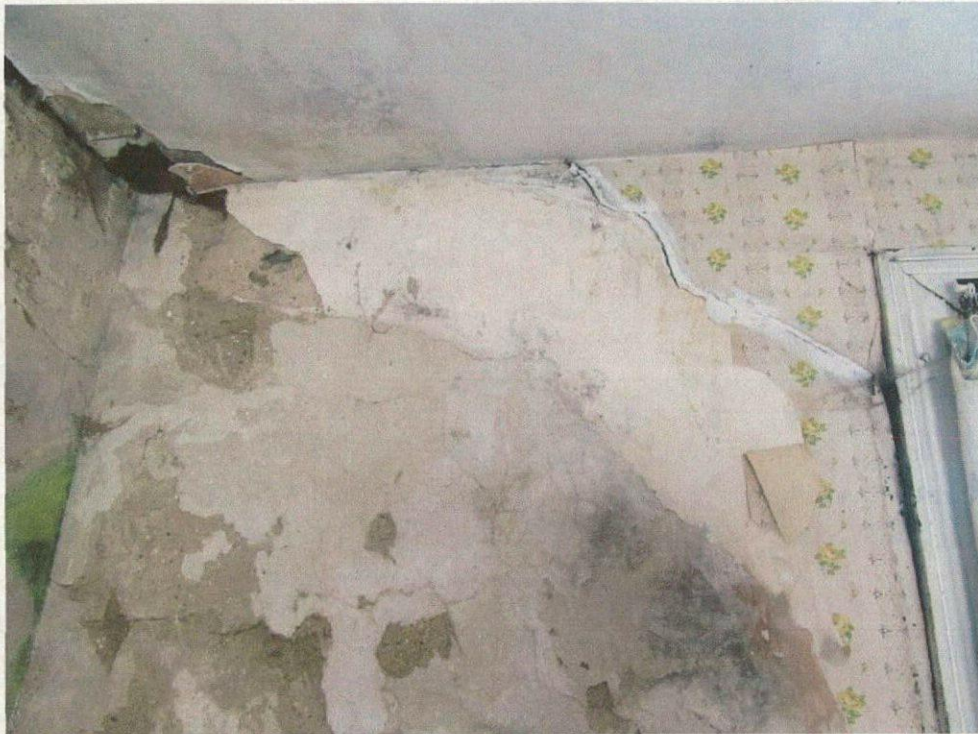
**Photo 29 – Settlement cracking to upper right corner, as the gable panel settles.**

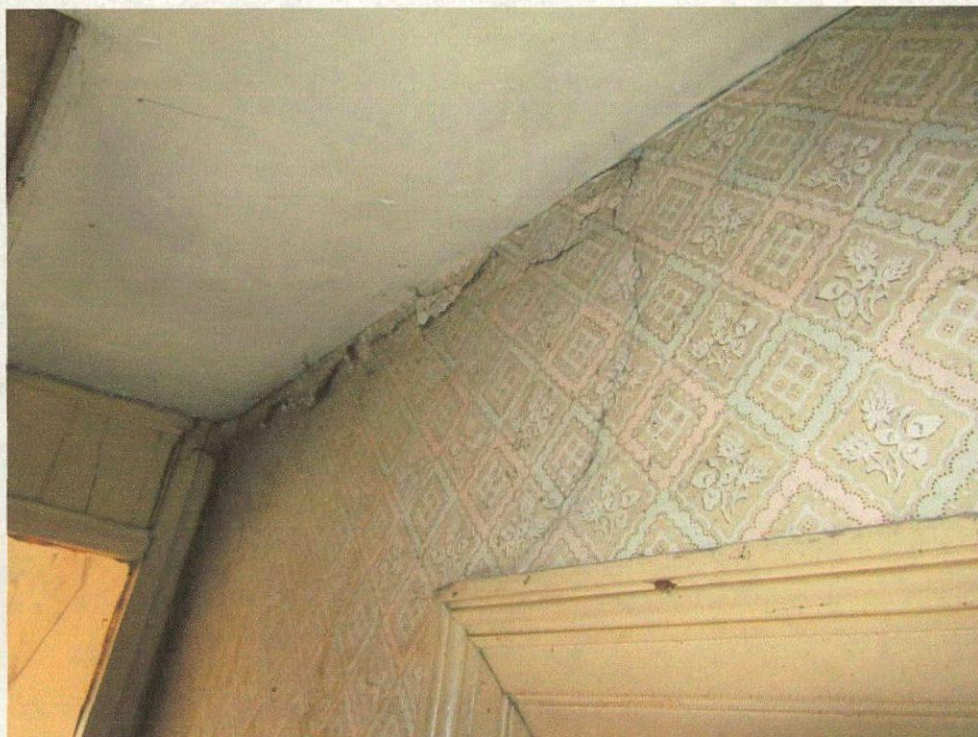
**Photo 30 – Cracking at head of internal masonry panel due to settlement.**

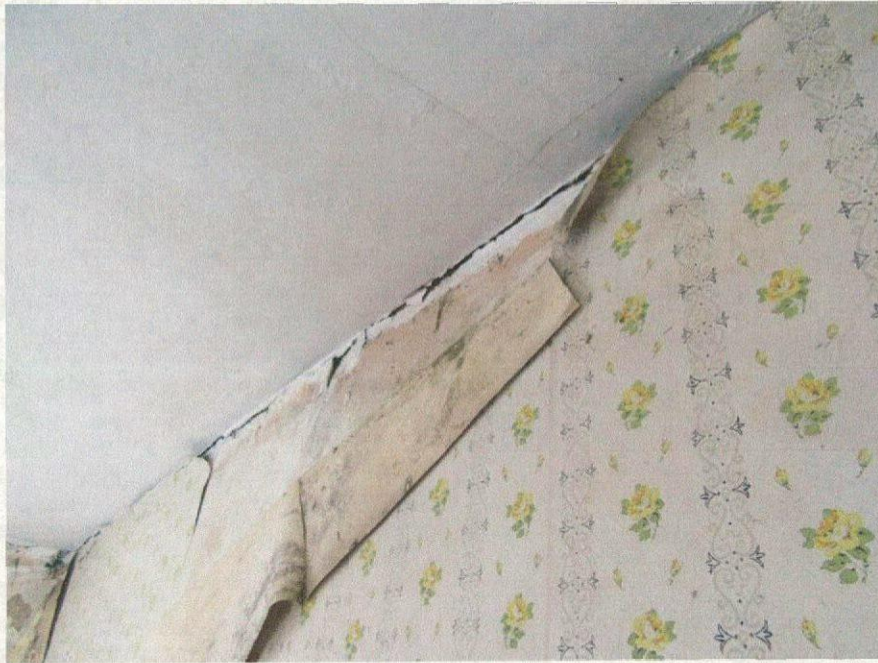
**Photo 31 – Further internal settlement to No 323.**

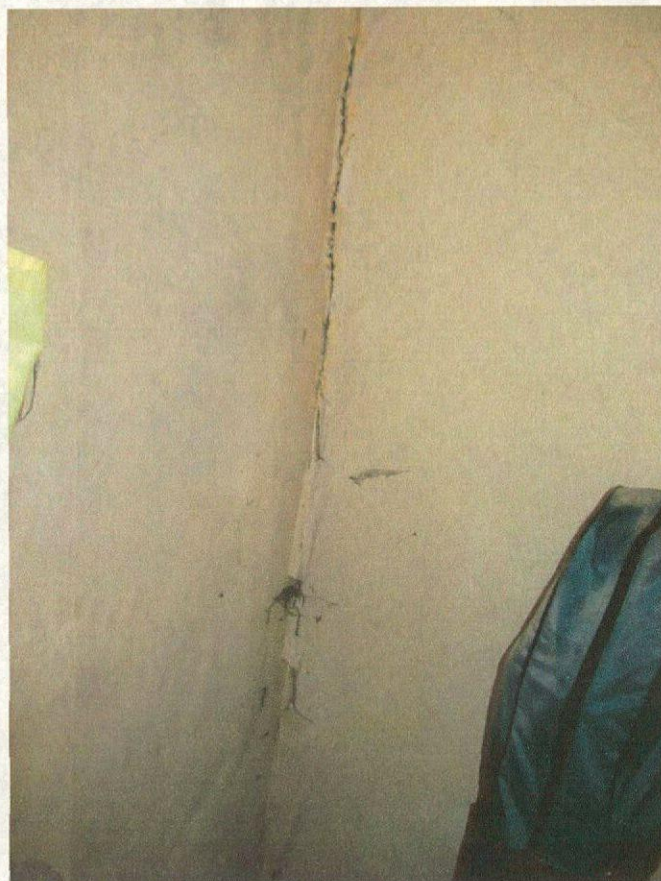
**Photo 32 – First floor internal wall to No 321. External wall to the right of the shot is moving out.**

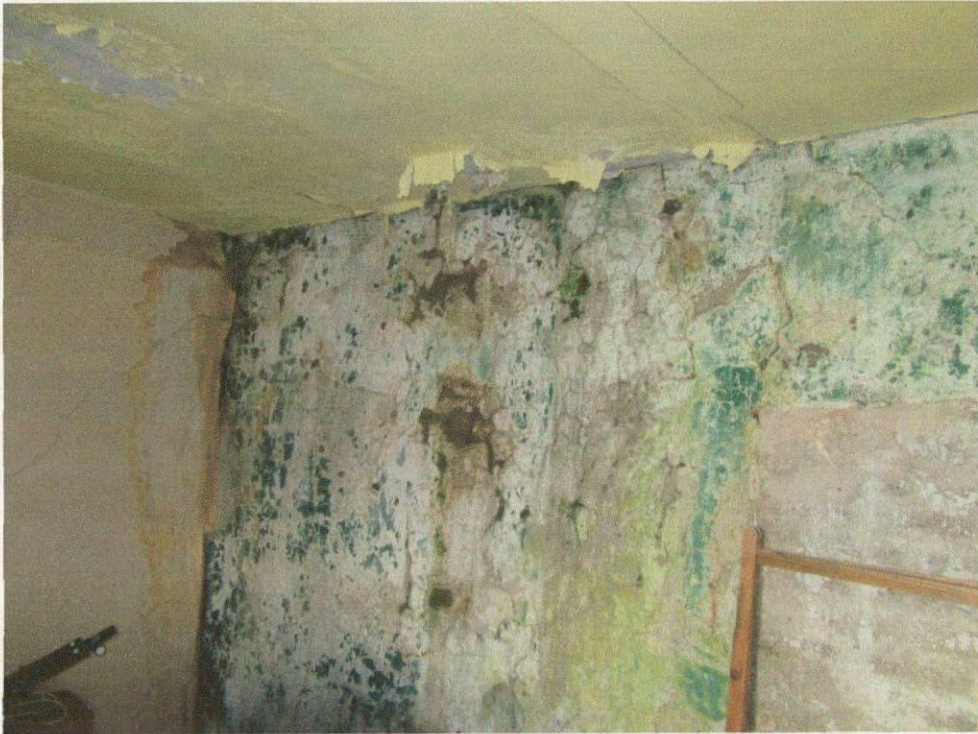
Photo 33 – Water damage on valley line of No 321.

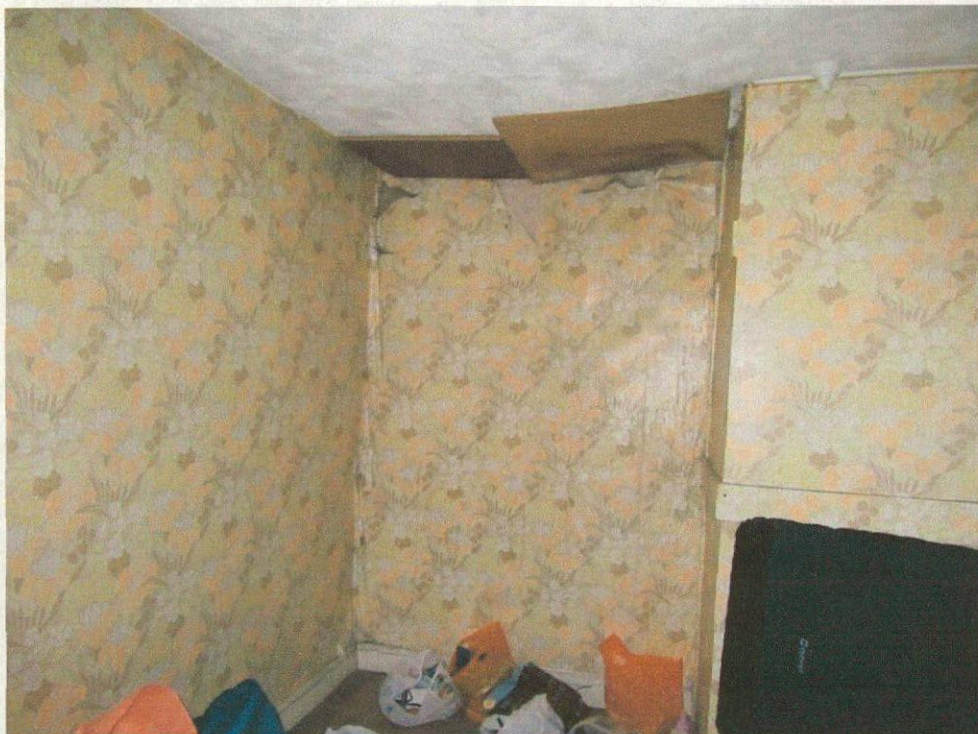
Photo 34 – Settlement of internal walls. Note – rucking of wallpaper at corner and boards over holes in the roof due to water ingress.

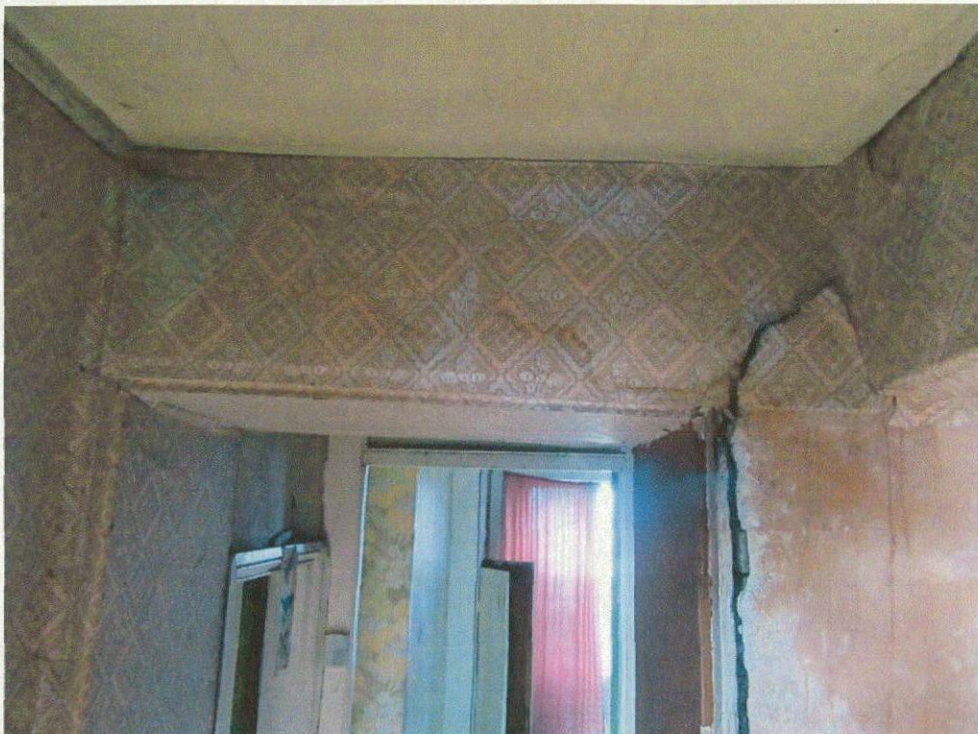
Photo 35 – Internal view looking from the front of No 323, through a doorway towards the rear. Note – severe settlement to right hand of the lintel members as the wall is settling.

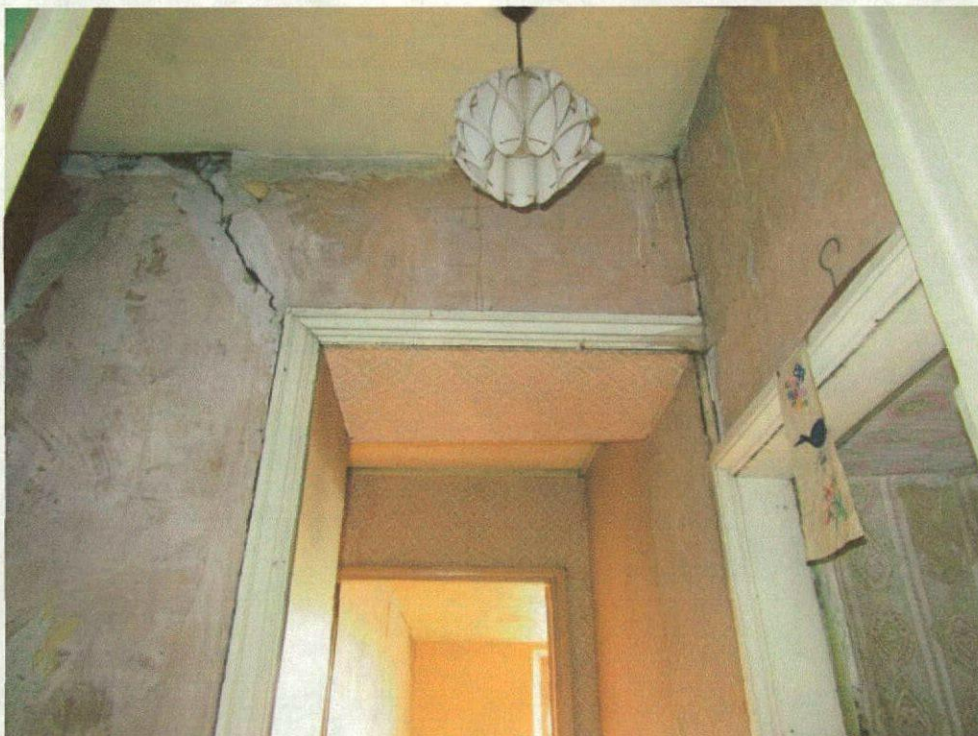
Photo 36 – Same door head looking from the rear towards the front of the property. All this movement is associated with the settlement of the right hand end of the building.

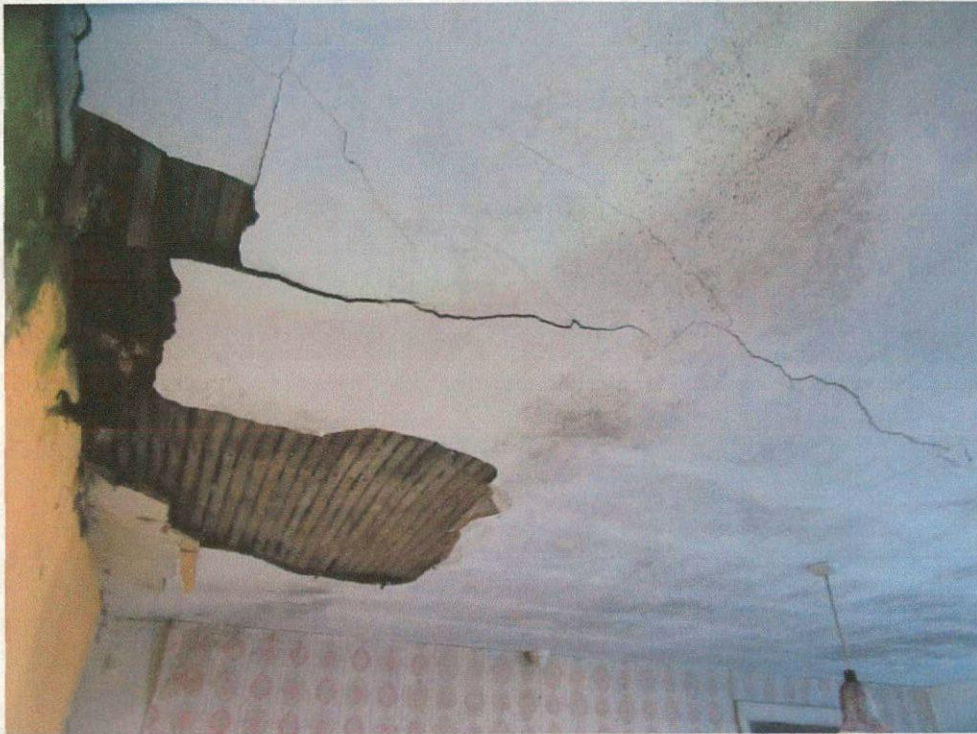
**Photo 37 – Water ingress at valley line with rotten timbers present.**
