Our Ref: 2017/436/TI

11<sup>th</sup> January 2018

**Structural Conditional Report for 319-323 Barnsley Road & 2 Haigh Lane, Hoylandswaine, S36 7HA**

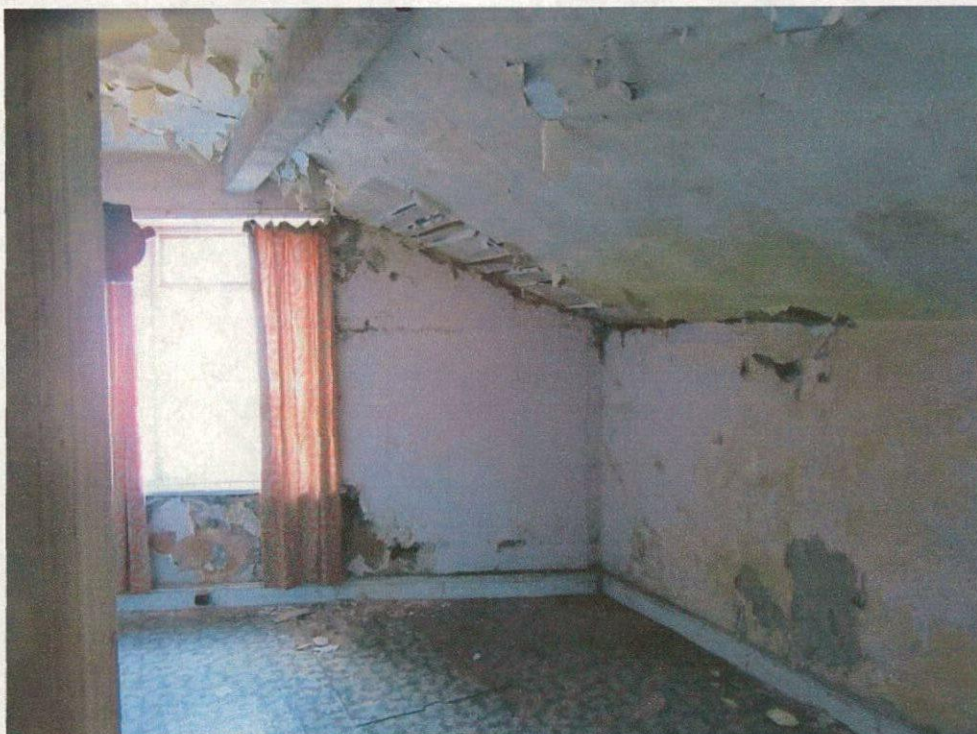
**Photo 38 – Water ingress to roof of No 2 Haigh Lane.**

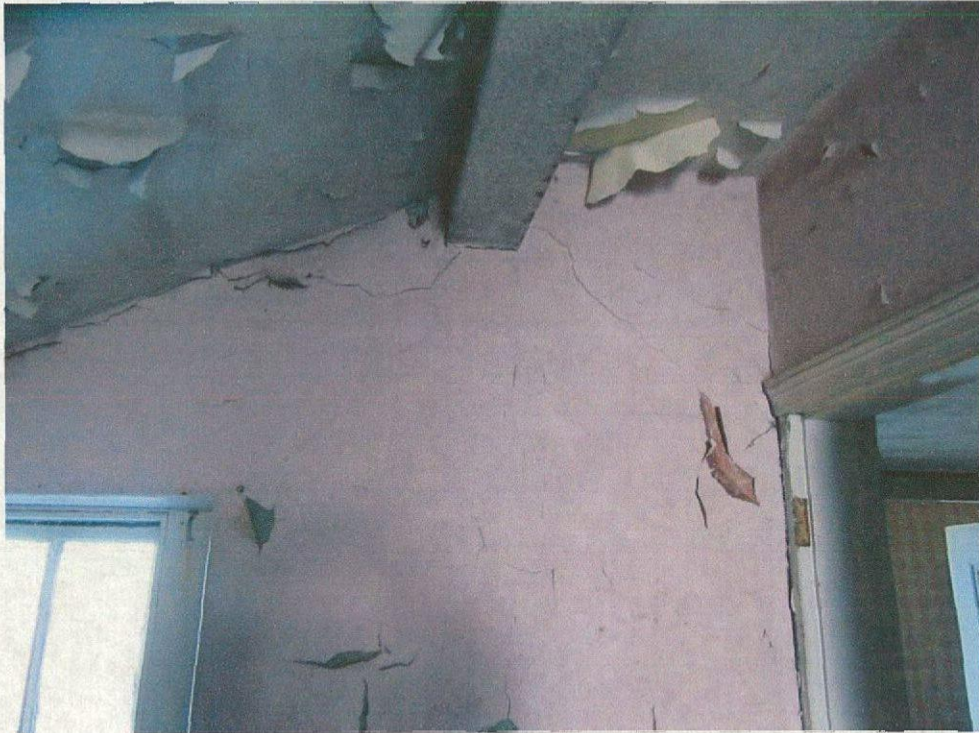
**Photo 39 – Settlement to right hand gable of No 2 Haigh Lane.**

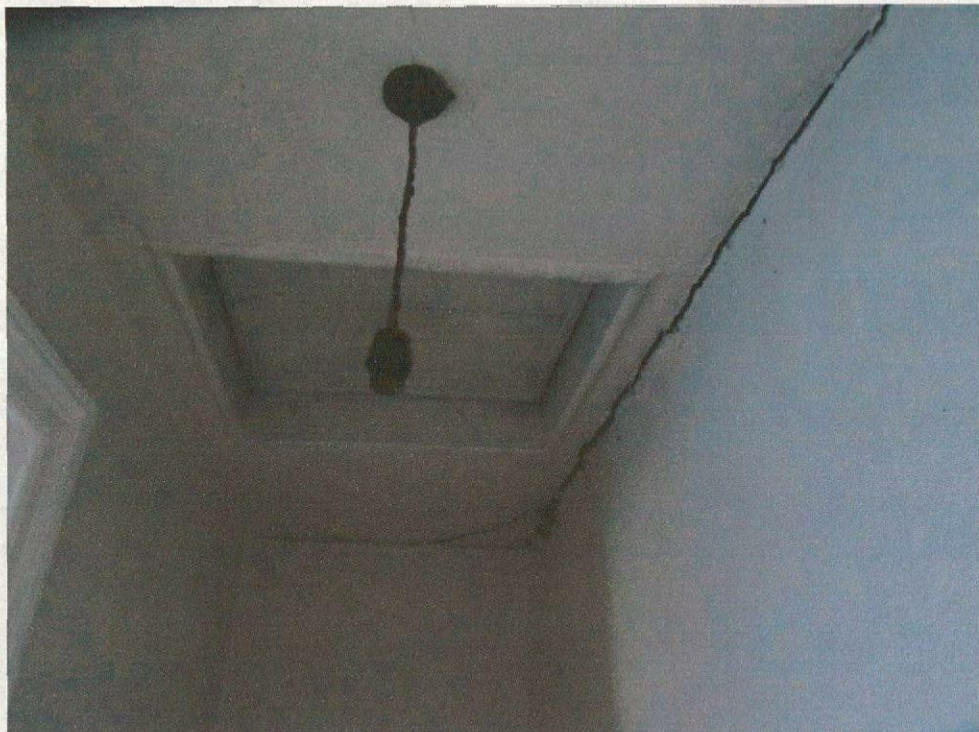
**Photo 40 – Severe internal settlement of No 2 Haigh Lane/ No 319.**

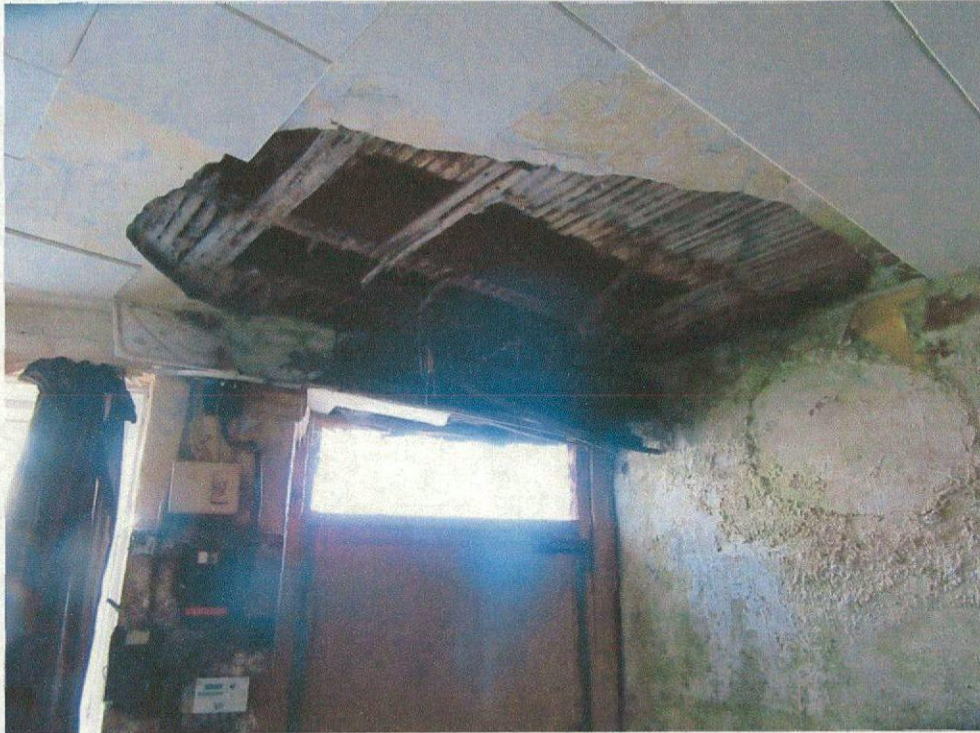
**Photo 41 – Rear left hand gable of 2 Haigh Lane. Severe water ingress – rear left corner.**

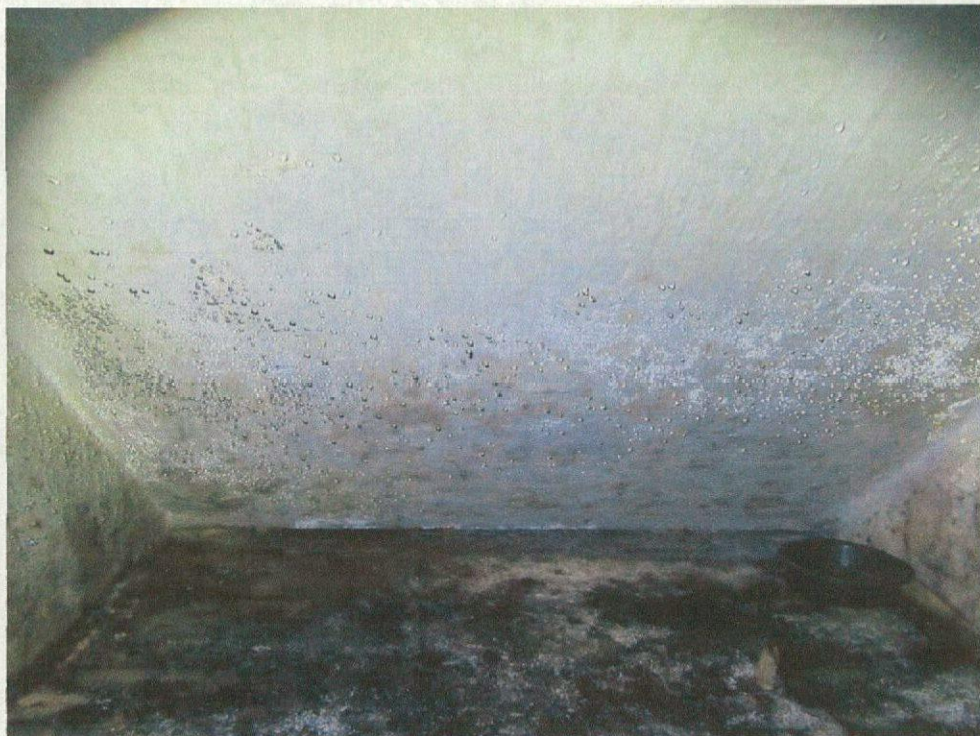
**Photo 42 – Condensation from water in the cellars at No 319. It is believed there may be a well beneath the property.**

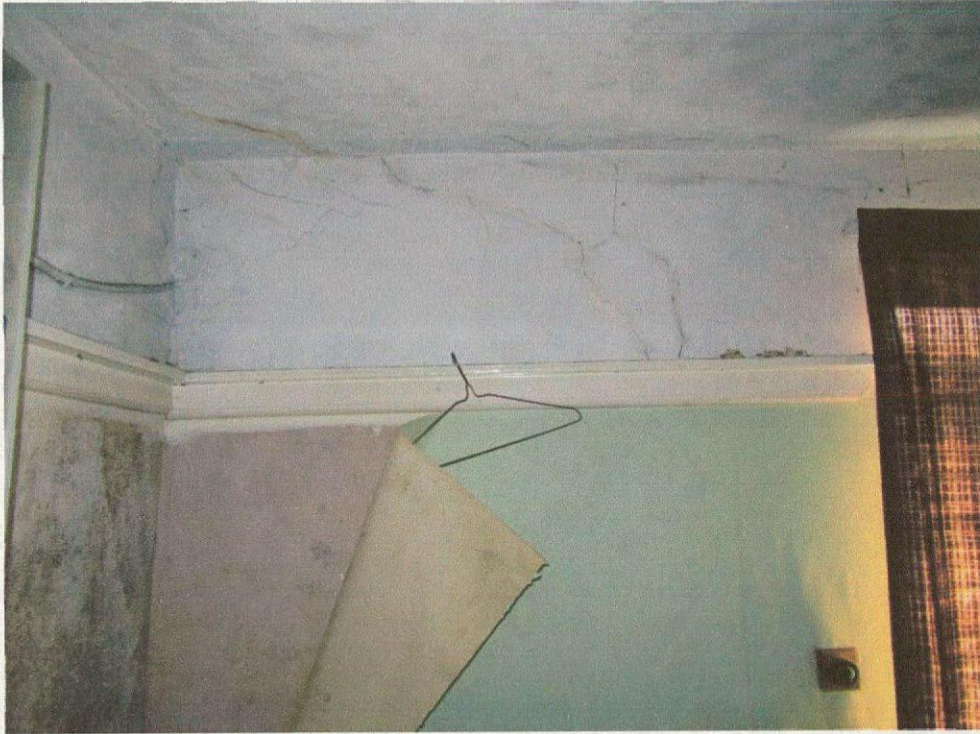
**Photo 43 – Cracking to front wall in No 323 due to settlement of right hand gable.**

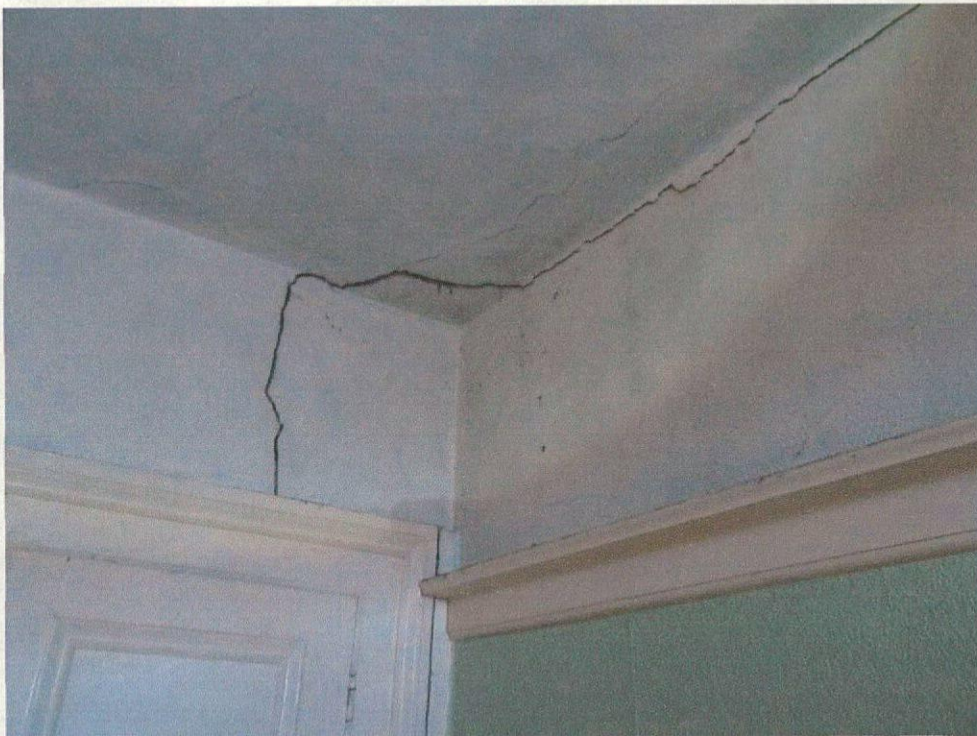
**Photo 44 – Internal cracking due to settlement of gable.**

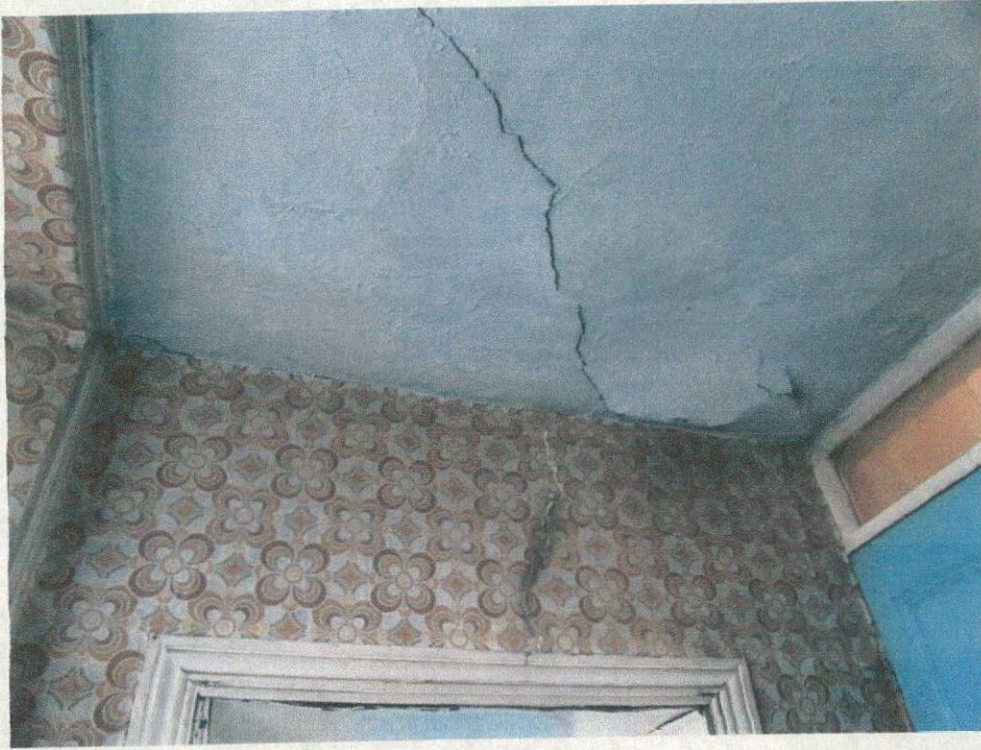
Photo 45 – Settlement of internal wall at No 323 and cracking of ceiling.

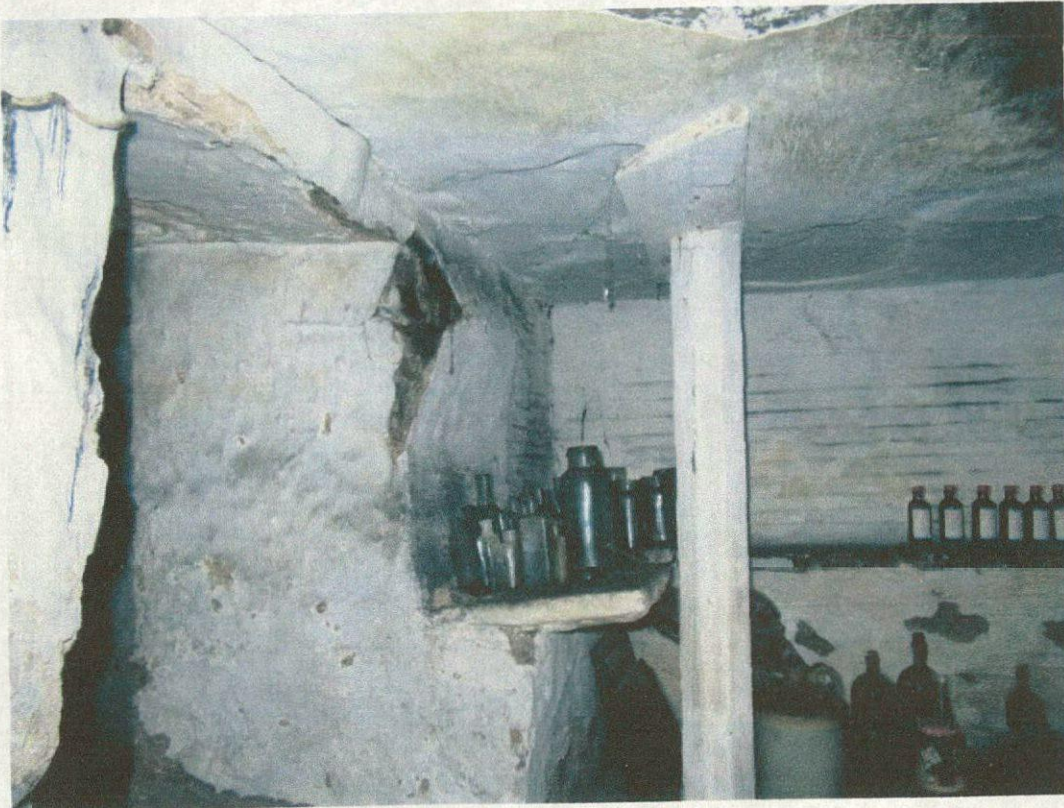
Photo 46 – Timber props in cellar.

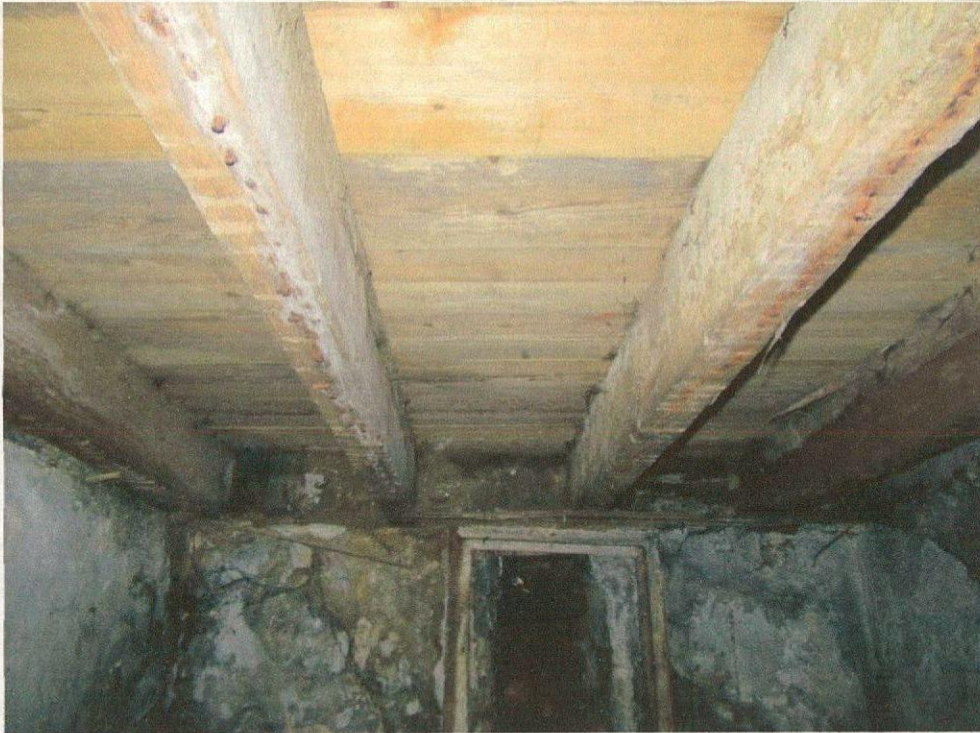
**Phot 47 – Cracking to stone wall and rotten floor joists.**
