Structural Solutions Ltd

Ref: NYP/15/188 Rev B

REF: 88 – 90 High Street, Dodworth, Barnsley – Boundary Wall Conditional Survey

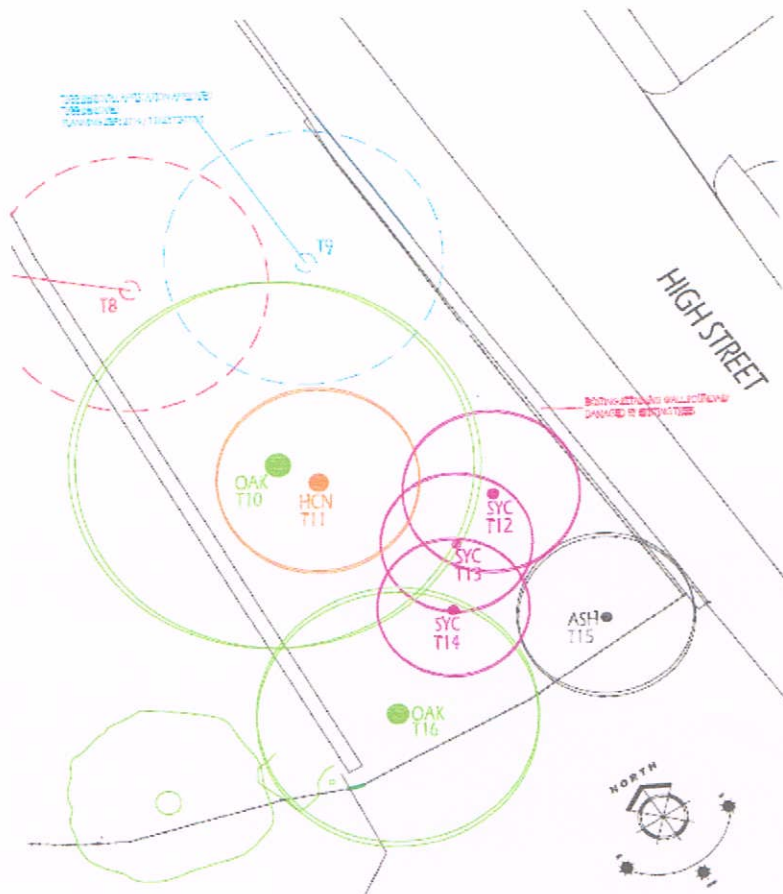
Fig 1

The wall as viewed from the road has a clear lean outwards with evidence of disturbance to the stone coursing and bonding of the wall further down High Street beyond the site.

The area of ground behind the wall, within the development site, contains a group of approx 7 trees. The trees are mature and have grown grouped close together, 4 of these are growing very close to the back of the boundary wall. (Refer to Fig 1)

From the visual site inspection, it is clear that the root and trunk growth of the trees in the area of raised ground directly behind the wall, as shown in Fig 1, has caused, and continues to cause, the existing boundary wall to be a potentially unstable state.

We would suggest that it will be necessary to undertake strengthening or even rebuilding works to this section of the boundary wall. In order to be able to carry out effective remedial works we suggest the trees directly behind the wall should be removed, these being T12, T13 & T15. These correspond to trees identified for removal in the arboricultural report. Removal of these trees will alleviate surcharge pressure from the rear of the wall. Where possible, and with approvals, other trees around the Oak trees, T10 & T16, should also be removed or thinned out.

It will be necessary for a specialist contractor to remove the canopy and trunks of each of the trees.

Sections of damaged / destabilised walls could then be taken down and rebuilt. We suggest that prior to commencing any excavation works that a specialist arboriculturist should be consulted to ensure that trees which are to remain are protected and that remedial works are not going to cause damage to the trees and roots.
