# **ARBORICULTURAL REPORT**

### **to BS5837:2012 at:**

*Land at*  
***Woodstock Road,***  
***Wilthorpe,***  
***Barnsley,***  
***South Yorkshire***  
***S75 1DX***

Reference: AWA3172

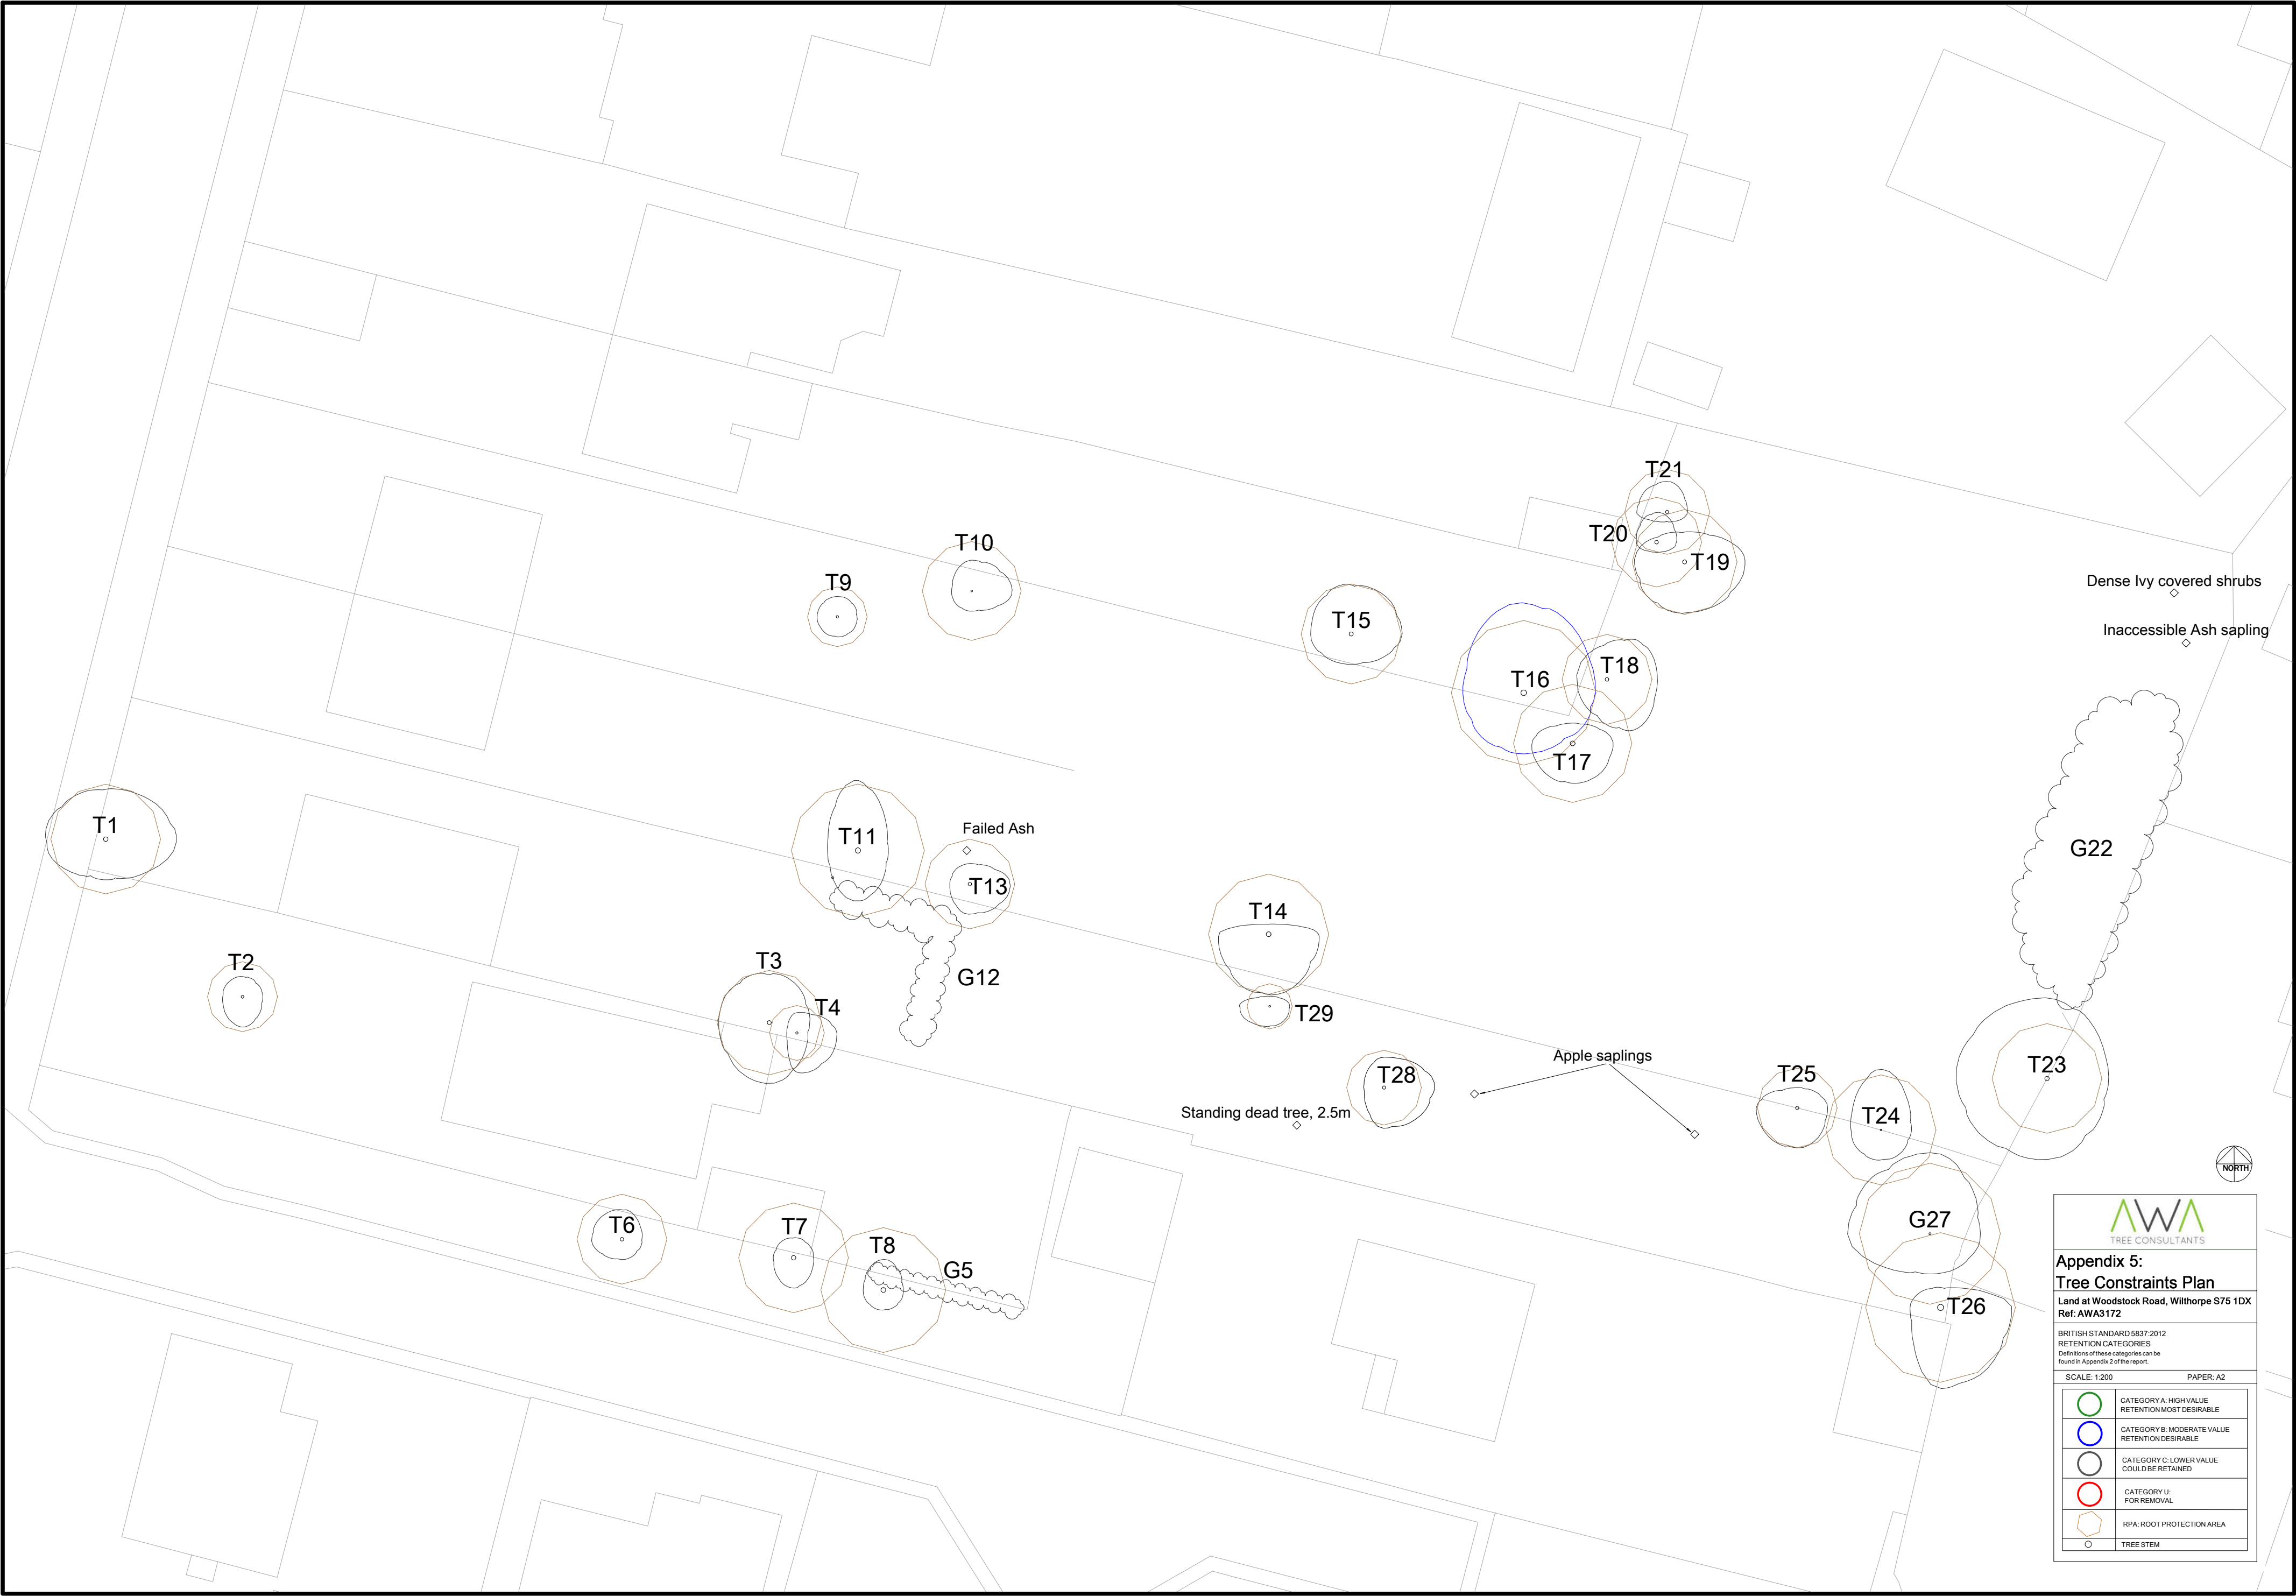
**Appendix 5:**  
**Tree Constraints Plan**  
Land at Woodstock Road, Willthorpe S75 1DX  
Ref: AWA3172

- 3.2.11 The tree Root Protection Area (RPA) detailed on the Tree Constraints Plan at Appendix 5 has been used as a layout design tool, to inform on the area around a tree where the protection of the roots and soil structure is treated as a priority.

- 3.2.13 The RPA for each tree has been plotted as a polygon centred on the base of the stem. Due to the presence of roads, structures, topography (and past tree management) the RPA is likely to be a simplified representation of the tree roots actual morphology and disposition. However, detailed modifications to the shape of the RPA would largely be based on conjecture and so have been avoided.

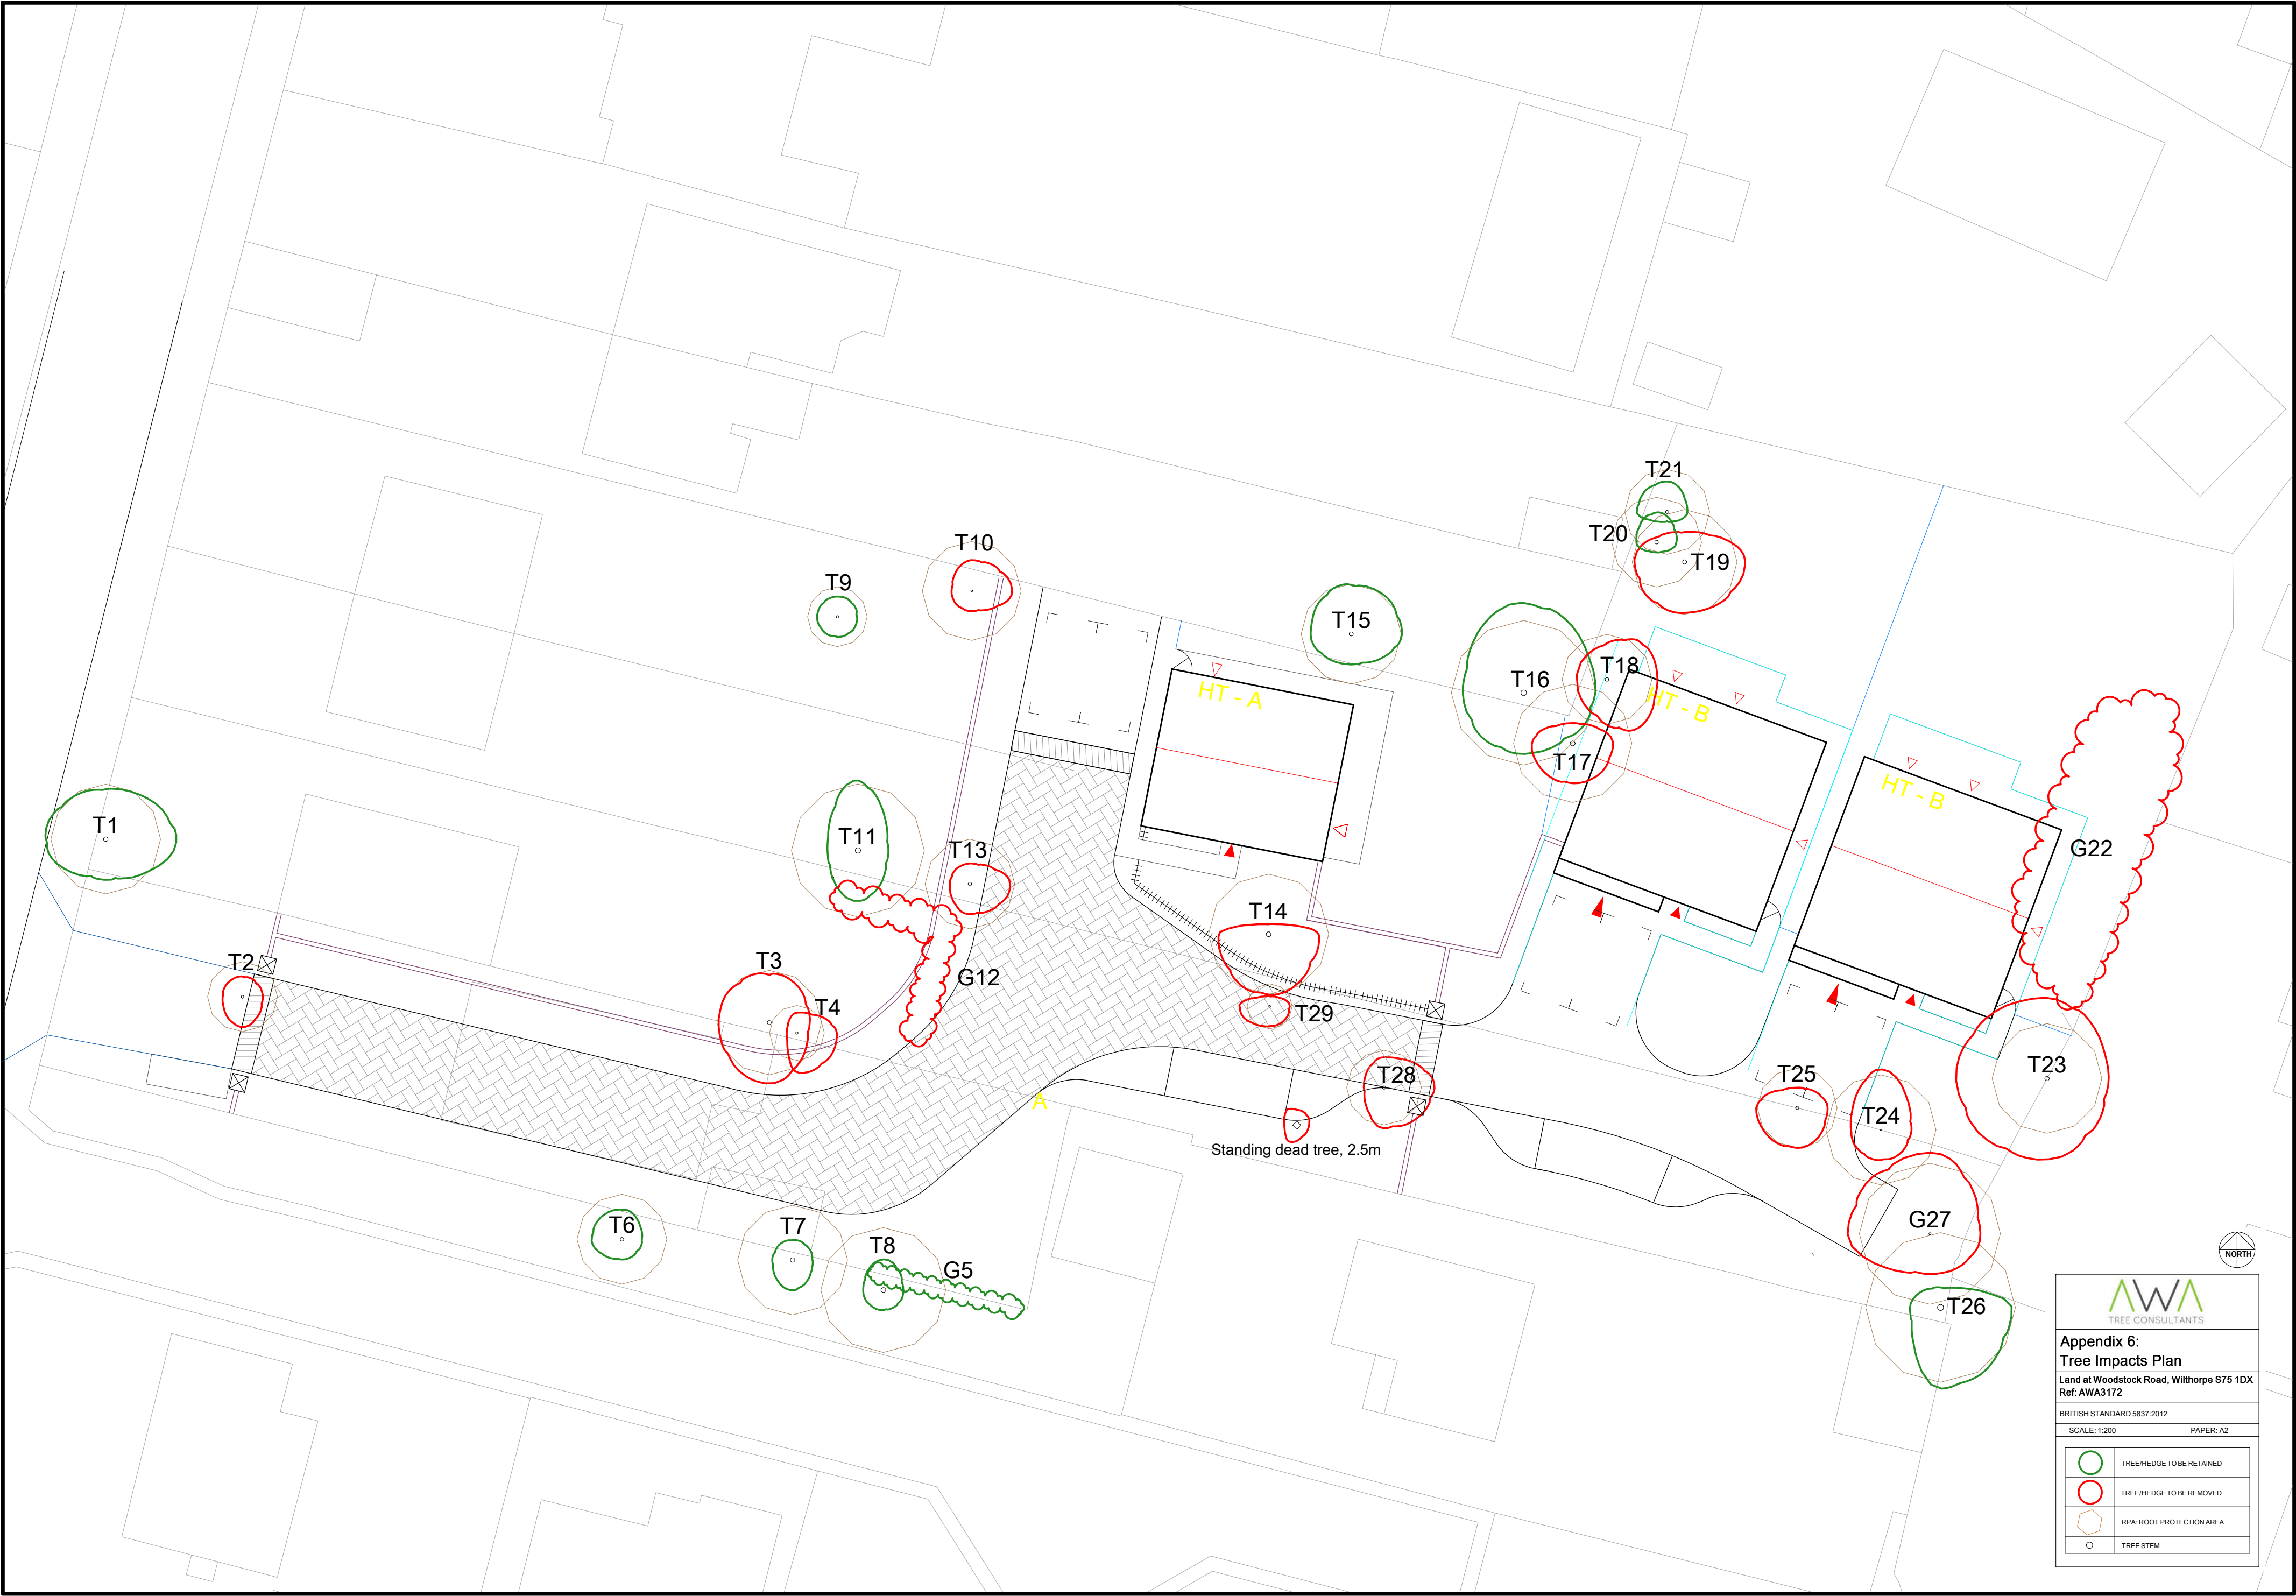
**Appendix 6:**  
**Tree Impacts Plan**  
Land at Woodstock Road, Wiltorpe S75 1DX  
Ref: AWA3172  
BRITISH STANDARD 5837:2012  
SCALE: 1:200 PAPER: A2

- 4.2.1 From assessing the new development proposals, 17 trees / groups will require removal as they are situated in the footprint of the structure or their retention and protection throughout the development is not suitable.
- 4.2.2 The trees that require removal are T2, T3, T4, T10, G12, T13, T14, T17, T18, T19, G22, T23, T24, T25, G27, T28, and T29.
- 4.2.3 The trees that require removal are all low value, retention category 'C'. Due to the low value of the trees to be removed the removals will have only a negligible negative arboricultural impact.

- 4.5.1 The retained trees will require protection by fencing in accordance with BS 5837: 2012, during the development phase. The protective fencing for this site should be located to protect the RPAs of the retained trees as detailed on the attached Tree Impacts Plan at Appendix 6.
