STRUCTURAL INSPECTION

BARN BUILDINGS

CLIFF HOUSE FARM

## 4.0 THREE CATTLE BARN

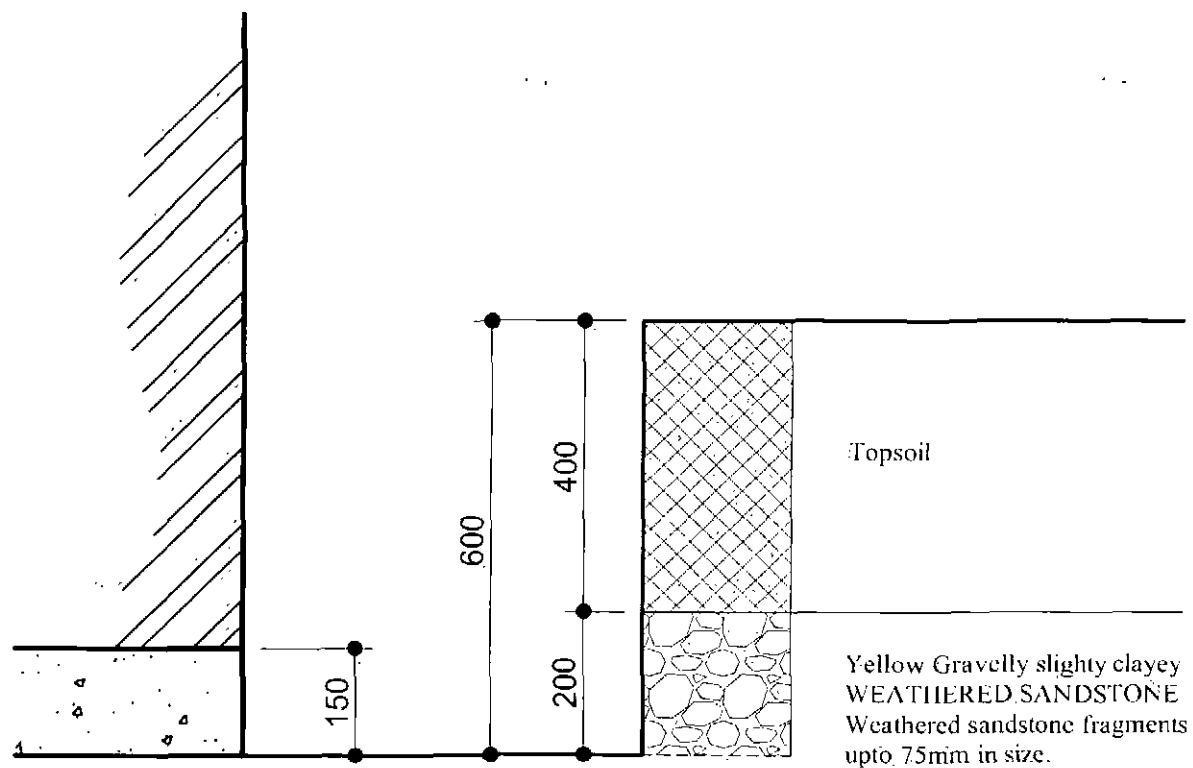
SECTION THROUGH TRIAL PIT  
ON  
WEST ELEVATION OF THREE CATTLE BARN

- 4.1.4.5 A trial pit was **dug on this elevation** and extended down approximately 600mm below ground level **(Figure 3)**. At the base of the trial pit a weak concrete footing to the brickwork wall was observed. This concrete was only 150mm thick and did not extend beyond the line of the wall. The **ground** encountered was gravelly weathered Sandstone with some clay content. The **trial pit** contained large amounts of tree roots some up to 50mm diameter. **(Photograph 43)**

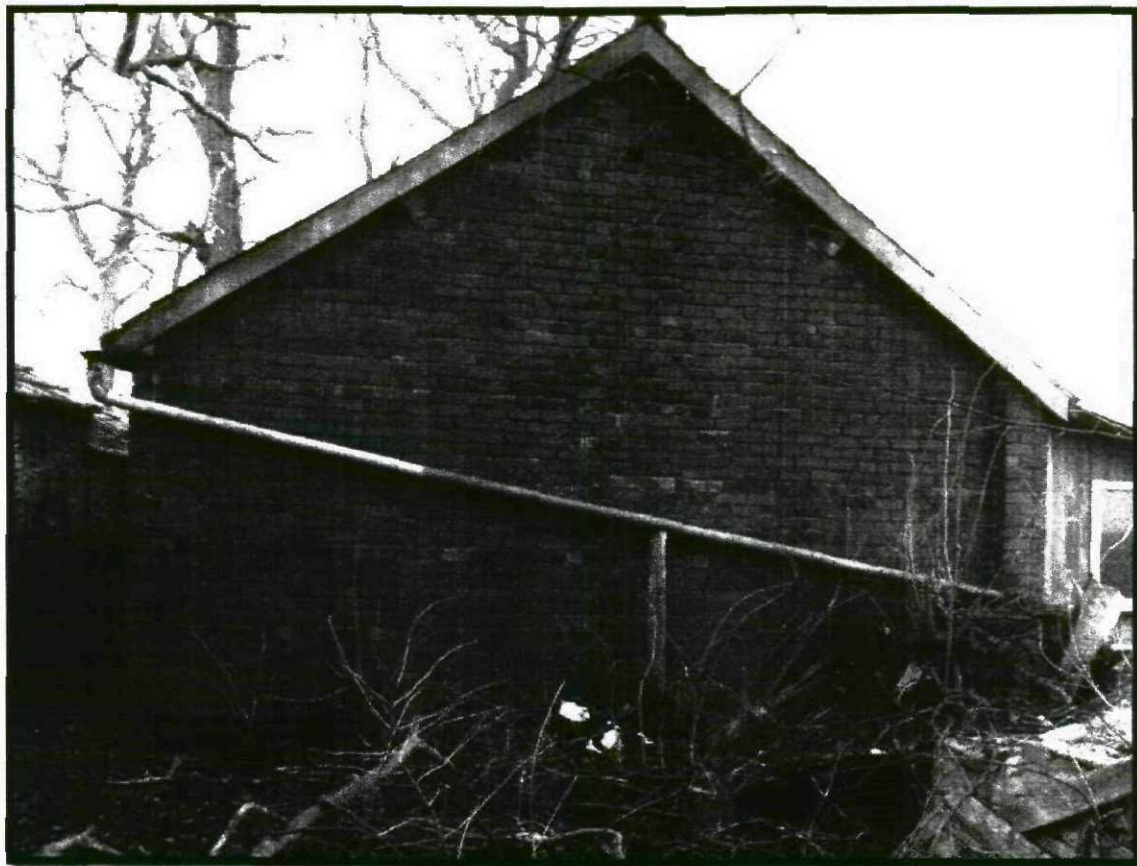
Photograph 39 – View of East Elevation

- 4.1.2.1 This is a **gable wall** and is constructed in red brickwork 225mm thick. The elevation is **generally** in good condition with no cracking or movement noted. (**Photograph 39**)
- 4.1.2.2 The **pointing** to this wall is in poor condition with mortar loss from joints of up to 25mm.
- 4.1.2.3 To the North East corner there is a 325mm x 100mm external pier to strengthen the wall.
- 4.1.2.4 At the North end of this elevation there is a block built lean-too section clad in timber. This section is in reasonable condition and is of more recent construction.
- 4.1.2.5 The verges are constructed in timber and are in reasonable condition.
- 4.1.2.6 There are three large trees located within 7.0 metres of this elevation one is only 2.0 metres away. (**Figure 5**)
- 4.1.2.7 A **plastic** rainwater pipe runs along this elevation picking up rainwater from a gutter to the North elevation.

- 4.3.2 All the external walls should be repointed in lime based mortar.
- 4.3.3 The timber roof structure is in good condition. The Structural adequacy of the roof timbers should be assessed for the new loading regime.

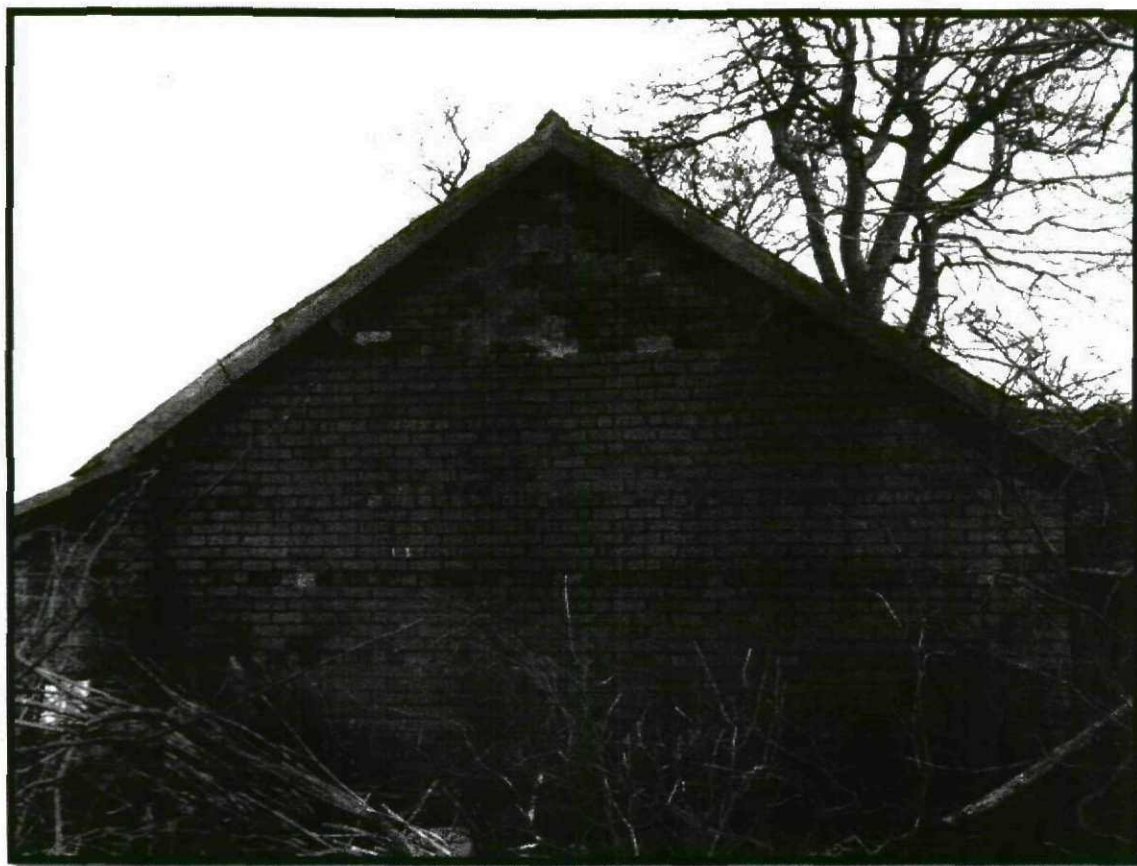
Photograph 40 – View of West Elevation

- 4.1.3.1 This is a **gable wall** and is constructed in red brickwork 225mm thick. The elevation is **generally** in good condition with no cracking or movement noted. (**Photograph 40 & 41**)
- 4.1.3.2 The **pointing** to this wall is in poor condition with mortar loss from joints of up to 25mm
- 4.1.3.3 To the **North East** corner there is a 325mm x 100mm pier to strengthen the corner.
- 4.1.3.4 At the **North** end of this elevation there is a block built lean-too section. This is in **reasonable condition** and is of more recent construction.
- 4.1.3.5 The **verges** are constructed in timber and are in reasonable condition.
- 4.1.3.6 There are **two large trees** located within 5.0 metres of this elevation one is only 2.0 metres away. (**Figure 5**)

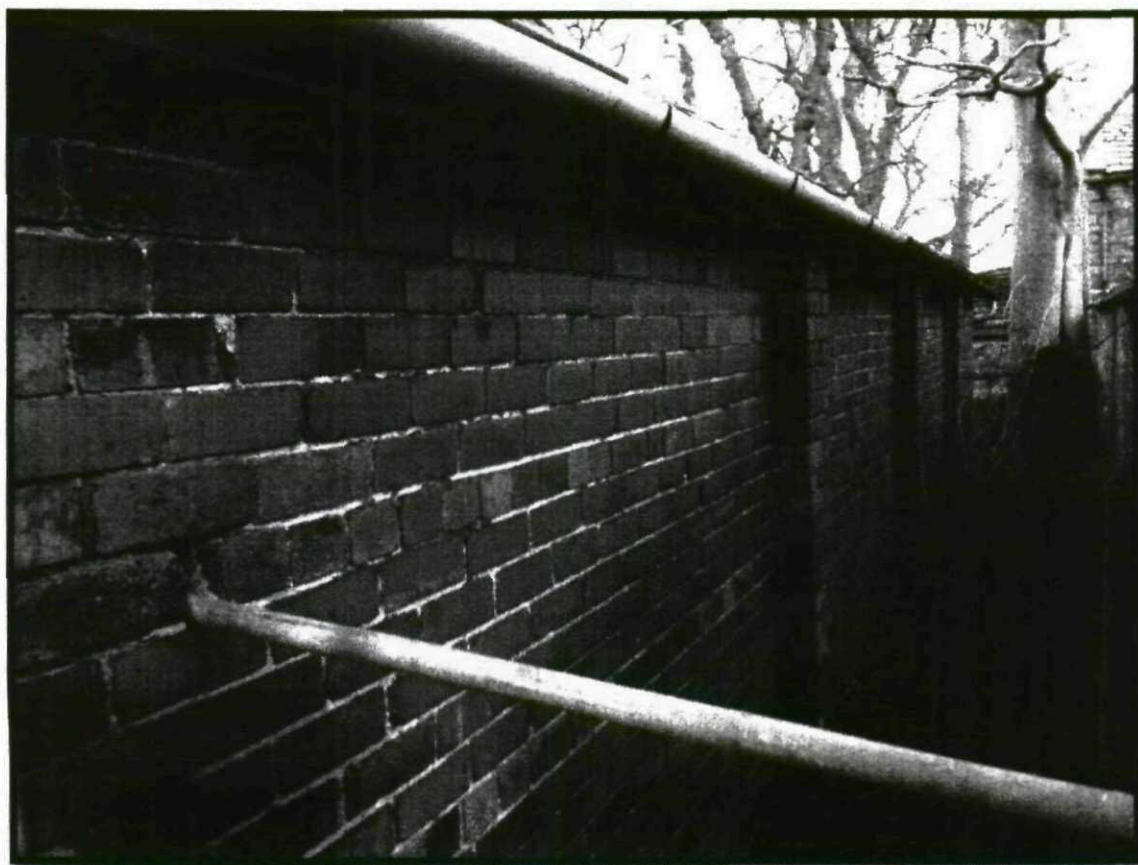
Photograph 42 – View of South Elevation

- 4.1.4.1 The South elevation constructed in **red brickwork** and is 225mm thick. This wall is in good condition with no signs of **cracking, settlement** or bulging. **(Photograph 42)**

- 4.1.4.2 The pointing to this wall is in **poor condition** with mortar loss from joints of up to 25mm
- 4.1.4.3 There are three piers **measuring** 225mm x 100mm at quarter point along this elevation acting to strengthen the **wall**.

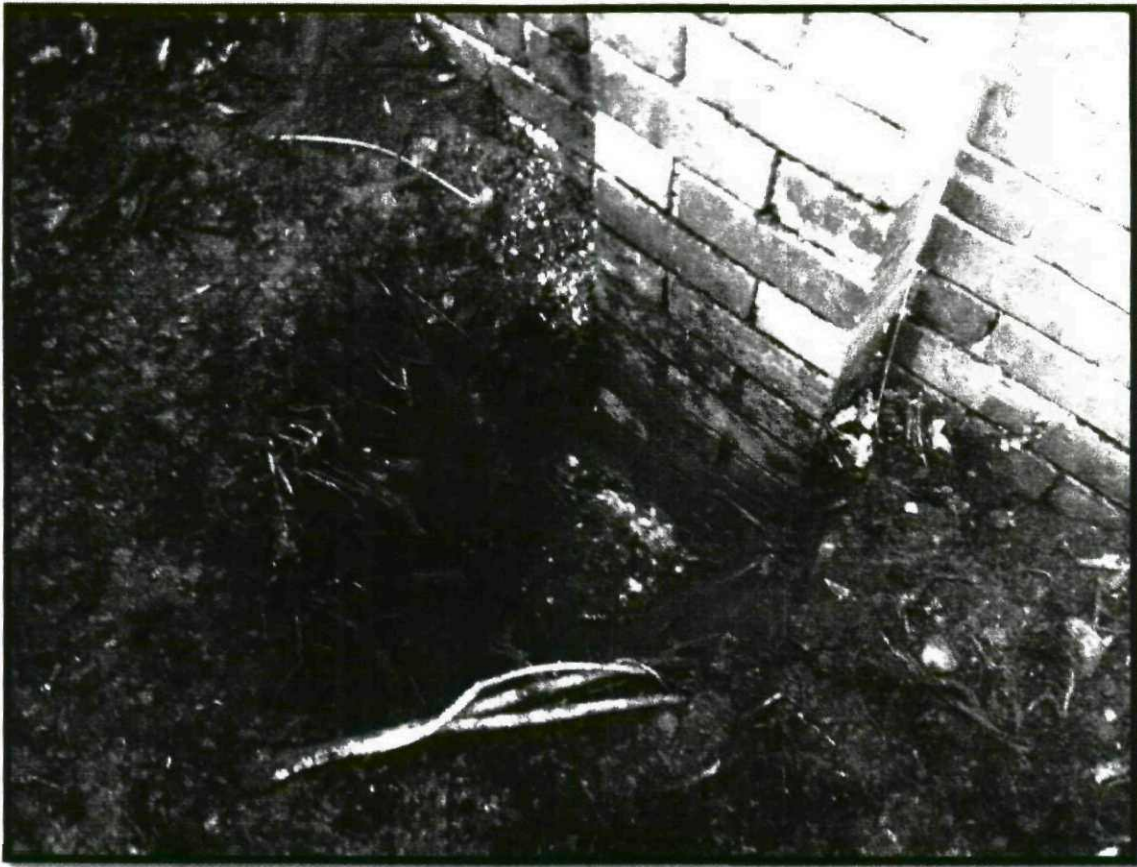
Photograph 43 – View of trial pit on South Elevation

- 4.2.7 Timber windows and doors were in good condition.
- 4.2.8 The trial pit that was dug on the South elevation revealed that the foundations were fairly shallow (600mm below ground level). It should be noted that at the location of the trial pit the ground level on the South elevation was higher than the North elevation. Excavation of a trial pit on the North elevation could not be undertaken to investigate this due to the presence of a concrete slab. The ground encountered was gravelly weathered Sandstone with some clay content. The trial pit contained large amounts of tree roots some up to 50mm diameter.

- 4.2.9 Although no movement was noted it may be prudent to carry out further investigations to determine the exact extent of the barn foundations.
- 4.2.10 Large trees were located within 5.0 metres of the barn. One in particular was located only 2.0 metres from the West elevation. This tree has large branches that reach over the barn and pose a safety risk if they fall. No major cracking or movement was noted the West elevation in the vicinity of the tree. Due to the granular nature of the subsoil the barn may not suffer movement due to seasonal moisture changes caused by the trees. In addition, the building is of more recent construction than the other barn buildings and may have been built after the trees matured.

- 4.3.5 The foundations to the external walls to the North elevation are fairly shallow. At present the structure is stable and the foundations appear to be capable of withstand the existing loads. As the proposal is to convert this barn to a bungalow loading will not increase and the structure should be capable of withstanding the proposed loading regime. However, there is the possibility that the walls are built of the floor slab. This should be further investigated and if inadequate an underpinning solution designed.

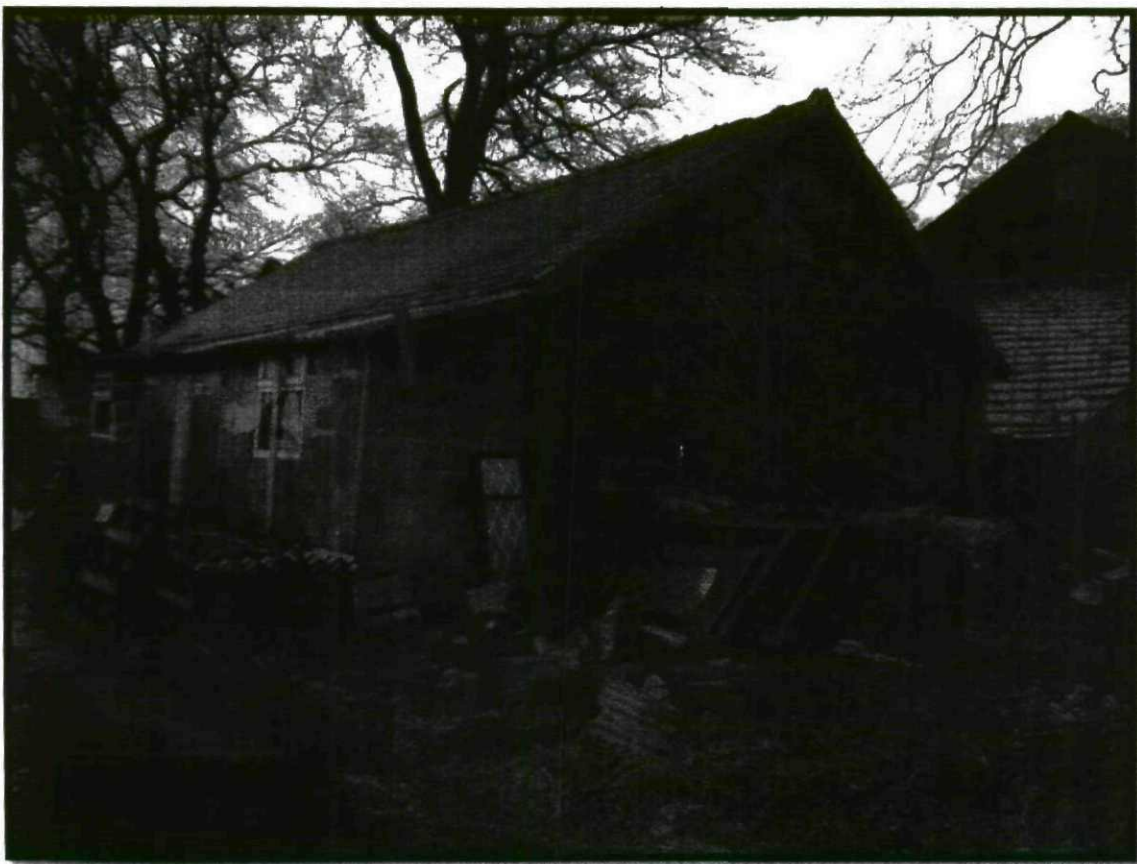
Photograph 44 – View of North Elevation

- 4.1.5.1 The **North elevation** constructed in unfinished concrete block. This wall is in reasonable condition and **showed** no signs of cracking or movement. **(Photograph 44)**
- 4.1.5.2 This **elevation is of a newer** construction than the original brick built building.
- 4.1.5.3 There are **two windows** and two doors in this elevation that are in good condition
- 4.1.5.4 There is a **plastic gutter** to this elevation but no rainwater downpipes

- 4.1.6.3 The **ridge line** is level with no missing or loose tiles.
- 4.1.6.4 The **roof slopes** are also linear with no sagging or undulations.
- 4.1.6.5 On the **North elevation** the roof to the blockwork extension is formed in light gauge steel sheeting and is in good condition. **(Photograph 44)**

- **Remove blockwork extension to North elevation and construct new North elevation to match existing.**

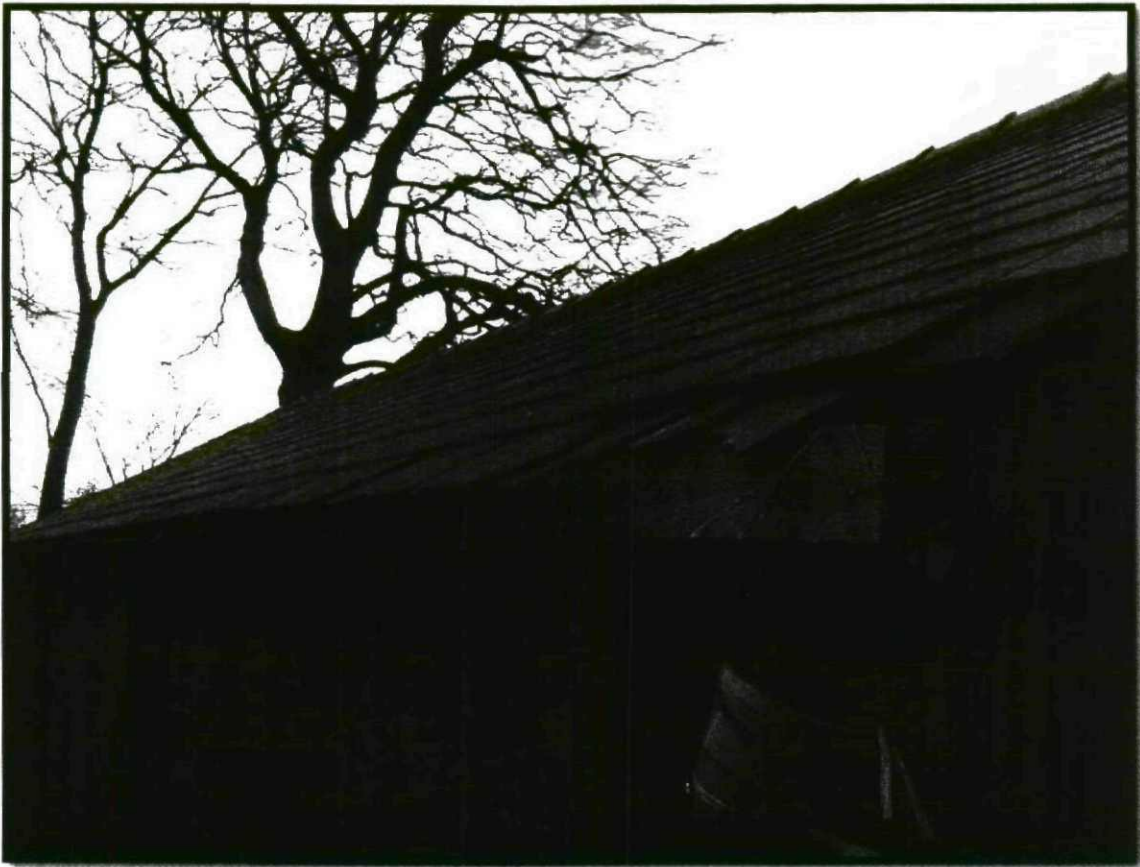
Photograph 45 – View of Roof showing damage to slate on South East corner

- 4.1.6.1 The **roof is a duo pitch** with gables on the East and West elevations.
- 4.1.6.2 The **roof is covered** in slate tiles with clay ridge tiles which are in good condition and intact over its **whole length** except a small patch in the South East corner. There is no under felt to the roof. **(Photograph 44 & 45)**

- 4.2.6 The slate tiles were intact over the whole roof area and were in good condition except for a small patch of damage on the South East corner. No under felting was present.

- 4.3.4 The existing slate tiled roof should be removed and new under felt installed. If serviceable the existing tiles can be reinstalled. New gutters and downpipes should also be installed.

- **Install roofing felt and either new roof covering or reinstate existing tiles. Install new rainwater goods. (New materials to be agreed with Planning Authority)**

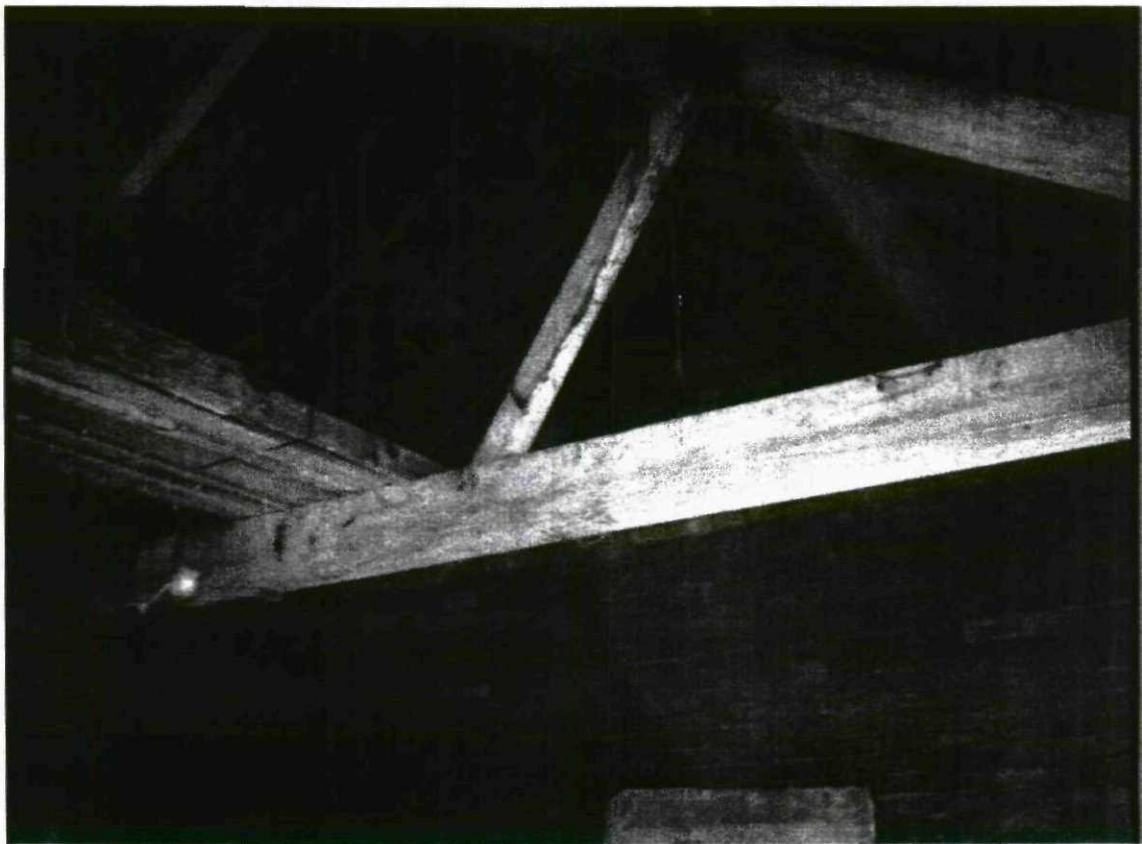
Photograph 46 – View showing roof structure

- 4.1.6.6 The **roof structure** consists of timber trusses at quarter points span between the North and South **elevations**. The trusses support purlins located at midpoint of the roof slope which in turn support **timber rafters**. All the timbers are in good condition and are free from signs of insect infestation or rot. **(Photograph 46 & 47)**

- 4.2.5 The timber roof structure was generally in good condition with no insect infestation or rot noted. The roof showed no signs of distress or permanent deformations.

- **Check structural capacity of existing roof to carry new loads and strengthen if necessary.**
- **Construct a new concrete slab incorporation a damp proof membrane. The slab to be able to withstand any possible seasonal moisture changes in subsoil.**

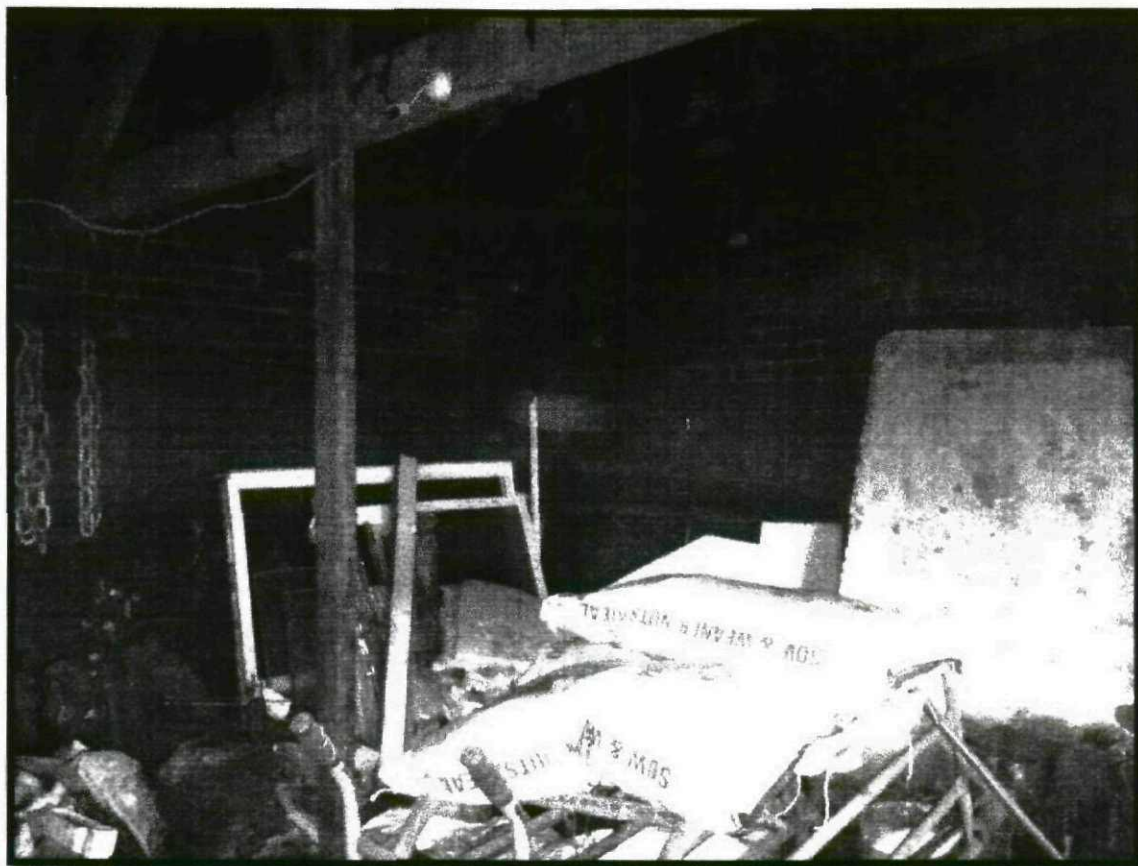
Photograph 47 – View showing internal walls

- 4.1.7.1 The walls internally are constructed in coursed red brickwork. Where visible they are in good condition and showed no signs of cracking or movement. **(Photograph 47)**

- 4.2.11 Internally the walls were in good condition and showed no signs of movement. They are 225mm thick and would require studding and insulating internally to comply with building regulations

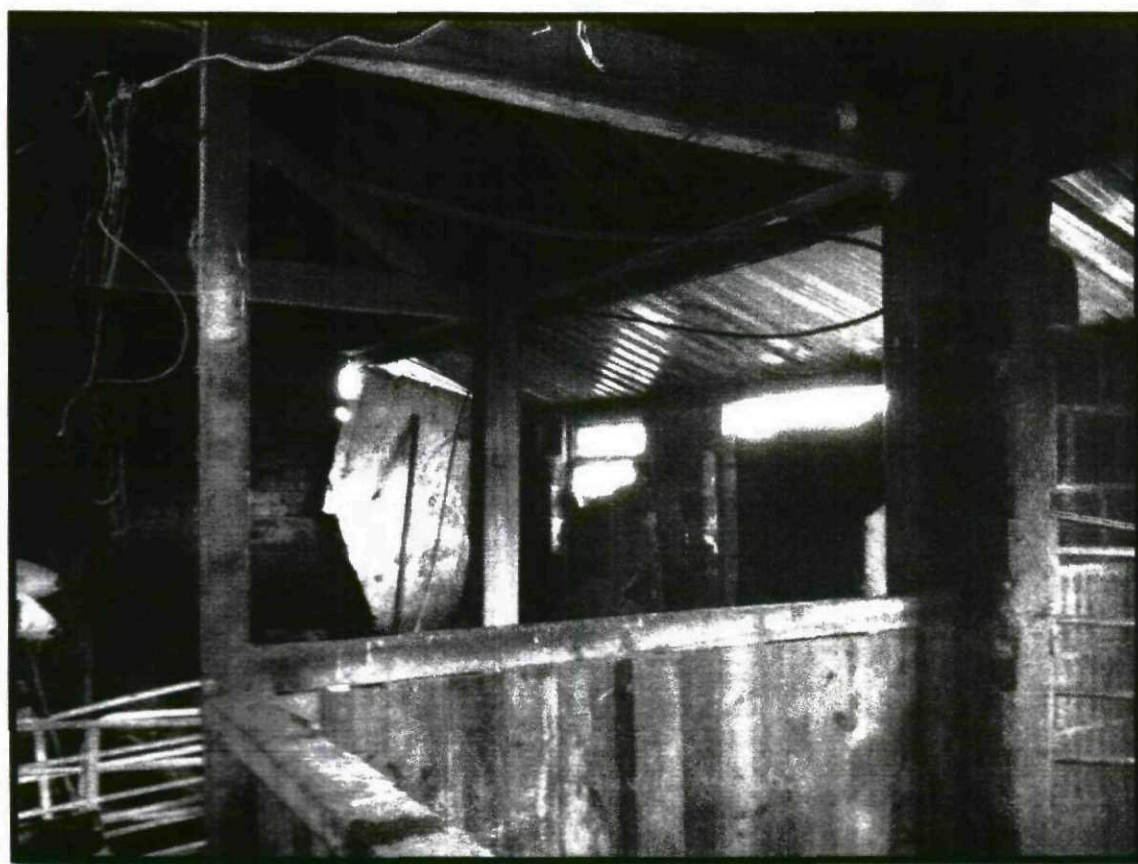
Photograph 48 – Showing timber columns and beams supporting North edge of roof

- 4.1.7.3 Timber beams supported the ends of the rafters to the main barn and extension roof and were supported by the large section timber columns. The beams are in good condition with no signs of insect infestation of rot. **(Photograph 48)**
