## STRUCTURAL REPORT

| Location | Knabbs Hall Farm, Silkstone Common, Nr Barnsley, S75 4RD |
| application | Re-development, Reinstatement of Dwelling and Conversion of Agricultural Buildings to form 4 dwellings |
| job number | 16/372 |

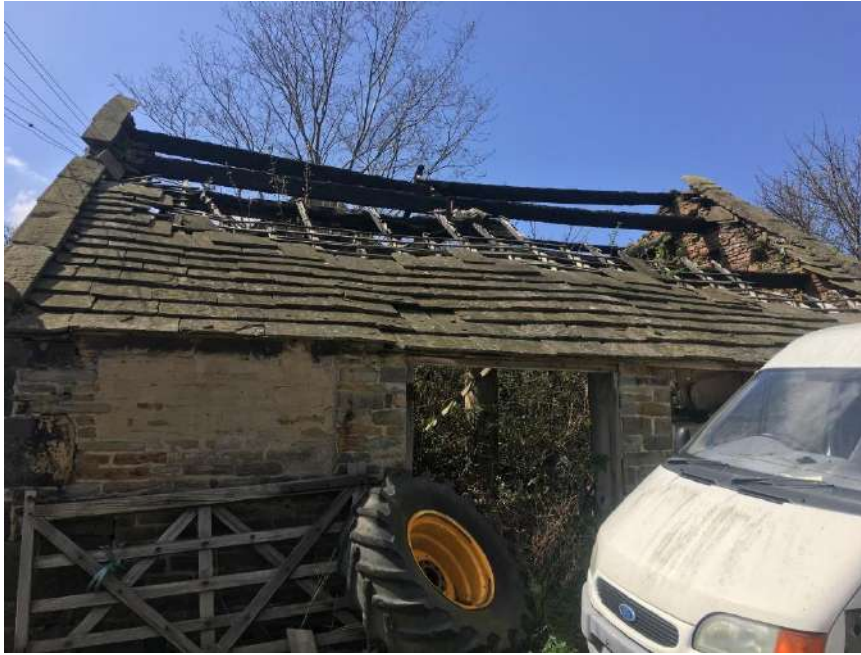
It appears the fire, whilst not isolated to the rear of the building, has caused most damage to this area with 95% of the roof (covering and structure) lost. The remaining rear half of the central truss is severely charred. The building has remained open to the elements since the fire with weather also taking its toll expediting the damage to the structure.

Unit 1 front (East) 50% of front roof slope lost due to fire

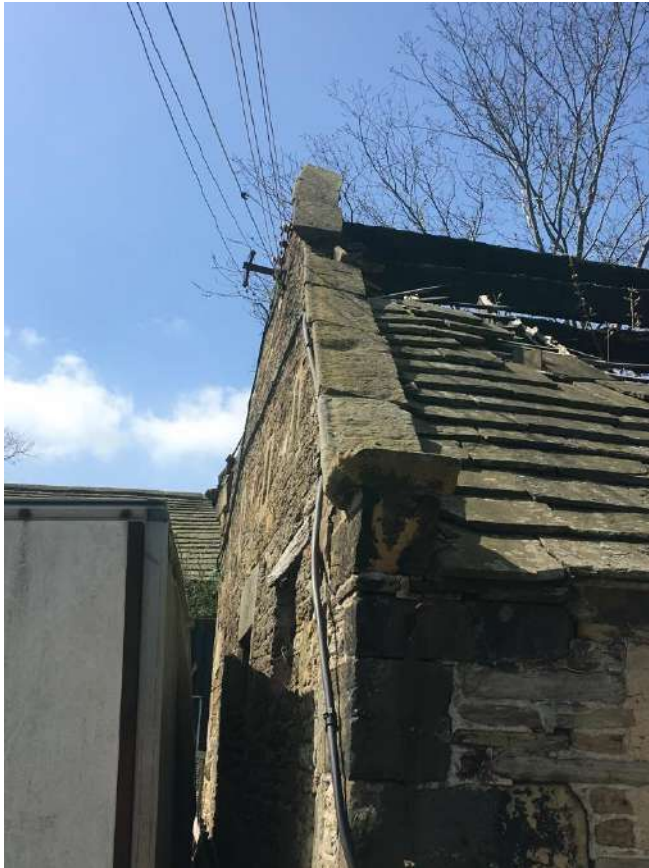
The peaks of both gables have partly collapsed. Due to the excessive lean, the these gables they need to be taken down, by circa a further 900mm to be rebuilt. Cables from an adjacent building connect to the south gable of the Unit 1, these cables are tight and therefore effectively providing some restraint preventing further collapse.

Leaning south  
gable of Unit 1

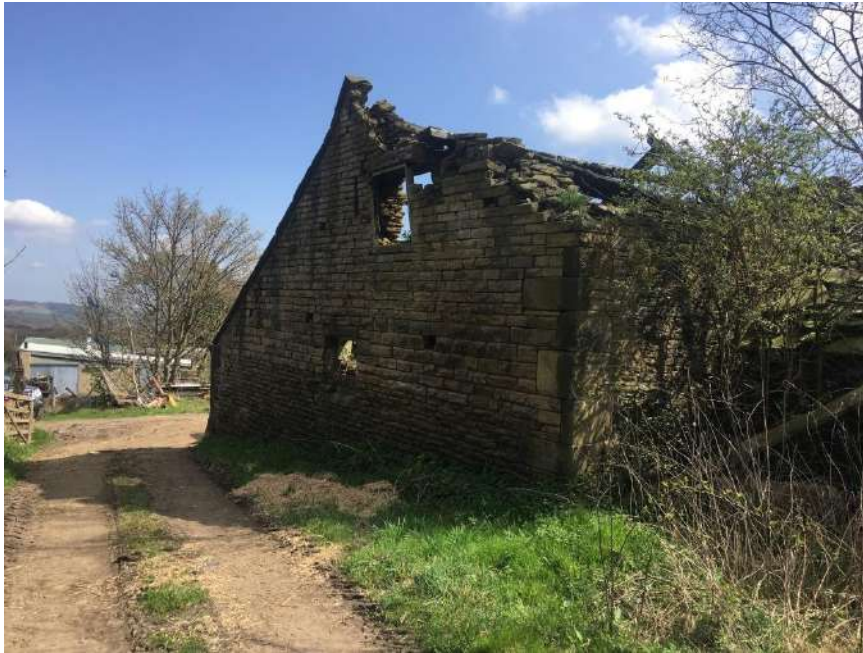
The loss of the roof structure has taken away critical support and stability for the gable walls. Purlins, originally pocketed into the inner skin, have been left providing a cantilever effect due to the fire and loss of support at opposing ends.

Gable and verge  
collapse of Unit 1

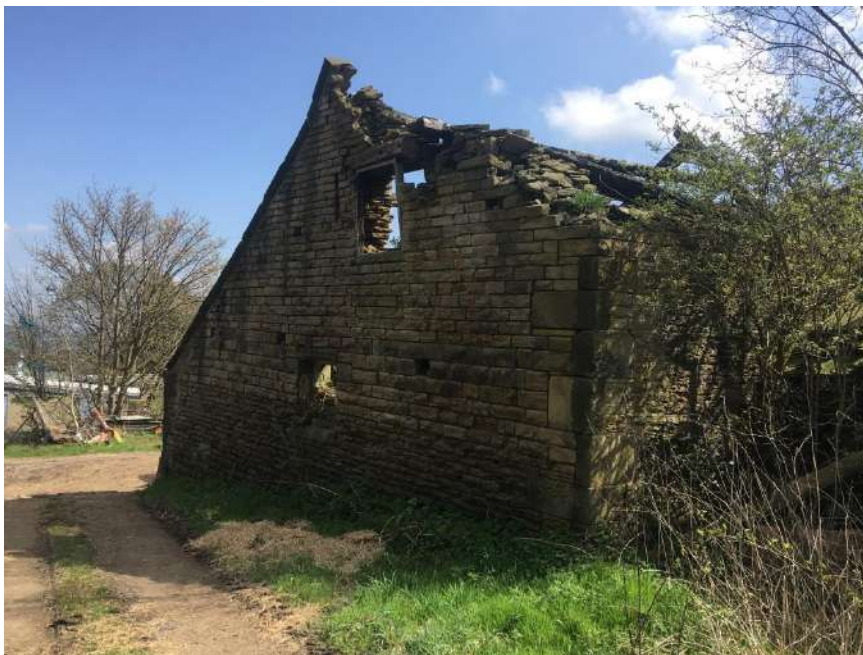
Gable and verge  
collapse of Unit 1

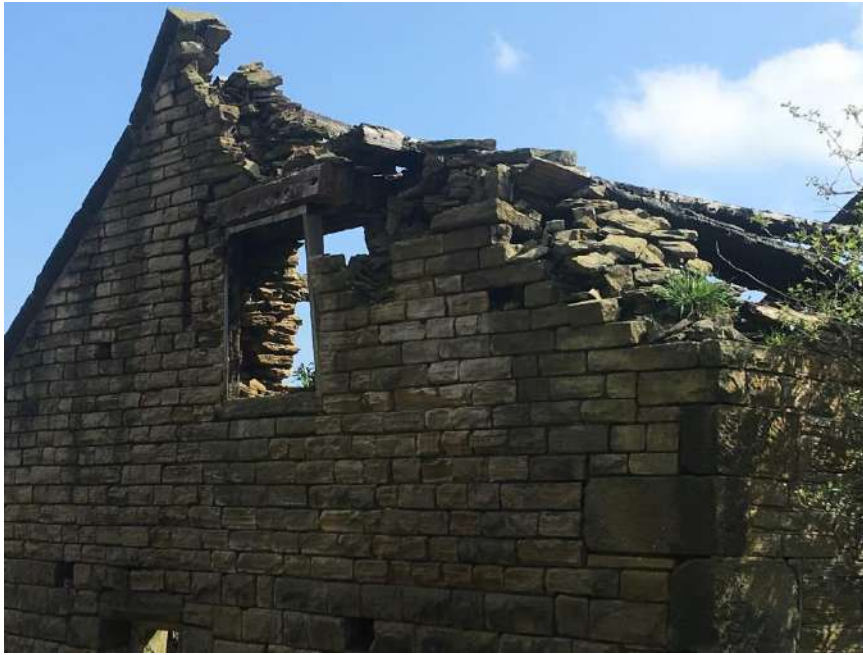
Closer view of gable  
and verge collapse to  
Unit 1

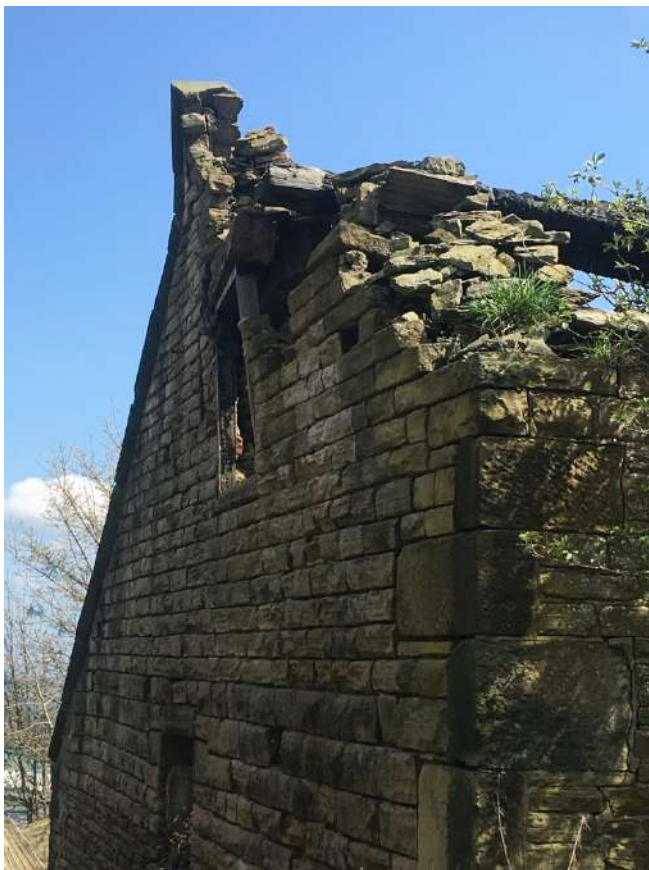
Leaning peak of  
partly collapse gable  
peak to Unit 1

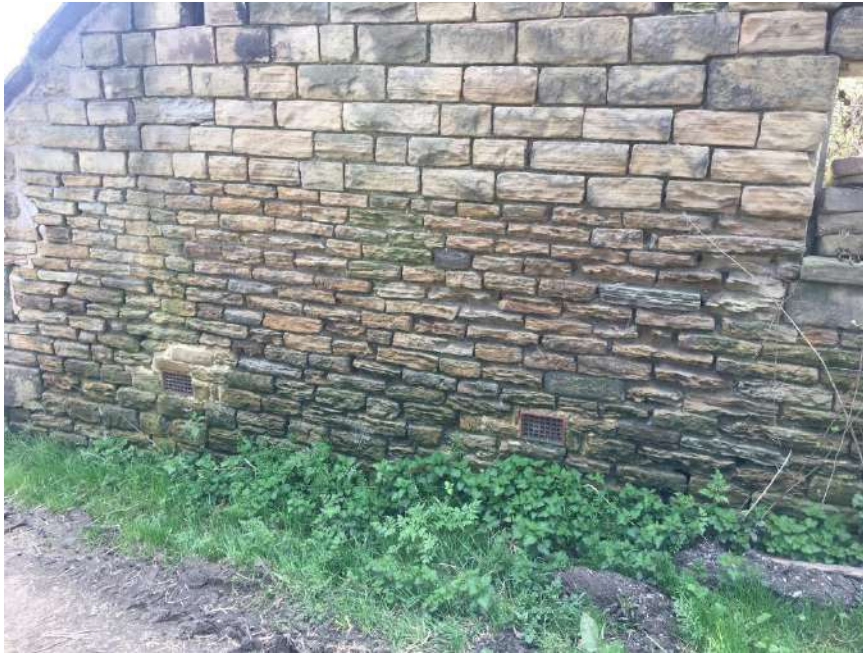
The outer leaf indicates erosion of the sandstone to the North gable but the stone is still fit for purpose.

Sandstone walling  
to Unit 1 eroded at  
low level

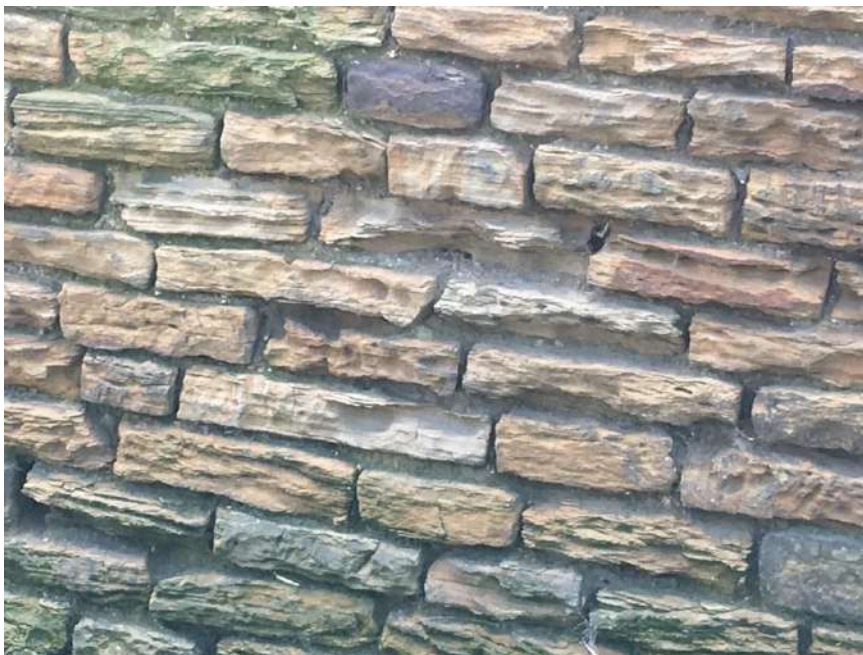
Close up of eroded  
sandstone to Unit 1

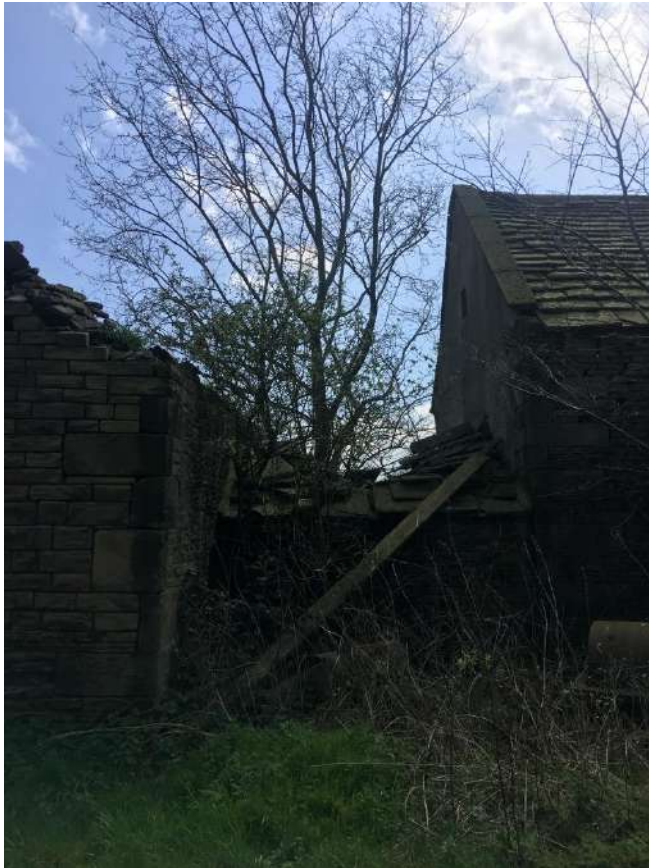
The small link building between unit 1 & 2 is in very poor condition. This appears to be a later addition and is not bonded in to either unit 1 or unit 2. The roof has 70% collapsed with damage to the masonry walls. This building has a mature tree growing from within that needs careful removal to prevent further damage, particularly to unit 1. This building is to be removed. It's considered beyond salvage, it is proposed to replace this building with a glazed link to connect unit 1 & 2.

Remains of collapsed  
duo pitch building  
between Unit 1 & Unit  
2 (viewed from North)

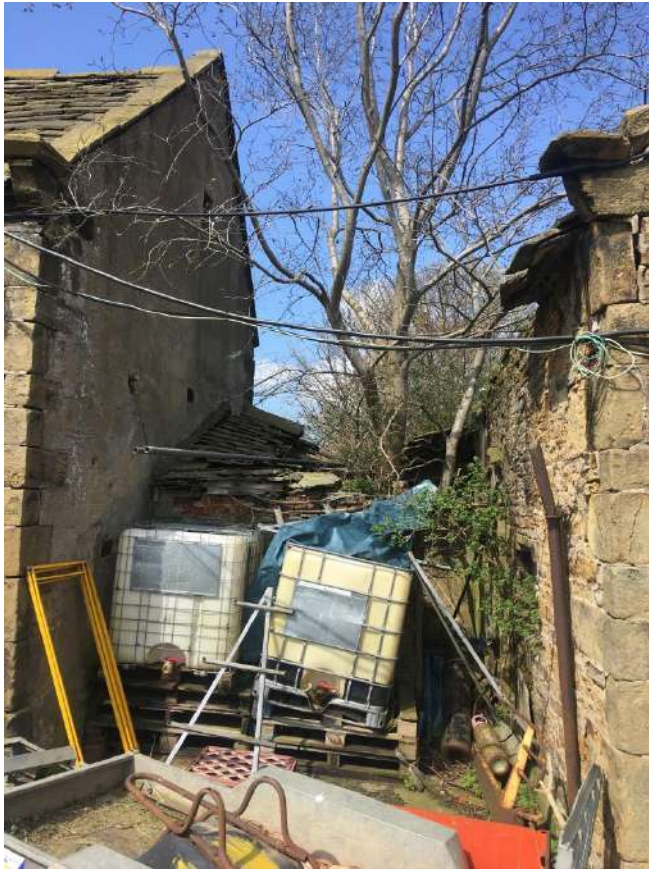
Remains of collapsed duo pitch  
building between Unit 1 & Unit 2  
(viewed from South)

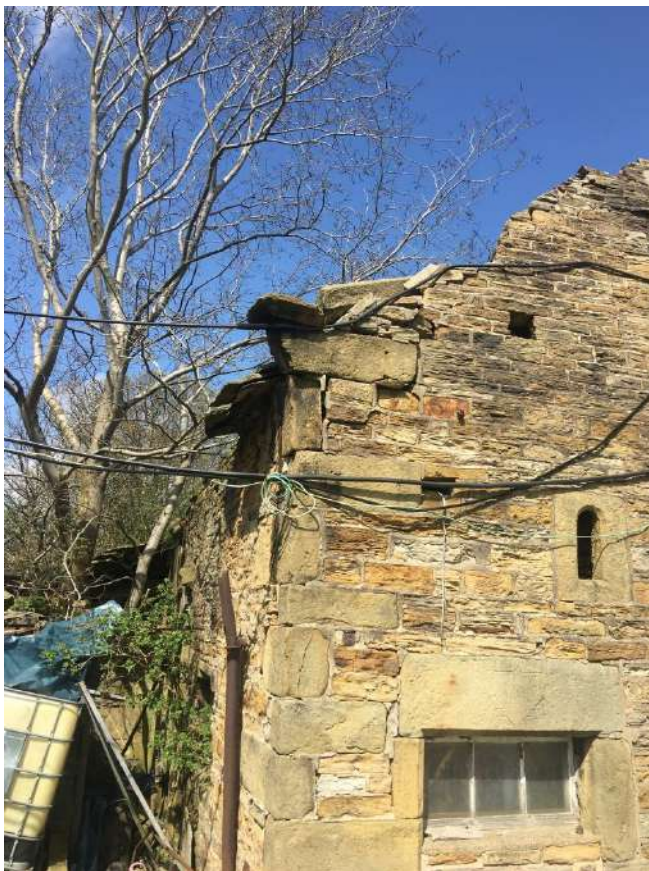
South west eaves  
displacement to Unit 1

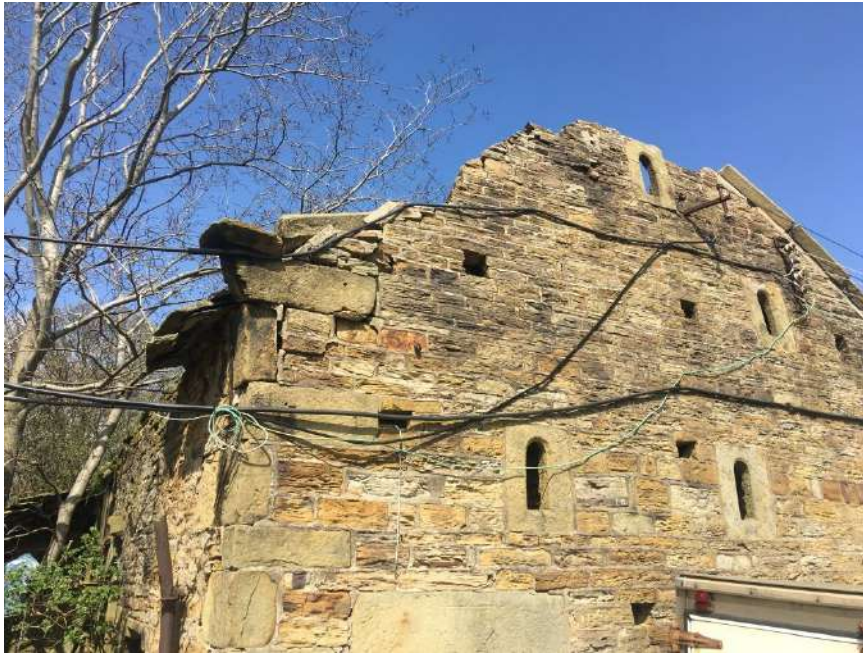
South gable to Unit 1  
showing collapsed  
peak

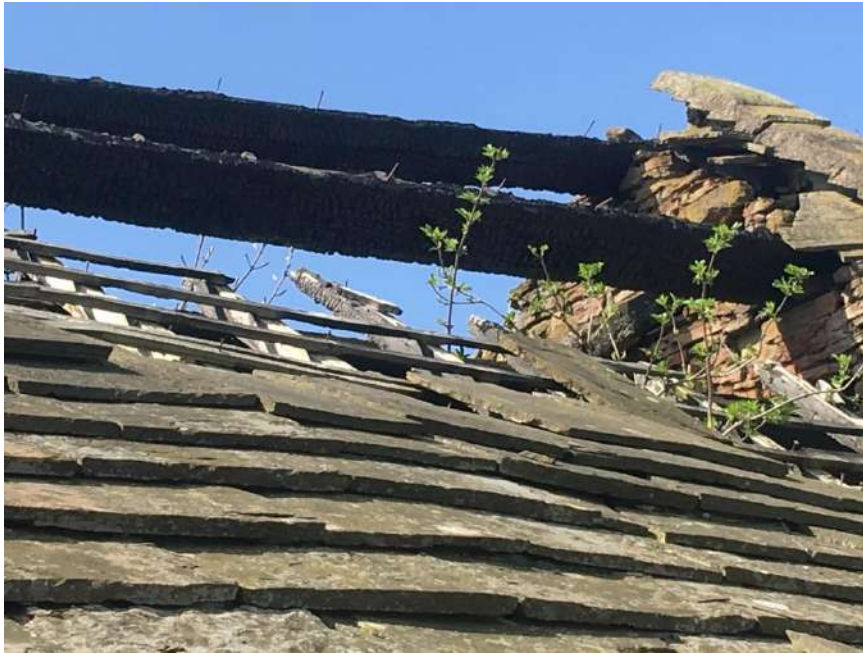
The remaining roof structure is beyond salvage and no longer fit for purpose. The fire and weather damage has resulted in these remaining timbers being incapable of supporting a new roof covering (in particular Yorkshire stone slate at 80-100Kg/sq m).

Charred front roof slope  
timbers to Unit 1

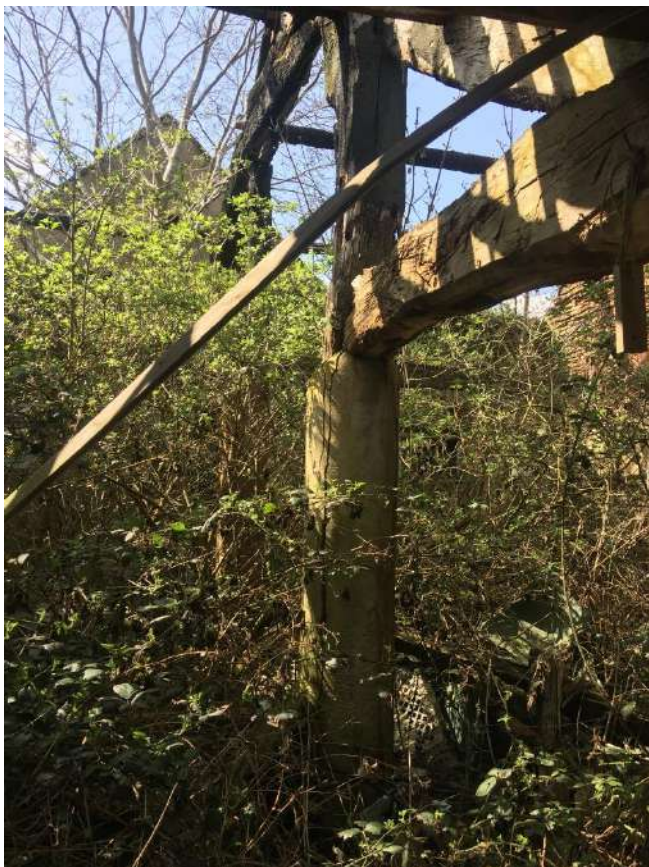
A rendered masonry pillar props the truss centrally within the building, below the defective render, brickwork is evident, which suggests this pillar is a non-original feature.

Internal photo of Unit 1.  
Masonry prop to remains of  
fire damaged truss

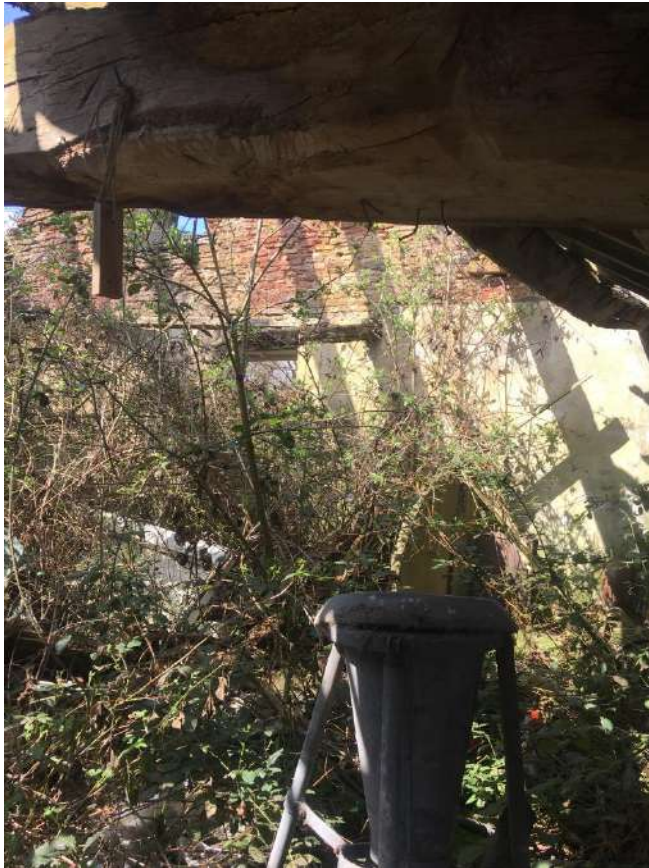
The inner skin of the building also shows evidence of the fire where masonry is now red in colour. It appears this stone is still intact, but needs a closer examination when the building is stabilised prior to safe access being enabled.

Internal shot of Unit 1 note red coloured masonry showing effects of fire

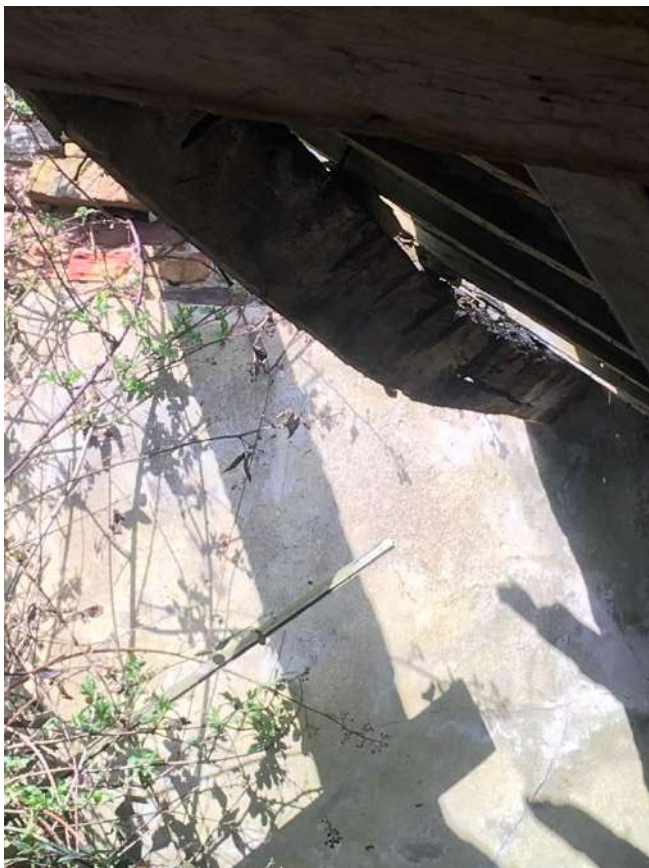
Fractured purlin to Unit 1

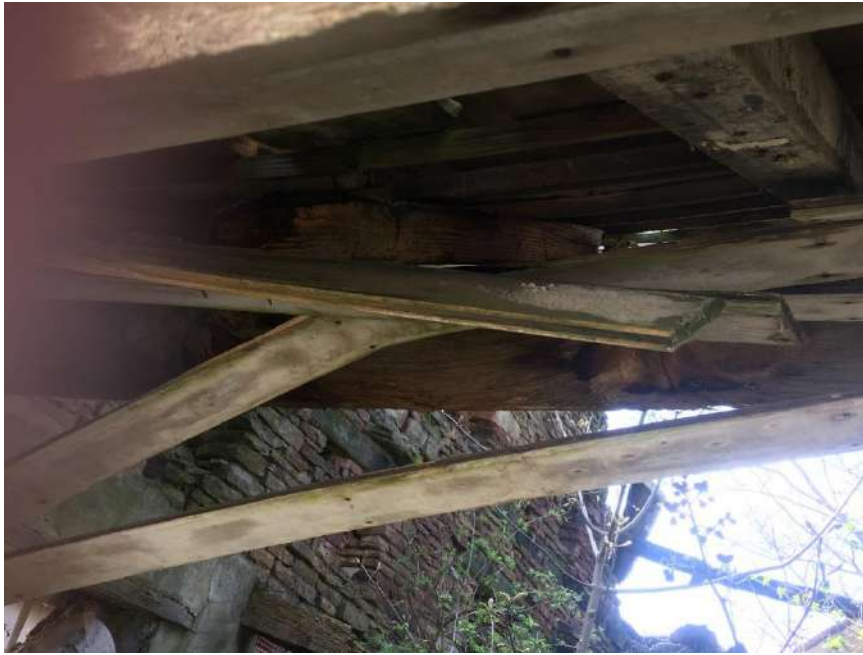
Sparse remaining  
roof to Unit 1

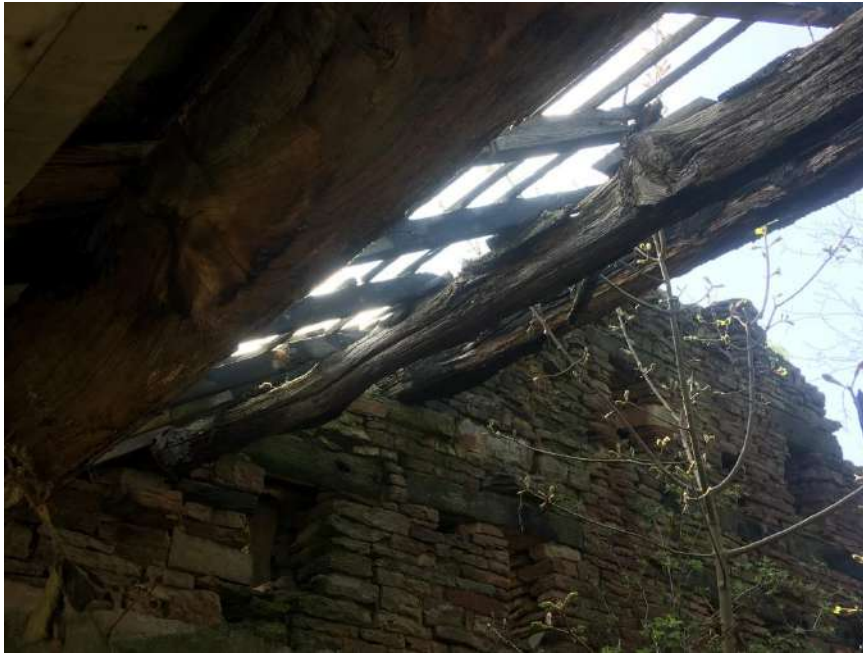
Purlin to Unit 1  
showing signs of  
damage due to  
elongated  
exposure to  
weather

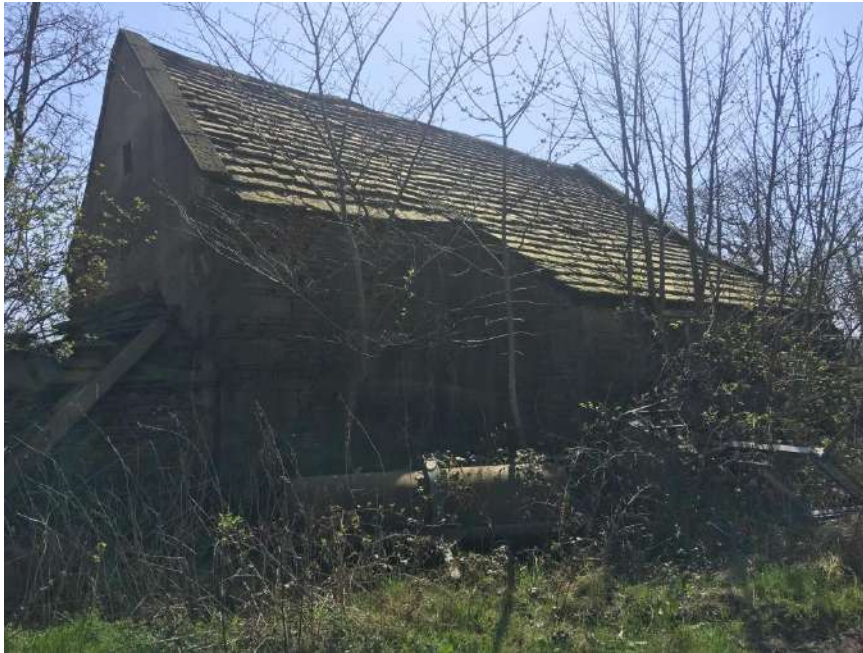
The rear of the building is densely screened by a number of young self-sown trees. These are within very close proximity to the building and should be removed to prevent root damage.

Unit 2 viewed from  
North East – note  
self-sown trees

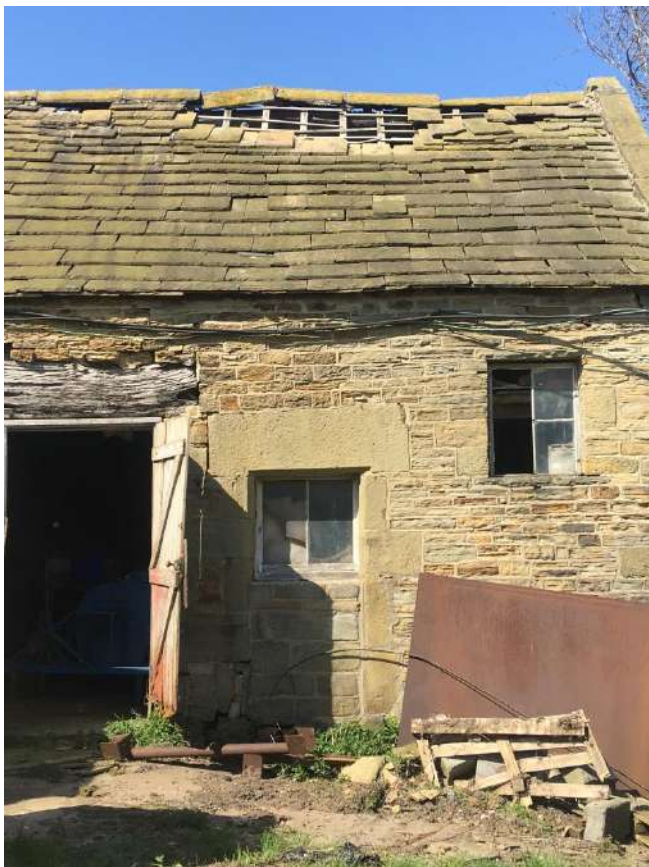
This building is generally in good structural condition. The most severe defect being caused by a small section of missing stone slates to the front (south) roof slope just off centre to the righthand side. This appears to be a longstanding loss of slates which has enabled water ingress and weather damage internally. To mitigate the damage a plastic sheet has been fixed to the underside of the first floor structure internally – this has resulted in further damage to the floor timbers as they have effectively been encapsulated and constantly in water.

Missing roof slates  
to Unit 2

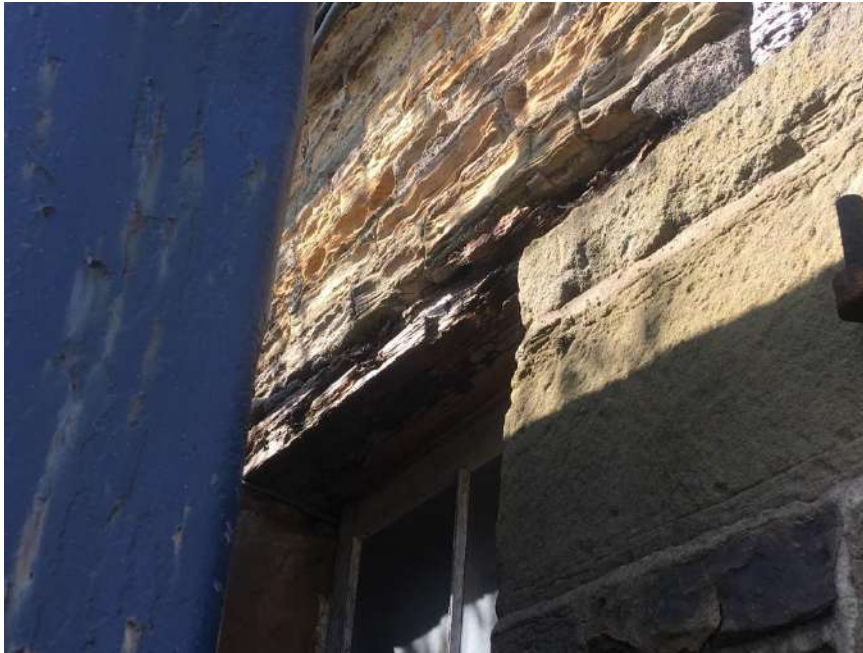
The timber lintel over the large front opening appears in good structural condition and capable of being retained. The timber lintel over the window to the left of the large front opening however shows evidence of weather and decay, this timber lintel needs to be replaced.

Rotten window head  
to front of Unit 2

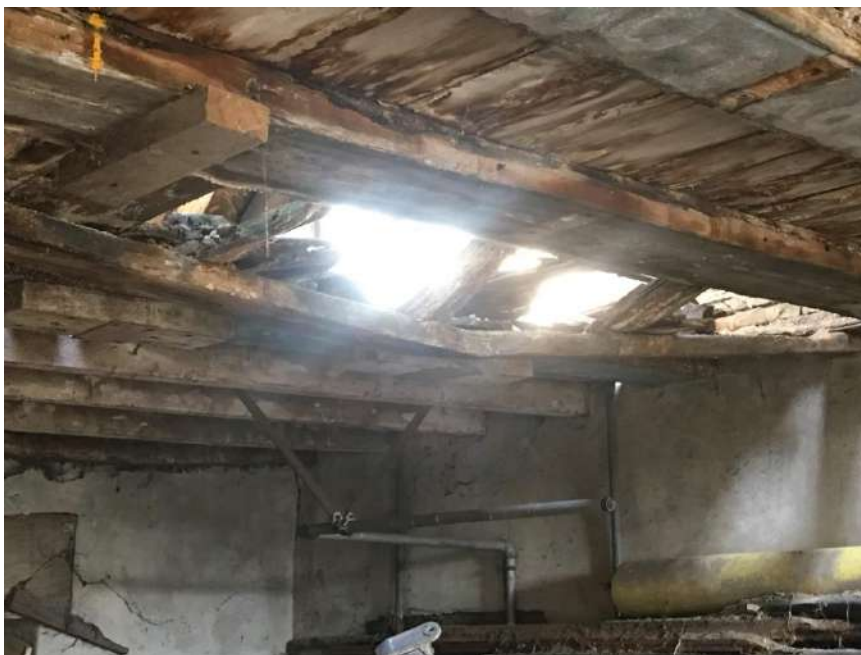
Internally the front right hand area of first floor (approximately a third of the overall first floor area) appears original. Some of these floor beams have fractured due to the water ingress with evident water staining. The remainder of the first floor is non-original, saw kerf marks are evident indicating a more modern and recent replacement.

Fractured floor  
joist to Unit 2

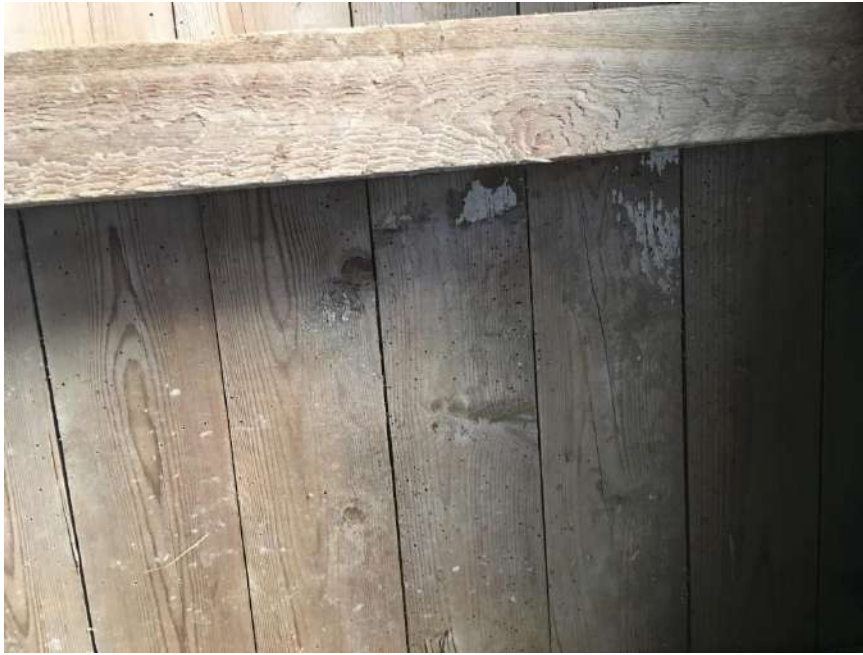
These replaced areas have evidence of insect infestation – this does not appear too damaging but a more specialist survey is required of all buildings when safer access is afforded.

Non-original timber floor to Unit 2. Note insect infestation

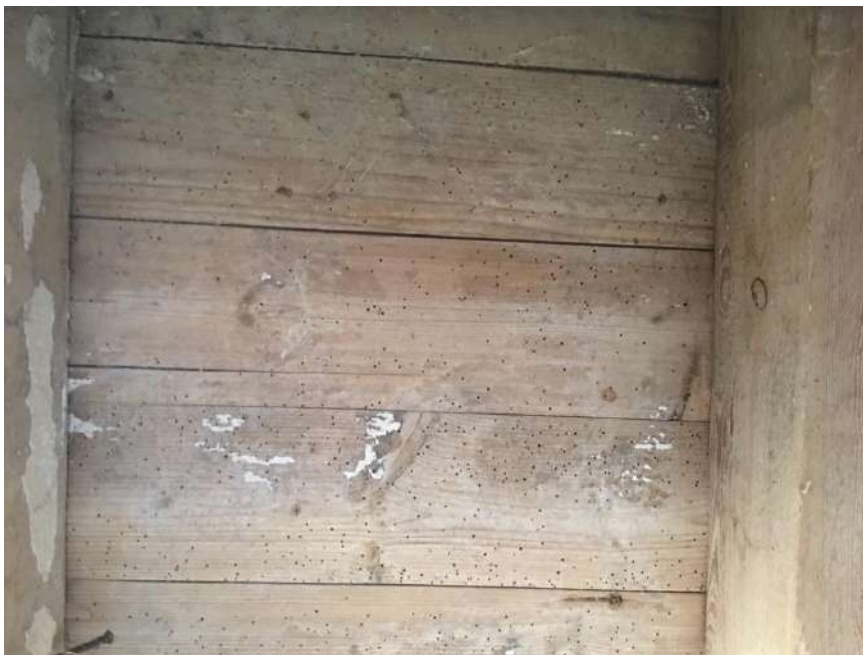
Insect infestation to non-original floor boards and joists Unit 2.

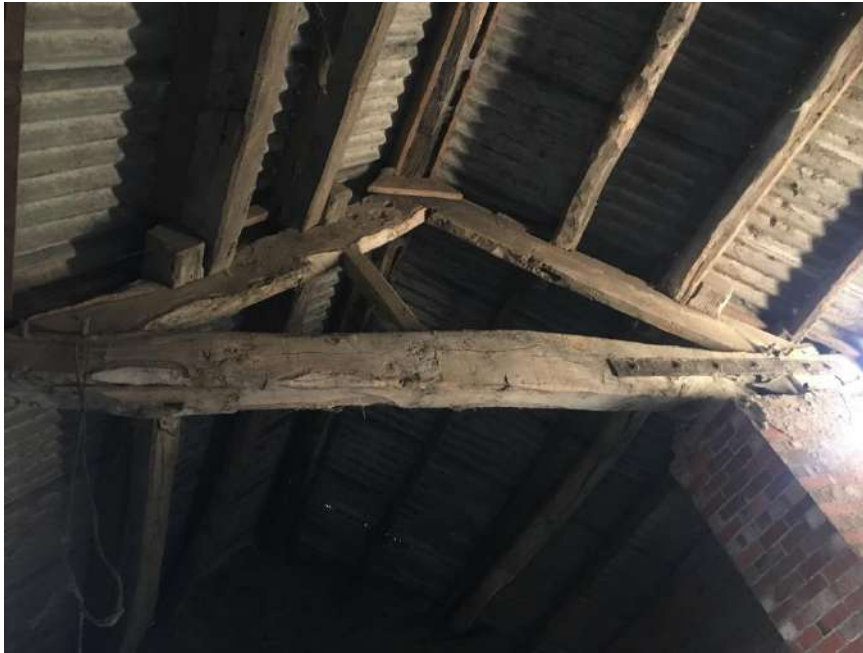
The barn has a duo pitch roof with 6 trusses at almost equal centres. The 2 most northern trusses are traditional queen post trusses with the remaining 4 being king post trusses yet without the central strut. The two queen posts trusses appear non-original, both these trusses have evidence of insect infestation, the most northern truss features steel plating where it is fractured. The sixth truss (LHS looking from front of barn) has its rear roof slope strut missing.

6<sup>th</sup> Truss to Unit 3.  
Bearing onto non-  
original brick pillar.  
Note rear roof slope  
strut missing

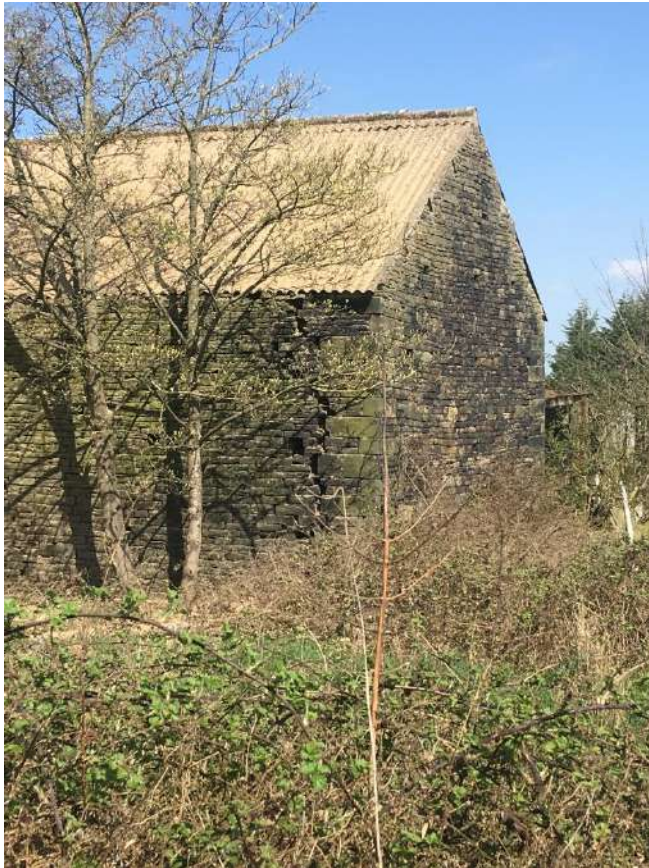
- Rear RHS corner where lateral movement has occurred full height. This movement is more or less equal (80mm at GL and 95mm at eaves level). It is difficult to tell if this movement is longstanding or ongoing given the straw strewn all around the rear of the barn. This movement may have been caused or contributed to, by the adjacent sycamore tree. Given the extent of movement it is considered prudent to carefully take down this rear corner and rebuild. Quoins could be numbered and laid out to ensure they are relaid the same as they are currently.

The sycamore tree located adjacent to the rear RHS corner of the barn is circa 20 years of age. This tree forks at ground level, a location prone for decay/rot. Taking this into account, and the proximity of the tree to the building, it should be removed.

Sycamore tree and  
masonry displacement to  
South West corner of Unit 3

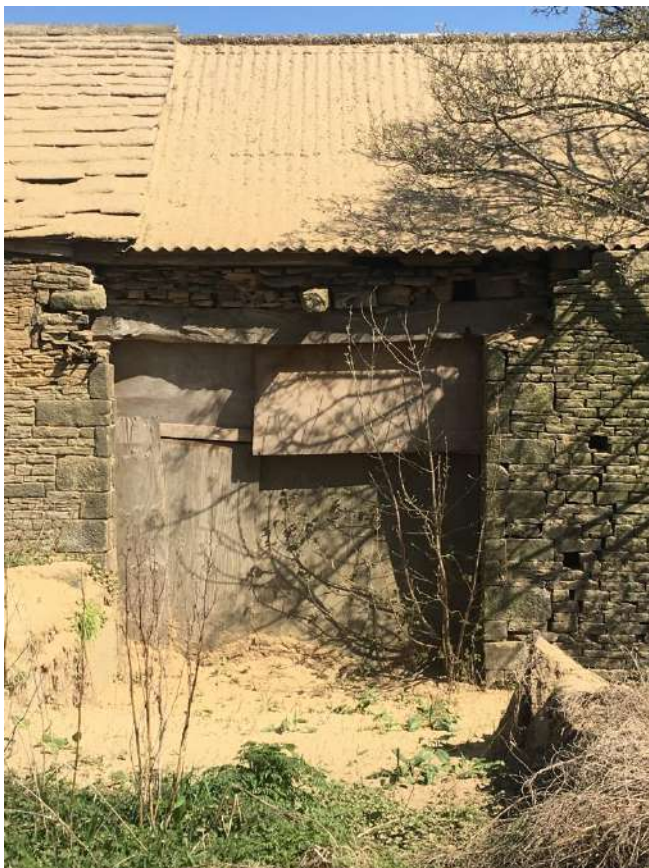
- Masonry above rear opening to LHS where current ducting passes through from wagon body into the barn.
- Masonry above RHS rear opening where outer lintel has been lost.

Missing rear lintel to  
rear of Unit 3

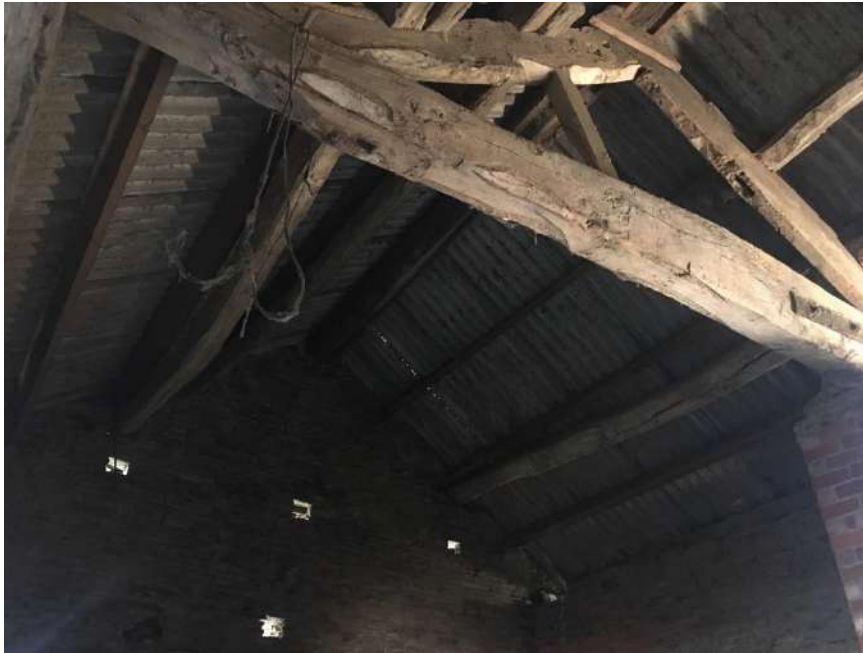
Strut missing to  
6<sup>th</sup> truss in Unit 3

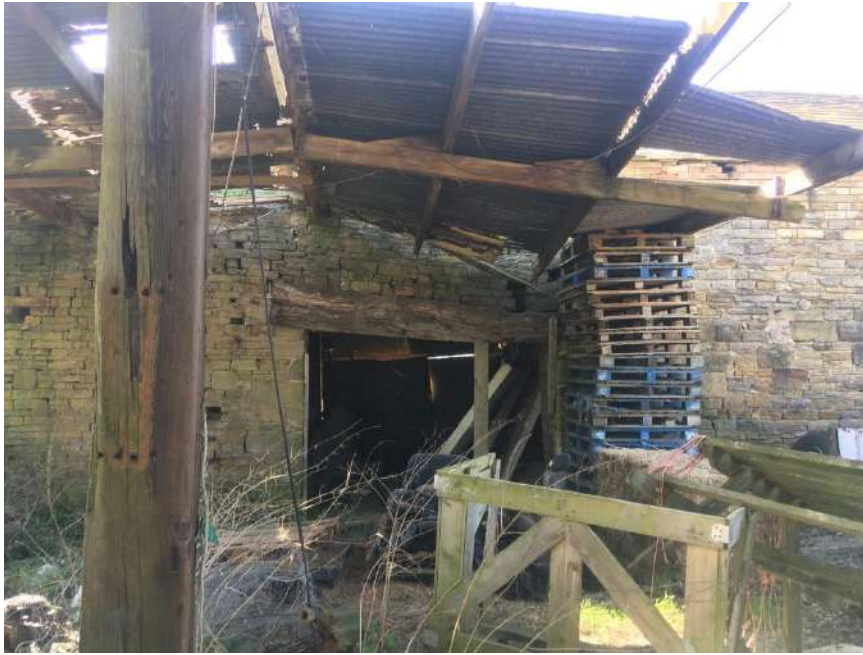
- Front elevation, just left of the principle opening
- Eaves level to front where tin roof covering abuts stone slate roof covering
- Masonry above opening to LHS of front elevation (far left hand side). The original timber lintel has dropped causing the masonry above to also dislodge. It may be the end bearing to this timber lintel has failed, this is currently covered by a stack of pallets that prop the roof of the adjacent/perpendicular building.

Pallets propping roof to dilapidated perpendicular agricultural pole building (to be removed) to East of Unit 3

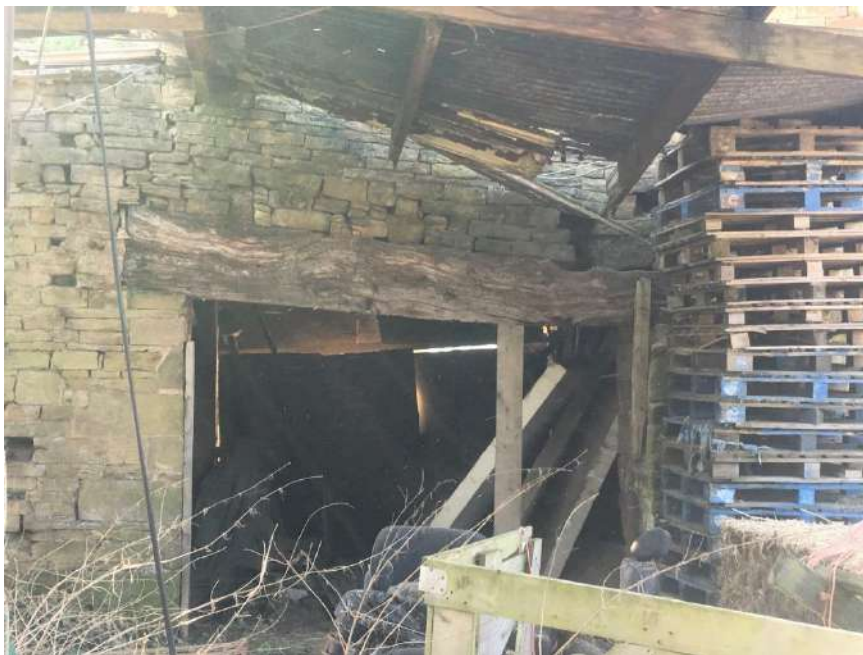
Pallets propping roof to dilapidated perpendicular agricultural pole building (to be removed) to East of Unit 3

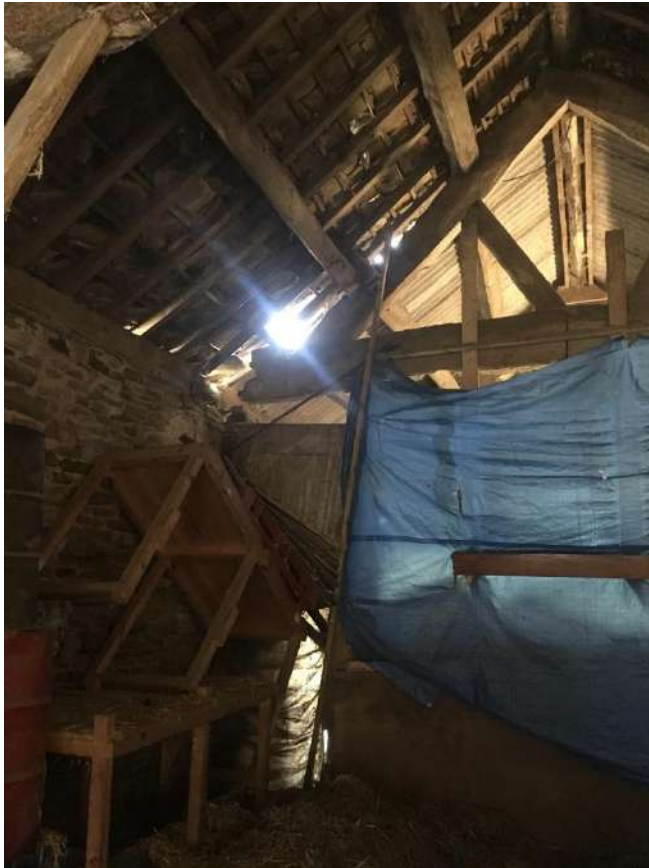
The fifth purlin (from right to left looking to the front) has rotted away and currently has no bearing on the external wall (see photos in appendix A) this needs a new piece splicing to the bottom chord, (possibly a steel channel to both sides of the bottom chord to extend onto the external wall).

5<sup>th</sup> Truss with no  
bearing onto front wall,  
Unit 3

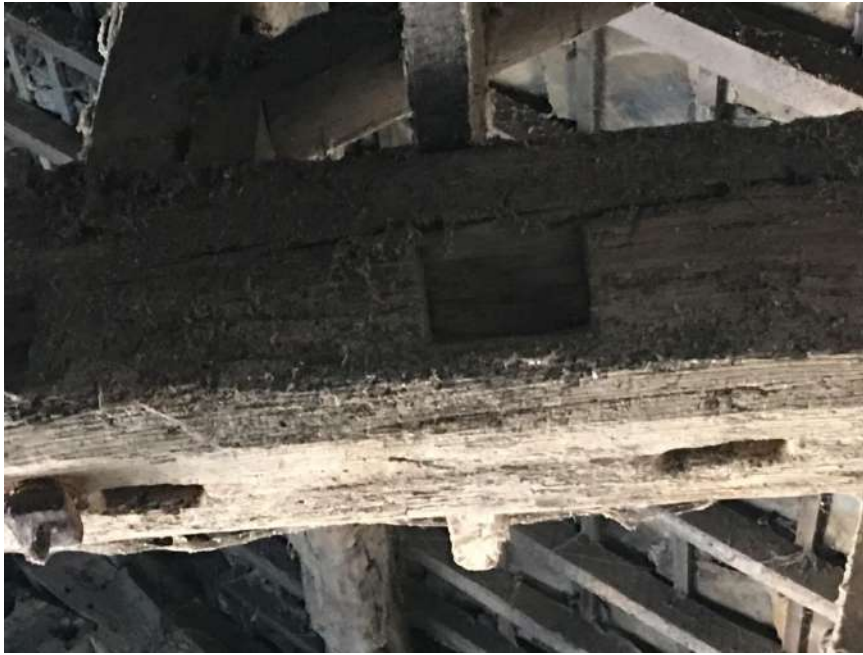
The insect infestation does not appear excessive, taking into account the sectional sizes of these timbers we anticipate all these trusses bar the most northern can be retained. The most northern roof truss replaced with a new truss to structural engineers detail/design.

Insect infestation to  
bottom chord of truss  
within Unit 3

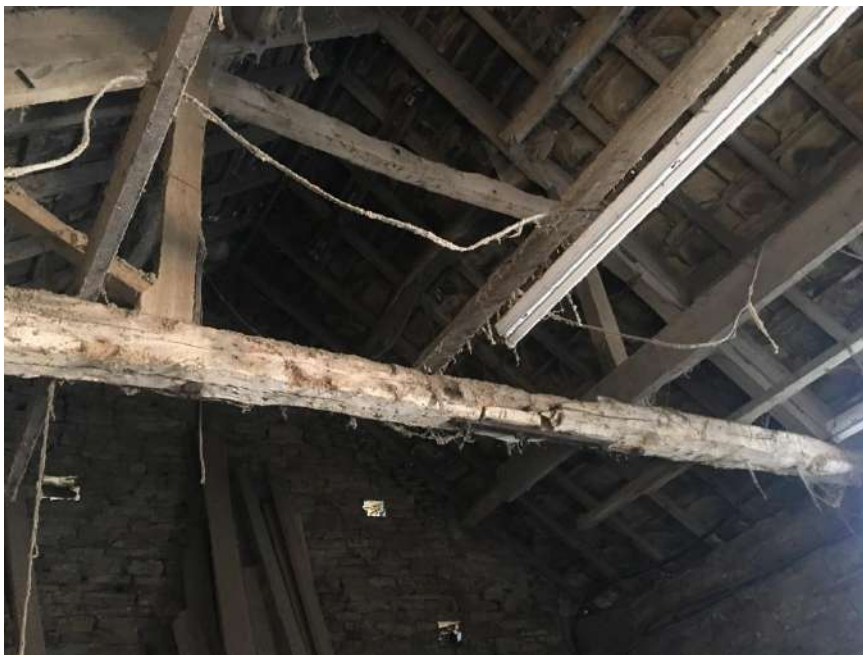
1<sup>st</sup> truss within Unit 3.  
Note splicing over  
fracture to bottom  
chord

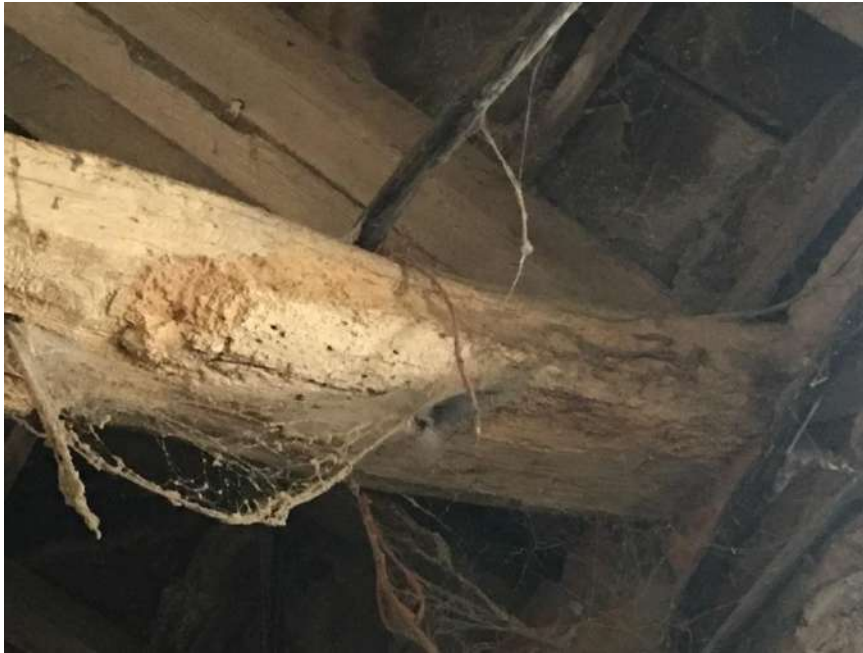
Insect infestation to  
bottom chord of truss  
within Unit 3

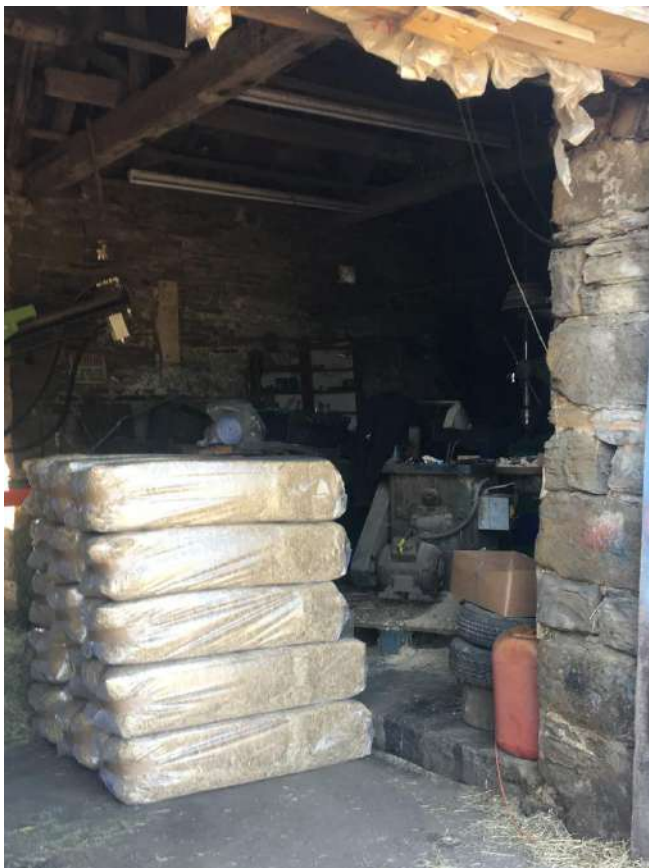
The floor of this building is concrete which steps down from North to South with a difference of circa 900mm.

The floor levels vary, the concrete slabs are non-original, unlikely to incorporate thermal insulation or appropriate damp proof membranes, it is anticipated these will be broken out with new floor slabs formed incorporating thermal insulation, drainage and damp proof membranes.

Concrete floor  
slab/differing levels  
to Unit 3.
