Station Road, Wombwell – November 2019 Flood Note

For:	Hartwood Estates
Date:	28 th November 2019
Author:	Ian Hopkinson BSc (Hons), MSc, MCIWEM – Senior Hydrologist
Approver:	Matt Travis, BSc (Hons), MSc, MCIWEM, C.WEM, CEnv, CSci - Director

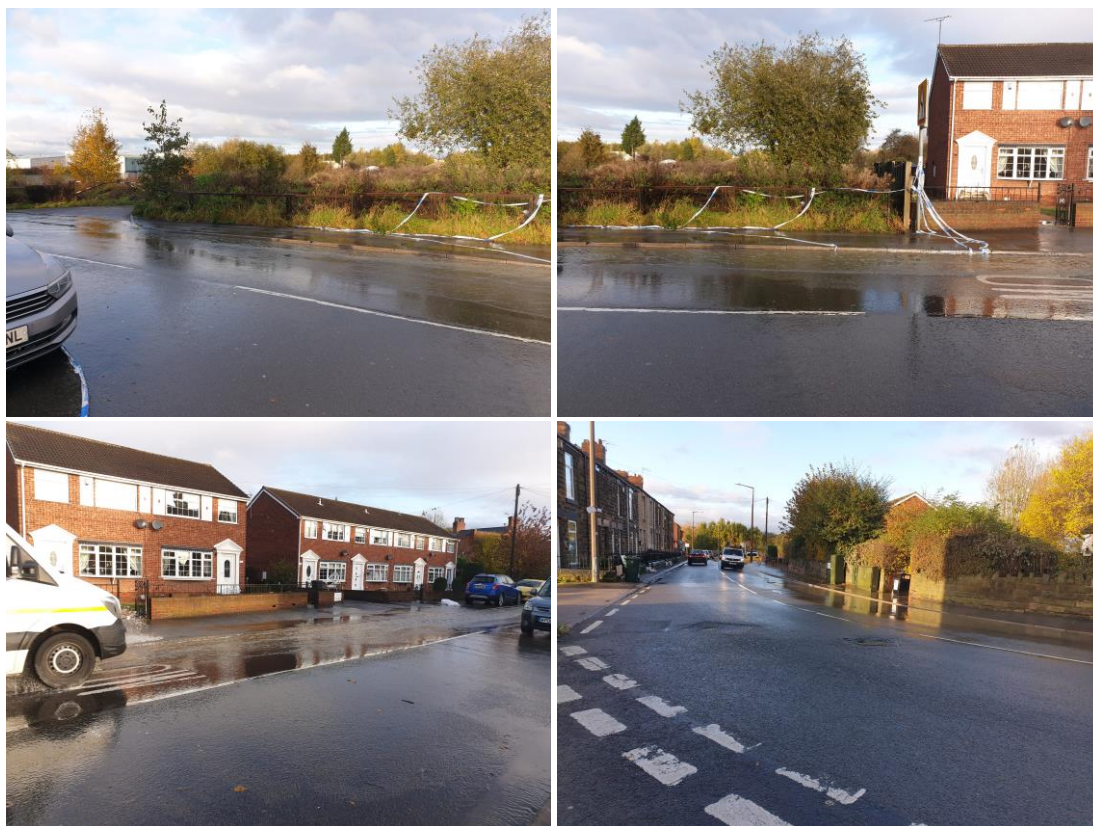
Properties along both sides of Station Road were flooded on November 7th and 8th. See Figure 1.

Figure 1: Flooding on Station Road

- Properties along both sides of Station Road and the rear of properties on Stonyford Road flooded after the River Dove overtopped its right bank upstream of the Stonyford Road Bridge.

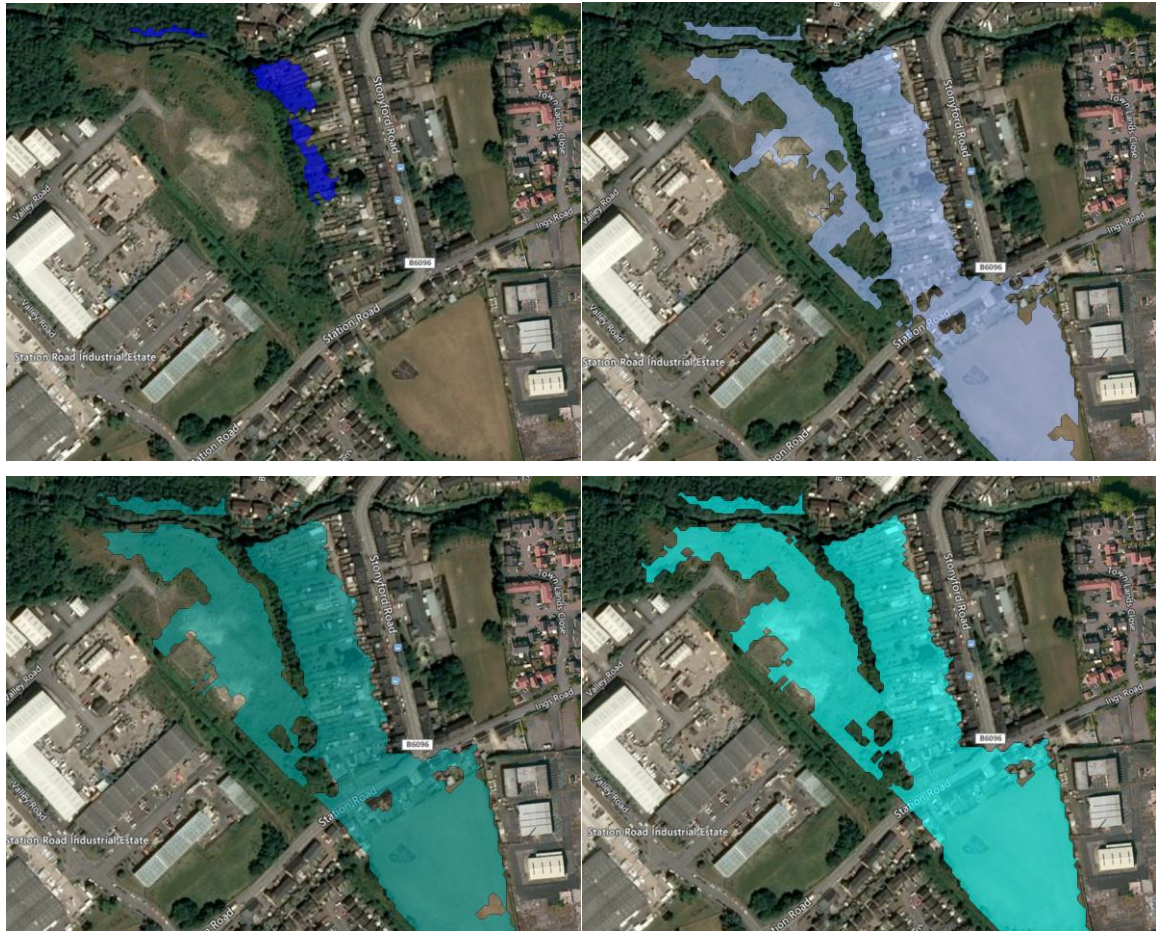
Figure 2 shows the 1 in 100-year, 1 in 100-year plus 30%, plus 50%, and 1 in 1000-year event flood extents at Low Valley from the Enzygo Ltd River Dove and Bulling Dyke model which was used to update the Environment Agency Flood Map for Planning in June 2018.

The model shows that flooding of Station Road and the properties along this road would occur in the 1 in 100-year plus 30% climate change event and upwards.

Figure 2: Modelled Flood Extents

Top Left: 1 in 100-year event; Top Right: 1 in 100-year plus 30% climate change event; Bottom Left: 1 in 100-year plus 50% climate change event; Bottom Right: 1 in 1000-year event

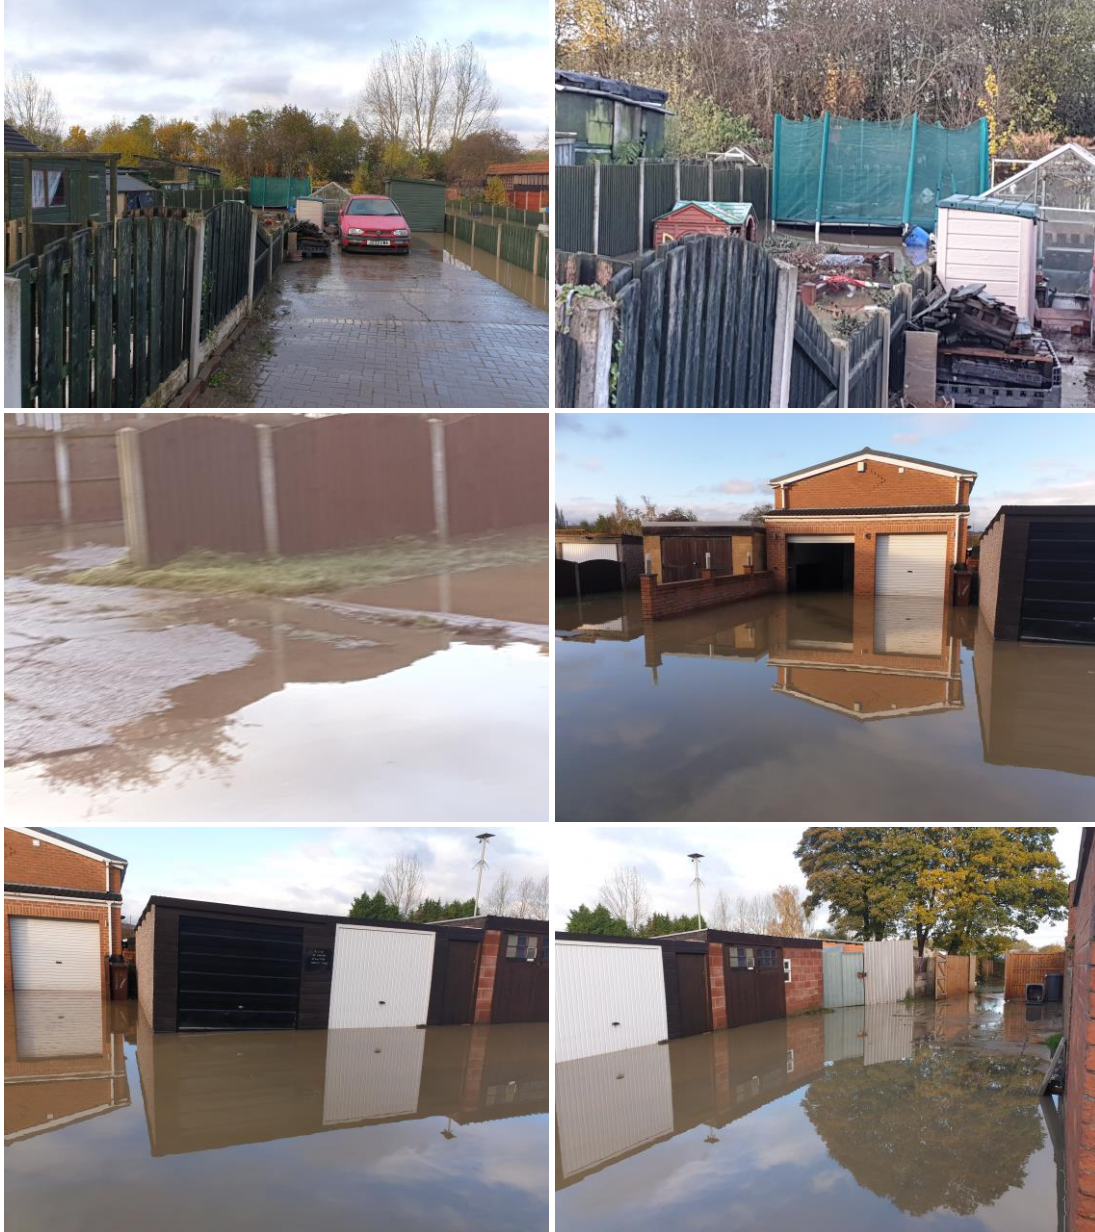
Flooding of the areas to the rear of properties on Stonyford Road also occurred (see Figure 3). It appears that the River Dove overtopped its right bank just upstream of the Stonyford Road bridge with flood water then flowing south into the allotments and rear gardens on Stonyford Road. This floodwater is then thought to have continued south to affect properties on either side of Station Road (Figure 1).

Figure 3: Flooding to properties on Stonyford Road

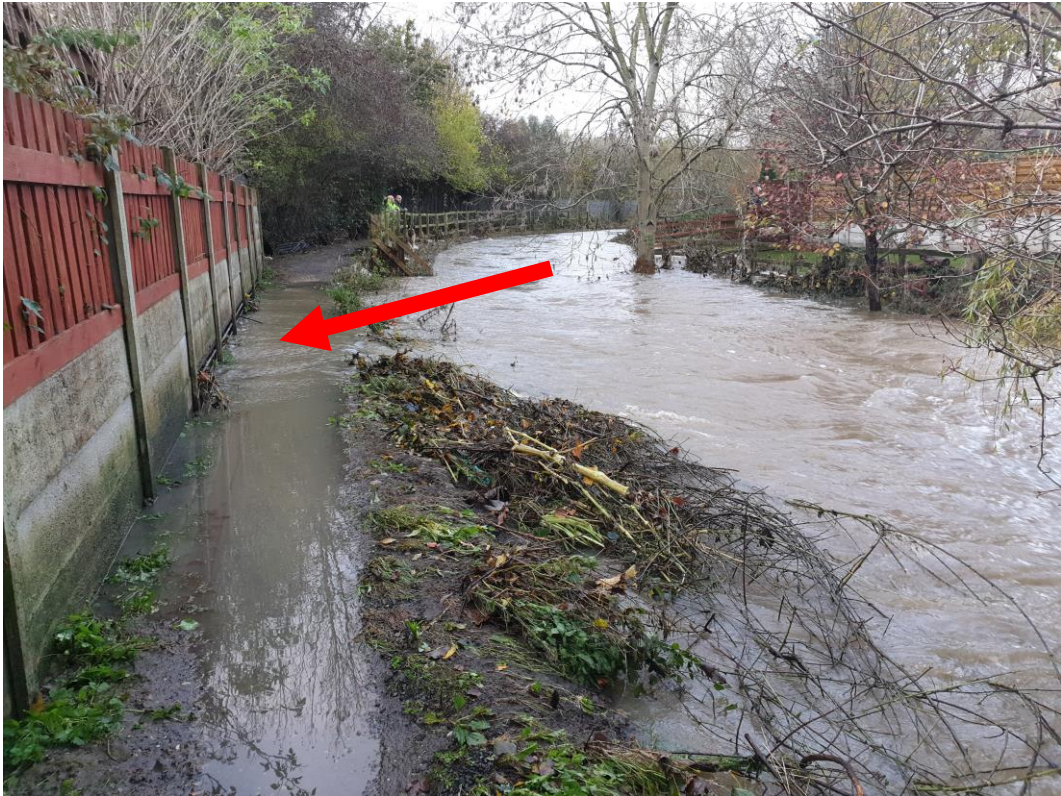
Figure 4 shows the right bank of the River Dove upstream of the Stonyford Road bridge on the morning of Friday 8th November. Levels in the river are very close to bankfull and floodwater can be seen on the right bank. It appears that this is one of the spots at which the river burst its bank. This flooding mechanism and the area of flooding is replicated in the model in all events from the 1 in 100-year upwards.

Figure 4: Right bank flooding on the River Dove upstream of Stonyford Road

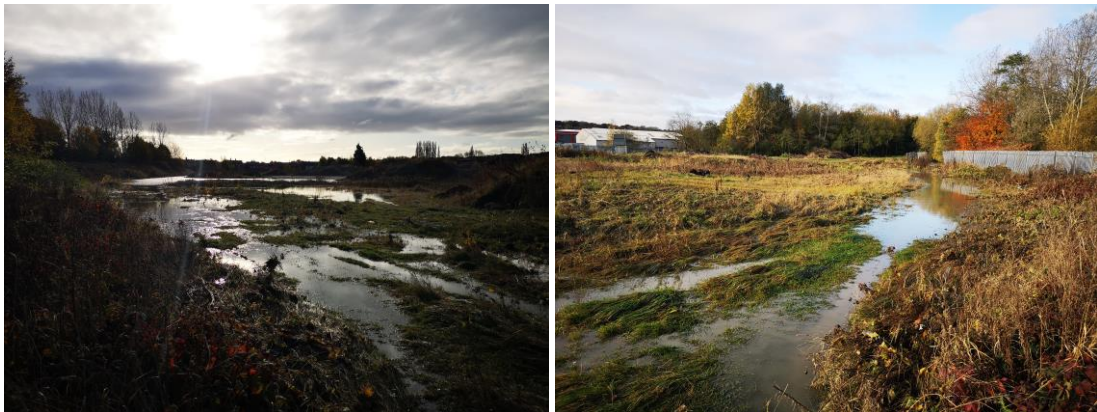
Areas within the northern part of the Site close to the right bank of the River Dove, and the north-western and central parts of the Site also flooded. Areas of standing water were clearly visible within the low areas in these parts of the Site on the morning of Friday 8th November (Figures 5 and 6).

Figure 5: Flooding within the northern part of the Site

The evidence indicates that the River Dove burst its right bank in this location (immediately downstream of the footbridge), floodwater then flowed south into the Site and resulted in flooding of the low spots seen in Figures 5 and 6. This flooding mechanism and area of flooding is replicated in the model from a 1 in 100-year plus 30% climate change event and upwards.

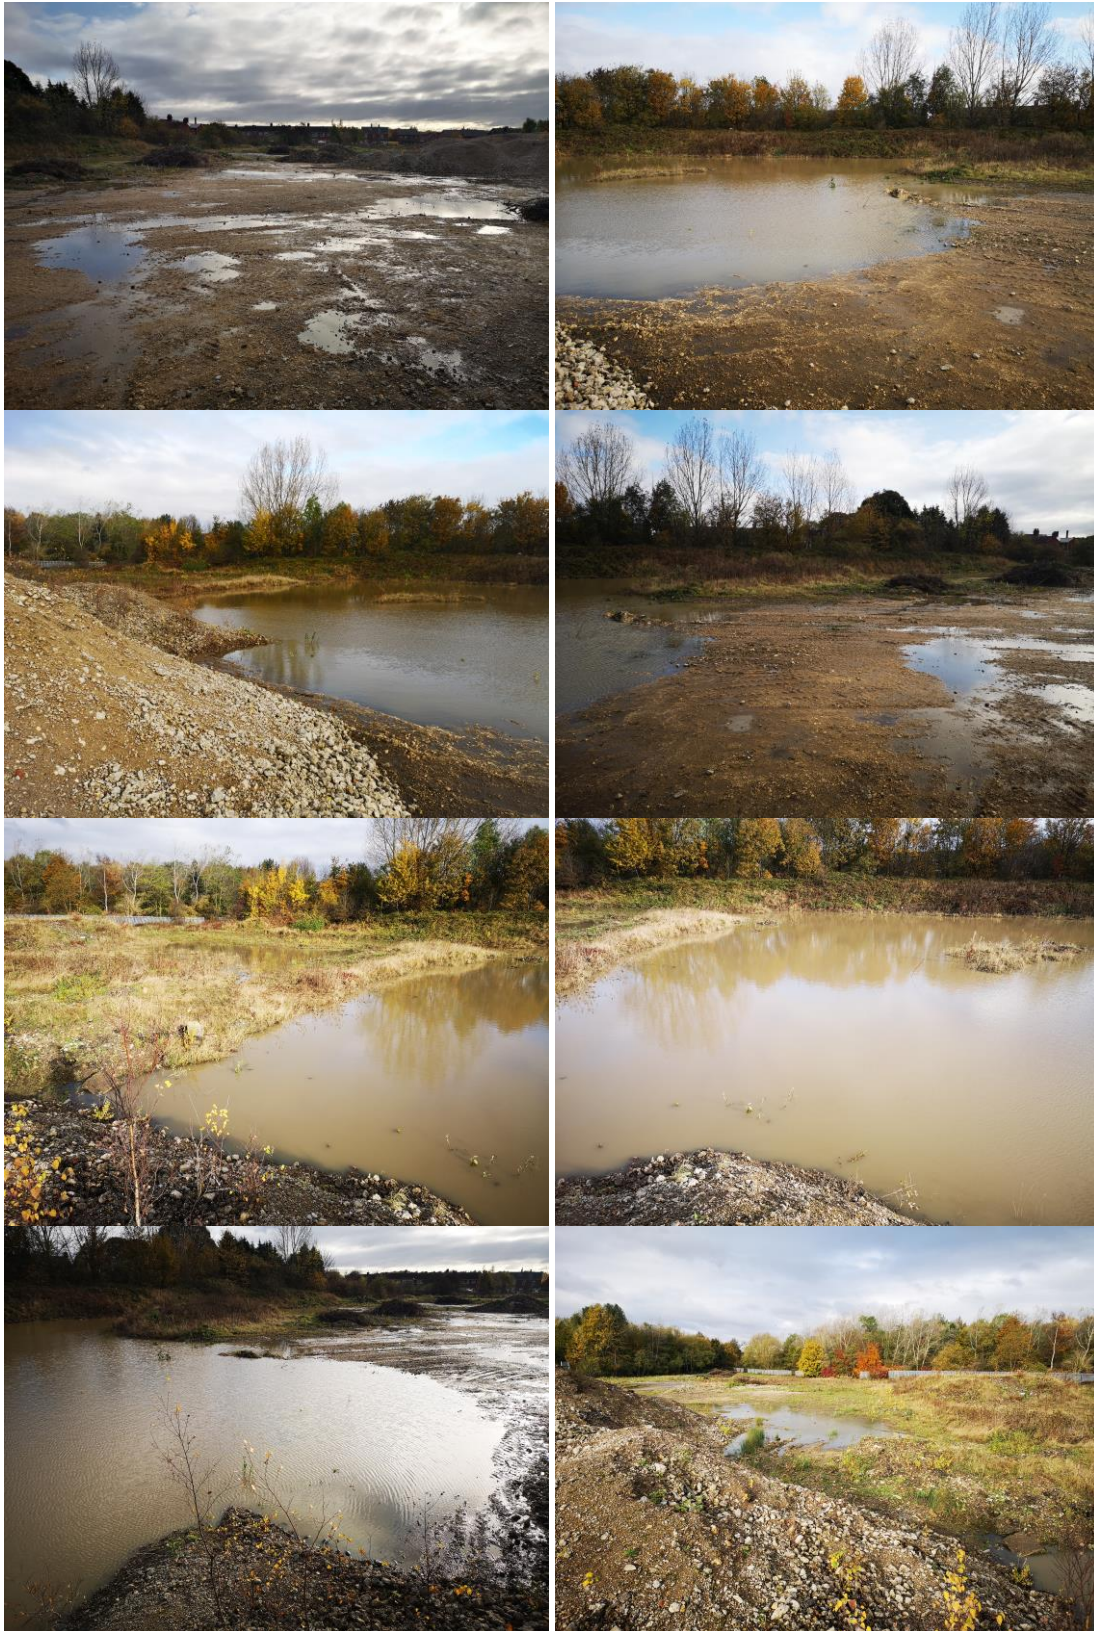
Figure 6: Flooding within the north-western and central parts of the Site

- Areas within the north-western and central parts of the Site were also flooded after the River Dove overtopped its right bank just downstream of the footbridge.

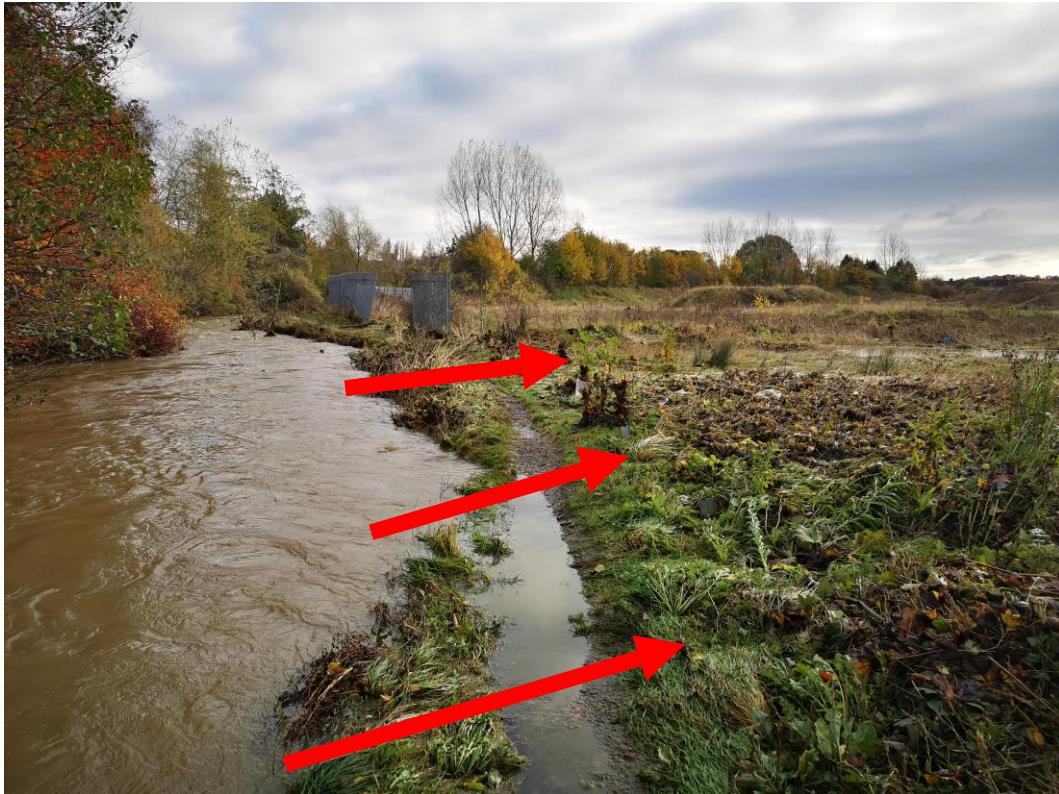
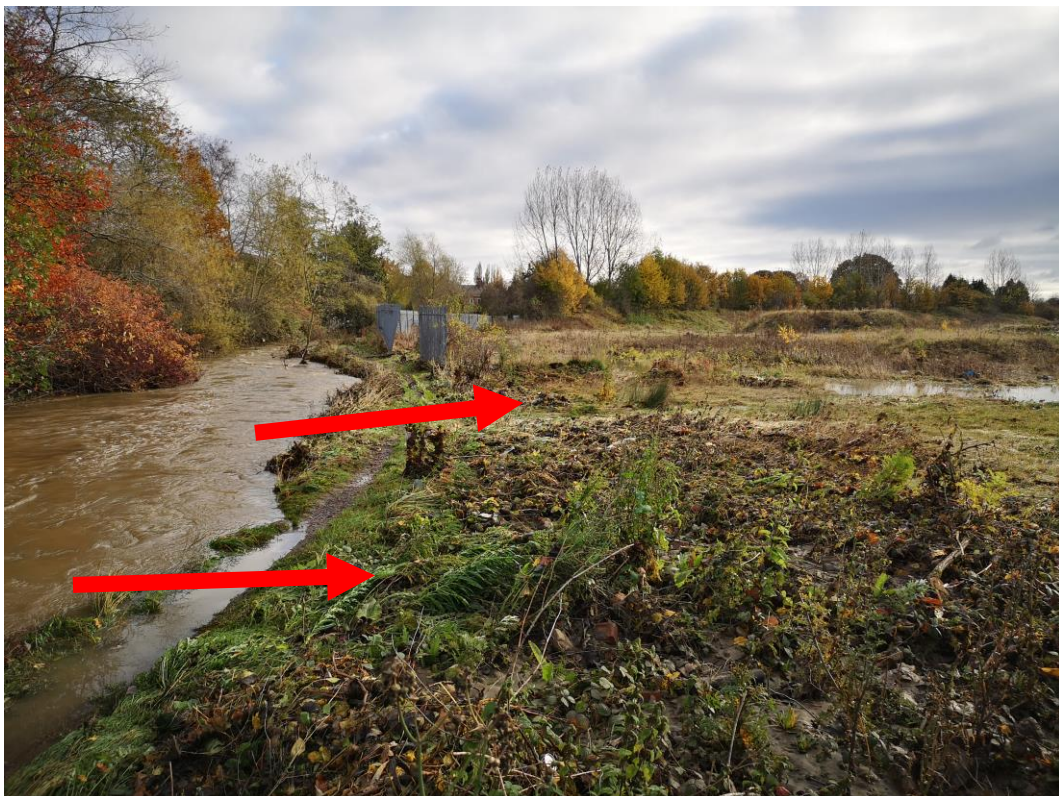
Inspection of the right bank of the river along the northern boundary of the Site showed clear evidence of overtopping. The vegetation had been flattened (Figure 7) and a line of debris on the footpath immediately downstream of the footbridge denoting the edge of the flood extent (i.e. a wrack mark) was visible (Figure 8).

Figure 7: Evidence of right bank flooding on the River Dove downstream of the footbridge

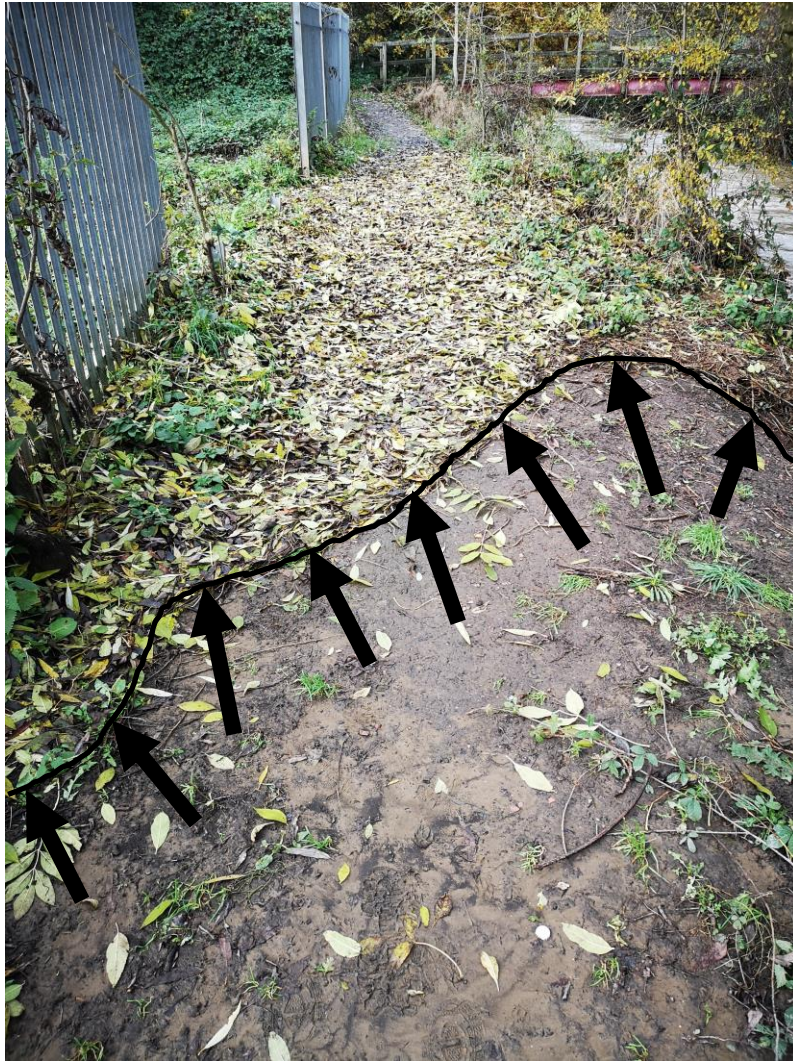
Figure 8: Wrack mark immediately downstream of River Dove footbridge

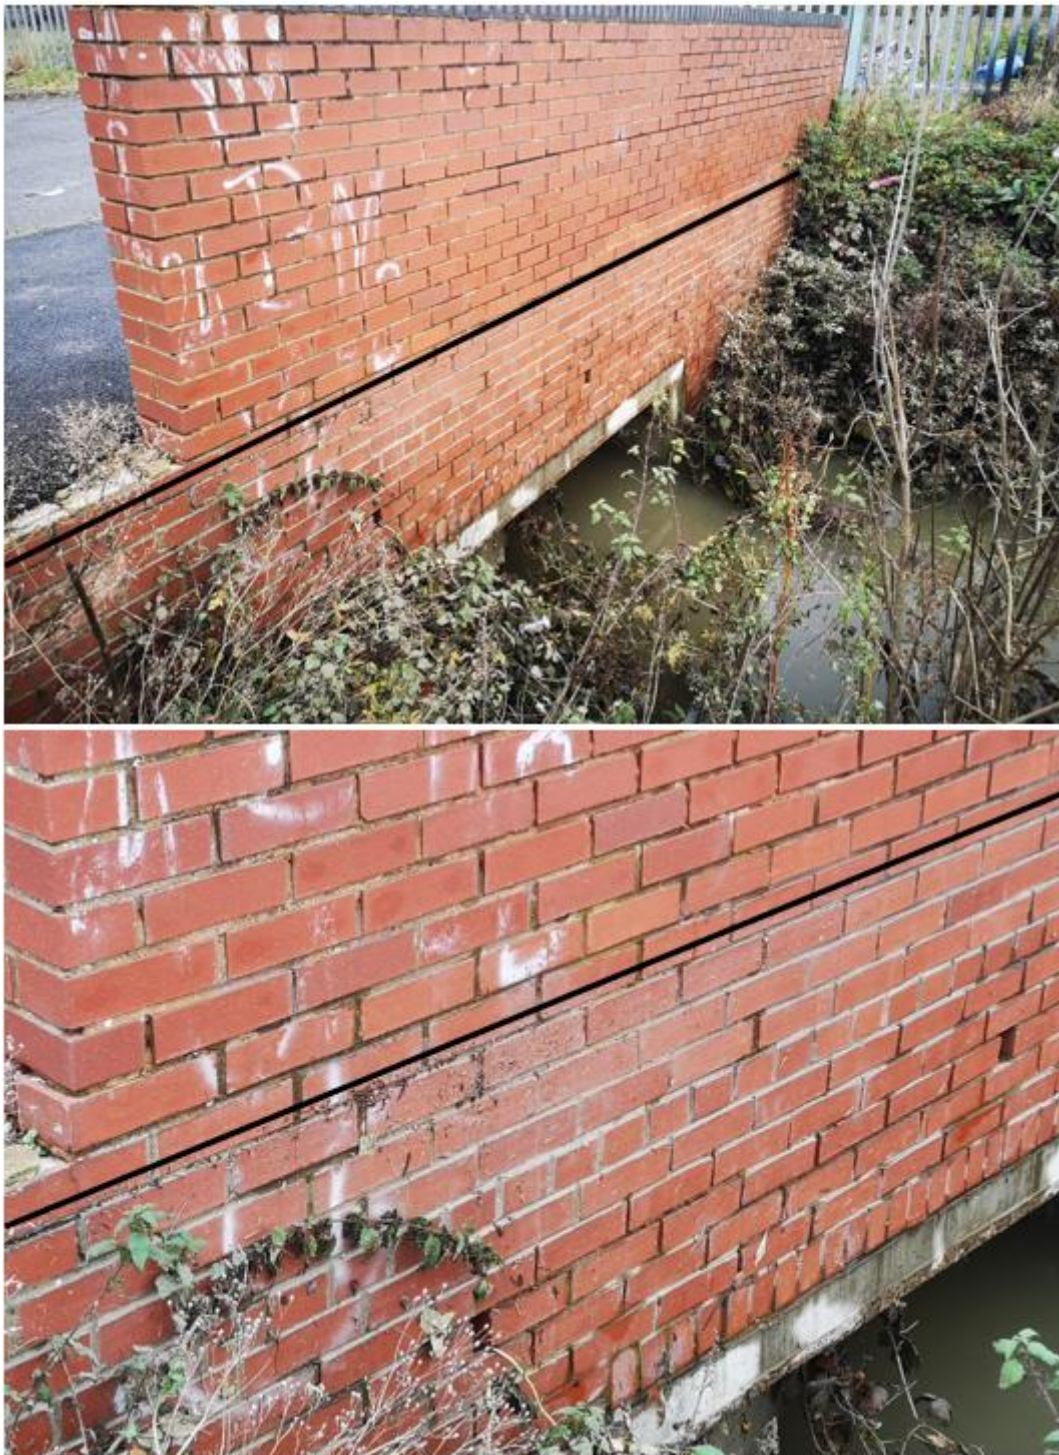
At the time of the walkover (the morning of Friday 8th November 2019), the levels in Bulling Dyke, which runs along the south-eastern boundary of the Site, were relatively low in comparison to those in the River Dove. It was clear from the amount of muddy silt deposited on the vegetation lining either bank of the Dyke and on the downstream face of the Valley Road access bridge that water levels had been much higher overnight/on the previous day. However, the top of these wrack marks was below bank top suggesting that Bulling Dyke had not overtopped and burst its banks in this location (Figures 9 and 10).

Figure 9: Bulling Dyke wrack mark downstream face of Valley Road access bridge

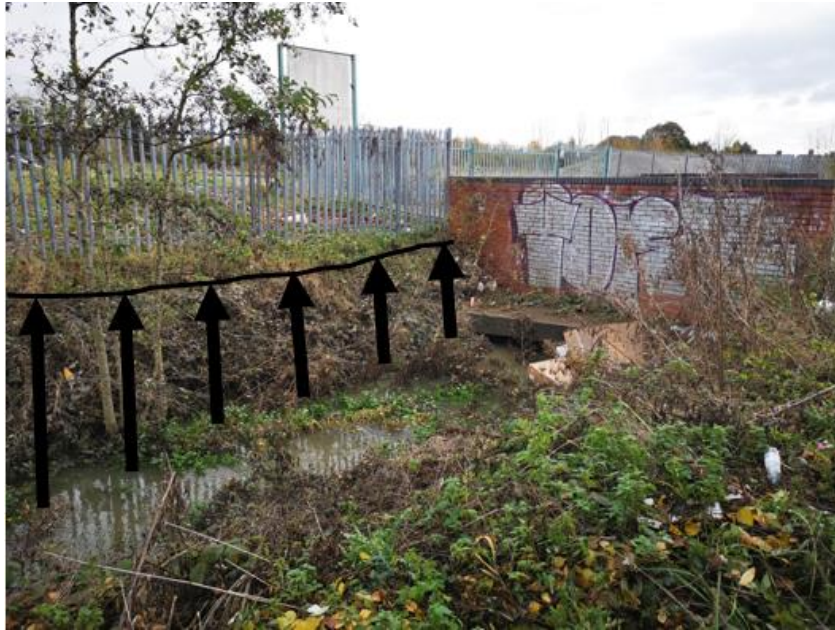
Figure 10: Bulling Dyke wrack mark upstream of Valley Road access bridge

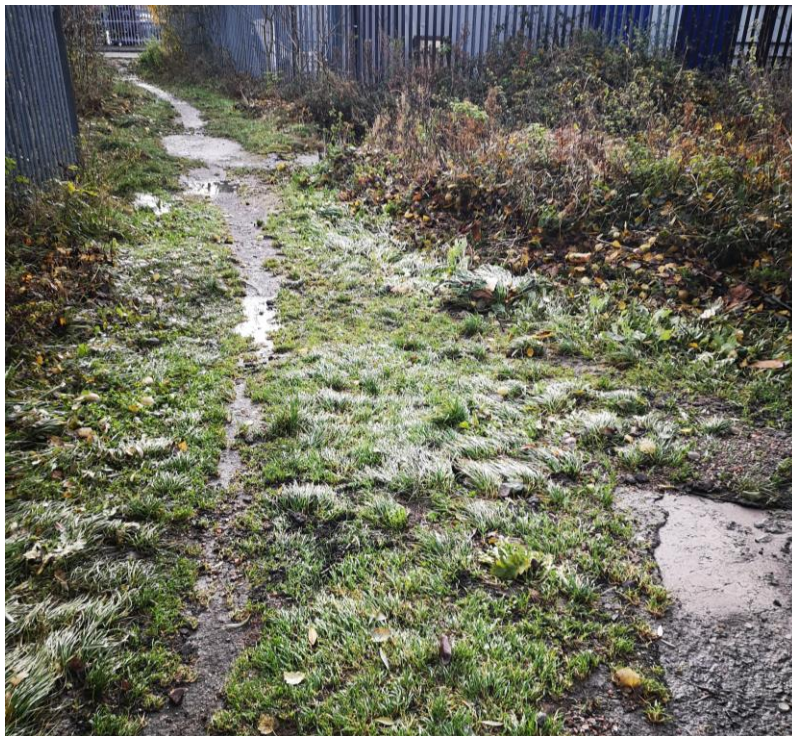
Figure 11: Evidence of flow pathway between River Dove and Bulling Dyke to west of the Site

Upstream of the access bridge, there was evidence in the form of flattened vegetation that suggested an overland flow pathway from the north into Bulling Dyke (Figure 11). It is possible that out-of-bank flooding from the right bank of the River Dove upstream of the Site and footbridge travelled south along the path that runs west of the Site before joining Bulling Dyke upstream of the Valley Road access bridge. This flood mechanism is not replicated in the model

but is known to have been a historical occurrence prior to the removal of the dilapidated Pitt bridge and its replacement with the New Bridge at Netherwood Academy.

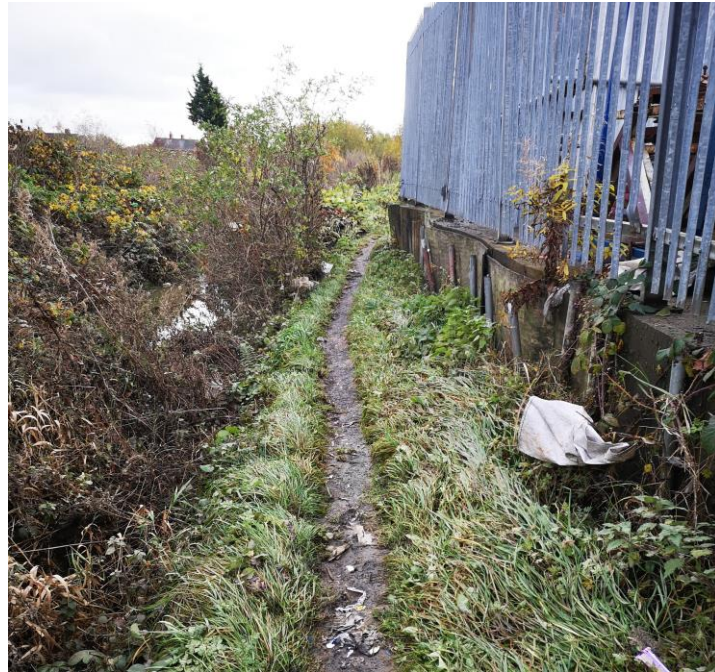
Downstream of the access bridge, there was evidence that flooding on the right bank of Bulling Dyke had occurred. Figure 11 shows an area of flattened vegetation around 20m downstream of the access bridge where the Dyke may have burst its right bank.

Figure 11: Evidence of right bank flooding on Bulling Dyke downstream of access bridge

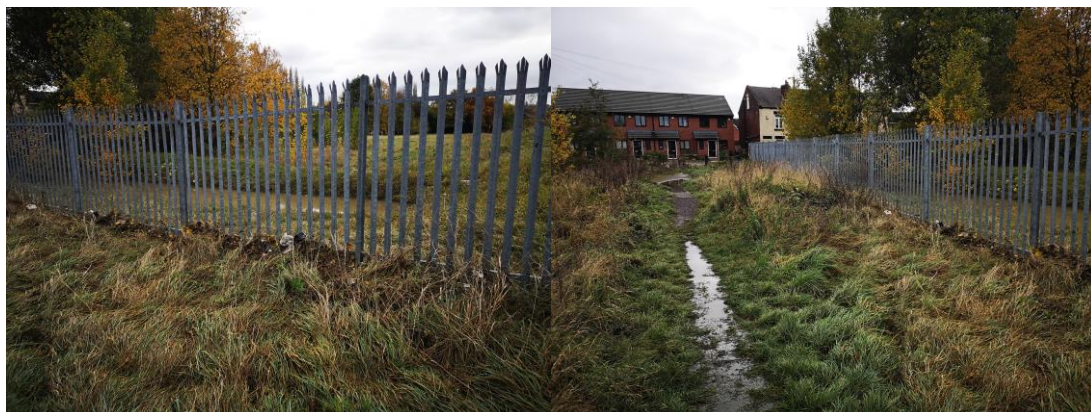
Figure 12 shows an area on the right bank of Bulling Dyke close to Station Road where, again the vegetation had been flattened, and there was a clear line of debris on the metal fence which indicated the level to which flood water had risen in this location. It is unclear whether the Dyke itself had burst its bank and caused this area of flooding or if floodwater had flowed in from Station Road to the south. Both areas are not predicted to flood in the model. It is also possible that other sources of flooding (the capacity of the surface water network, failure of sewers) may have contributed.

Figure 12: Evidence of right bank flooding on Bulling Dyke close to Station Road

- Evidence of flooding on the right bank of Bulling Dyke just upstream of Station Road was observed and not represented in the model.
- It is unclear if the two mechanisms of flooding around Bulling Dyke are fluvial or whether other factors (capacity of the surface water drainage network, sewer failure, may have played a part).
