## STANCLIFFE HOUSE FARM, S35 7DA

### STRUCTURAL ASSESSMENT OF EXISTING BUILDING

YK0024-EMPACE-XX-XX-RP-S-0001

31/05/2024

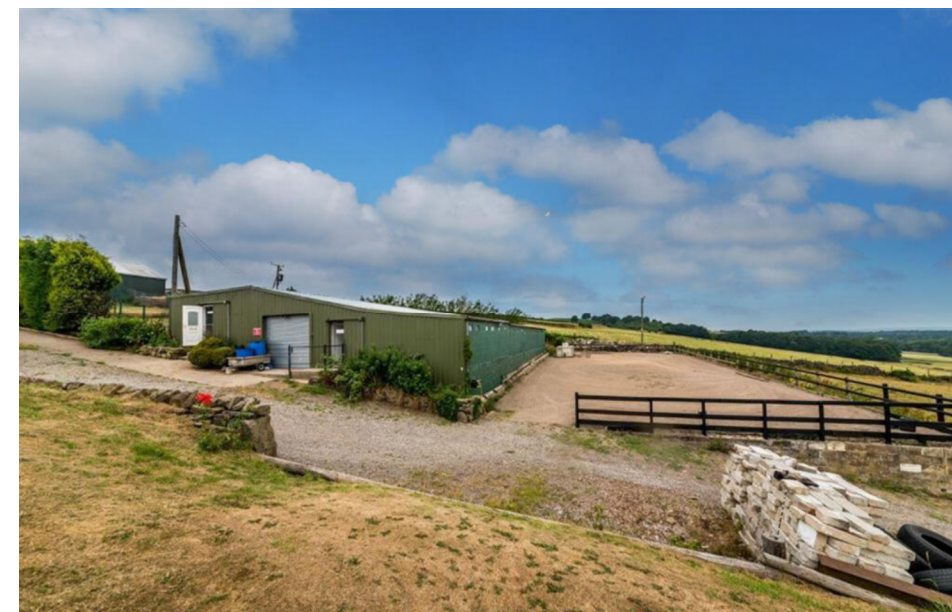
Southeast elevation view of the building noting the sloping ground.

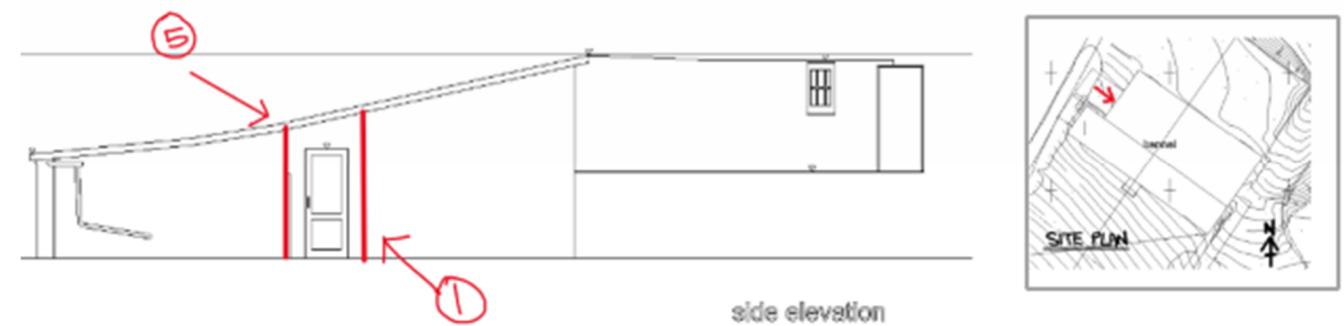
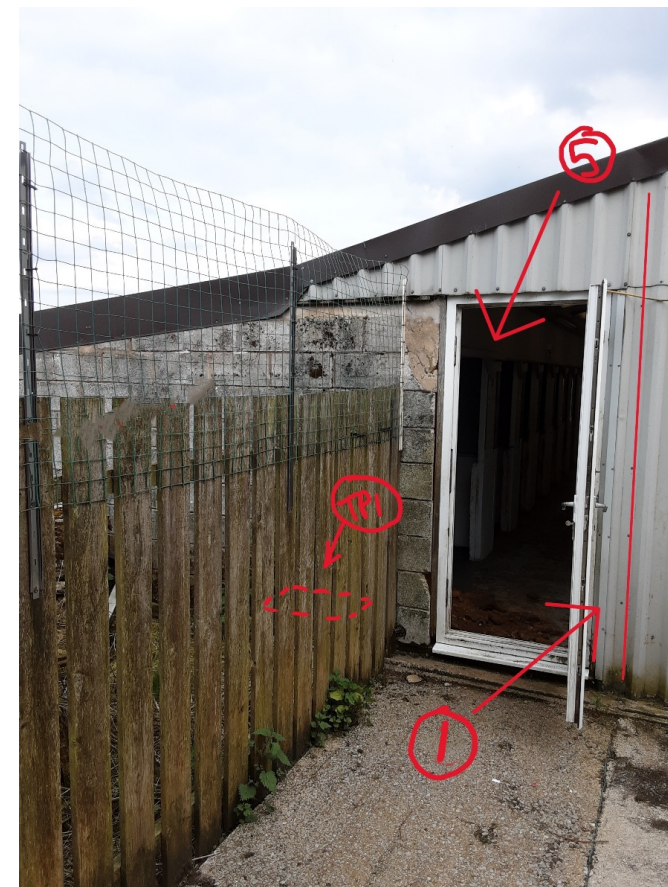
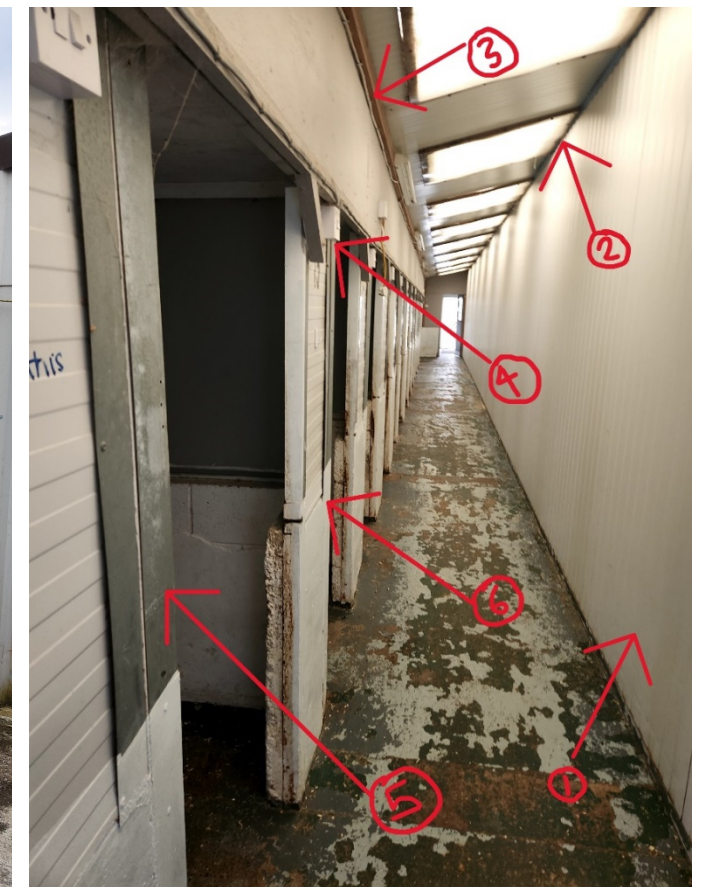
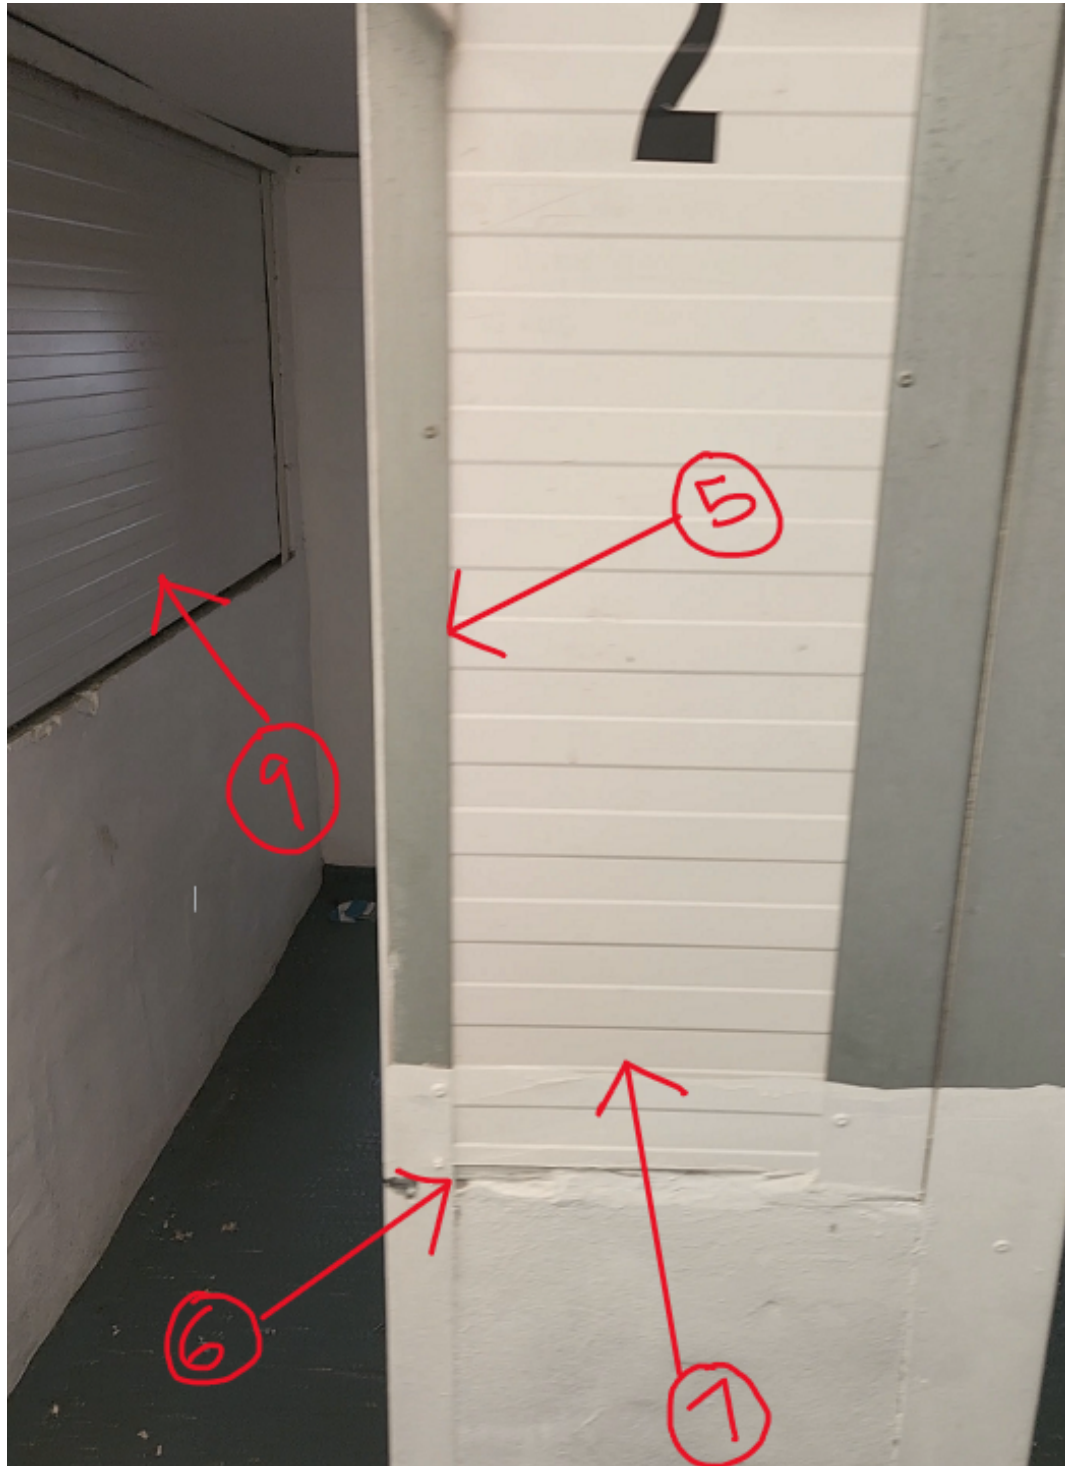
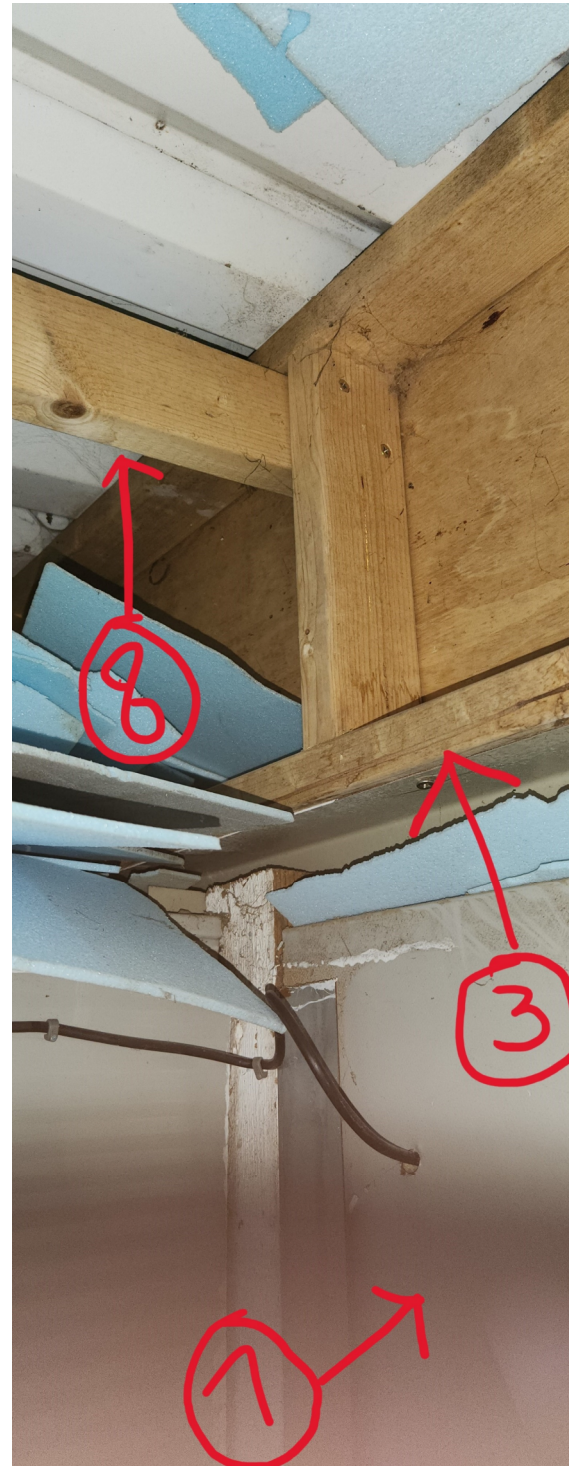
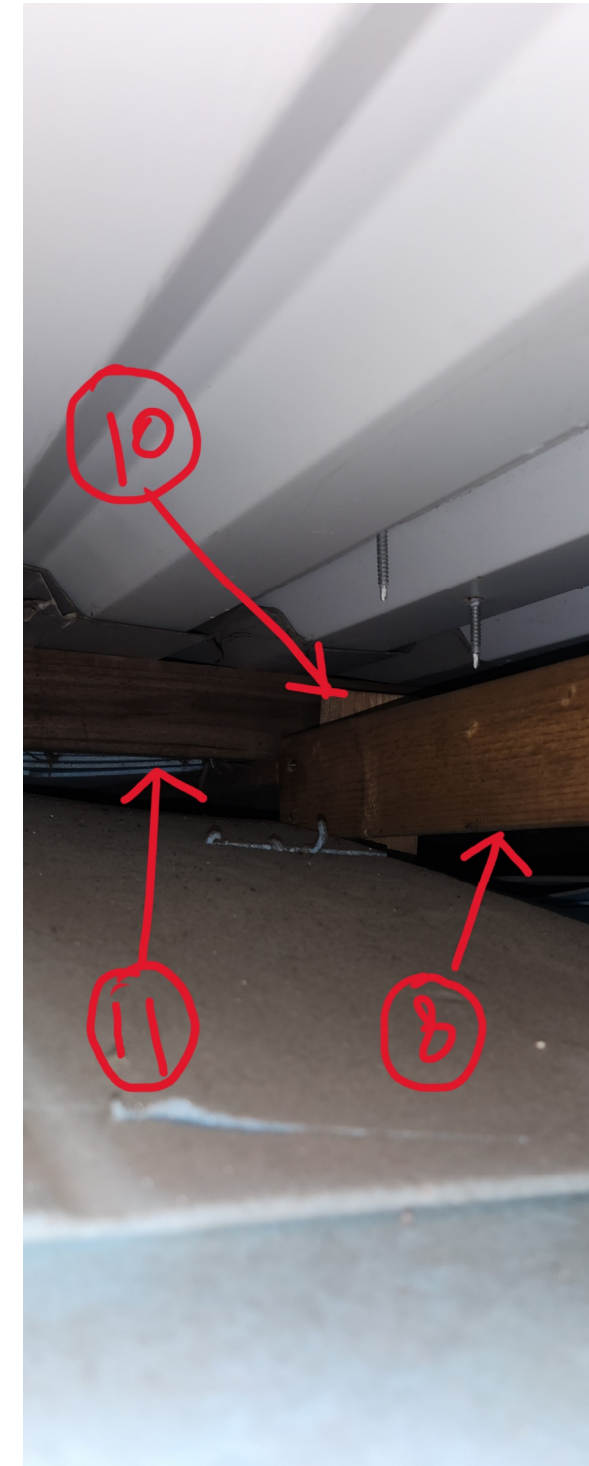
In summary for this section of the building, as per the commentary and description, the presumed current load transfer system appears to be inadequate in all locations except perhaps the timber framed Purlin. However, this too cannot be confirmed to be necessarily adequate without detailed calculations which are beyond the scope of this report.

1. The Element numbered 1 is presumed to be vertically installed composite panels acting as a primary wall support structure. Presumed to be 50 mm thick and comprising light gauge thin metal panels sandwiching an insulation layer, these type of panels are not usually designed to provide primary structural support, and ordinarily utilised as secondary cladding elements. Here, they appear to provide intermediate support to the roof panels which also appear to be of the same construction. Although the panels appear to be in reasonable condition from this side, they are unlikely to be compliant to current regulation in terms of providing vertical wall (axial loading) support and resistance to bending action induced by internal wind pressures.

2. Element numbered 2 is a line of support provided by the vertical composite panel wall. Note it appears that skylights have been cut out within the composite panel without any further significant structural trimming out. These types of composite panels are not designed for creating voids within them as they tend to weaken the structure of the panel. In modern practice, where there are skylights within the roofs, roof composite panels of this type are generally trimmed out around supporting steelwork. Hence, they are unlikely to meet current codes of practice.

3. The roof panels are also then supported at location 3 on a makeshift Purlin arrangement which appears to be built-up to comprise timber framing with sheathing on one side. Although built up purlins are common practice in modern usage, the support provided to the Purlin arrangement below (as marked by location 4 on the image) is questionable.

4. The built-up Purlin above described in point 3 appears to be taking support at regular locations defined by the partition between the kennels. Although the diagonal timber member providing support may not be all that unusual, the connection of the diagonal member into the steel profiled sheet panel is questionable and unlikely to meet current codes of practice. This diagonal member appears to be screwed into a coldrolled folded plate which appears to then be connected by screws to the vertically installed (single layer of) steel sheet panels. The sheet panels also appear to be installed in their weak axis. A close-up of a similar coldrolled folded plate is described below in point 5, as can be seen in the foreground.

6. The vertically installed steel profiled panels appear to be bearing onto a single skin of block work wall with very nominal apparent connection.

7. This vertical steel profiled panel is noted to be a single sheet of presumably light gauge steel. It also appears to be laid on its weaker axis. This is unlikely to be satisfactory to modern codes of practice.

11. This timber Purlin appears to provide intermediate support to the profile roof. It looks to be in satisfactory condition and may be acceptable from a structural perspective given that it is a short span. However full calculations would be required to assess the timber section for the load it is required to carry.

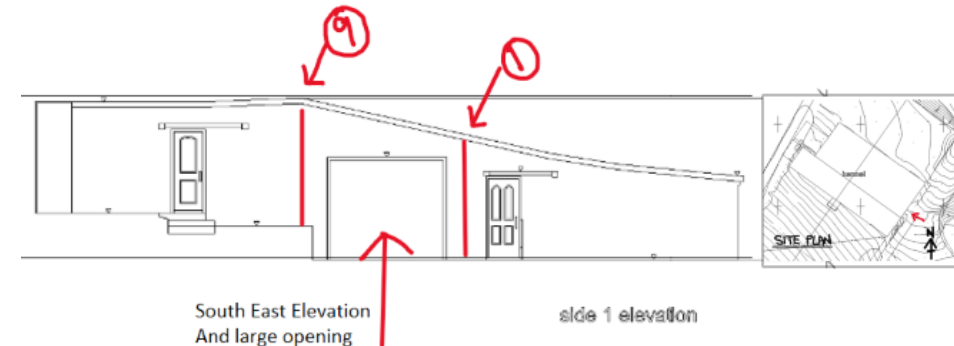
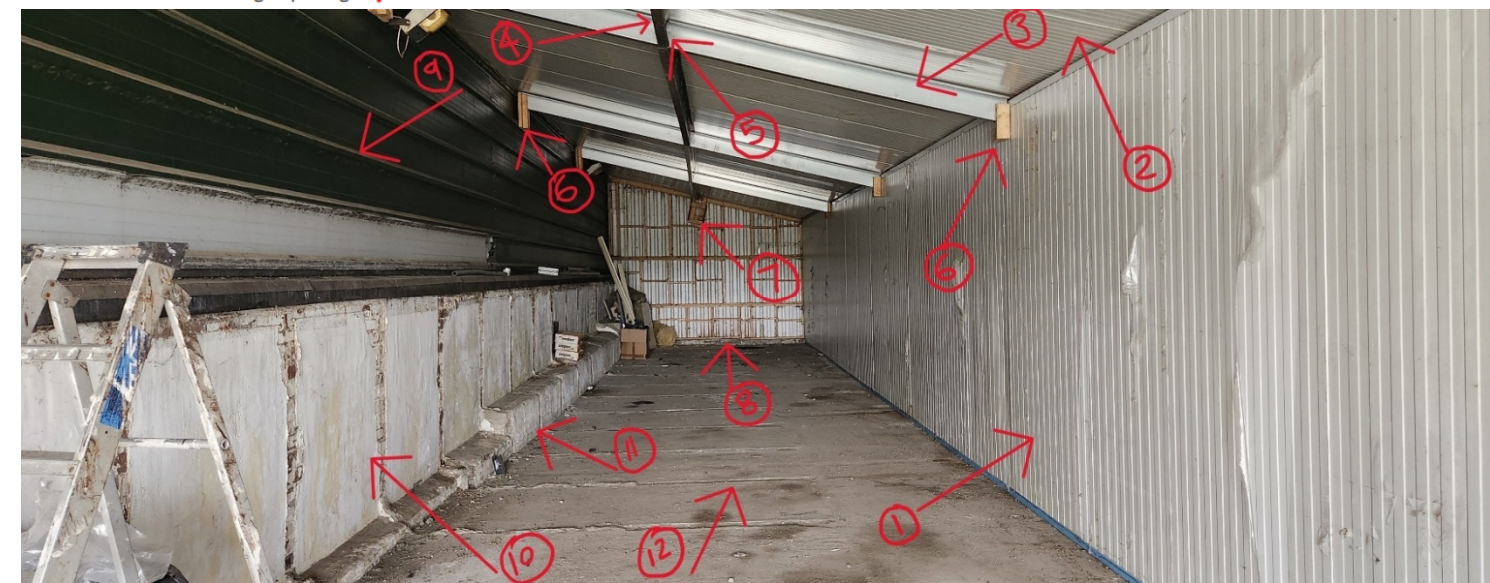
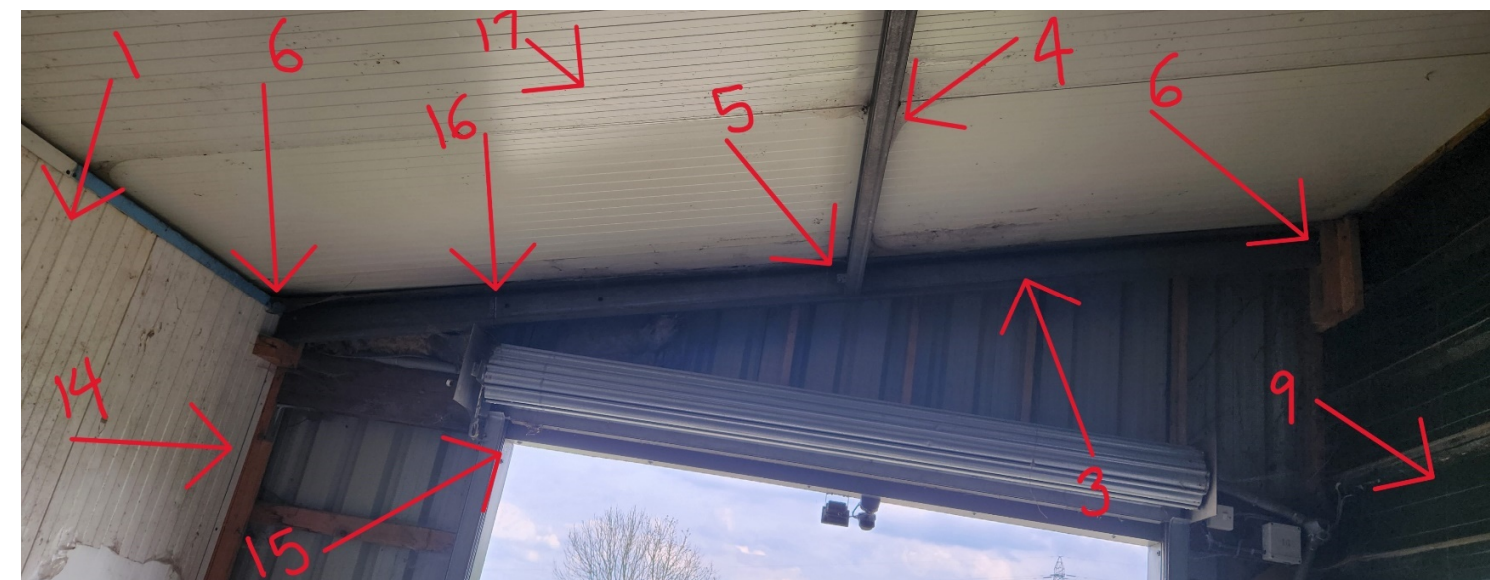
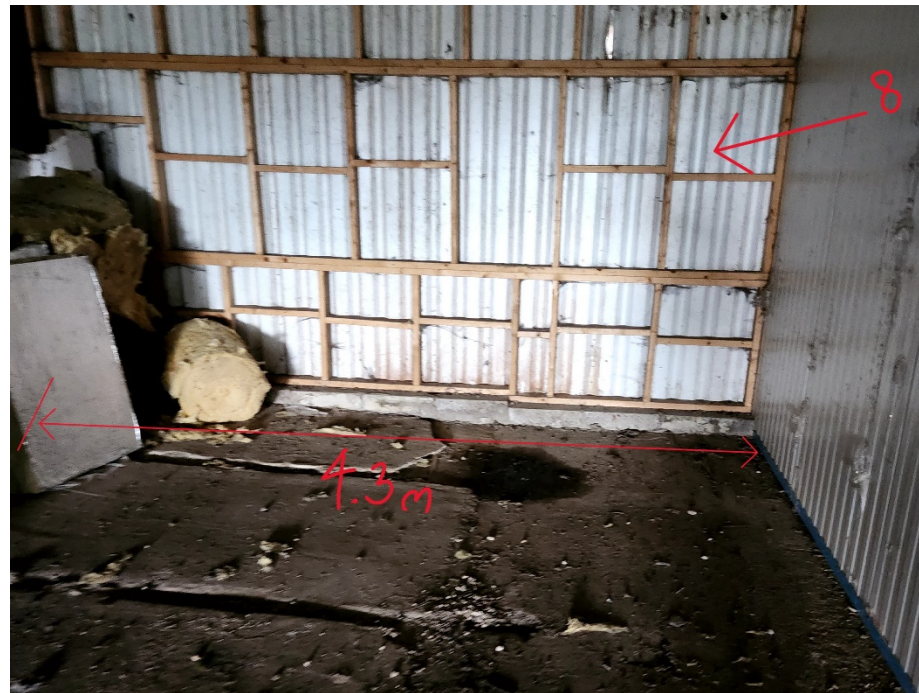
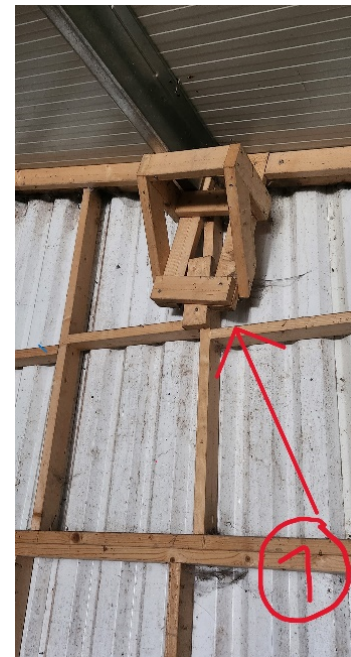
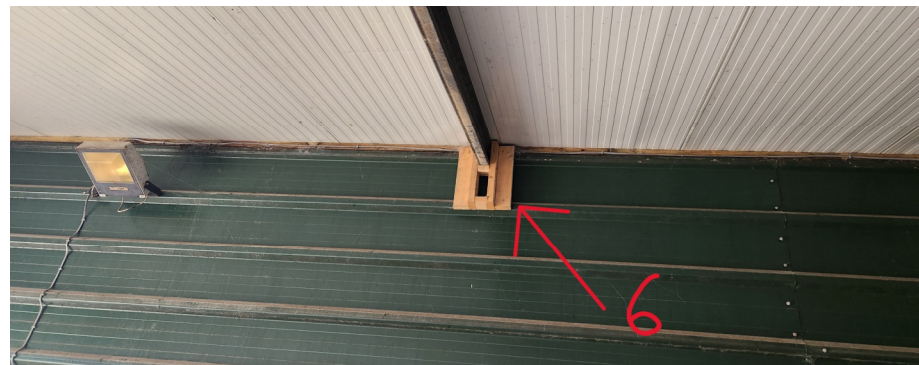
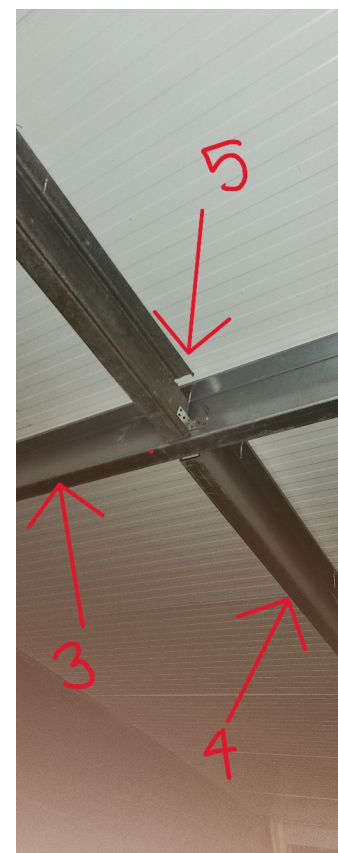
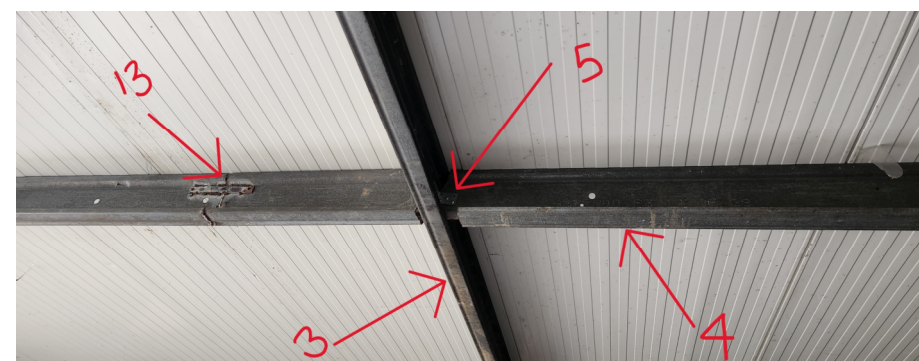
In summary for this section of the building, based on the below commentary, we are of the opinion that most of the elements are likely to be compliant to current codes of practice. The exception being perhaps the members acting as purlins, denoted number 4 in the photographs. This is because they are likely to be carrying the lowest load of all the structural elements. However detailed calculations are required to confirm their acceptability. Also to note the retaining wall as denoted number 10 in the photographs may also require further calculations to confirm whether it is compliant, due to its masonry construction there is a possibility that it may not be so.

1. This wall appears to be the same one from the previous images as noted by point 1. There is no evidence to suggest that it is supplemental to the wall panel as seen on the other side. I.e. that this wall is likely to be a single 50 mm thick composite panel as described previously. On this side defects in the walls can be clearly seen. The wall on this side appears to be providing support to light gauge Z shape steel members acting as rafters and are connected to the composite panel wall using an elaborate timber connection which is unlikely to be compliant to current practice.

3. Cold rolled Z shape light gauge member, 180 mm deep acting as rafter. The elements marked number 4 are purlins connected to these rafters and are presumed to be of the same structural properties, i.e. 180 mm deep Z purlin. These type of members are ordinarily utilised as purlins ( secondary support) rather than as a rafter which acts as a primary support. Given that these (rafter) members are spanning about 4.4 m on pitch, and supporting purlins with a tributary roof area of approximately 2.4 m wide by approximately 5 m long (the approximate average spacing between rafters), and taking this amount of loading as a point load, it is unlikely that these rafters are within acceptable structural code and probably require a major upgrade to hotrolled steelwork.

4. Element number 4 is presumed to be of the same section properties as element number 3, i.e. 180 mm deep Z shape Purlin. Most of the purlins are spanning approximately 5 m, except one purlin which is spanning up to 6 m. The tributary area that these purlins are carrying is approximately 2.4 m wide. The 6 m spanning purlin is likely to be unsatisfactory, but the 5 m span purlins cannot be confirmed definitively to be unacceptable, and further calculations will be required to check for this.

5. Element number 5 points to the connection of the purlins to the rafters (with close up images overleaf). From the visual inspection, the connection appears to be very nominal and likely to be unsatisfactory.

6. Element number 6 points to the connection of the rafters (element number 3) into the vertical supports, i.e. the presumed composite insulation panels. There appears to be an elaborate timbered connection constructed to support the rafters onto the composite panels. Although the timbered connection is unlikely to be designed, the likely reason for the elaborate connection is to acknowledge that at the point load from the rafter would be best distributed as evenly as possible onto the vertical composite panels, as the composite panels consist of thin metal sheeting, and would likely to be sheared

with concentrated forces induced by nominal metal brackets and screws. These composite panels are not ordinarily designed to support point loads of this type and hence, the timbered connection as well as the general principle of the support of this rafter point load on the wall panels is non-compliant.

8. The elevation to the back of the building (Northwest) appears to have been constructed using timber work. The timber framing then supports what appears to be a single thin sheet of trapezoidal profile metal. This elevation measures approximately 4.3 m wide by 3.9 m high at its highest point. The timber framing is therefore presumed to be acting as a makeshift cladding rail (façade support) arrangement with intermediate timbers. This is clearly inadequate and likely to require upgrading to major structural steelwork to comply with modern regulations.

9. Element number 9 appears to be another composite metal sheet and insulation panel acting as primary wall support to the roof structure, i.e. the rafters noted in element number 3 are connected and supported off this panel. The panel also appears to have been laid on its weaker structural axis, as can be seen by the trapezoidal profile grooves. This was likely for convenience as usually these panels span longer parallel to the stiffening axis, i.e. installing them in their stronger access may have necessitated additional work. As per the commentary in relation to the other vertically installed composite panels acting as walls (noted as element 1), these panels are not ordinarily designed to provide primary structural support and are ordinarily relied upon as secondary cladding elements which require supporting themselves. Hence this wall panel is unlikely to be compliant.

10. Element number 10 appears to be a masonry wall, presumed to be at least 215 thick and acting as a retaining wall, with the retained height of approximately 1.5 m. further investigation will be required to confirm the acceptability of this wall, in the first instance exploratory work to establish its thickness and whether there is any concrete composition involved. It is likely though that given the construction of the rest of the structure, it is probably not designed structurally and may not be compliant. Indeed masonry only walls with such a retained height do not generally comply.

13. Element number 13 is not shown in the main image and can be seen further down. It points to an apparent 'splice' connection to join together two pieces of the Z shaped the purlins. This connection is immediately apparent to be non-compliant structurally.

15. Element number 15 points to the opening and roller shutter doors into this section. Ordinarily the structural design of an opening into an elevation would be trimmed out by vertical rails or hotrolled steelwork (connected to a primary steel rafter at the head) with the provision for support for roller shutter doors. However, this arrangement is clearly non-compliant as there doesn't appear to be any significant trimming structural support to the opening.

16. Element number 16 points to the edge rafter again consisting of the coldrolled Z section member. However this member is further weakened by what appears to be a non-compliant splice connection at the location of the pointer.

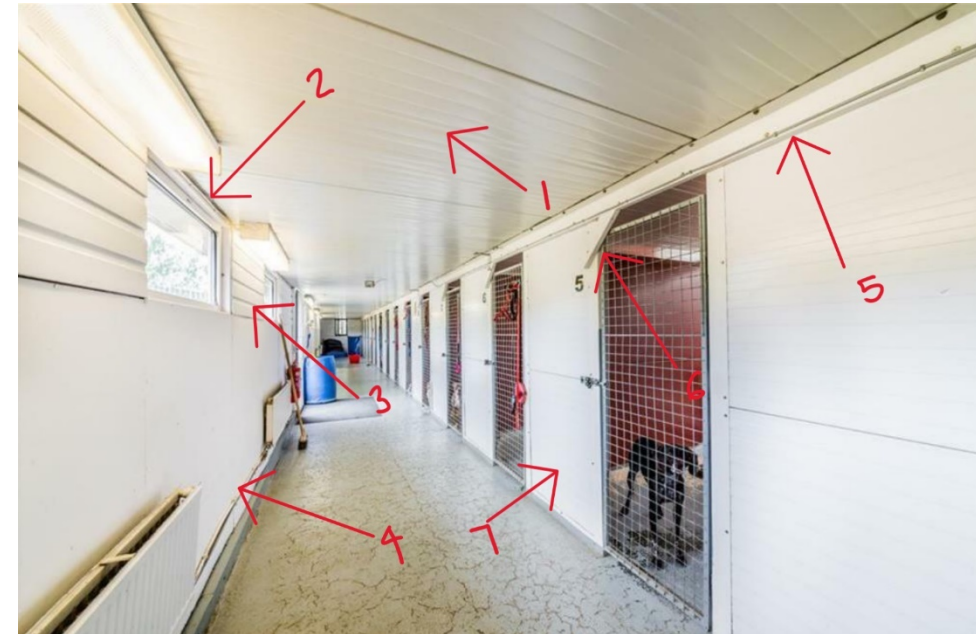
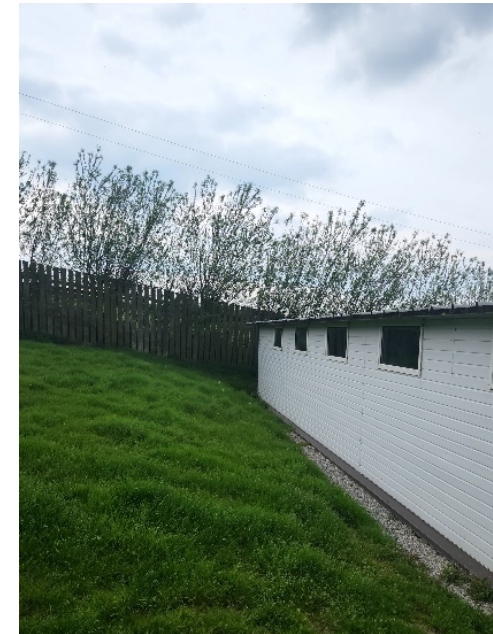
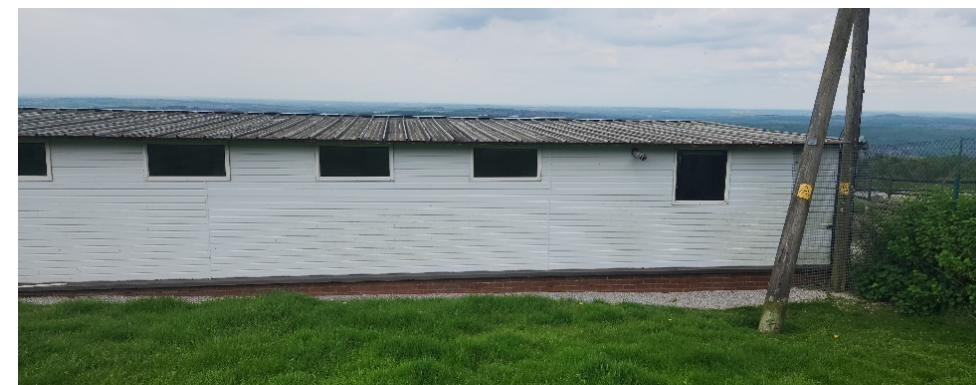
This section of the building follows a similar pattern of construction and largely assumed to be not designed structurally. Note that the reference image is not current, and the kennels are now vacated but the current structural arrangement generally is as indicated in this image.

2. Element number 2 denotes the location of the roof panels being supported on the external elevation, and in certain locations as indicated here, appearing to sit directly onto the window framing. The window framing is unlikely to have been designed to take this loading, and hence a non-compliant arrangement.

3. element number 3 denotes a part of the wall comprising apparently more insulated composite panels acting as vertical primary wall supports to the roof, also installed in their weaker axis. As discussed previously these panels are not ordinarily designed to provide primary structural support and hence a non-compliant arrangement.

4. Element number 4 denotes what appears to be blockwork walling constructed to the underside of the windows. Although the block work walling will be providing substantial structural gravity support, it is unlikely that the walls are compliant as they don't appear to be restrained at the head with any substantial steelwork. Partially built block work walls (also known as dado walls in portal frame sheds) usually require restraining at the head and are generally also not used for primary structural support as it appears to be in this case.

6. Similar to the arrangement described in section 1, element number 3, the Purlin noted above then appears to be taking support at regular locations defined by the partition between the kennels. Although the diagonal timber member providing support may not be all that unusual, the connection of the diagonal member into the steel profiled panel is questionable and unlikely to meet current codes of practice.

7. Element number 7 appears to be a non-compliant full height composite panel again laid on its weak axis providing primary structural support as well as acting as a partition wall.

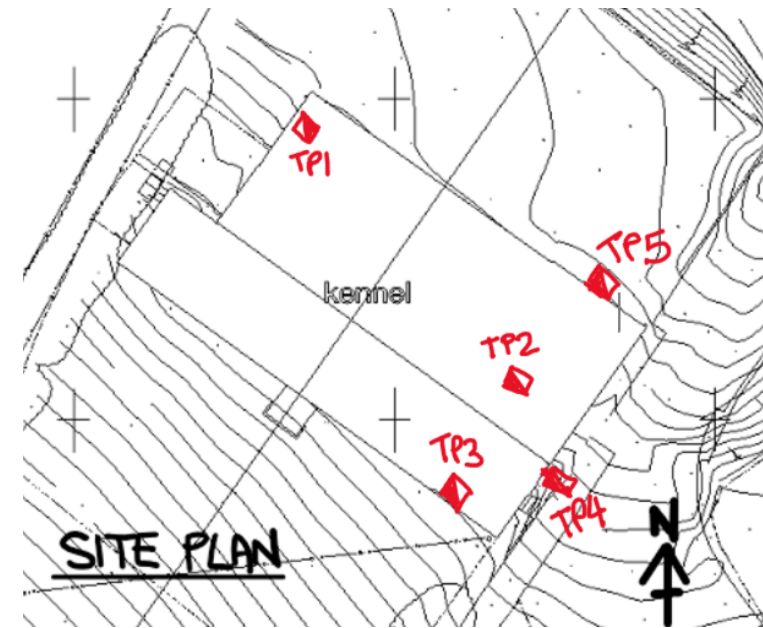
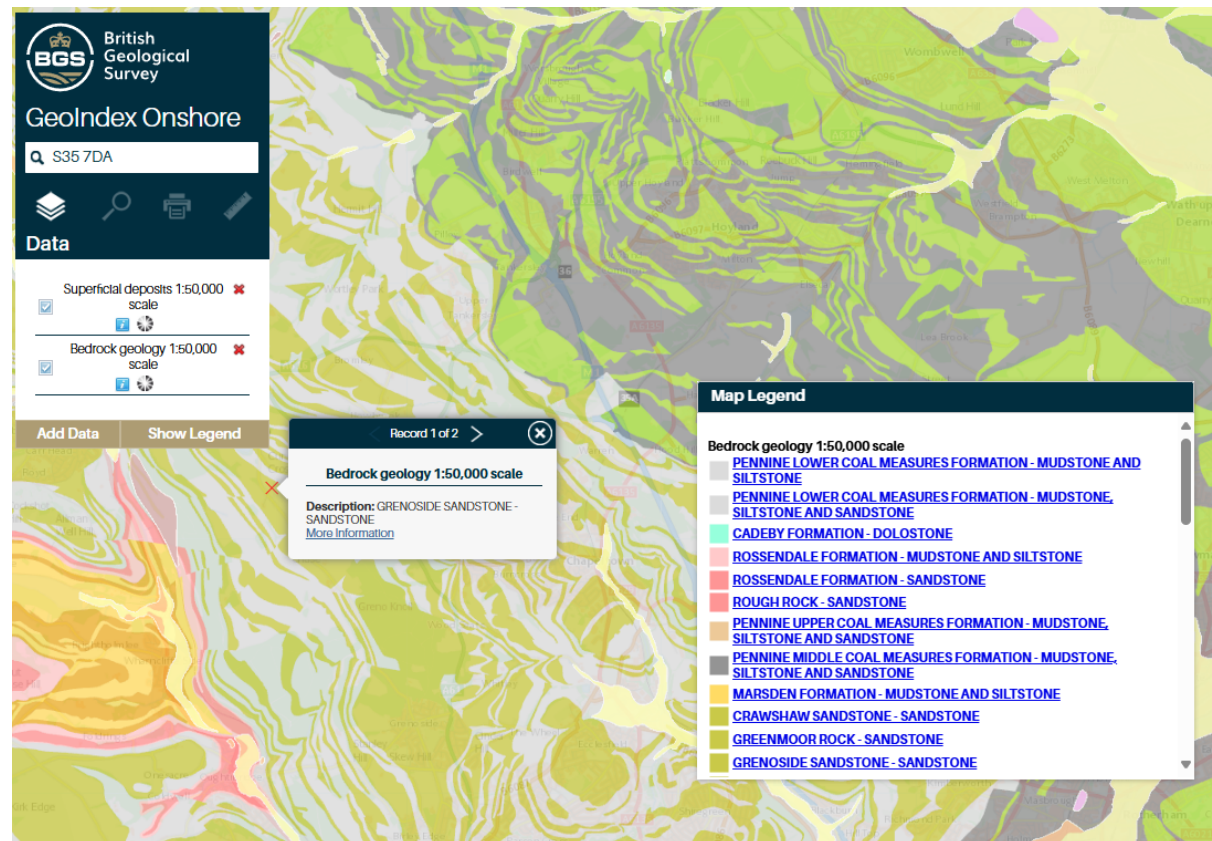
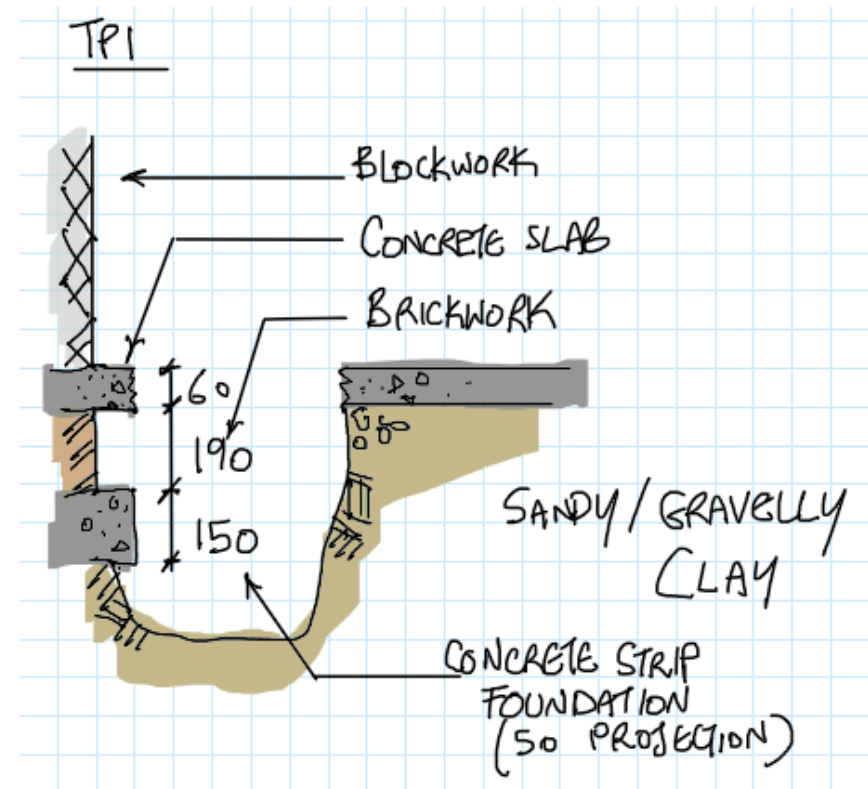
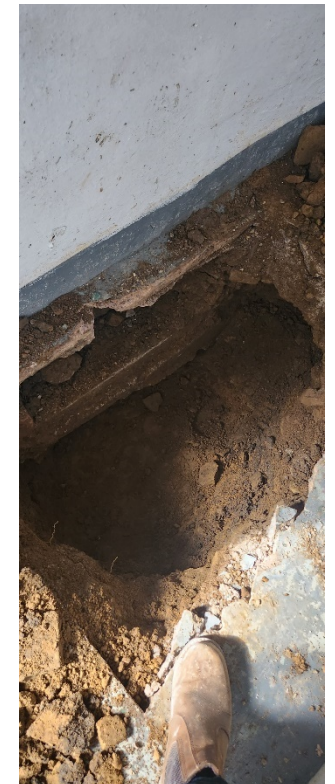
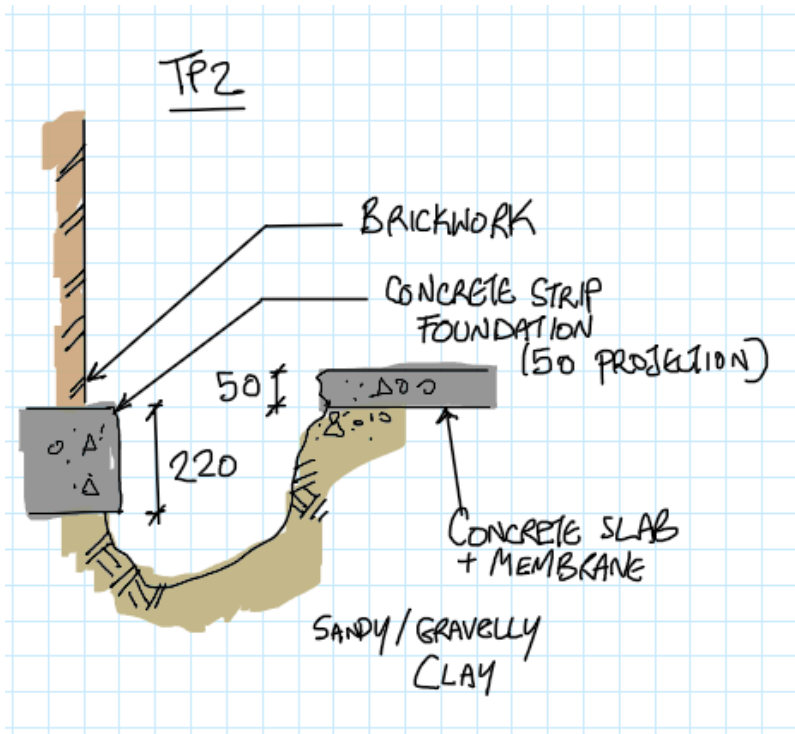
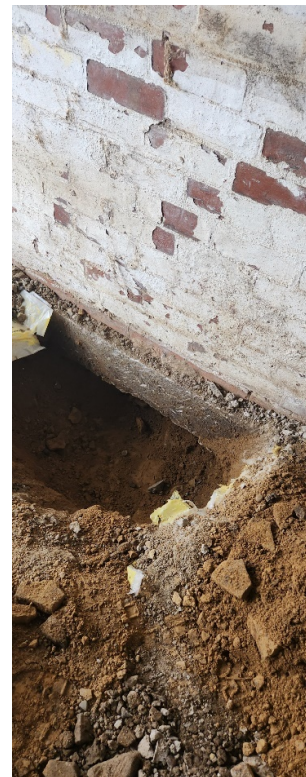
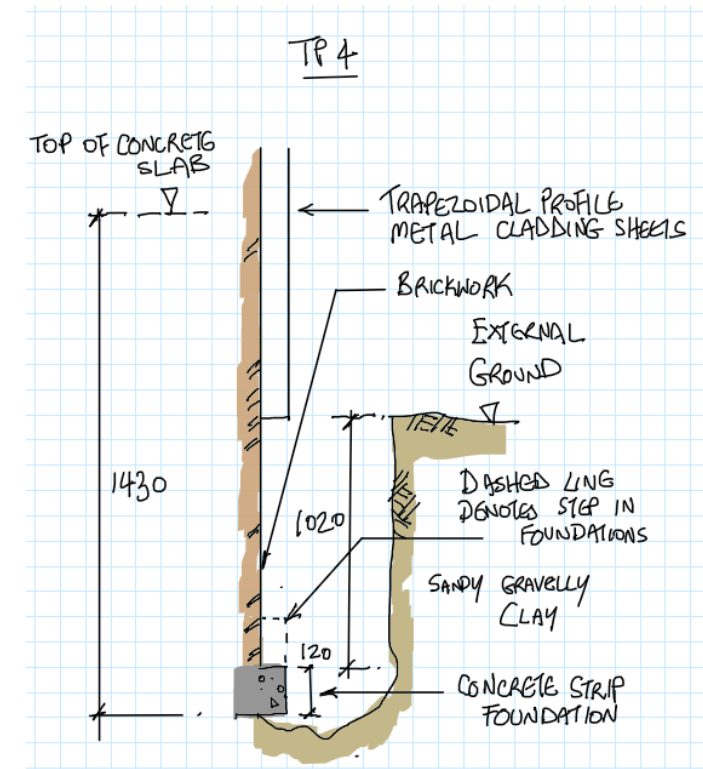
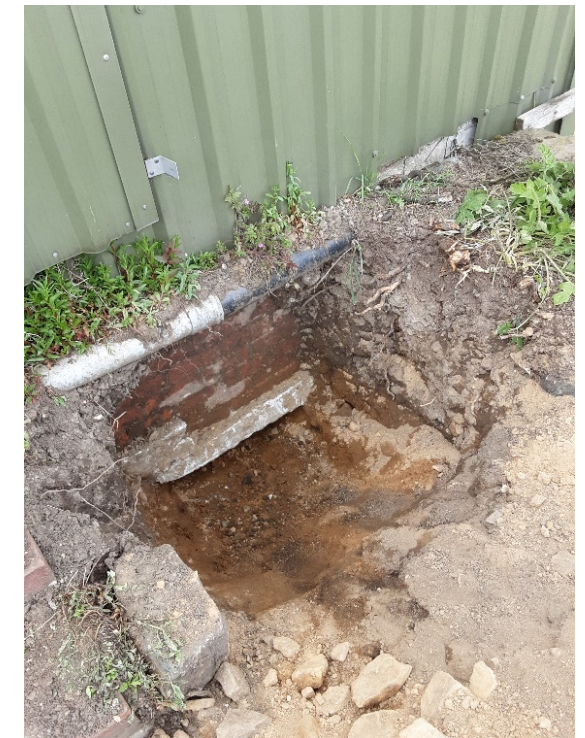
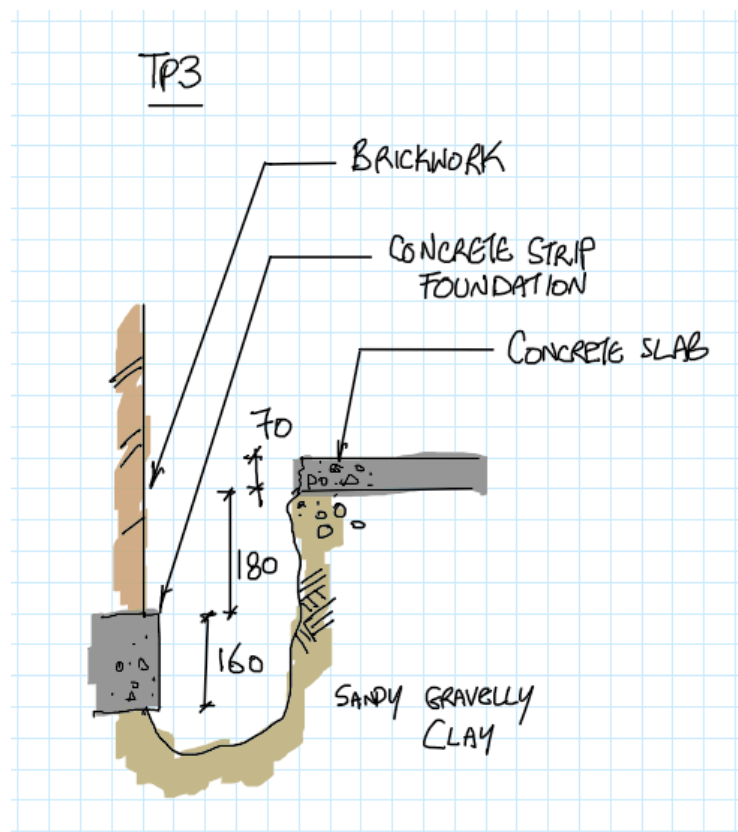
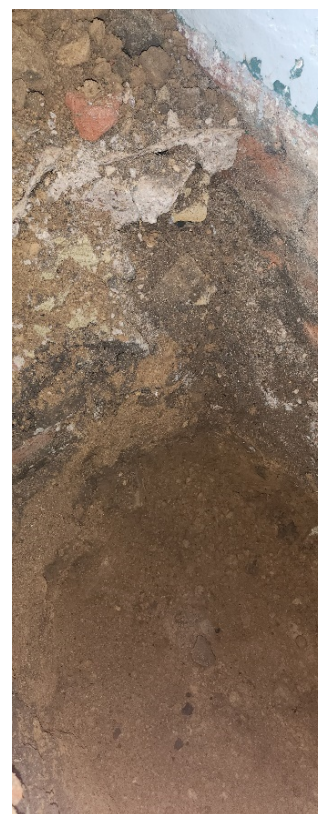
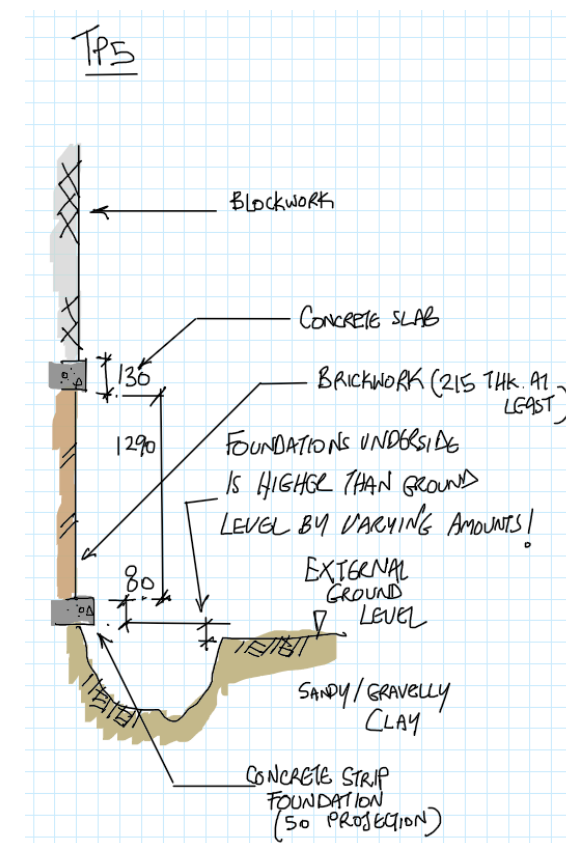
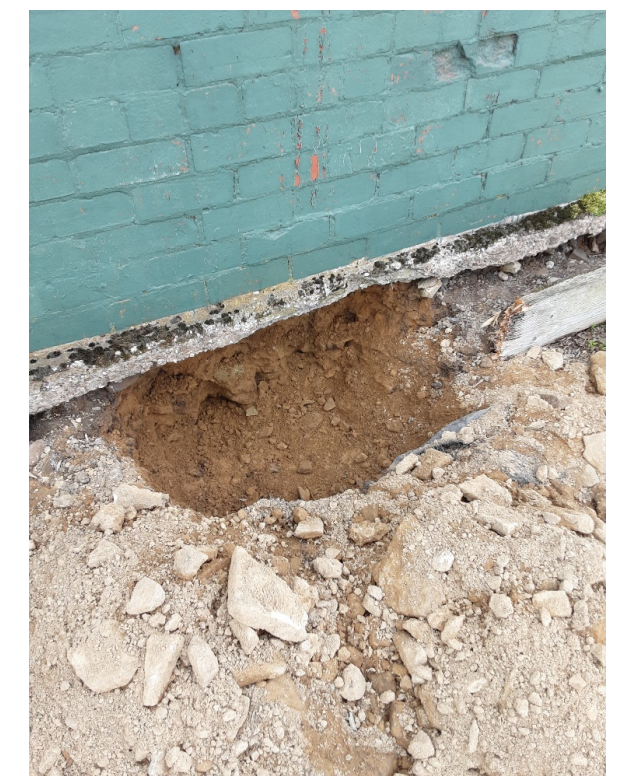
The observations indicated that the ground conditions are typically sandy/gravelly clay down to an approximate 1 to 1.5 m depth as observed in the various trial pits. There were signs of pieces of rock which would indicate potential rock further down. Indeed records from the British geological survey indicate sandstone bedrock in the locality as indicated in the image below.

The foundations were found mostly to consist nominal concrete strips in most locations including the internal retaining wall dividing sections 2 and 3 as indicated in the report.

Generally, the existing foundations are unlikely to be suitable for any modernisation of the existing arrangement. Indeed, they are likely to be inadequate or compliant to support the *current* structural arrangement. As discussed in the previous sections, a building of this scale ordinarily requires substantial supporting framework, usually steelwork which then necessitates at the very minimum mass concrete pad type foundations for columns of significantly larger sizes than the current arrangement. In a modern compliant steelwork portal shed arrangement (which would be the usual for this kind of building) there may be strip foundations present only to support non-structural short dado walls which act as cladding in between the primary structural steel framing.

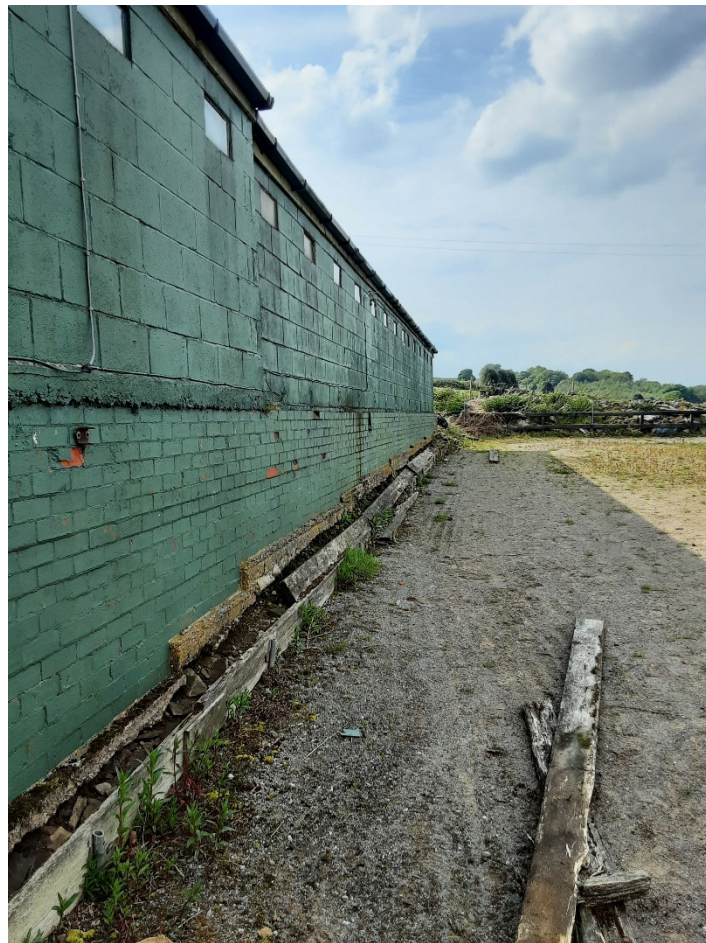
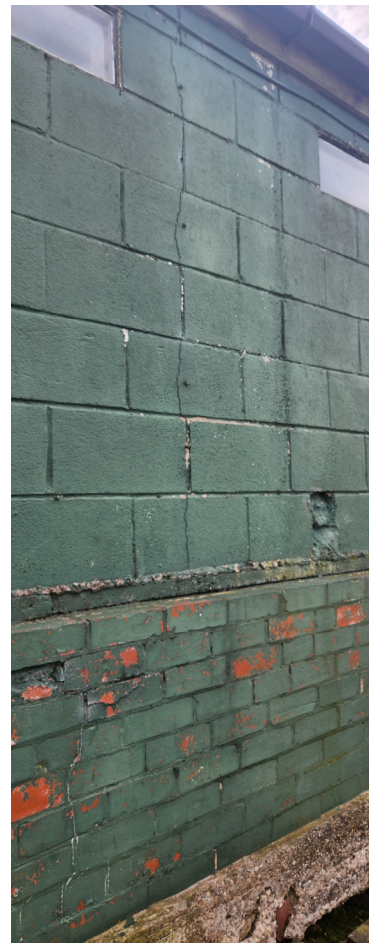
The north-east elevation displayed signs of soil wash out from under the foundations across its entire length. As can be seen in the image below and as indicated in trial pit number TP5 the underside of the foundation is actually at a higher level than the adjacent ground level.

Presumably, in order to avoid undermining the foundations under the building, it appears that timber shuttering was installed to confine a strip of adjacent soil due to the difference in levels. This indicates that the ground level adjacent was indeed likely to have been reduced either during construction of the building or after.

The timber shuttering as can be seen in the image has badly degraded to the extent that it has collapsed, and this has subsequently allowed the soil to migrate and wash out under the stepped strip foundation.

Although this hasn't led to any significant collapsing structure, it is an unstable situation which would require attention at the earliest opportunity to remediate. Indeed at the far end of the elevation it can be seen that the corner of the building has begun to subside as indicated by the stepped cracking in the images below.

- 4.6 Also to note significantly, the Northeast elevation of the building is experiencing soil washout under the foundations and requires attention at the earliest opportunity to stabilise the existing building.
