## STANCLIFFE HOUSE FARM, S35 7DA

### STRUCTURAL ASSESSMENT OF EXISTING BUILDING

YK0024-EMPACE-XX-XX-RP-S-0001

31/05/2024

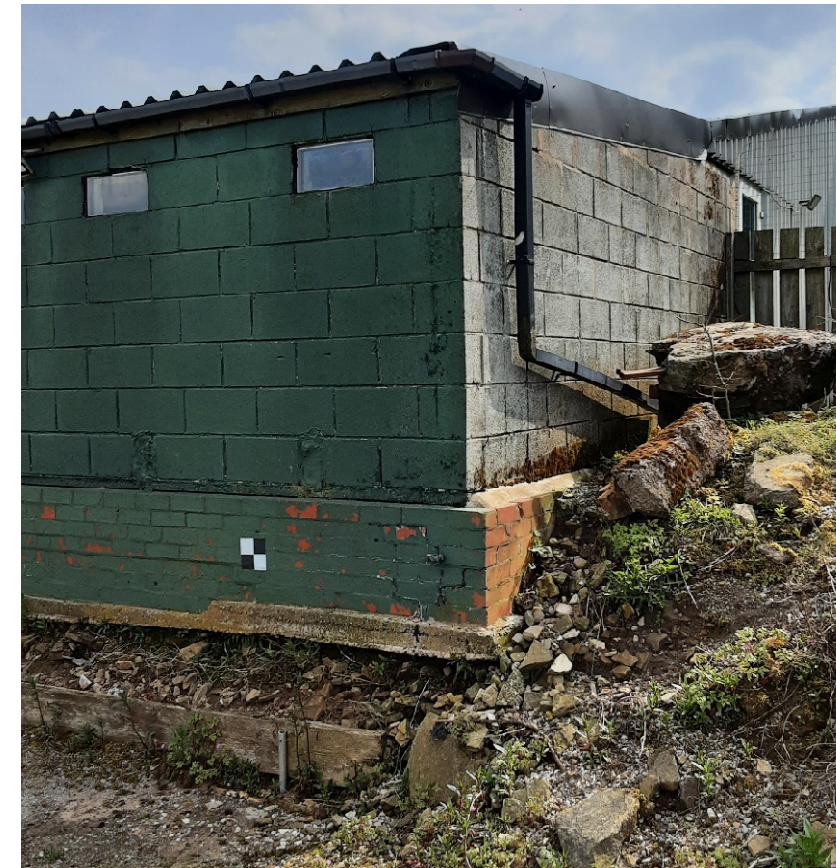
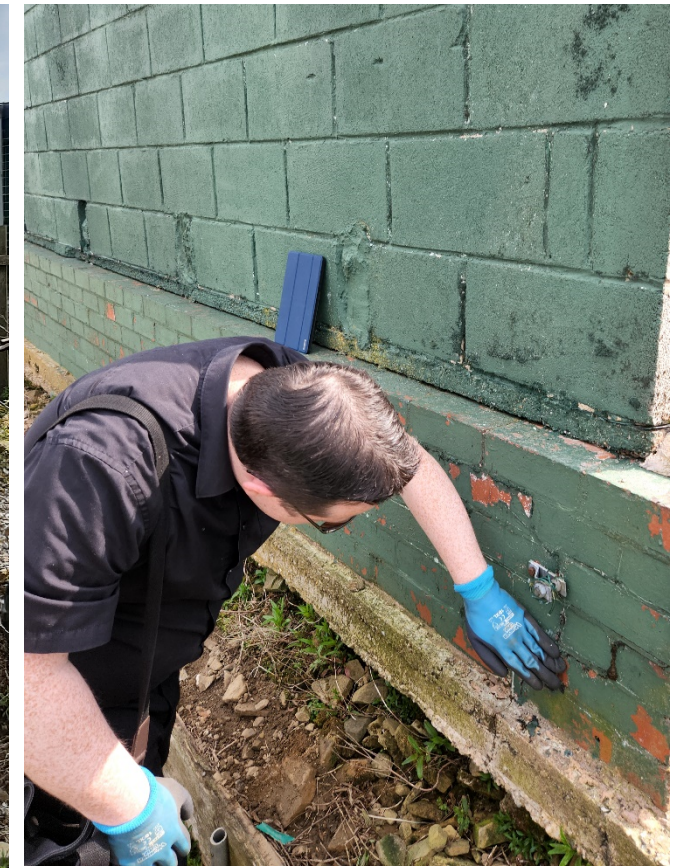
It is quite apparent that, there are no movement joints in the building. Ordinarily masonry requires movement joints at regular spacings. I.e. no more than a 6m horizontal length of blockwork and 9m of brickwork should be constructed without introducing a movement joint.

The lack of the movement joints has forced the building to create its own movement joint in the form of a vertical crack located at the longest continuous blockwork wall in the building, i.e. the Northeast elevation. The crack can be seen in the images below and runs vertically from the top down also including the brickwork wall below.
