**STRUCTURAL SURVEY REPORT**  
PRIVATE AND CONFIDENTIAL

**OFFICE BLOCK & SITE, FOUNDARY STREET,  
ELSECAR, S74 8EQ**

**30<sup>th</sup> May 2022**  
**Ref: HD-S22-0520**

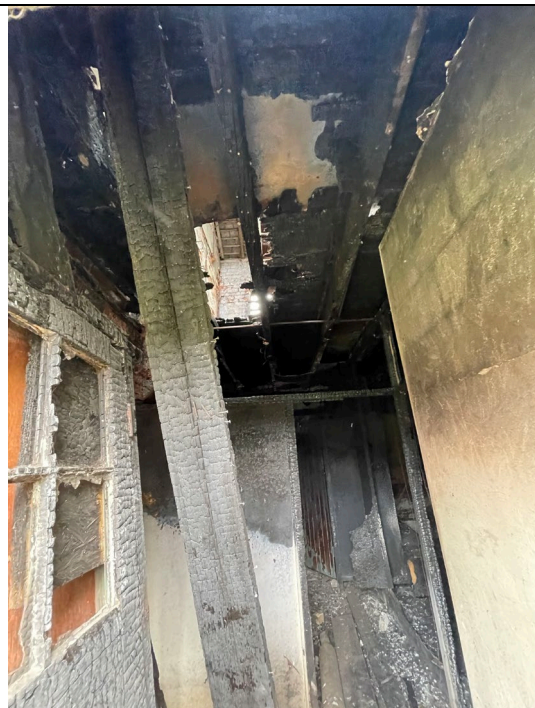
19. Main Building House Fire
