## **ASBESTOS SURVEY REPORT**

Report Number: OJS1050

Demolition Asbestos Survey

Workshops 1, 2, & 3  
Junction 38 Industrial Estate,  
Huddersfield Road,  
Darton,  
Barnsley,  
S75 5QQ

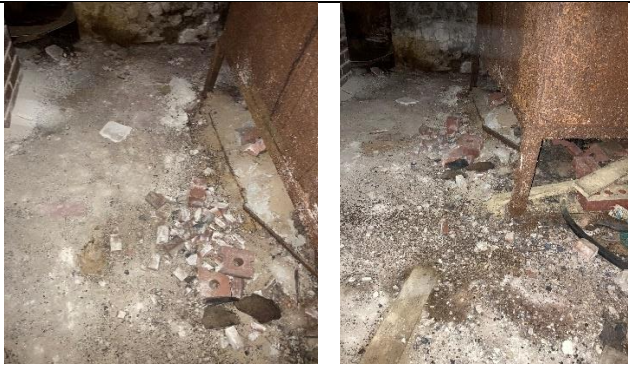
| Location | Client | Job No | Date of Survey | Surveyor |
|---|---|---|---|---|
| | | <p>Surveyors Comments</p> <p>Workshop 2 confined space area was inspected for asbestos containing materials. Samples were taken of the debris materials within this area. Analysis has not detected any asbestos within the debris throughout the basement.</p> | | |

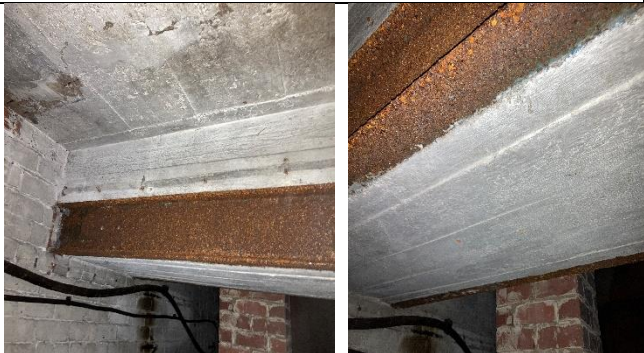
| Location | Client | Job No | Date of Survey | Surveyor |
|---|---|---|---|---|
| | | <b>Surveyors Comments</b><br><br>Workshop 2 confined space area was inspected for asbestos containing materials. Samples were taken of the cement product attached to the steel beams. Analysis has not detected any asbestos within this material. | | |

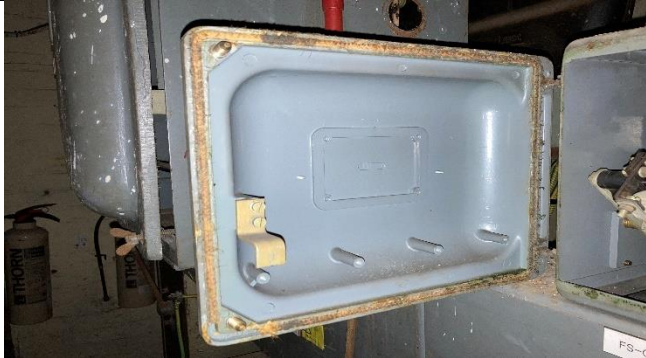
| Location | Client | Job No | Date of Survey | Surveyor |
|---|---|---|---|---|
| | | Workshop 2 electrical panels were inspected for asbestos containing materials. Samples were taken of the woven rope seal to doors. Analysis has not detected any asbestos within this material. | | |

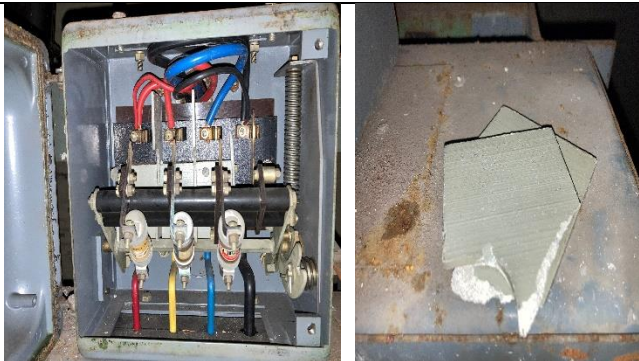
| Location | Client | Job No | Date of Survey | Surveyor |
|---|---|---|---|---|
| | | <p><b>Surveyors Comments</b></p> <p>Workshop 2 ground floor electrical panels were inspected for asbestos containing materials. Samples were taken of cement product separation fins within the panels. Analysis has detected Chrysotile (White) asbestos within this material. I would recommend that these are removed by a competent person under the Control of Asbestos Regulations 2012 once all electrics have been fully isolated by a qualified electrician.</p> | | |

| Material Description | Existing Protection<br>(Material sealed) | Daily Occupied | Susceptibility to Damage | Material Location | Total Points |
|---|---|---|---|---|---|
| 6 | 6 | 6 | 6 | 6 | 30 |

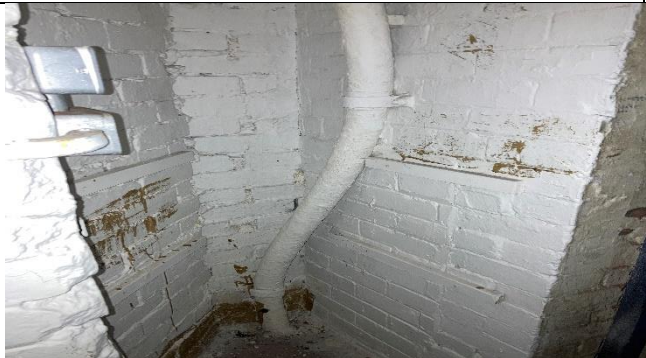
| Location | Client | Job No | Date of Survey | Surveyor |
|---|---|---|---|---|
| | | Workshop 2 electrical cable was inspected for asbestos containing materials. Samples were taken of the bituminous woven wrap. Analysis has not detected any asbestos within this material. | | |

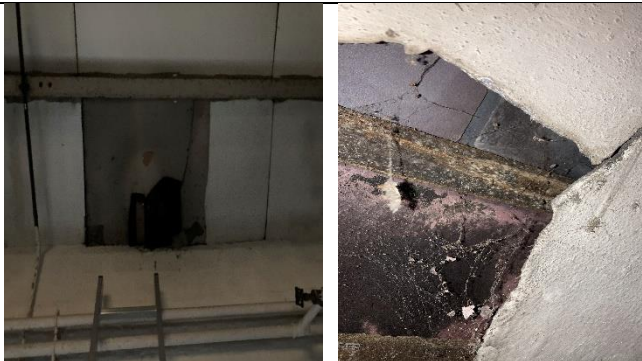
| Location | Client | Job No | Date of Survey | Surveyor |
|---|---|---|---|---|
| | | <p><b>Surveyors Comments</b></p> <p>Workshop 2 ceiling was inspected above the mezzanine floor for asbestos containing materials. Samples were taken of Cement product board underneath the insulating panels. Analysis has detected Chrysotile (White) asbestos with the cement board. I would recommend that all the cement boards are removed by a competent person under the Control of Asbestos Regulations 2012.</p> | | |

| Material Description | Existing Protection<br>(Material sealed) | Daily Occupied | Susceptibility to Damage | Material Location | Total Points |
|---|---|---|---|---|---|
| 6 | 6 | 6 | 6 | 6 | 30 |

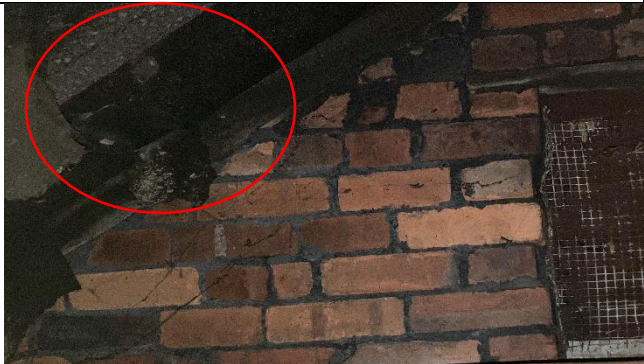
| Location | Client | Job No | Date of Survey | Surveyor |
|---|---|---|---|---|
| <p><b>Surveyors Comments</b></p> <p>Workshop 2 interior roof was inspected for asbestos containing materials. Samples were taken of the bituminous roofing felt. Analysis has not detected any asbestos within this material.</p> | | | | |

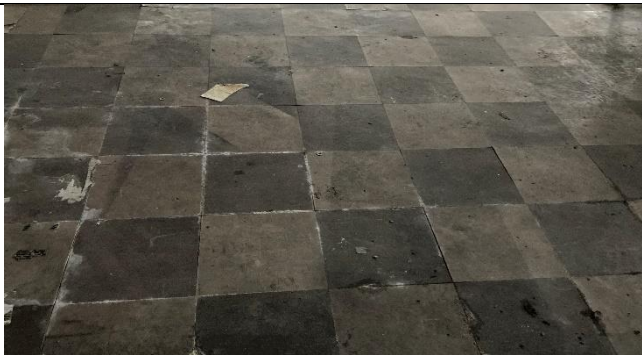
| Location | Client | Job No | Date of Survey | Surveyor |
|---|---|---|---|---|
| <p>Surveyors Comments</p> <p>Workshop 2 ground floor front office was inspected for asbestos containing materials. Samples were taken of the thermoplastic floor tiles. Analysis has detected Chrysotile (White) asbestos within the tile and adhesive. I would recommend that the floor tiles and adhesive are removed by a competent person under the Control of Asbestos Regulations 2012.</p> | | | | |

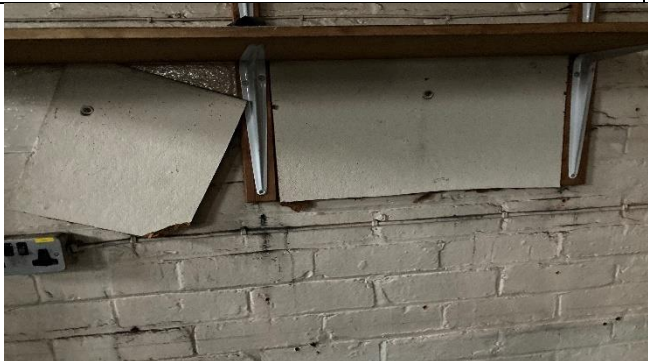
| Location | Client | Job No | Date of Survey | Surveyor |
|---|---|---|---|---|
| <p>Surveyors Comments</p> <p>Workshop 2 ground floor front office was inspected for asbestos containing materials. Samples were taken of the compressed fibre notice board. Analysis has not detected any asbestos within this material.</p> | | | | |

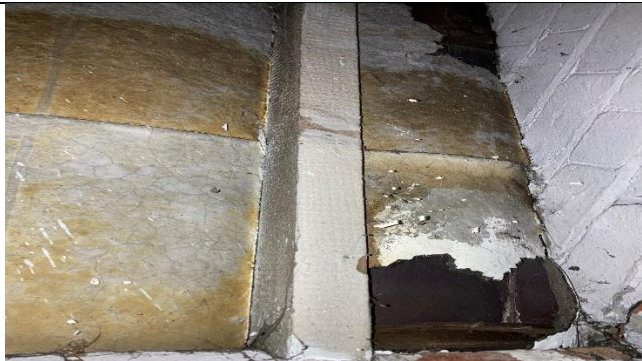
| Location | Client | Job No | Date of Survey | Surveyor |
|---|---|---|---|---|
| <p>Surveyors Comments</p> <p>Workshop 2 ground floor front entrance was inspected for asbestos containing materials. Samples were taken of the compressed fibre board to ceiling. Analysis has not detected any asbestos within this material.</p> | | | | |

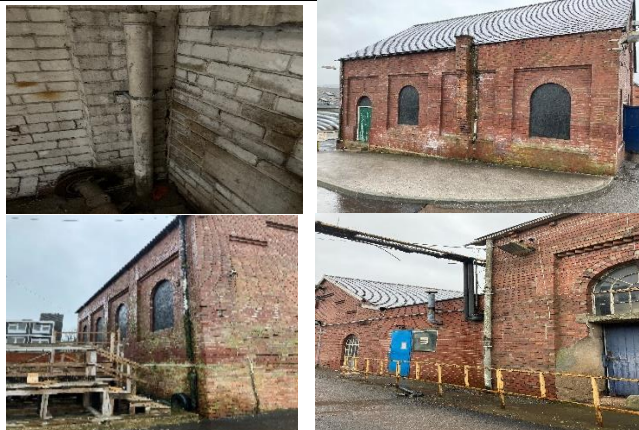
| Location | Client | Job No | Date of Survey | Surveyor |
|---|---|---|---|---|
| | | Surveyors Comments<br><br>All 3 workshops were inspected for asbestos containing materials. Samples were taken of cement product downpipes. Analysis has detected both Amosite (Brown) & Chrysotile (White) asbestos within these pipes. I would recommend that all the cement downpipes are removed by a competent person under the Control of Asbestos Regulations 2012 | | |

| Material Description | Existing Protection<br>(Material sealed) | Daily Occupied | Susceptibility to Damage | Material Location | Total Points |
|---|---|---|---|---|---|
| 6 | 6 | 6 | 6 | 6 | 30 |

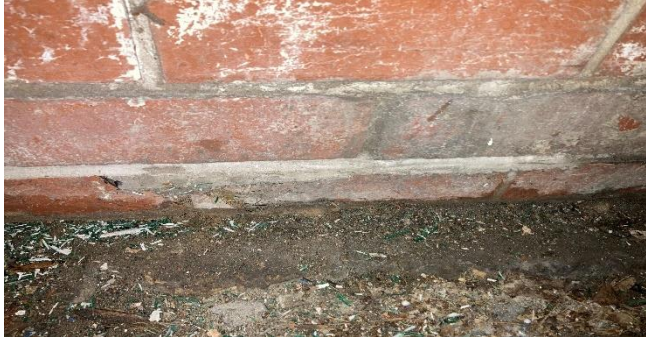
| Location | Client | Job No | Date of Survey | Surveyor |
|---|---|---|---|---|
| | Workshop 2 single storey building was inspected for asbestos containing materials. Samples were taken of the bituminous damp proof course from multiple locations. Analysis has not detected any asbestos within this material, however, the previous report has identified this material as positive therefore this material must be treated as containing asbestos and removed by a competent person under the Control of Asbestos Regulations 2012 | | | |

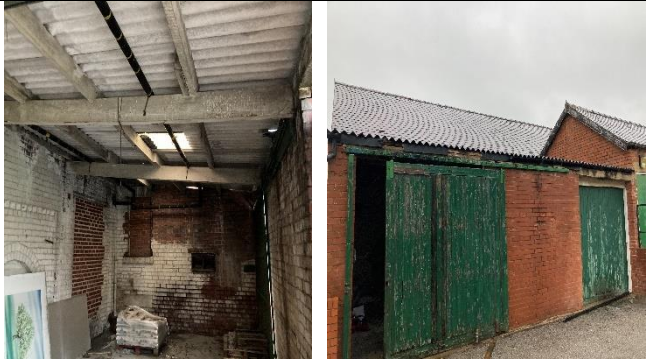
| Location | Client | Job No | Date of Survey | Surveyor |
|---|---|---|---|---|
| | | <b>Surveyors Comments</b><br><br>Workshop 2 single storey building was inspected for asbestos containing materials. Samples were taken of corrugated cement product roof sheets. Analysis has detected Chrysotile (White) asbestos within this material. I would recommend that this is removed by a competent person under the Control of Asbestos Regulations 2012. | | |

| Material Description | Existing Protection<br>(Material sealed) | Daily Occupied | Susceptibility to Damage | Material Location | Total Points |
|---|---|---|---|---|---|
| 6 | 6 | 6 | 6 | 6 | 30 |

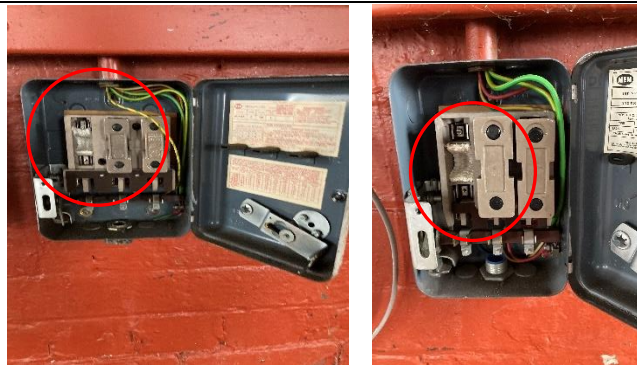
| Location | Client | Job No | Date of Survey | Surveyor |
|---|---|---|---|---|
| | | Surveyors Comments<br><br>Workshop 3 electrical panels were inspected for asbestos containing materials. Samples were taken of the white woven insulating material. Analysis has detected Chrysotile (White) asbestos within this material. I would recommend that these are removed by a competent person under the Control of Asbestos Regulations 2012. | | |

| Material Description | Existing Protection<br>(Material sealed) | Daily Occupied | Susceptibility to Damage | Material Location | Total Points |
|---|---|---|---|---|---|
| 8 | 6 | 6 | 6 | 6 | <b>32</b> |

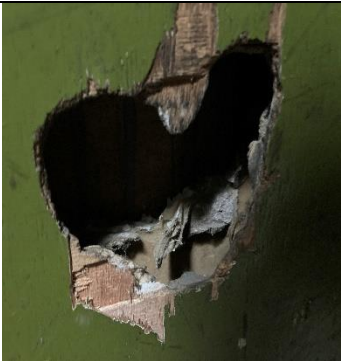
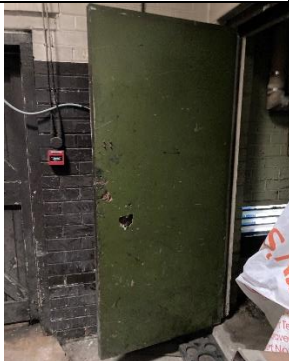
| Location | Client | Job No | Date of Survey | Surveyor |
|---|---|---|---|---|
| | | Surveyors Comments<br><br>Workshop 3 storeroom was inspected for asbestos containing materials. Samples were taken of the cement insulating board material within the fire door. Analysis has detected Chrysotile (White) asbestos within this material. I would recommend that the fire door is removed by a competent person under the Control of Asbestos Regulations 2012. | | |

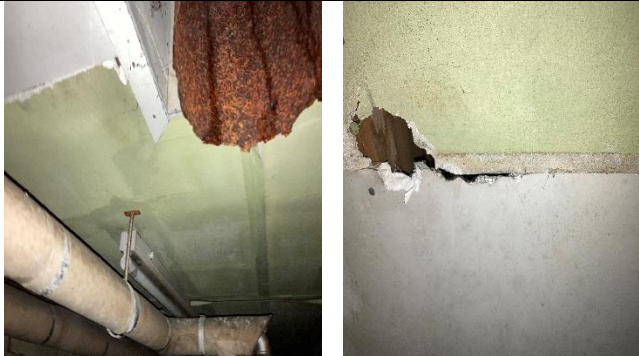
| Location | Client | Job No | Date of Survey | Surveyor |
|---|---|---|---|---|
| | | <b>Surveyors Comments</b><br><br>Workshop 3 storeroom was inspected for asbestos containing materials. Samples were taken of the insulating board material on the ceiling. Analysis has not detected any asbestos within this material. | | |

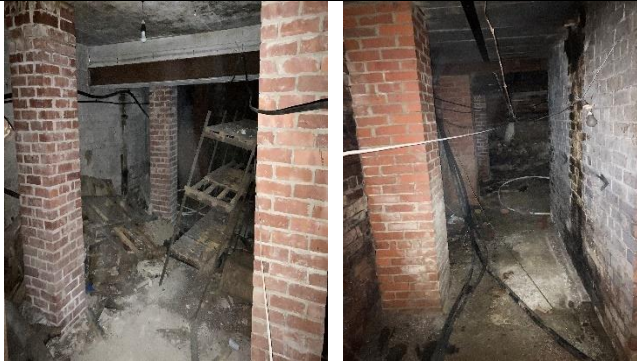
| Location | Client | Job No | Date of Survey | Surveyor |
|---|---|---|---|---|
| | | <p>Surveyors Comments</p> <p>Workshop 2 confined space was inspected for asbestos containing materials. No asbestos was detected within this area.</p> | | |

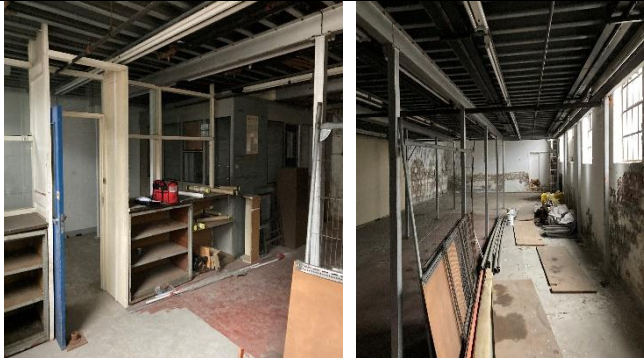
| Location | Client | Job No | Date of Survey | Surveyor |
|---|---|---|---|---|
| | | <p>Surveyors Comments</p> <p>Workshop 2 lower ground floor was inspected for asbestos containing materials. No asbestos was detected within the area.</p> | | |

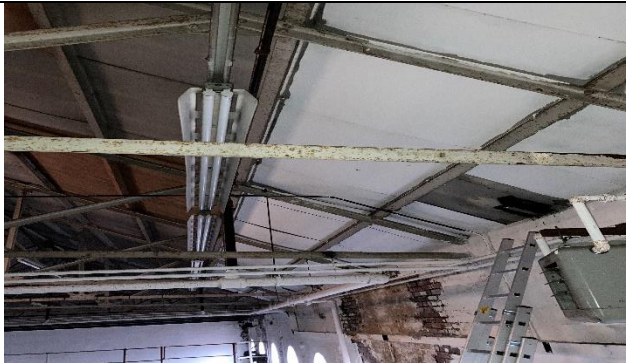
| Location | Client | Job No | Date of Survey | Surveyor |
|---|---|---|---|---|
| Workshop 2 interior roof void | NS003 | 85m <sup>2</sup> | Chrysotile | |

| Location | Client | Job No | Date of Survey | Surveyor |
|---|---|---|---|---|
| <p><b>Surveyors Comments</b></p> <p>Workshop 2 interior roof void was inspected for asbestos containing materials. As per sample number SP006 Chrysotile was detected within the cement product panels.</p> | | | | |

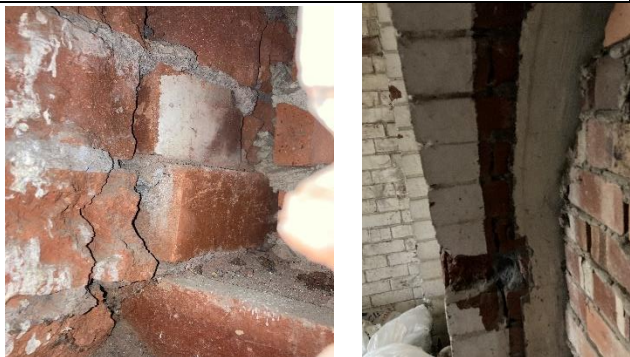
| Location | Client | Job No | Date of Survey | Surveyor |
|---|---|---|---|---|
| Cavity Wall | NS004 | N/A | NAD | |

| Location | Client | Job No | Date of Survey | Surveyor |
|---|---|---|---|---|
| | | Surveyors Comments<br><br>Cavity walls were inspected for asbestos containing materials. No asbestos was detected | | |

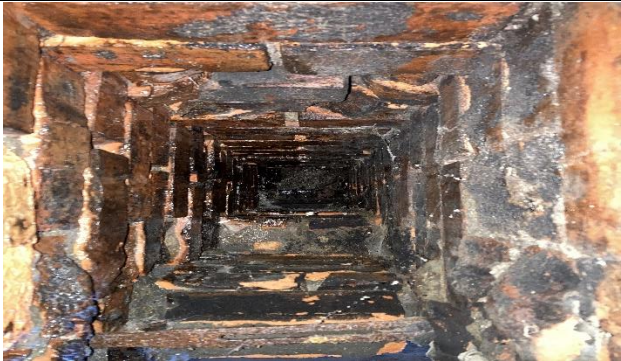
| Location | Client | Job No | Date of Survey | Surveyor |
|---|---|---|---|---|
| Workshop 1 Chimney | NS005 | 40m <sup>2</sup> | NAD | |

| Location | Client | Job No | Date of Survey | Surveyor |
|---|---|---|---|---|
| | | Workshop 1 chimney was inspected for asbestos containing materials. No asbestos was detected | | |

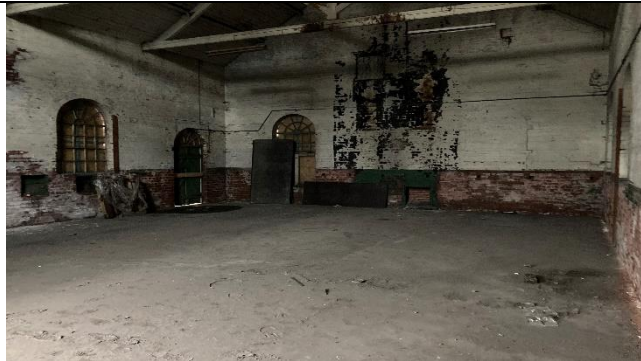
| Location | Client | Job No | Date of Survey | Surveyor |
|---|---|---|---|---|
| Workshop 1 | NS006 | 50m <sup>2</sup> | NAD | |

| Location | Client | Job No | Date of Survey | Surveyor |
|---|---|---|---|---|
| | Workshop 1 was inspected for asbestos containing materials. No asbestos was detected within main area. | | | |

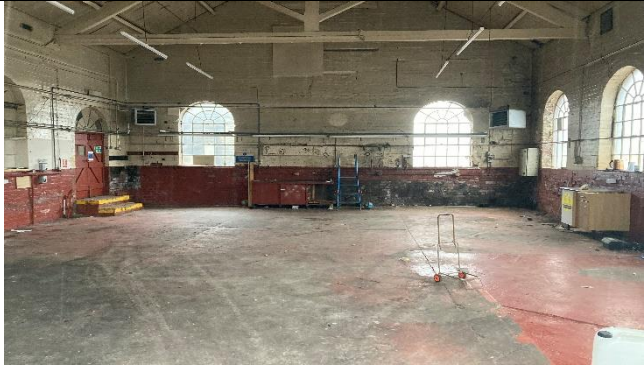
| Location | Client | Job No | Date of Survey | Surveyor |
|---|---|---|---|---|
| | | <p>Surveyors Comments</p> <p>Workshop 3 was inspected for asbestos containing materials. No asbestos was detected within the main area.</p> | | |

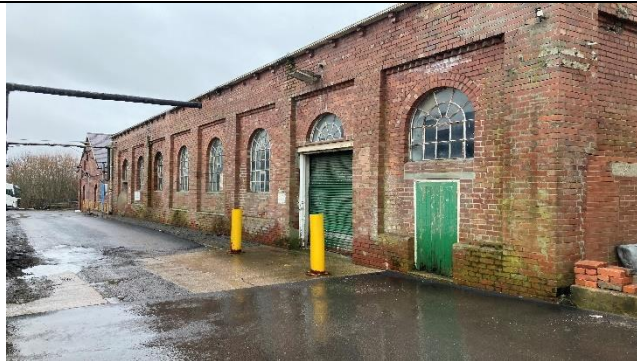
| Location | Client | Job No | Date of Survey | Surveyor |
|---|---|---|---|---|
| | | Surveyors Comments<br><br>Exterior off all workshops were inspected for asbestos containing materials. As per sample number SP011 there are multiple waste downpipes and as per sample number SP013 there is corrugate cement roof sheets to single storey building. | | |

| Material Description | Existing Protection<br>(Material sealed) | Daily Occupied | Susceptibility to Damage | Material Location | Total Points |
|---|---|---|---|---|---|
| 6 | 6 | 6 | 6 | 6 | 30 |
