Ref: AWA1940

Arboricultural Report for Homebuyers

at:
***Sycamore Cottage, 38 Ingbirchworth Road,
Thurlstone, Barnsley, S36 9QN***

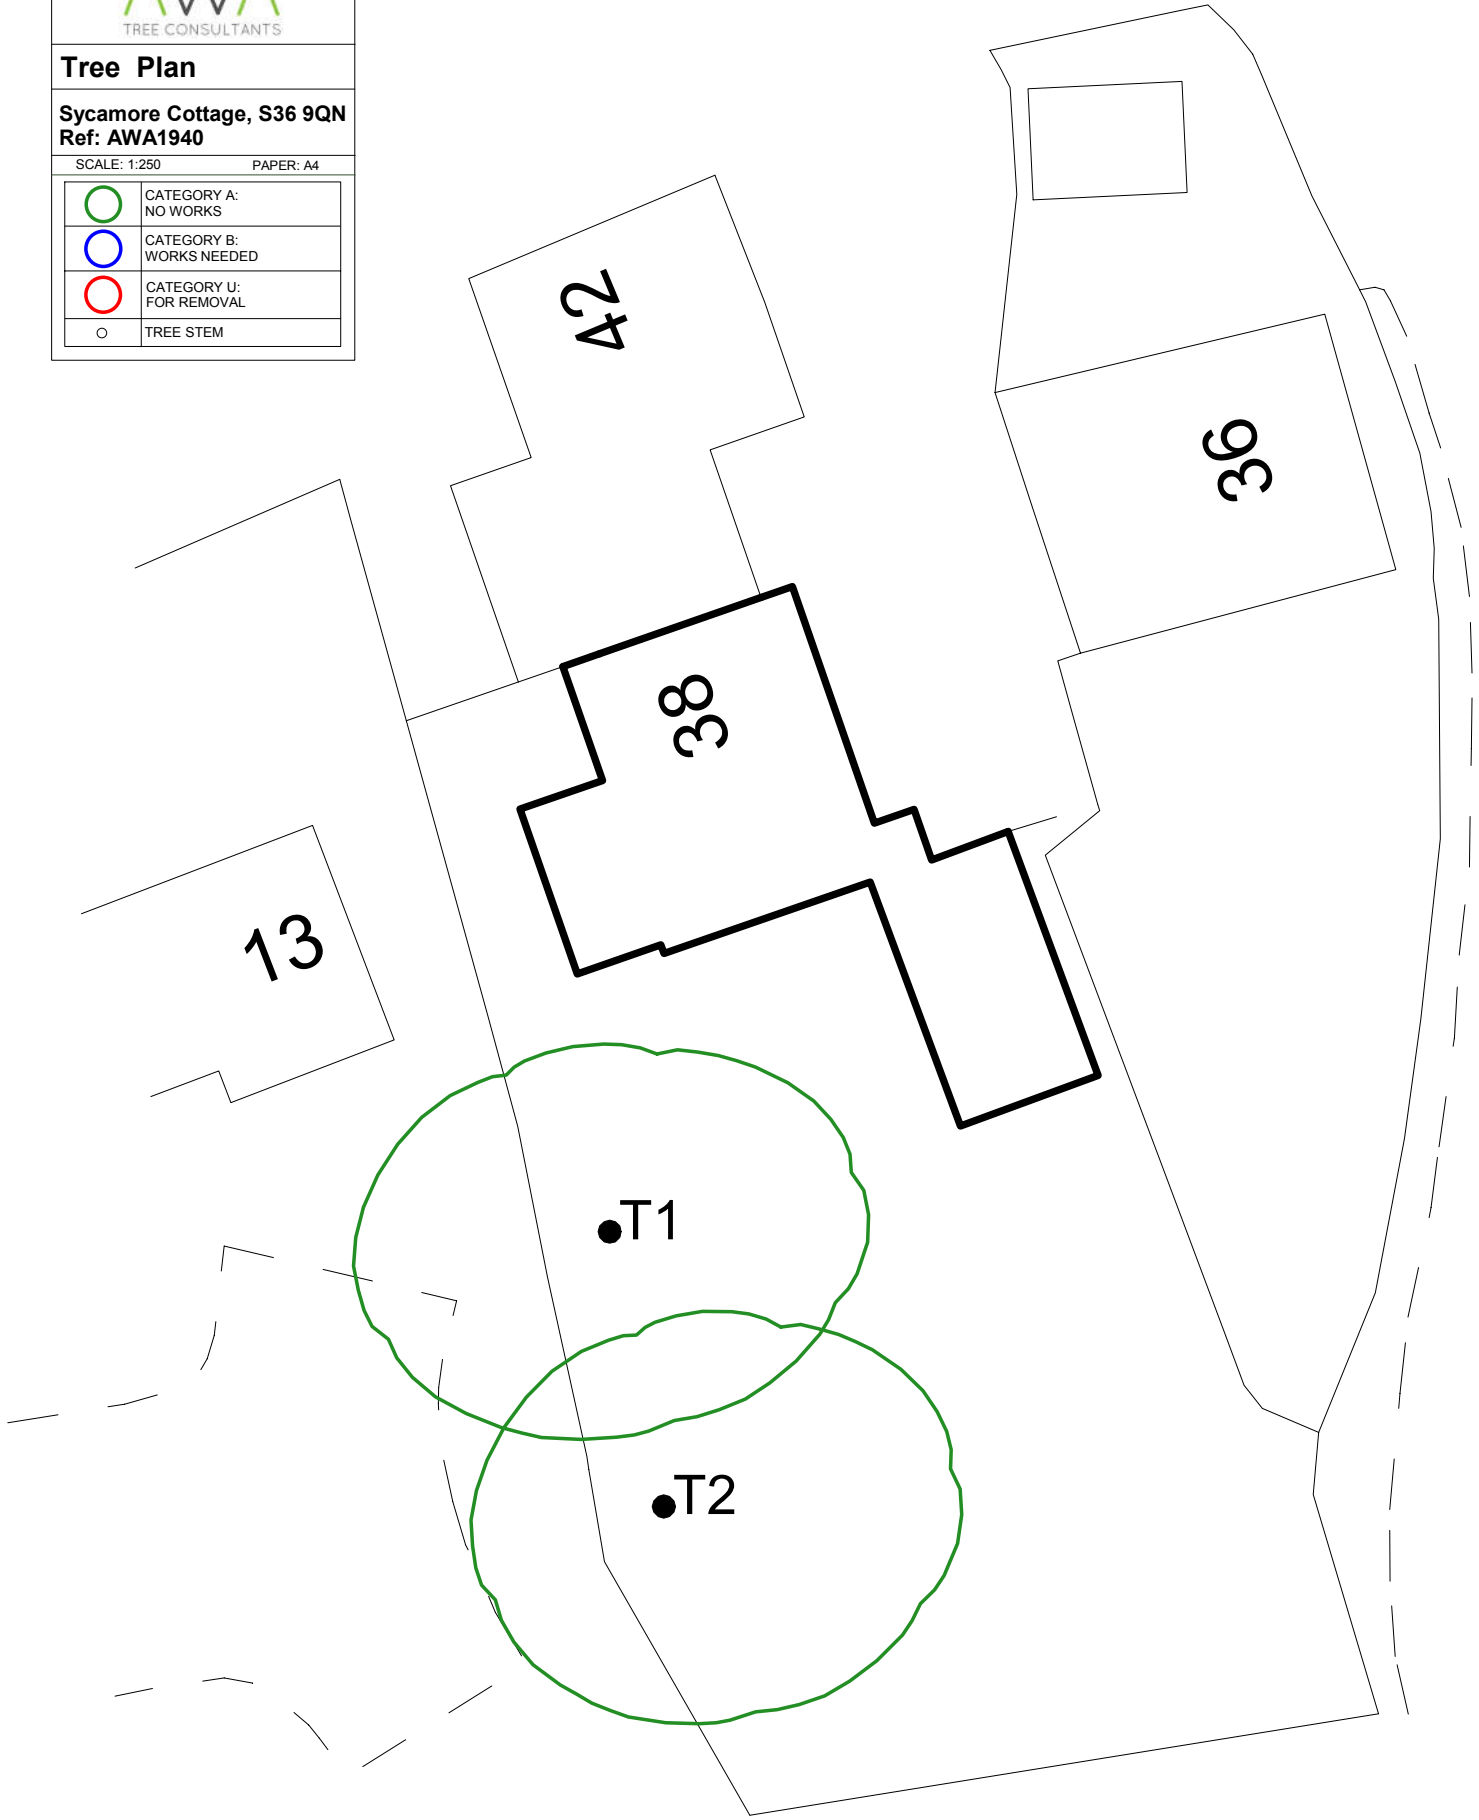
Tree Plan

The property is stone residential dwelling with courtyard to the front and lawn garden to the rear. The rear garden contains two significant trees, numbered **T1** and **T2** on the attached plan. Other less significant vegetation was not surveyed in detail in this instance.
