**RE: Bolton Hall Nursing Home, Carr Head Lane, Rotherham (Application Number 2016/0926)**

On the morning of Thursday 6<sup>th</sup> April 2017, Bell Munro Consulting Limited visited the site known as Bolton Hall Nursing Home, Rotherham to conduct a highway condition survey in accordance with planning condition number 8 of planning application number 2016/0926.

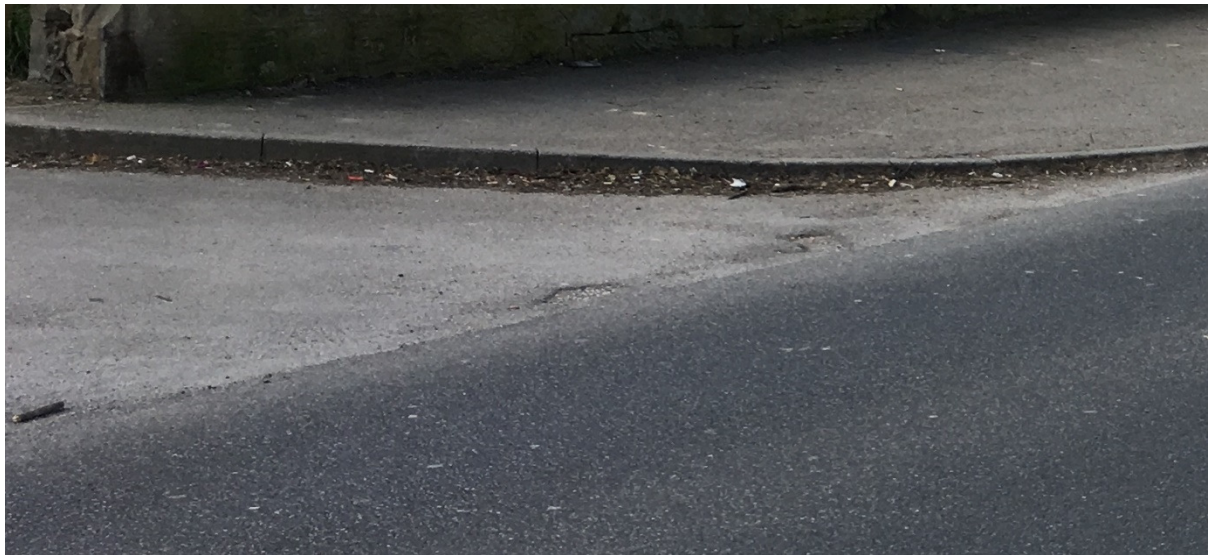
No major defects of the road surface were visible. Two small areas of surface abrasions (figure 2) that have stripped off the top layer of asphalt were noted however this area is to be re-surfaced as part of the S278 works that will be undertaken as part of the overall scheme. Some patching of the existing entrance appears to have been made as seen in figure 3, however this area is to be re-surfaced during the works. Kerbs at the bell mouth are of upstand construction with no allowance for dropped kerbs for pedestrian access, again, refer to figure 3. Incoming water manhole covers are present (shown in figure 3) in the footway adjacent the site entrance (Eastern side) and appear to be in good condition. A boundary wall shown in figure 4 has damage most likely from vehicular impact in the past. However, this wall is to be replaced as part of the works.

*Figure 2 Signs of Surface Abrasion*

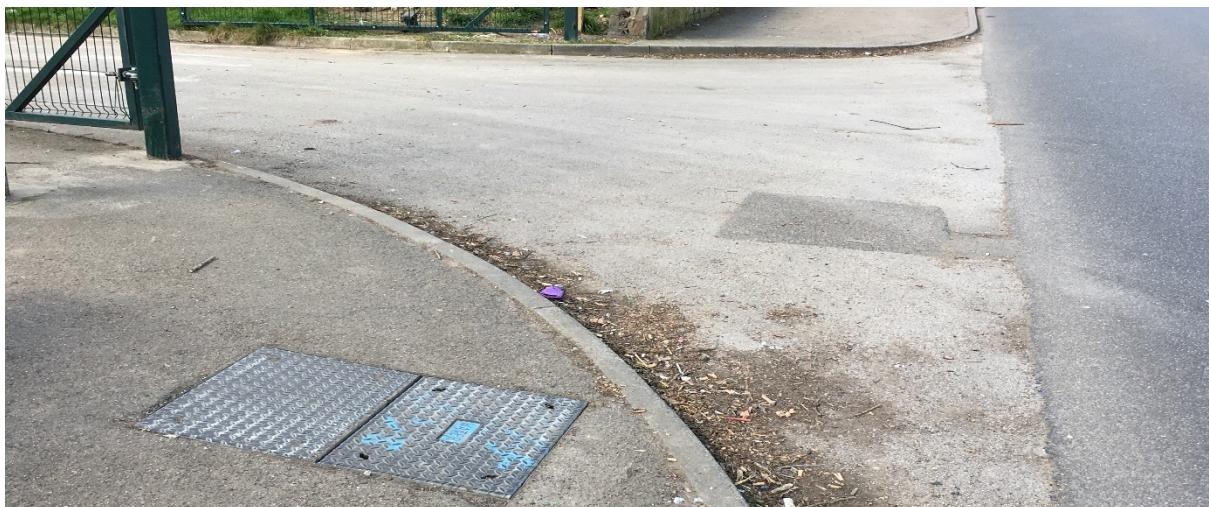
*Figure 3 Bell Mouth Overview*

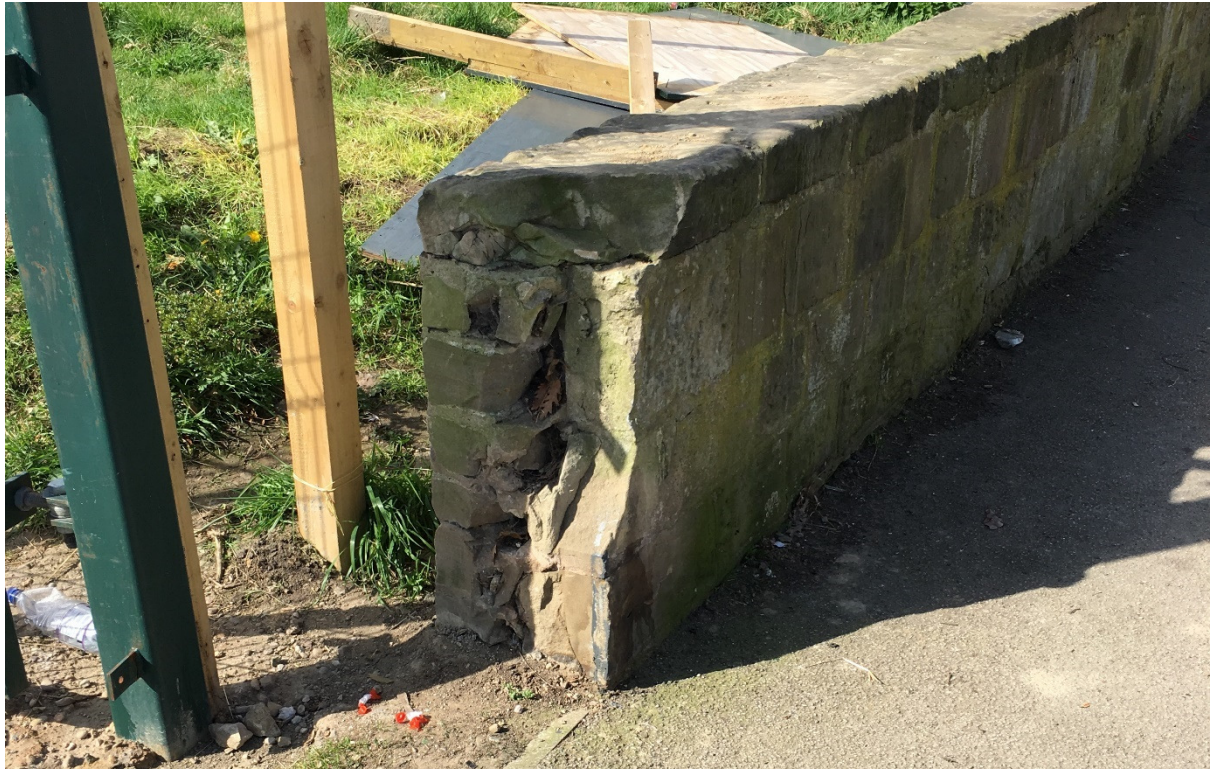
*Figure 4 Wall Damage*

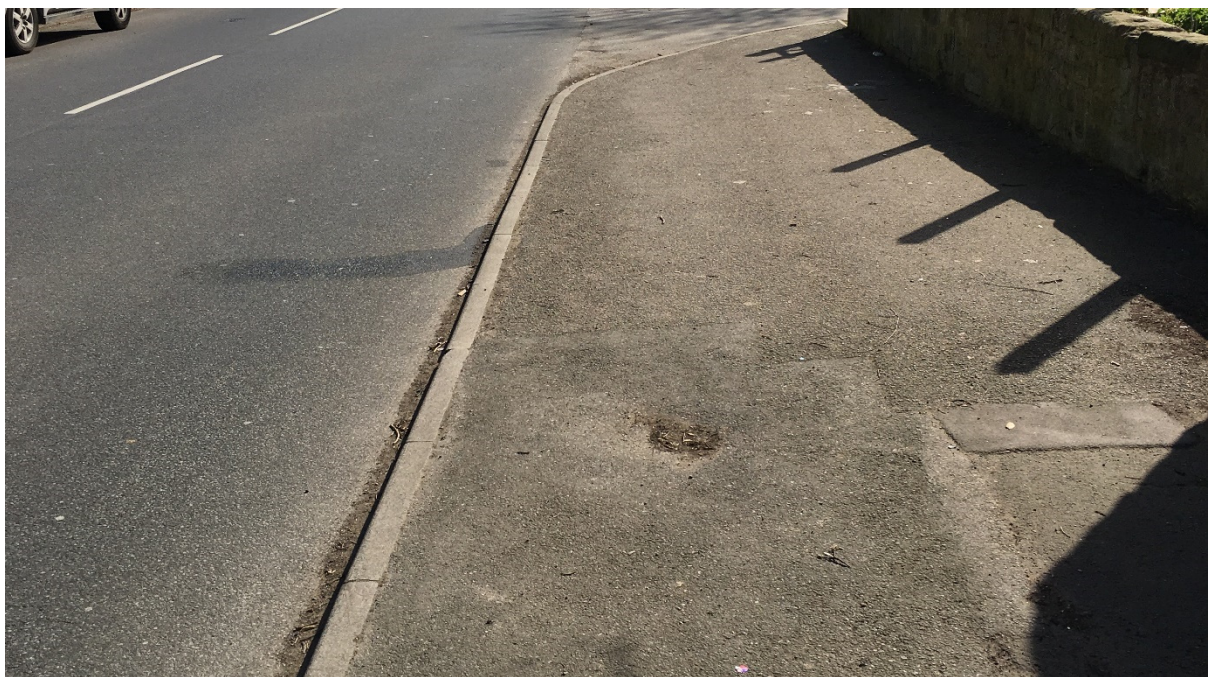
No defects along the Eastern side of area 1 were noted. The kerbs appear to be of max 25mm upstand in this area as shown in figure 5. The highways surface at the Western side of area 1 was in generally good condition. A sunken gully was noted in this area seen in figure 6. Again, kerb upstands of max

*Figure 5 Eastern Side of Bell Mouth (Area 1)*

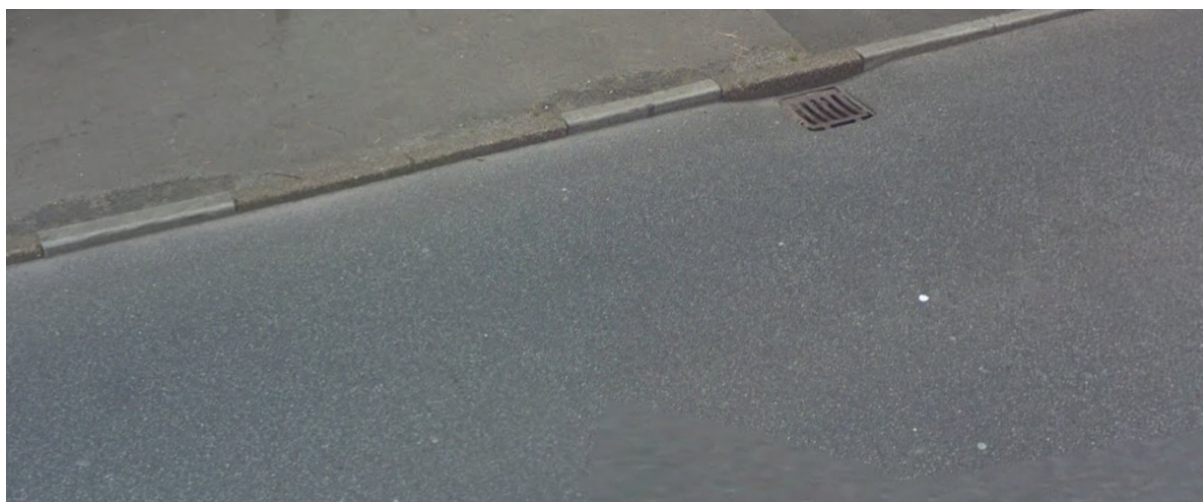
25mm were noted, as well as some obvious replacements, as well as footway surface patching shown in figure 6. A general observation of dirt and tree foliage was noted at the interface between the highway surface and kerb face along the Eastern side.

*Figure 6 Sunken Road Gully*

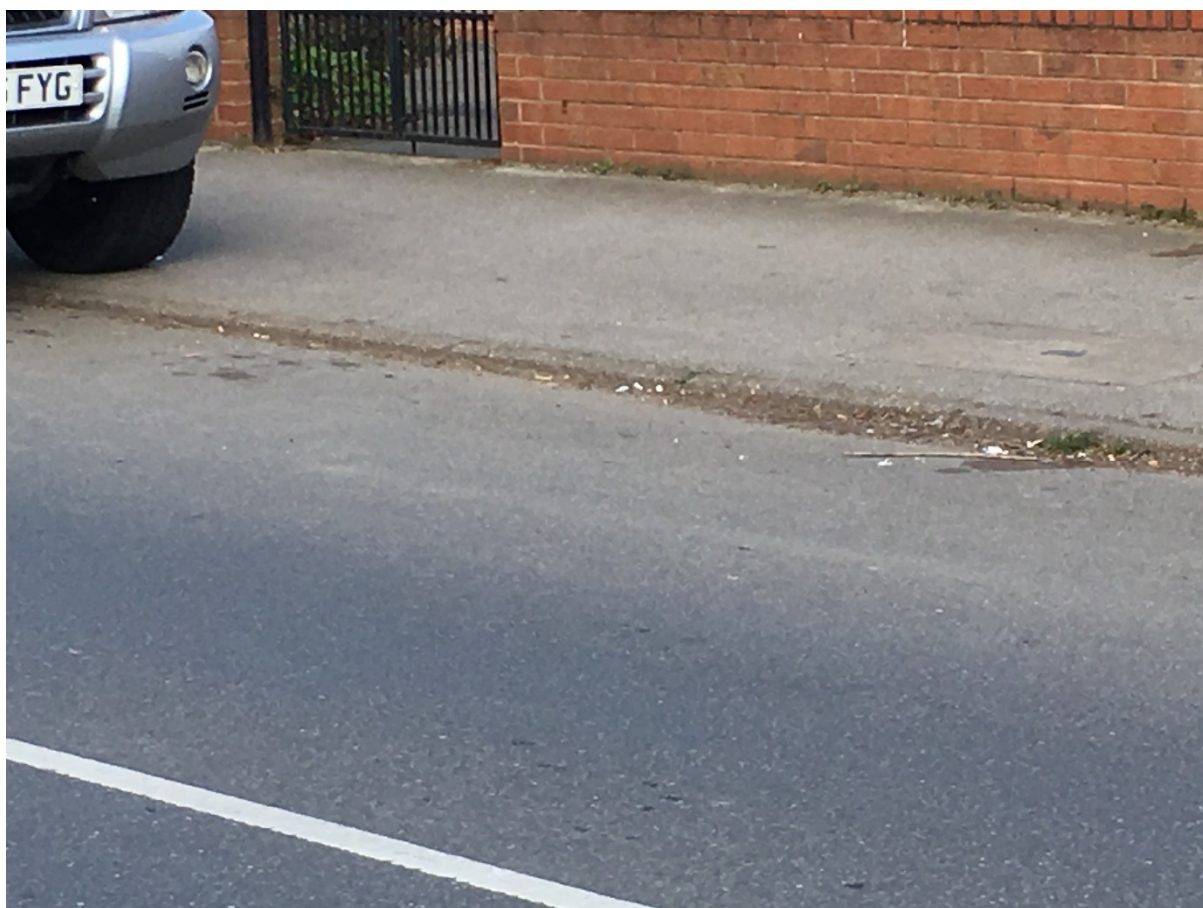
No defects were noted within the highway surfacing. Kerbs were generally of 25mm upstand, and in relatively good condition as shown in figure 7. Some patching of the footway was noted, but was in good condition as shown in figure 8. An entrance to a funeral home shows signs of degraded tactile paving shown in figure 9. A general observation of dirt and tree foliage was noted at the interface between the highway surface and kerb face.

*Figure 7 General road and kerb condition*

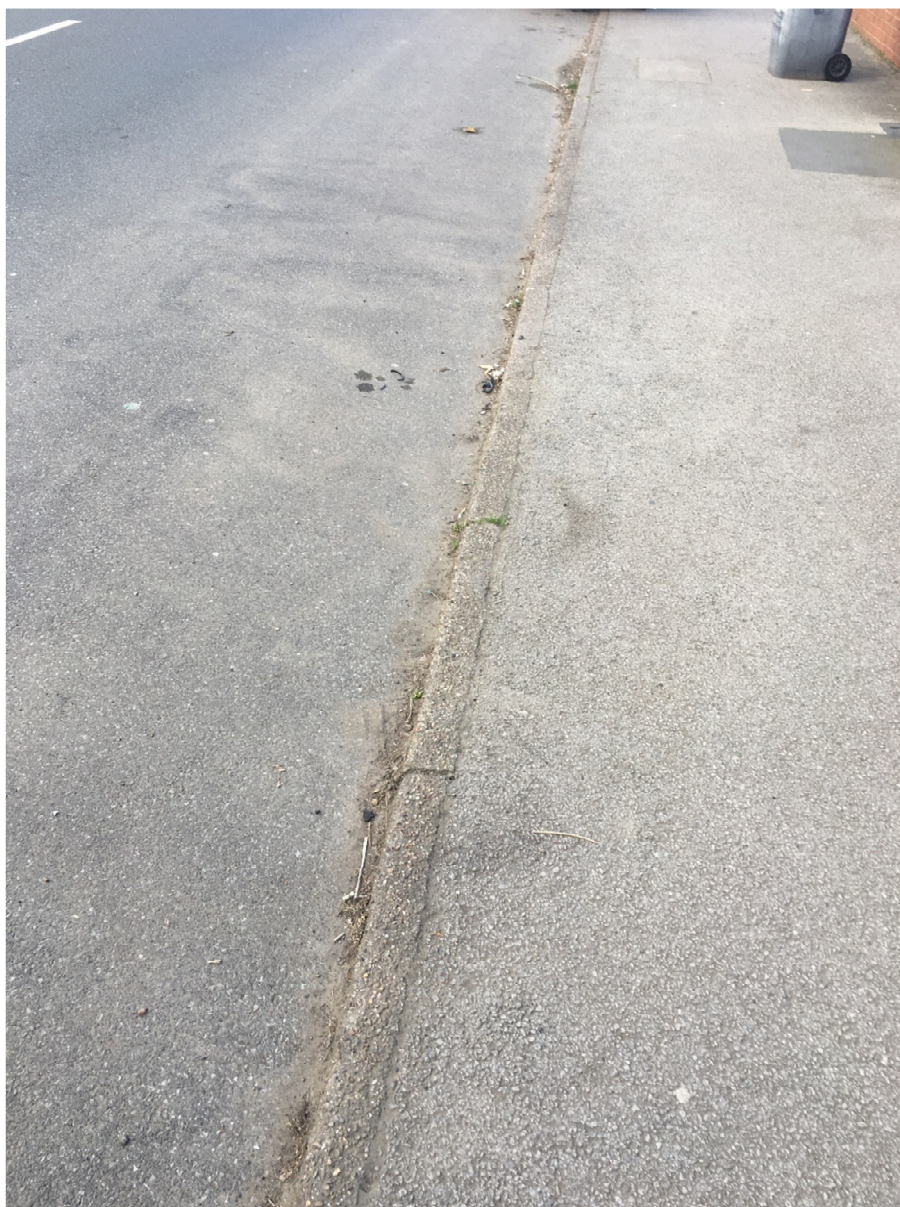
*Figure 8 General condition showing areas of patching in footway*

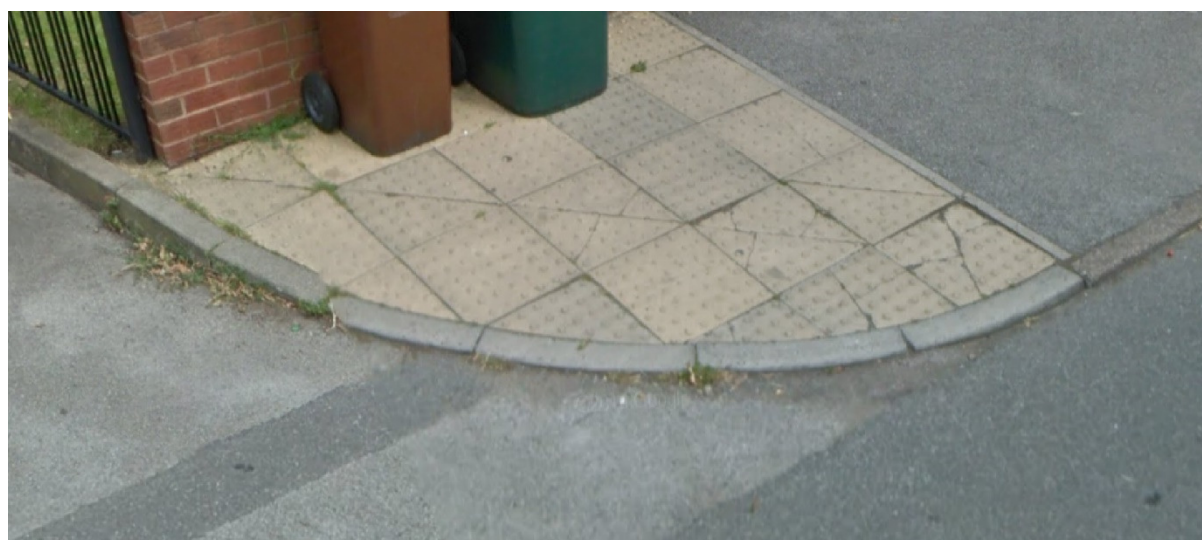
*Figure 9 Tactile pavements showing signs of degradation*

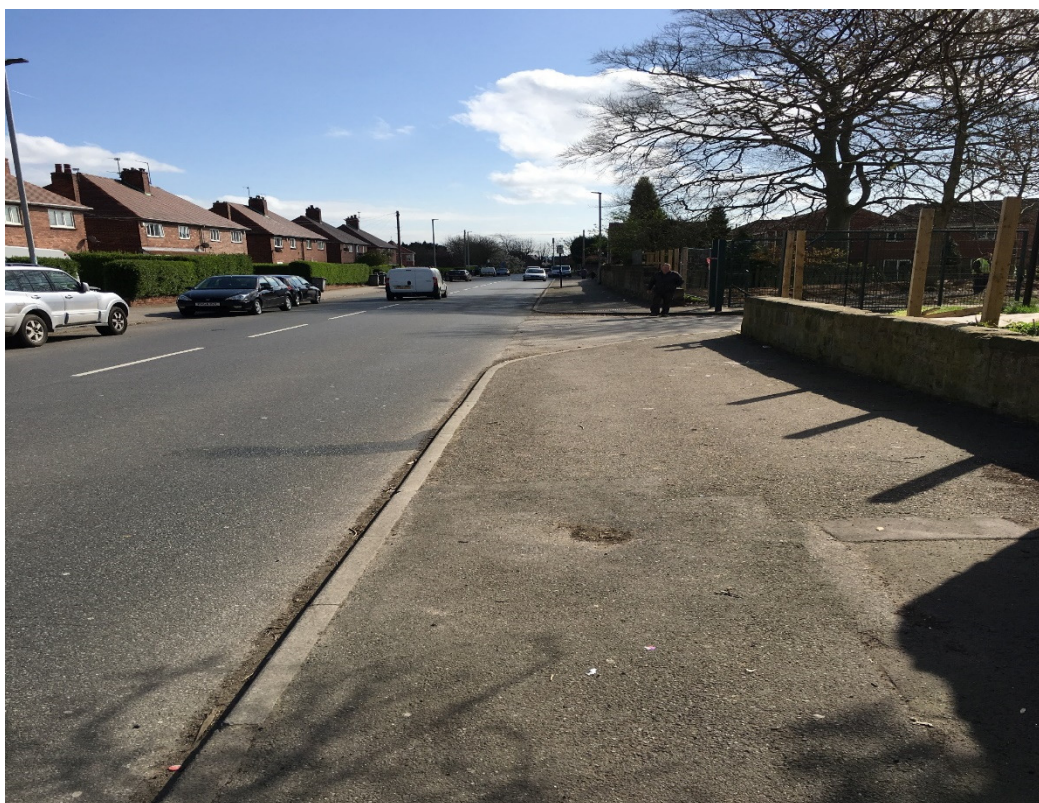
It was noted that local residents park along the roadside mainly on the East bound carriageway, an example of this traffic is shown in figures 10 and 11. A majority of this traffic was there temporarily and would likely be people accessing the local amenities. However, it is also likely that some of the vehicles that park on the road side belong to the residents of the properties opposite the site.

*Figure 10 View of parked vehicles looking Eastbound*

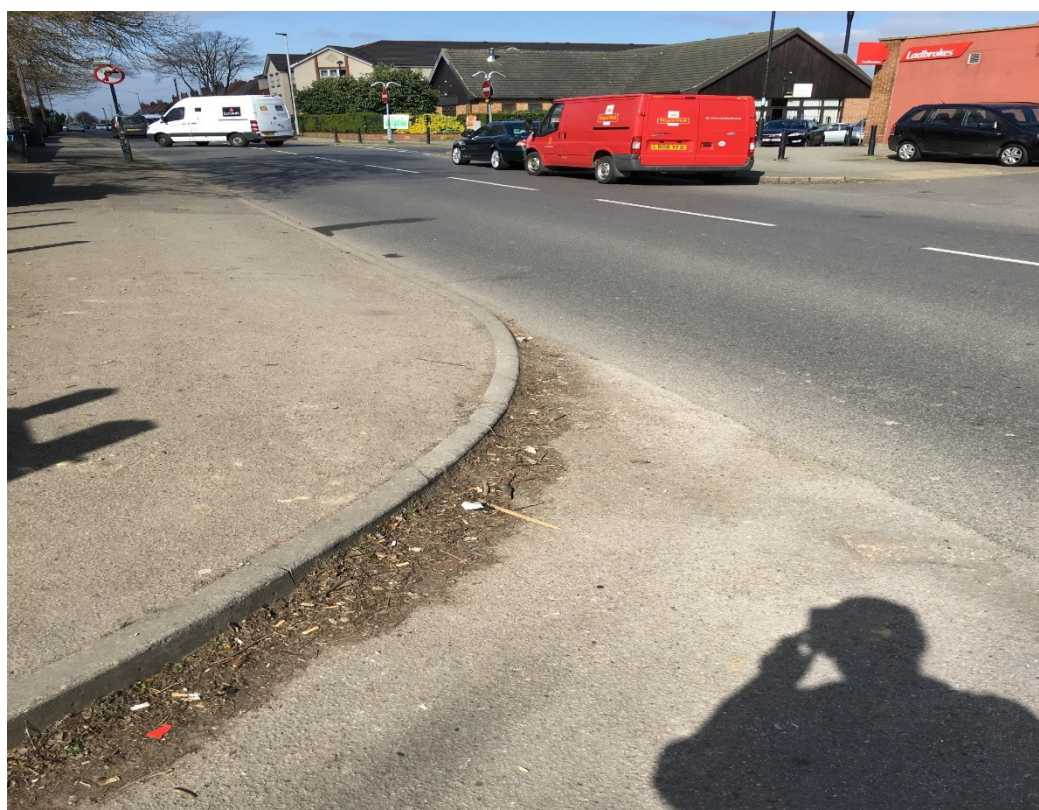
*Figure 11 View of parked vehicles looking Westbound*
