# **ARBORICULTURAL REPORT & Impact Assessment to BS5837:2012 at:**

*Land north of  
**Keresforth Road,  
Dodworth,  
Barnsley,  
South Yorkshire  
S75 3QY***

Prepared for:  
**Persimmon Homes West Yorkshire**  
*3 Hepton Court,  
York Road,  
Leeds,  
West Yorkshire  
LS9 6PW*

Reference: *AWA2044*

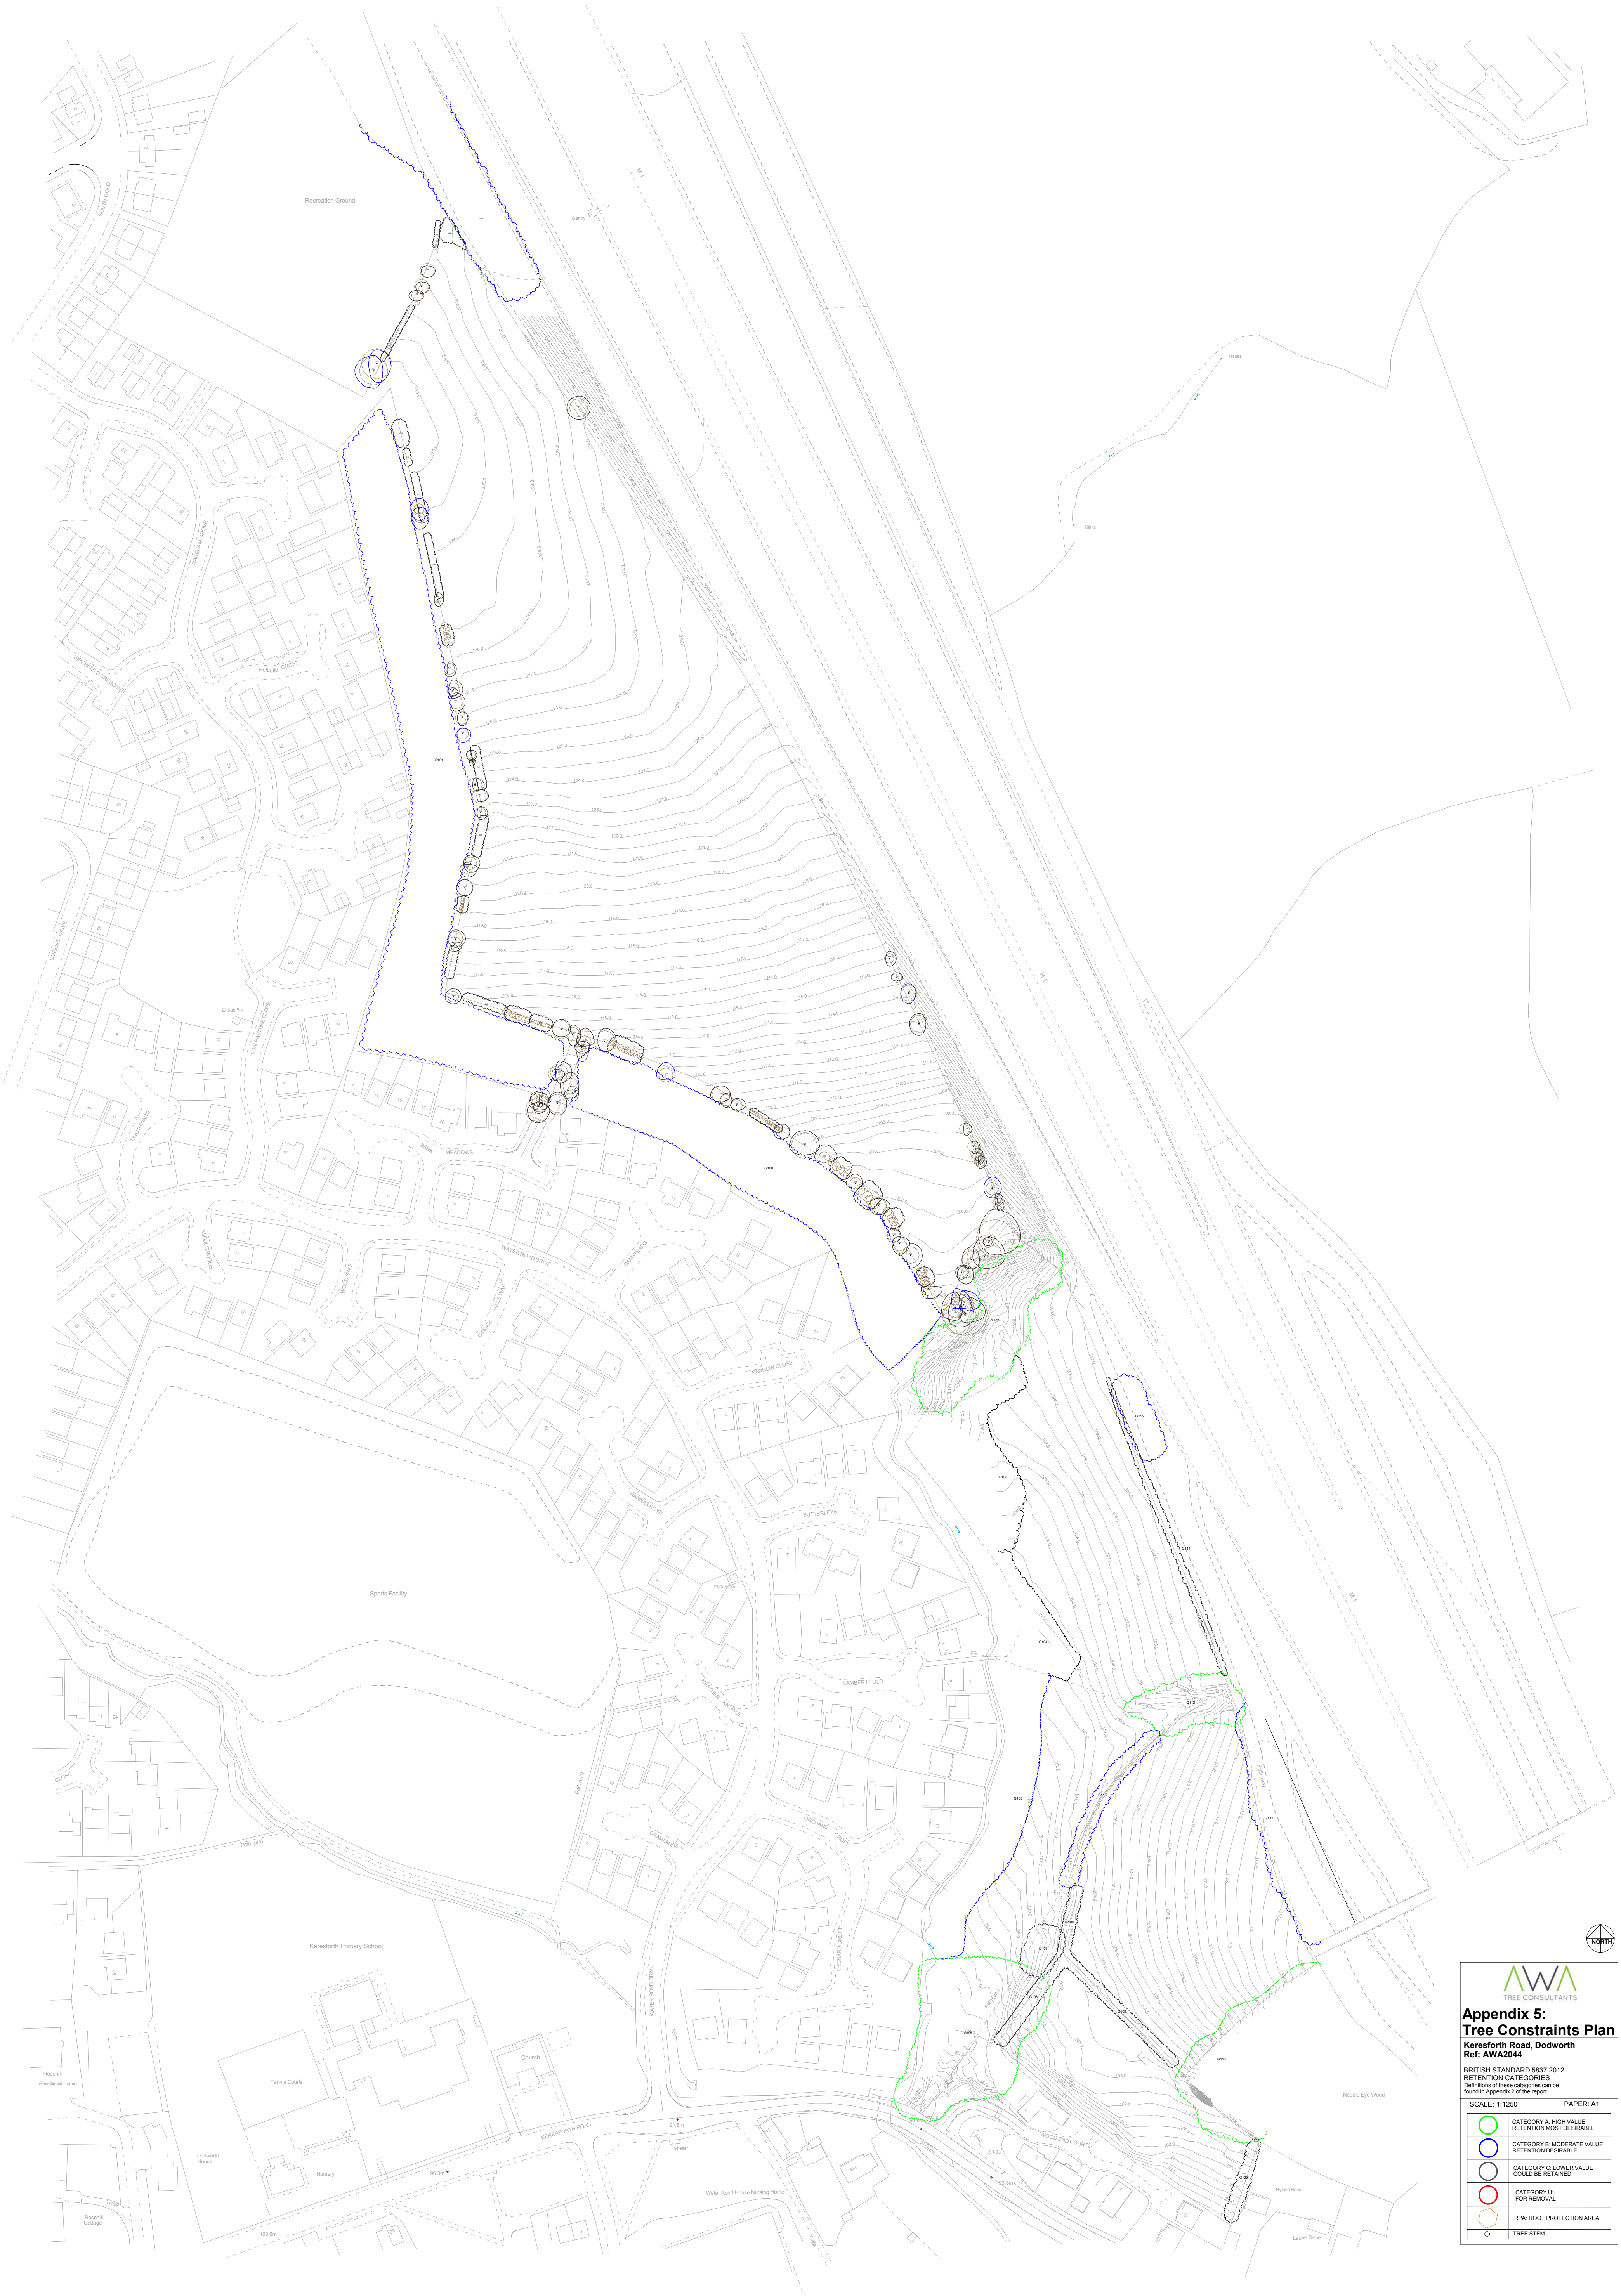
**Appendix 5:**  
**Tree Constraints Plan**  
Keresforth Road, Dodworth  
Ref: AWA2044

- 3.2.7 Trees T1 to T11 are situated on the steep banking of a river which separates the northern section of the site from the southern section. All the trees have exposed roots and soil erosion at their base and have numerous minor defects throughout, including cavities, deadwood, dieback and snapped limbs. The large Willows T1, T3, T8 and T9 may be unsuitable for retention within close proximity to new development at the site.

- 3.2.9 Groups G105, G111, G113 and G115 are of moderate value. G105 and G113 are groups of semi to early mature trees in relatively good overall condition and with good future prospects. G111 and G115 form bands of boundary landscape plantings situated on banking which separates the site from the adjacent motorway to the east, providing valuable screening and noise dampening to the site from the motorway.

- 3.2.10 Groups G103, G104, G107, G108, G109 and G114 are all of low value. G103, G104 and G107 are boundary groups, with G103 comprised of dense shrubby Blackthorn and Elder and G104 and G107 comprised of young to semi mature Ash, Sycamore and Cherry stems. G108, G109 and G114 are field boundary hedges in generally poor to fair overall condition.

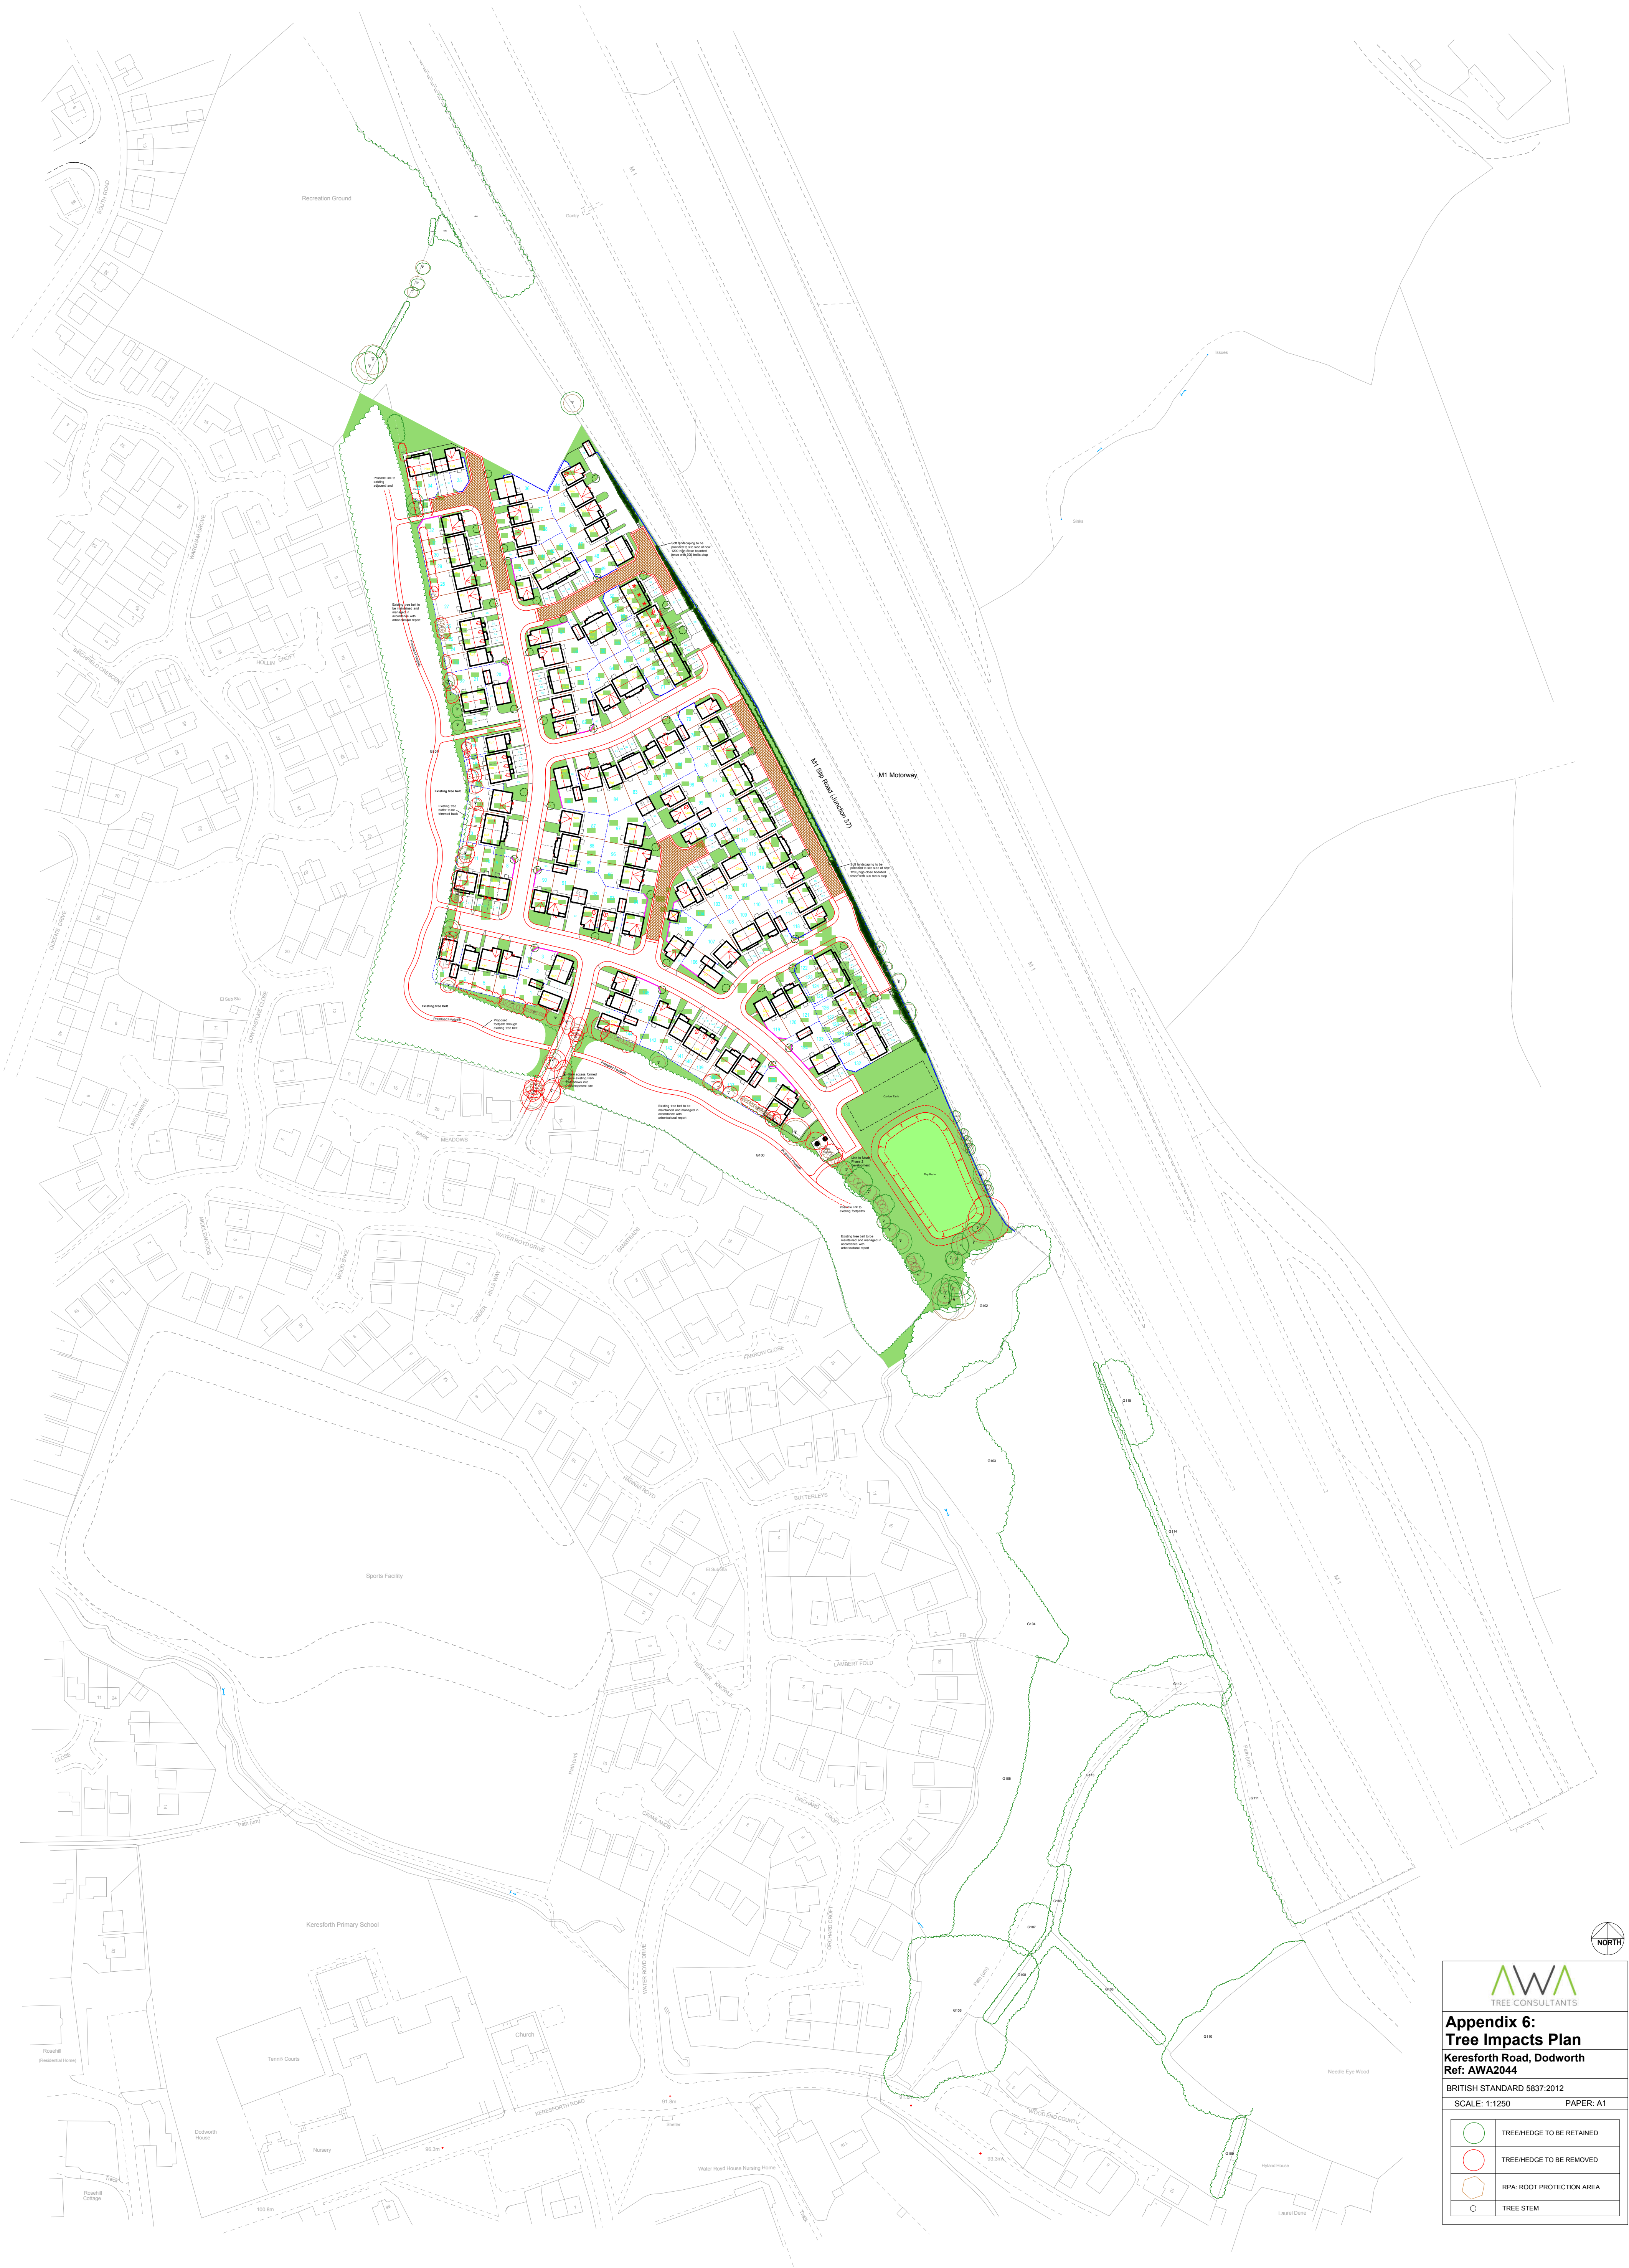
**Appendix 6:  
Tree Impacts Plan**  
Keresforth Road, Dodworth  
Ref: AWA2044

- 4.2.4 The large Crack Willow T1 is in relatively poor overall condition and likely had limited long term value regardless of development at the site. It may be suitable to heavily cut back the crown and retain the stem as a pollard for habitat value.

- 4.3.3 New garden boundary fencing is proposed within the RPA of a number of retained trees. The encroachment into the tree's RPA should not significantly adversely impact on the health or future condition of the trees, provided care is taken during their construction to avoid root damage, including the use of posts and panels or pile and beam type footings as opposed to strip footings.

- 4.3.4 The proposed new footpath through the wide spreading boundary groups G100 and G101 will increase the usage of these groups and will create a higher value target. It is therefore recommended to undertake suitable management works throughout the groups, consisting of the removal of any significant deadwood from the trees' crowns and any dead standing trees within the groups.
