## Tree

| Tag Number: | T1 |
| Common Name: | Lombardy poplar |

| Location | |
|---|---|
| Address: | 59 High Street |

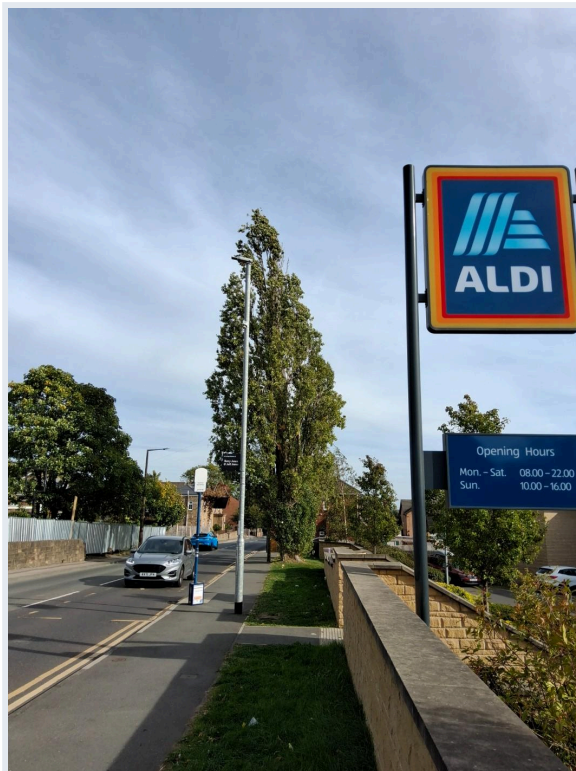
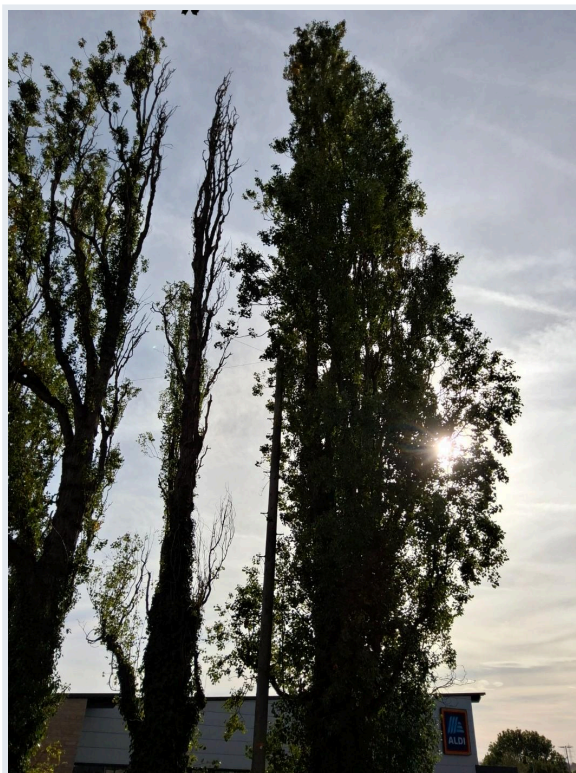
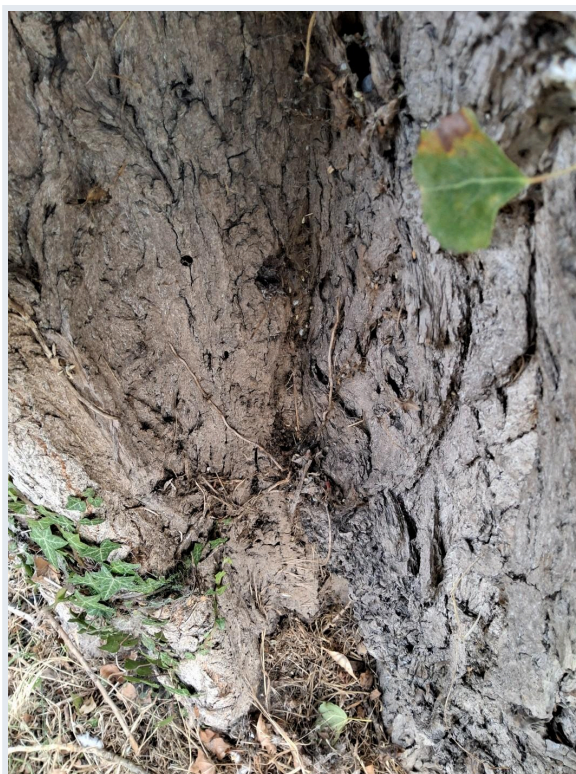
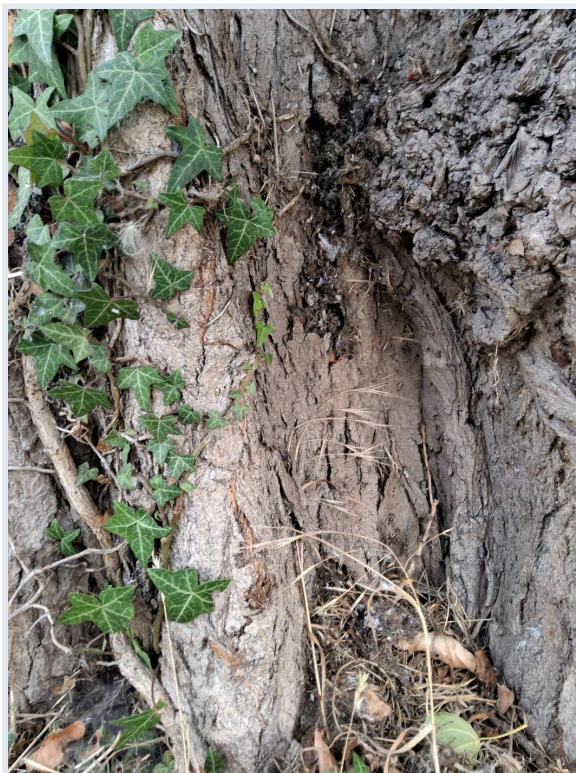
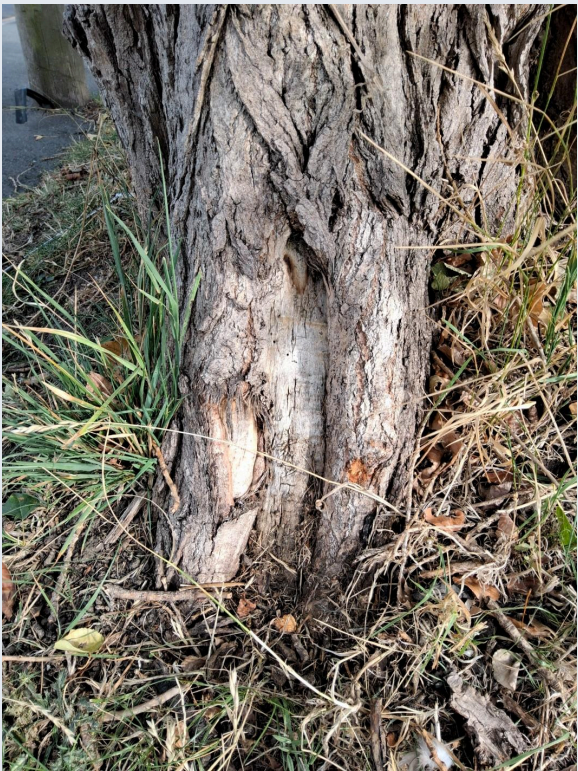
| Tree Comments: | Removal of trees to East will greatly increase exposure on side which has few branches and no significant buttress roots. This is combined with high target location and likelihood of near future basal decay if not already present. |

| Crown Comments: | One sided due to co-dominance, putting out lots of new epicormic on east side of stem now centre tree has died back. Telegraph wires will be in canopy when epicormic branches extend to east. |
| Trunk Comments: | Very hollow sounding bark between buttresses to north, slight lean to north and west. |
| Root Comments: | Buttress roots to exposed west side only, mechanical damage to one but still seems relatively sound |
| PPD Comments: | Defoliated by Satin moth in 2025, but recovered later in the year. |

| 7270 | As for Tree Comments - Recommend felling and stump grinding would be prudent if other trees were felled due to already having a slight lean, only having half a crown and a compromised root system due to co-dominance and | katherinechurch | 23/09/2026 | 15 | Good |

| INSPECTION<br>ID | INSPECTION NOTES | INSPECTED<br>BY | DATE | TREE<br>HEIGHT<br>[M] | VITALITY |
|---|---|---|---|---|---|
| | previous mechanical damage, while<br>being in a high target location. | | | | |
