## SUBSIDENCE ENGINEER'S REPORT

| <b>Risk Address</b> | 6 Butterleys, Dodworth, Barnsley, S75 3TD |

| <b>GHG Reference</b> | L/2020/62058/S/DC/jlm |
| <b>Date of Report</b> | 30 September 2020 |

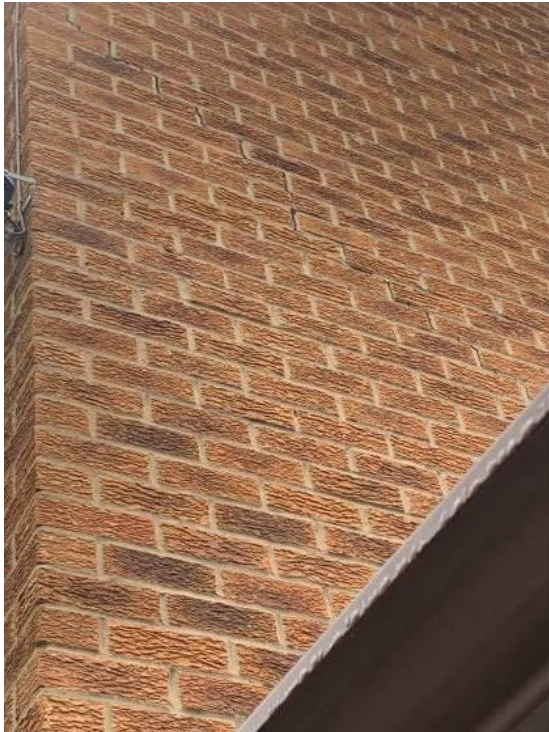
This photograph shows a general view of high-level stepped cracking on the left-hand-flank wall of the main building running up to the rear corner.

On this elevation, we noted a diagonal crack at high level, this commences at approximately 500mm from the roofline at the rear corner running down towards the front to beneath the flashings to the garden-store extension. To the front of the extension there appears to be some slight disturbance along the damp-proof course level on the main gable and some vertical cracking down from an airbrick situated approximately 1.5m from the front corners. The diagonal nature of the cracking, which opens to high level, estimated to be up to 10mm in width, suggests rotational movement of the rear left-hand corner of the main building. No significant cracking was noted to the garden-store room, apart from some slight cracking of the front junction with the main gable wall and some minor distortion of the rear door frame at low level.

On this elevation, we noted that the high-level diagonal cracking from the gable wall turns around the corner and steps up towards the eaves, then runs across horizontally to the head of the left-hand bedroom window.

The pattern of cracking is consistent with rotational downward movement of the rear left-hand corner of the main building and our site investigations have identified shallow concrete foundations bearing onto predominantly clay subsoils. It is noted that the site slopes down steeply from right to left and that there is a retaining wall along the left-hand boundary with the neighbour which retains approximately 900mm of the site relative to the adjacent site. However, our site investigations did indicate that the building has been founded on natural soils rather than made ground, though the lowering of levels at the left-hand side of the site has left the main house foundation at a relatively shallow level. The single-storey extension is likely to have been constructed on a flat concrete-raft founded at the same level as the underside of the main building which is at a depth of only around 300mm below the lowest paving level at the rear left-hand corner of the extension. Root activity has been observed beneath the foundation level and soil conditions were found to be stiff and dry at the time of our investigation.

The indications are, therefore, that damage has been caused by clay-shrinkage subsidence exacerbated by the extraction of moisture by roots from adjacent vegetation and trees.

Subject to appropriate vegetation management measures being undertaken, we would hope that robust superstructure repairs only will be necessary to restore the structural integrity to the building. However, given the shallowness of the foundations, if evidence from our investigations is considered to be insufficient to support a request for vegetation removal, it may be necessary to undertake some localised underpinning of the foundations.

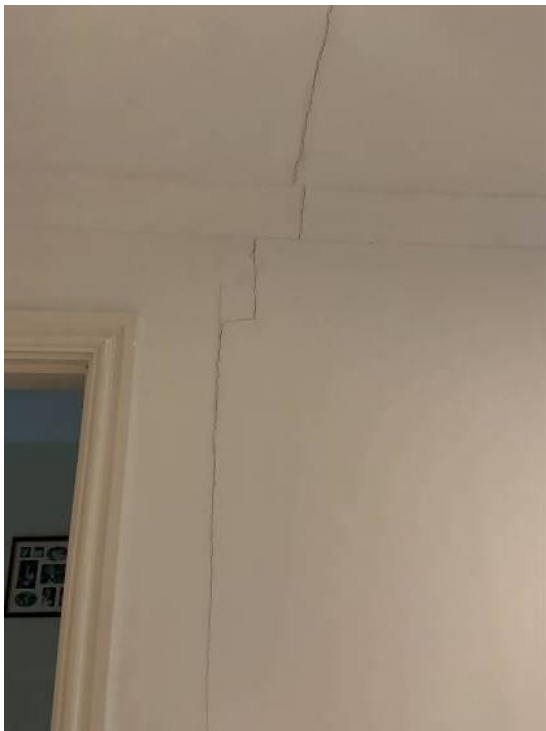
This photograph shows vertical cracking to the rear of the doorway into the hallway from the kitchen extending into the ceiling.

In this room, we noted some vertical cracking opening slightly to high level, to the front left-hand side on the partition wall with the lounge. The cracking is just to the rear of the door frame and appears to run round the end of an embedded lintel with cracking

extending into the coving and across the ceiling which then splits and runs towards the rear, again likely on a board joint which tapers out towards the right-hand side. This crack was previously filled at the end of 2019 by the Policyholder and has opened again by around 1mm and suggests some pulling towards the rear of the building.
