ARBORICULTURAL REPORT

to **BS5837:2012** at:

***Roughbirchworth Lodge,
Roughbirchworth Lane,
Oxspring,
Barnsley,
South Yorkshire
S36 8YZ***

Reference: *AWA2150*

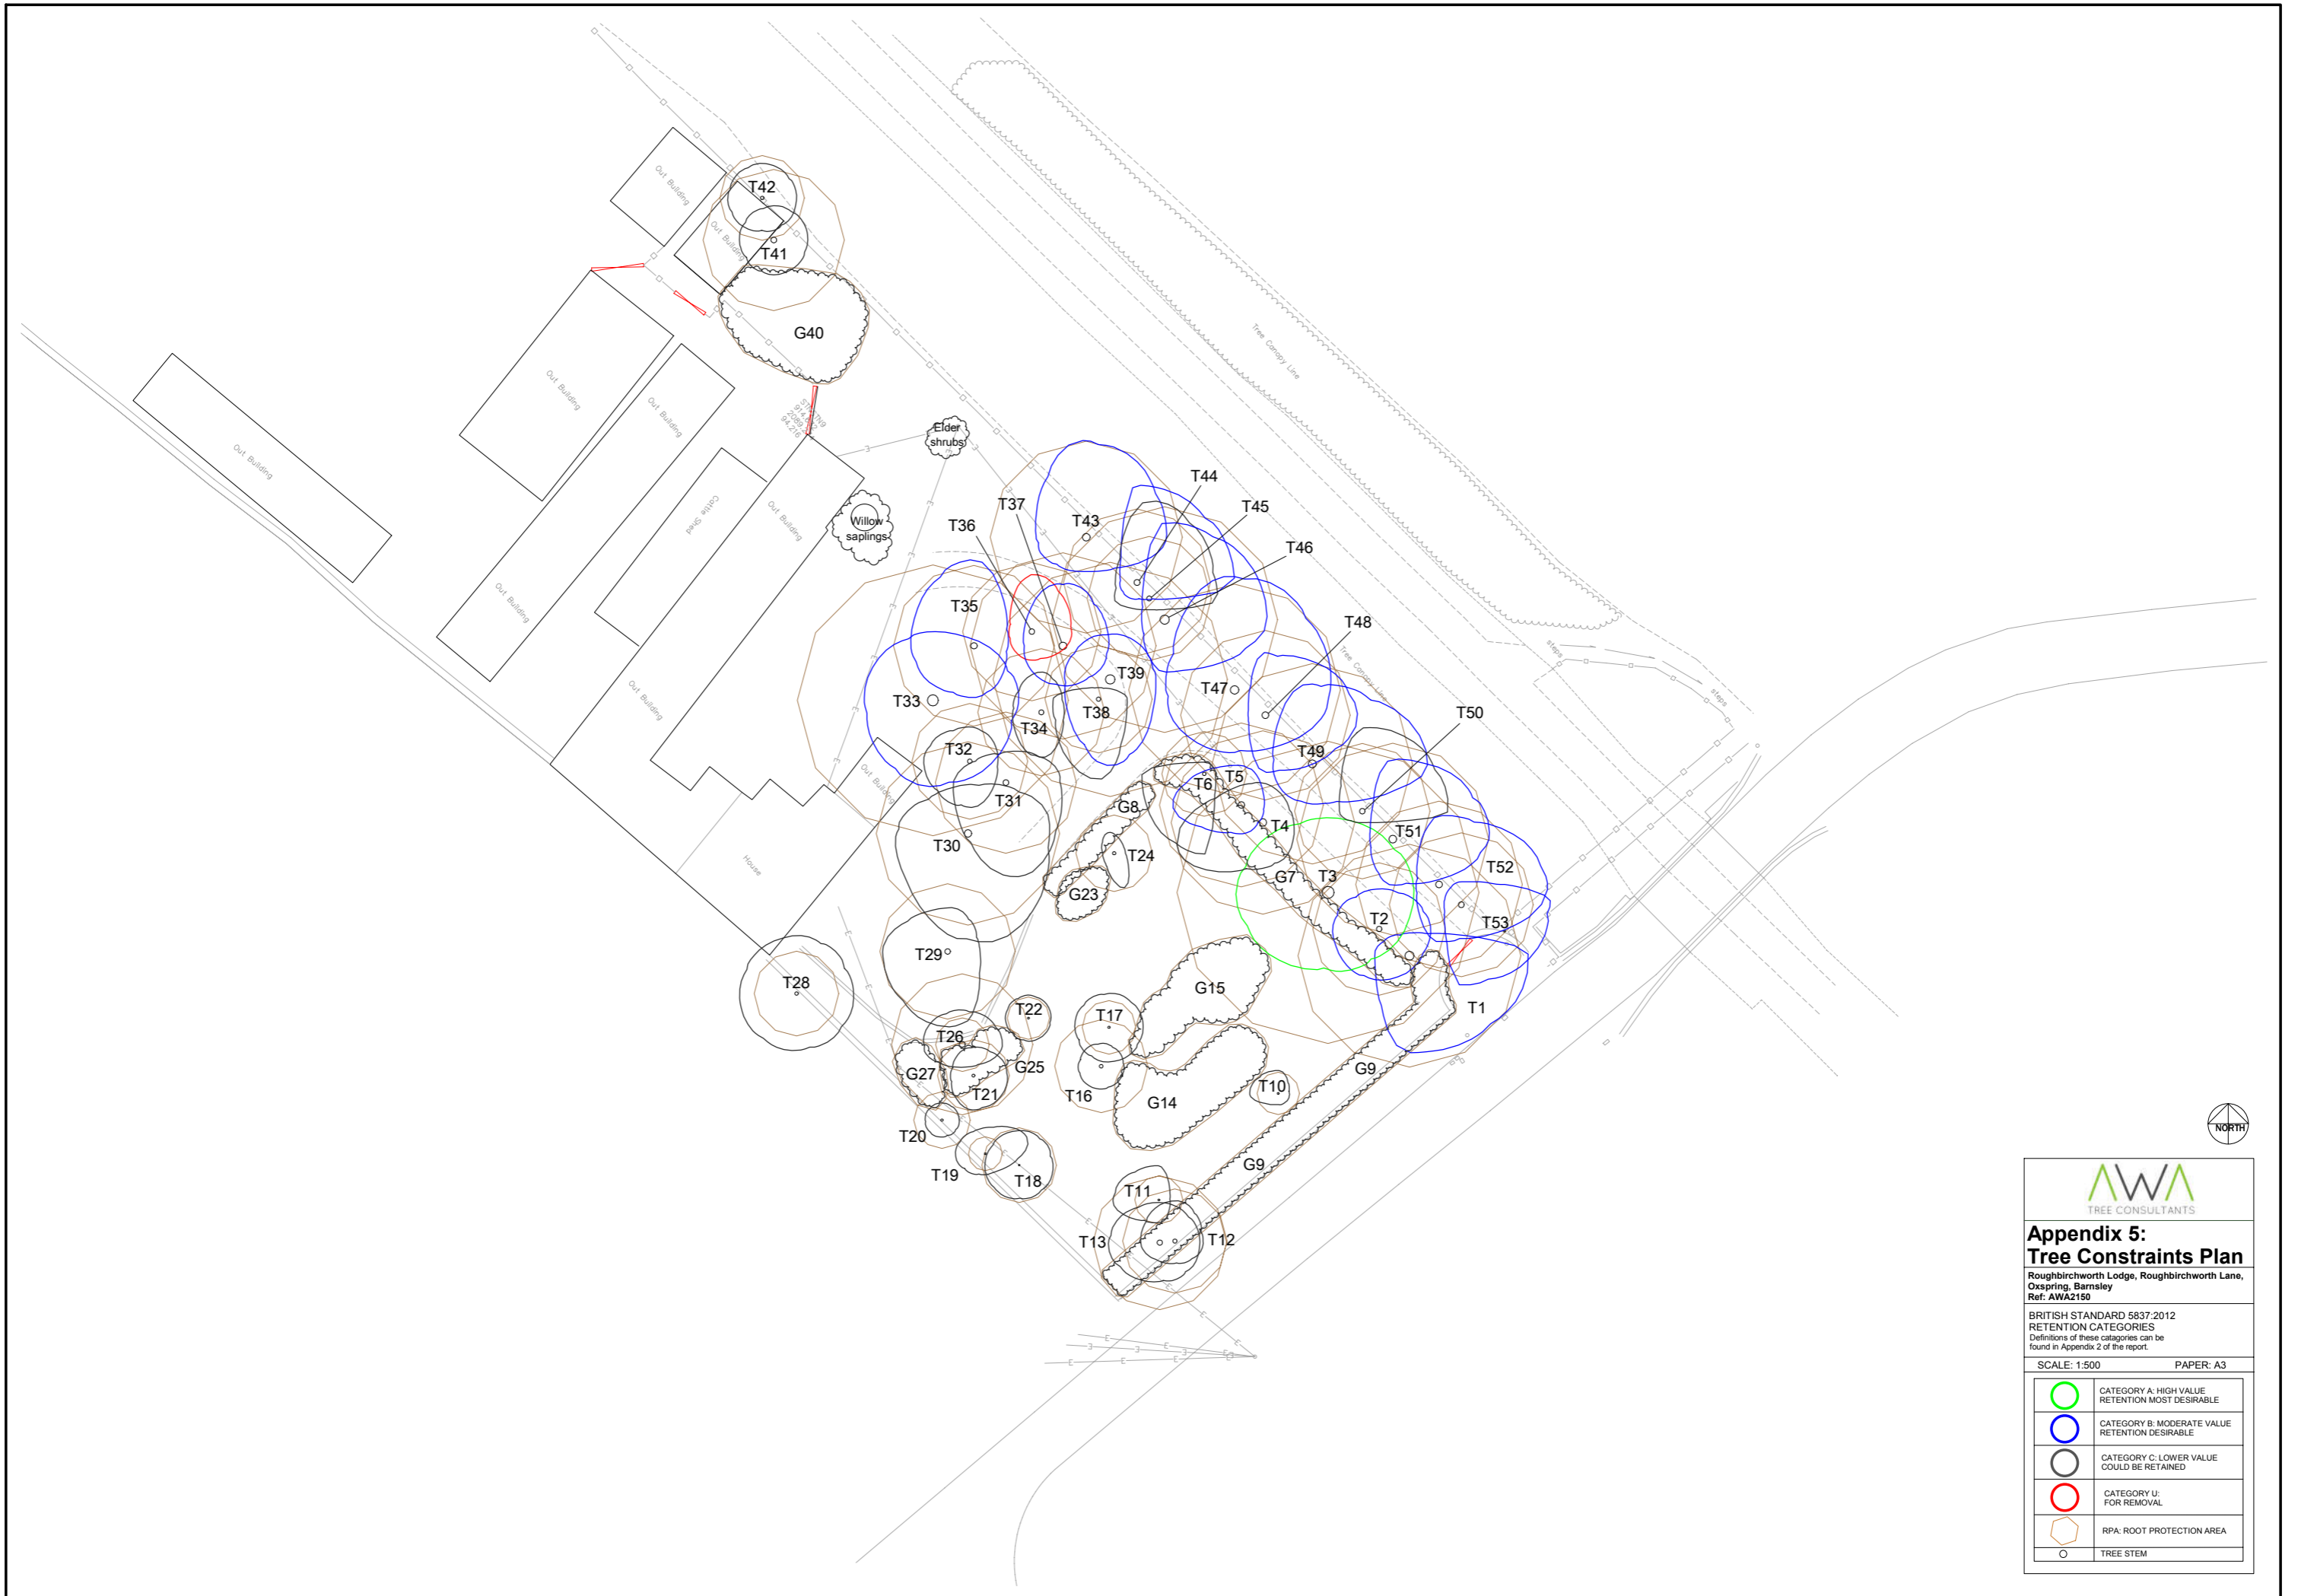
**Appendix 5:
Tree Constraints Plan**

- 3.2.13 The tree Root Protection Area (RPA) is detailed on the Tree Constraints Plan at Appendix 5. The RPA for each tree has been plotted as a polygon centred on the base of the stem. Due to the presence of roads, structures, topography (and past tree management) the RPA is likely to be a simplified representation of the tree roots actual morphology and disposition.
