Gas Membrane Installation  
Validation Report  
Caddick Construction  
Gateway 36 Phase 2a  
Shortwood Roundabout  
Dearn Valley Parkway  
Barnsley  
S74 9DF

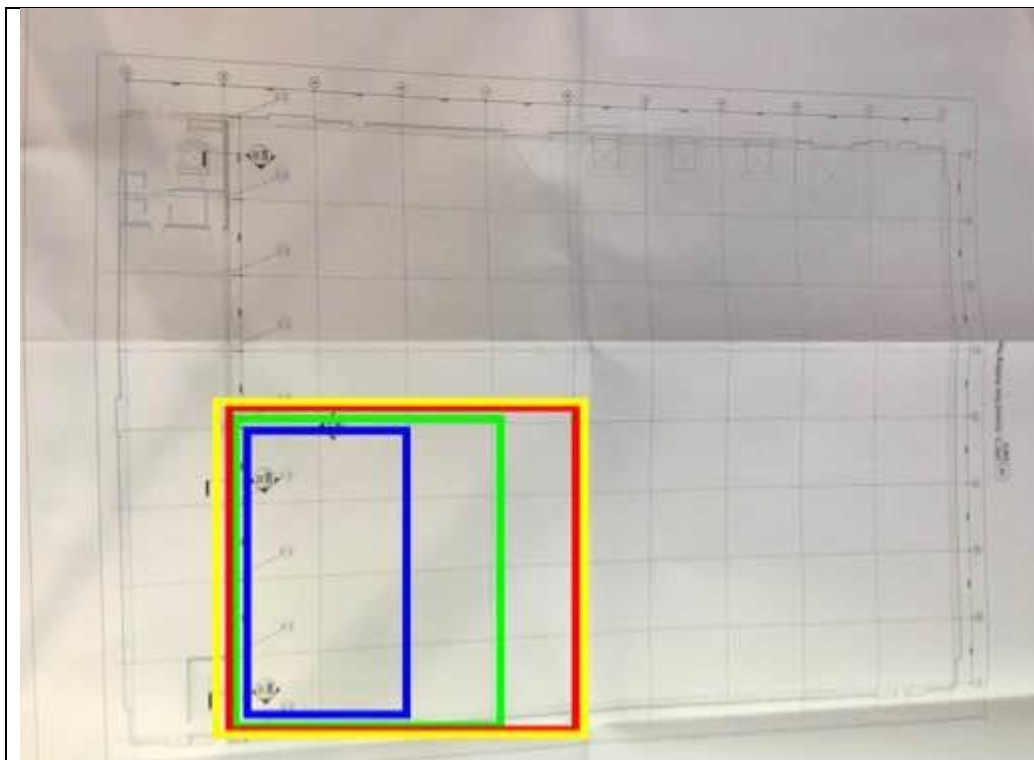
Area Inspected

| | Installation Notes | <b><u>(brief description of area/plots and list of defects/repairs identified to the main membrane sheet, excluding detailing and joints)</u></b><br><br>MEC Environmental carried out a thorough visual inspection of the membrane that was laid on a just in time basis in front of a laser pour, during our inspection we witnessed the installer carrying out their own CQA repairs as the pour progressed. The membrane is lined across the main footprint and is joined to the perimeter edge using double sided butyl tape. Butyl tape is used on all membrane joints and to seal to the membrane left extended from pour 1. All penetrations and patch repairs sealed using SAGM. | |

| <p><b><u>(List any defects to detailing work and joints):</u></b></p> <p>During our inspection the following defects and repairs were carried out: 8no patch repairs made by the installers using SAGM.</p> <p>Have any defects identified above been satisfactorily rectified <input checked="" type="checkbox"/> Yes <input type="checkbox"/> No <input type="checkbox"/> N/A</p> <p>The Area has passed inspection <input checked="" type="checkbox"/></p> <p>The Area has failed inspection and a corrective action sheet has been left with the contractor <input type="checkbox"/></p> <p>The Area is incomplete as detailed above <input type="checkbox"/></p> <p>Signed: <b>Dan Squire</b> Date: <b>25/07/2022</b></p> | | | |

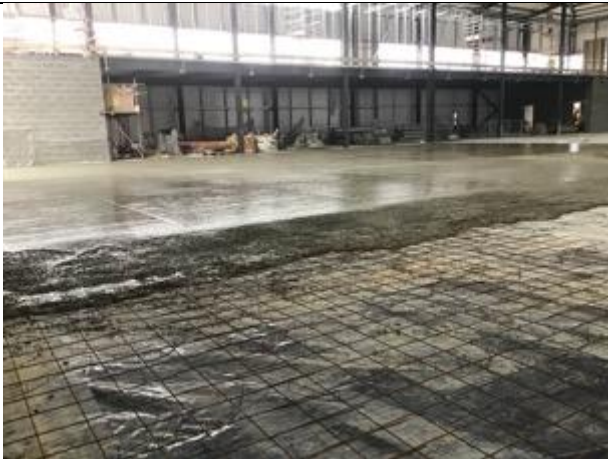
Unit 3 pour 2 laser screed installation

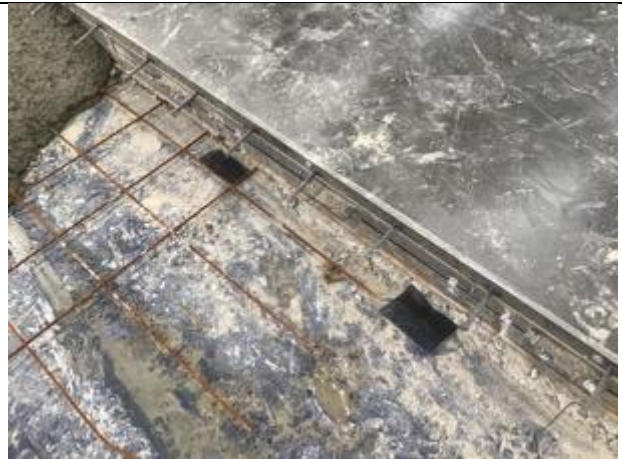
Sealed SAGM patch repairs

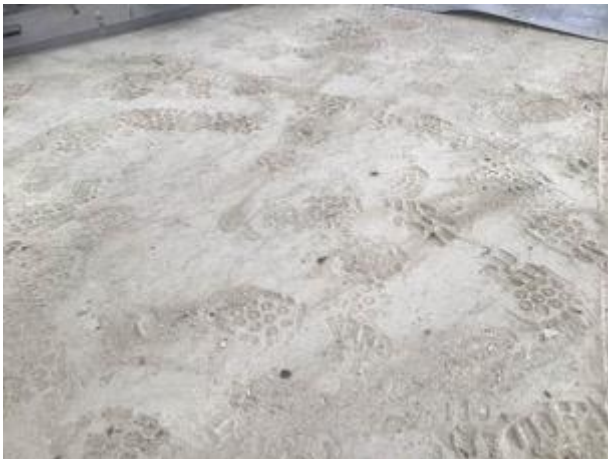
Sand blinding sub grade prior to being rolled

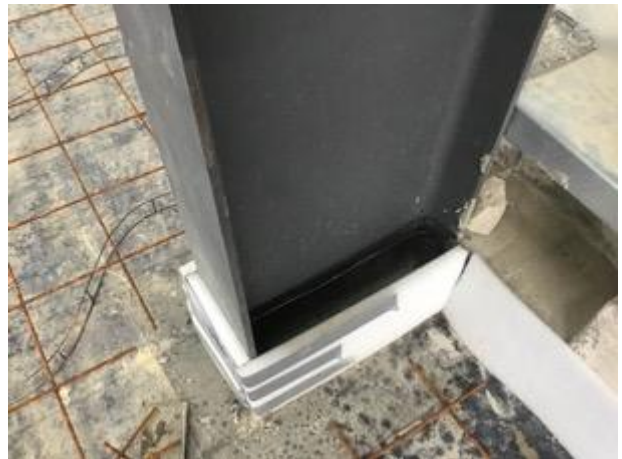
Sealed stanchion detail

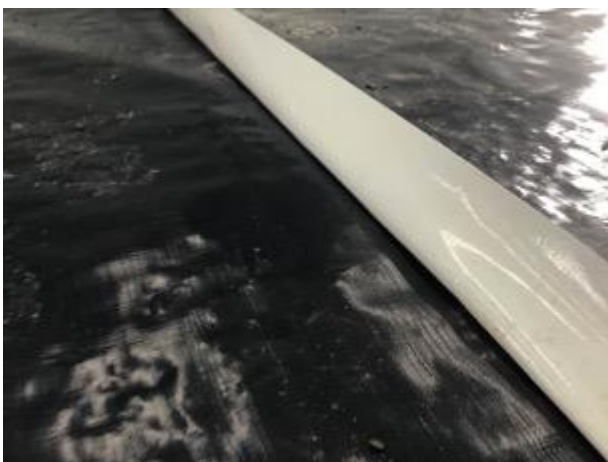
Sealed double sided tape joint

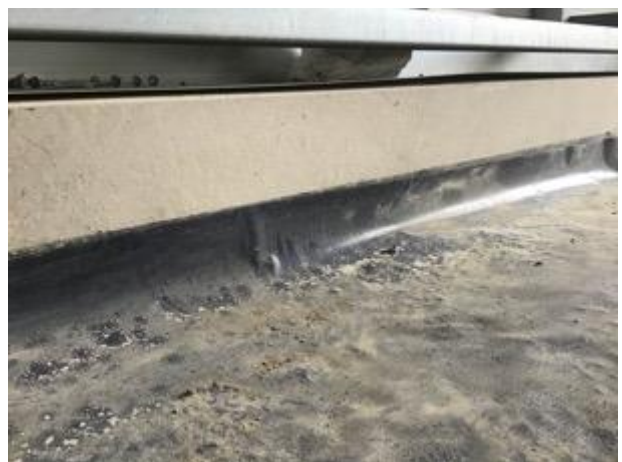
Sealed perimeter detailing

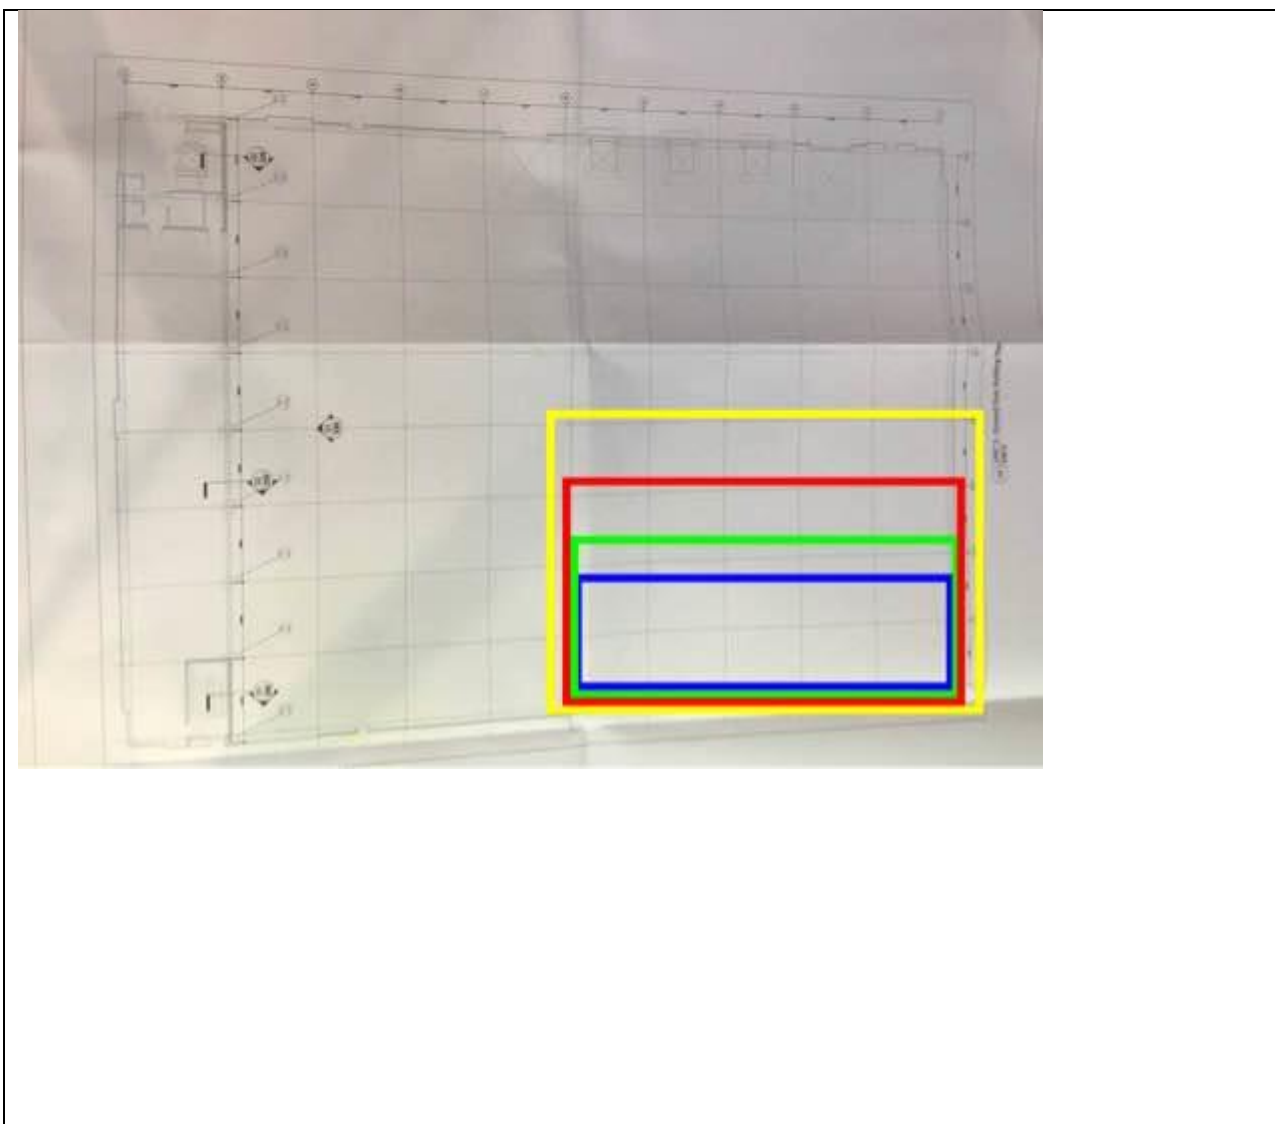
Area Inspected

| Installation Notes | <p><b><u>(brief description of area/plots and list of defects/repairs identified to the main membrane sheet, excluding detailing and joints)</u></b></p> <p>MEC Environmental carried out a thorough visual inspection of the membrane that was laid on a just in time basis in front of a laser pour, during our inspection we witnessed the installer carrying out their own CQA repairs as the pour progressed. The membrane is lined across the main footprint and is joined to the perimeter edge using double sided butyl tape. Butyl tape is used on all membrane joints and to seal to the membrane left extended from pour 2. All penetrations and patch repairs sealed using SAGM.</p> <p>Site installed miothene strips surrounding all pipes and stanchions prior to the concrete pour.</p> <p>Marked up drawing key:</p> <p>Area in yellow is the full pour area</p> <p>Area in red is completed membrane work during our inspection.</p> <p>Area in green is how far the pour had progressed during our inspection.</p> <p>Area in blue is how far the pour had come and covered the membrane prior to our inspection.</p> | | | |

| | <p><b><u>(List any defects to detailing work and joints):</u></b></p> <p>During our inspection the following defects and repairs were carried out: 15no patch repairs made by the installers using SAGM.</p> <p>Have any defects identified above been satisfactorily rectified <input checked="" type="checkbox"/> Yes <input type="checkbox"/> No <input type="checkbox"/> N/A</p> <p>The Area has passed inspection <input checked="" type="checkbox"/></p> <p>The Area has failed inspection and a corrective action sheet has been left with the contractor <input type="checkbox"/></p> <p>The Area is incomplete as detailed above <input type="checkbox"/></p> <p>Signed: <b>Dan Squire</b> Date: <b>27/07/2022</b></p> | | | |

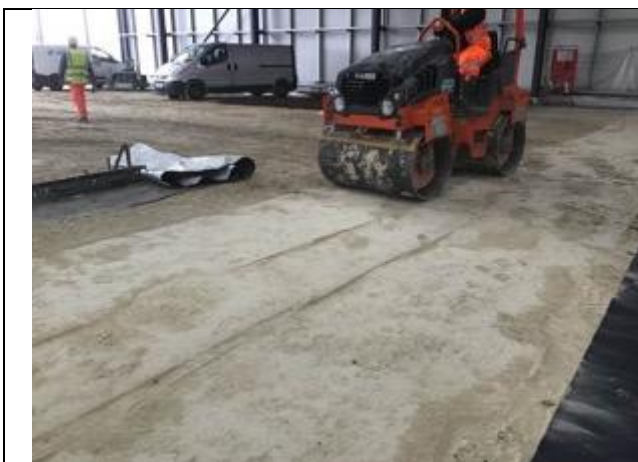
Sub grade prep

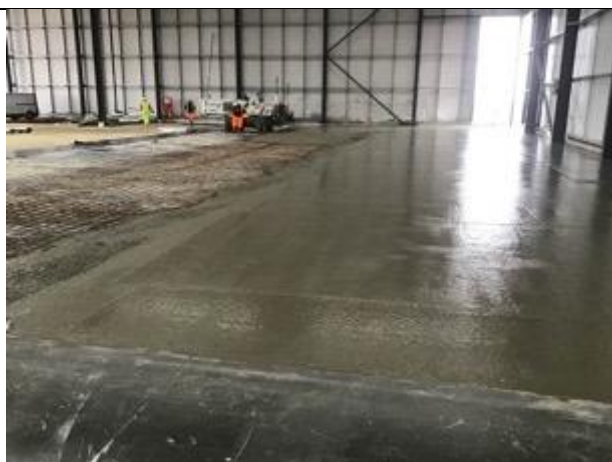
Pour 3 of 4 laser screed installation

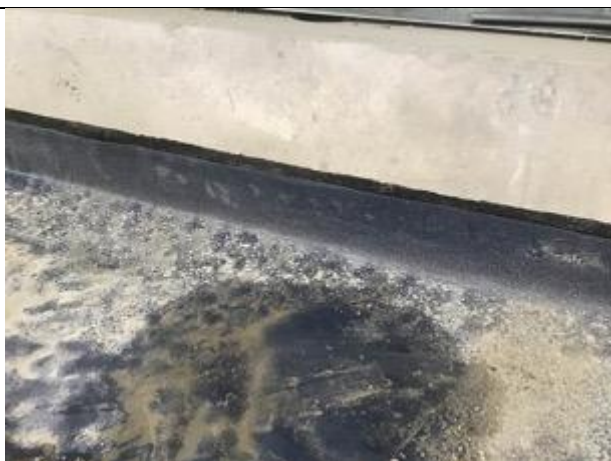
Sealed perimeter detailing

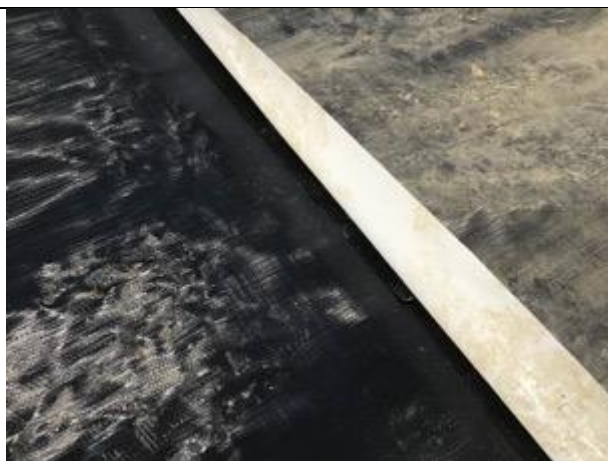
Butyl tape membrane joint

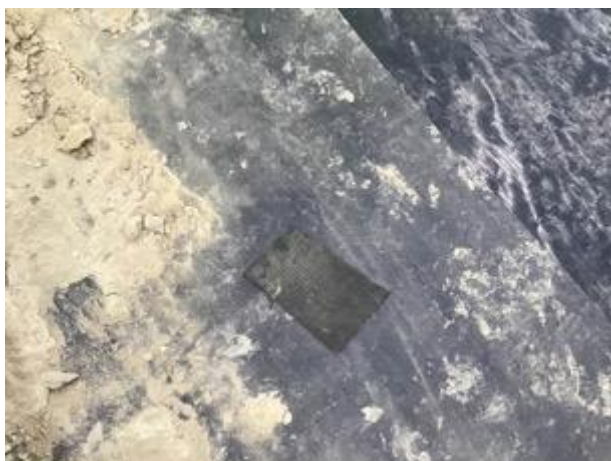
Sealed SAGM patch repair

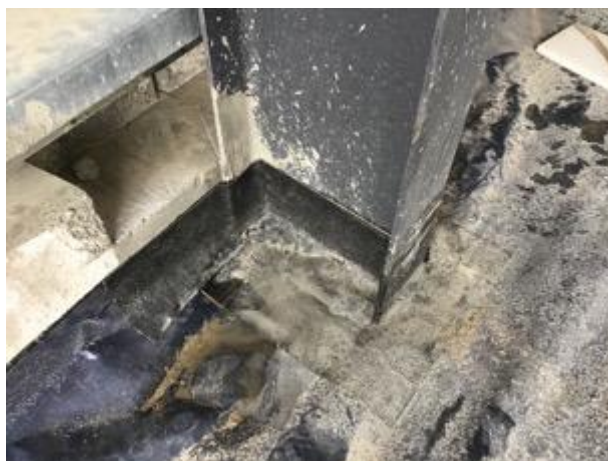
Sealed stanchion detail

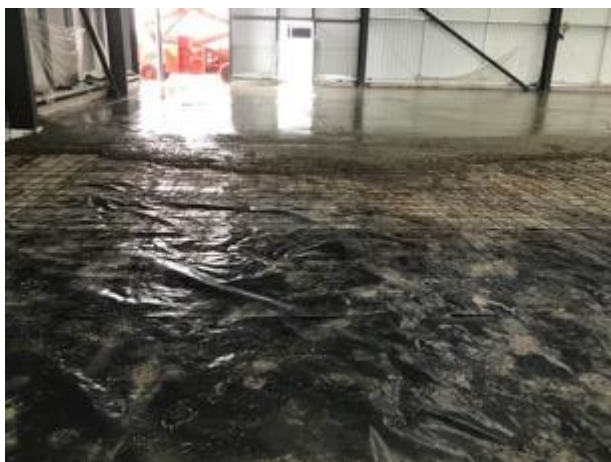
Pour 3 of 4 laser screed installation

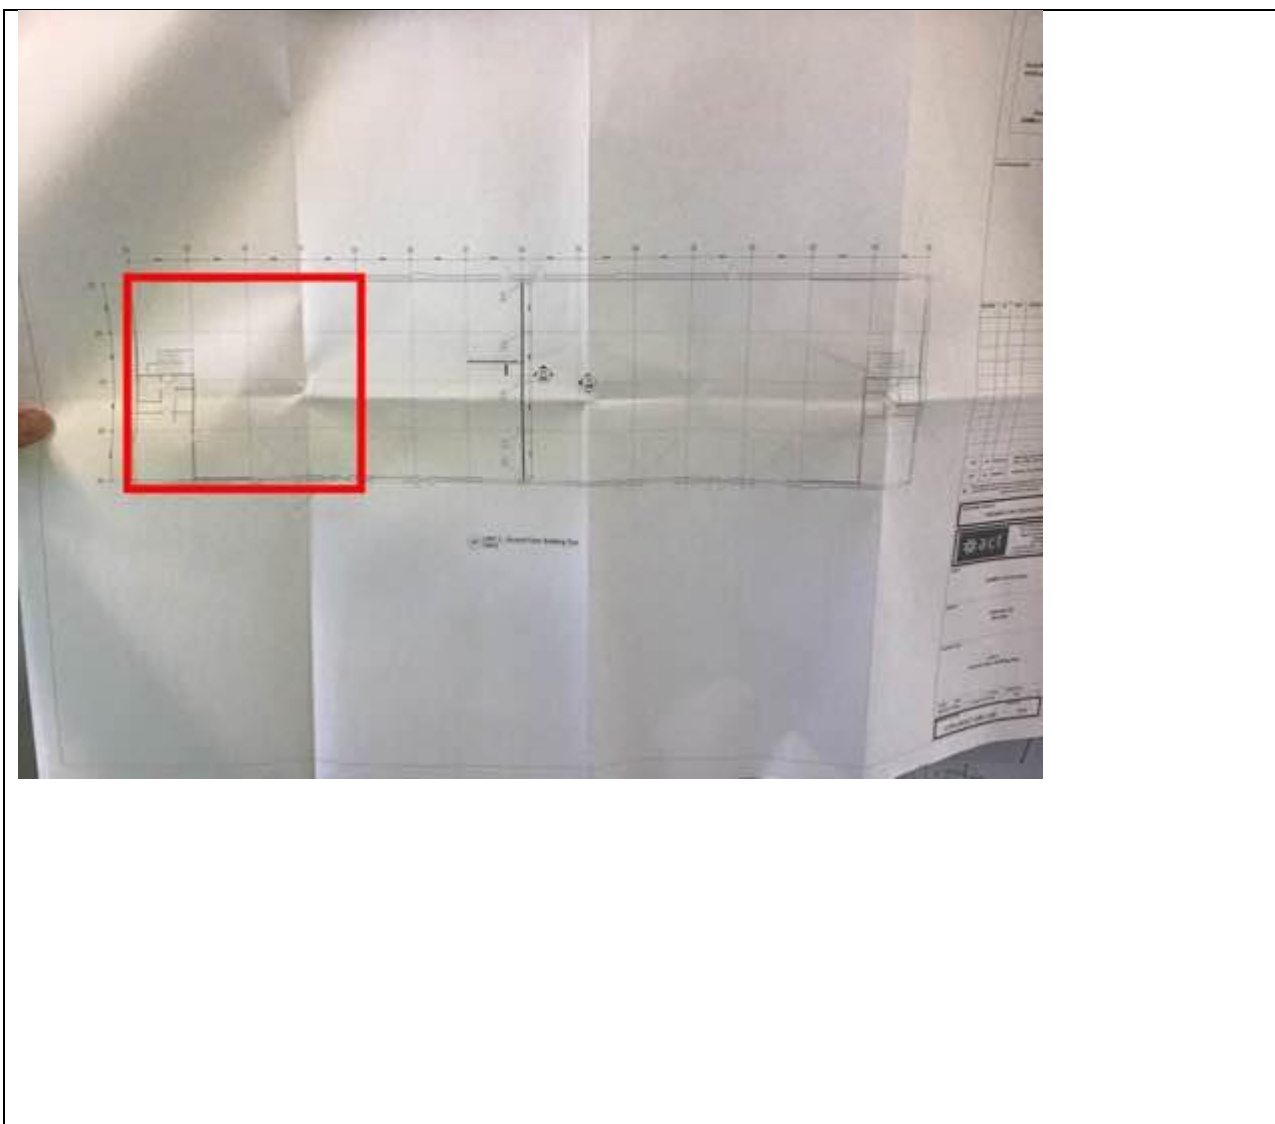
Area Inspected

| | Installation Notes | <p><b><u>(Brief description of area/plots and list of defects/repairs identified to the main membrane sheet, excluding detailing and joints)</u></b></p> <p>MEC Environmental carried out a thorough visual inspection of the membrane that was laid as a full line in preparation for the first pump pour. The membrane is lined across the main footprint and is joined together and to the perimeter membrane previously installed using double sided Butyl tape. All penetrations and patch repairs sealed using SAGM.</p> <p>Site installed miothene strips surrounding all pipes and stanchions prior to the concrete pour.</p> <p>MEC were unable to inspect the membrane which is installed under the perimeter blockwork. We were also restricted to an inspection in the thickening channels which had steel mesh installed prior to our inspection.</p> | |

| | <p><b><u>(List any defects to detailing work and joints):</u></b></p> <p>During our inspection the following defects and repairs were carried out: 9no patch repairs made by the installers using SAGM.</p> <p>Have any defects identified above been satisfactorily rectified <input checked="" type="checkbox"/> Yes <input type="checkbox"/> No <input type="checkbox"/> N/A</p> <p>The Area has passed inspection <input checked="" type="checkbox"/></p> <p>The Area has failed inspection and a corrective action sheet has been left with the contractor <input type="checkbox"/></p> <p>The Area is incomplete as detailed above <input type="checkbox"/></p> <p>Signed: <b>Dan Squire</b> Date: <b>12/08/2022</b></p> | | | |

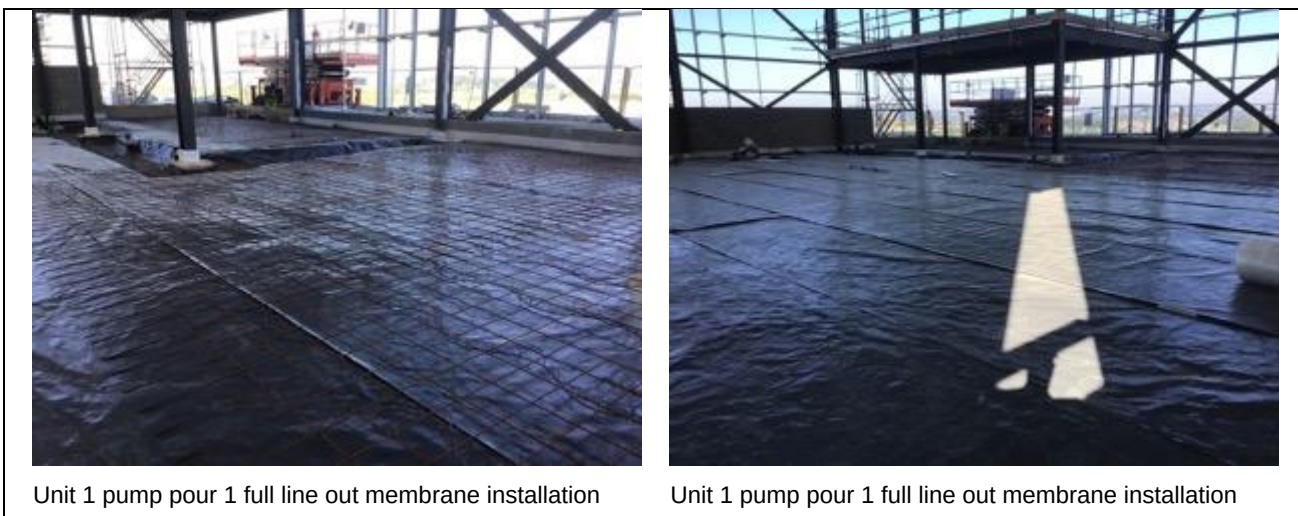
Unit 1 pump pour 1 full line out membrane installation

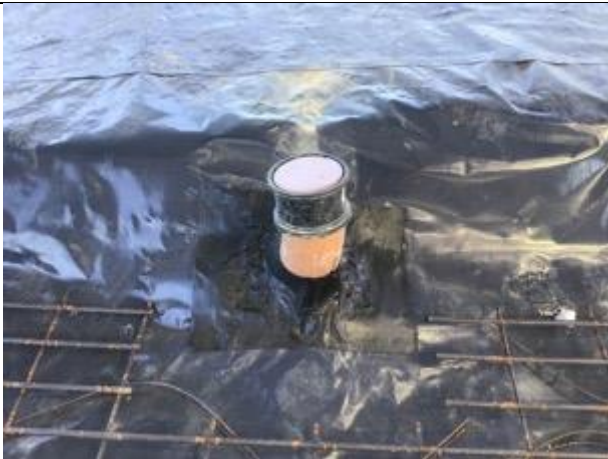
Sealed pipe penetration

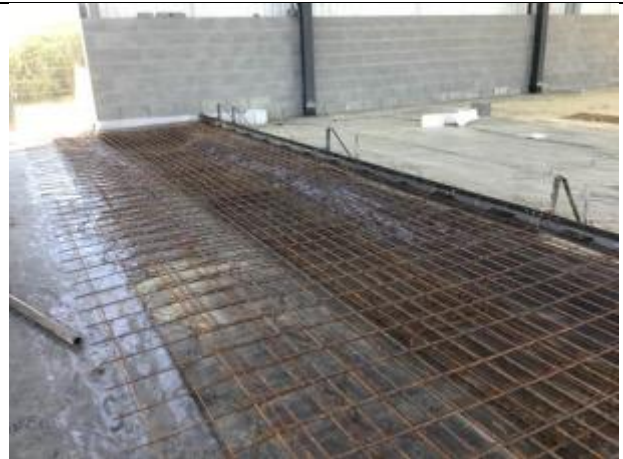
Thickening area restricted inspection

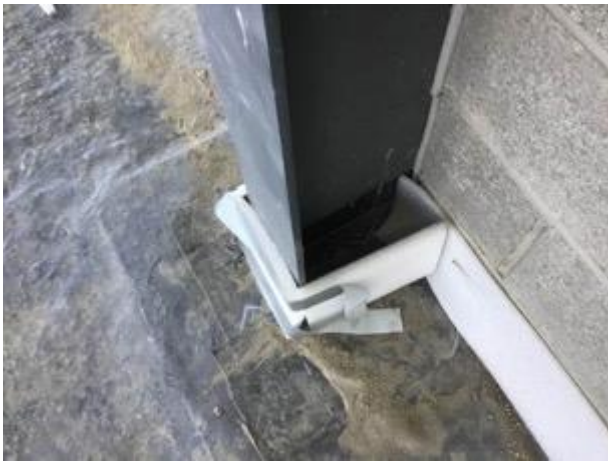
Sealed stanchion detail

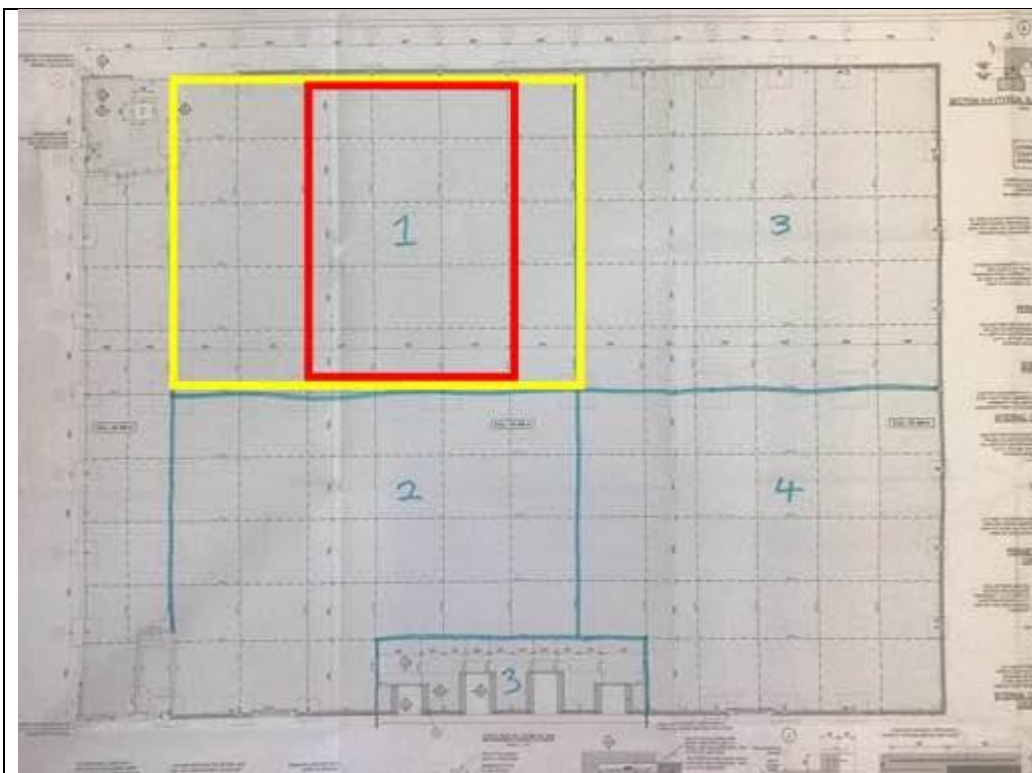
Area Inspected

| | Installation Notes | <b><u>(brief description of area/plots and list of defects/repairs identified to the main membrane sheet, excluding detailing and joints)</u></b><br><br>MEC Environmental carried out a thorough visual inspection of the membrane that was laid on a just in time basis in front of a laser pour, during our inspection we witnessed the installer carrying out their own CQA as the pour progressed. At the perimeter edge, the membrane has been sealed to the primed surface of the concrete base of the cladding walls, internally, the membrane has been joined to the previously installed membrane from an earlier pour. Stanchions have been sealed using SAGM which has been sealed to the primed surface of the stanchions and onto the membrane. | |

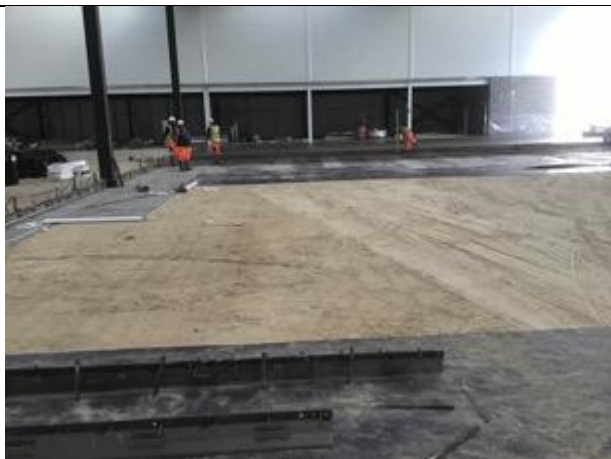
Overview Unit 2, Pour 1 of 4

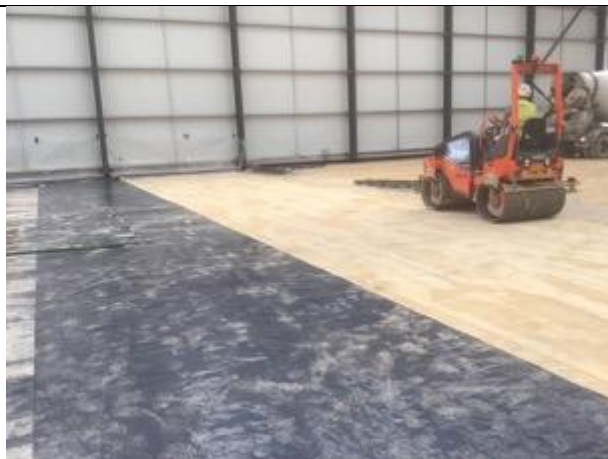
Ground being rolled, membrane laid

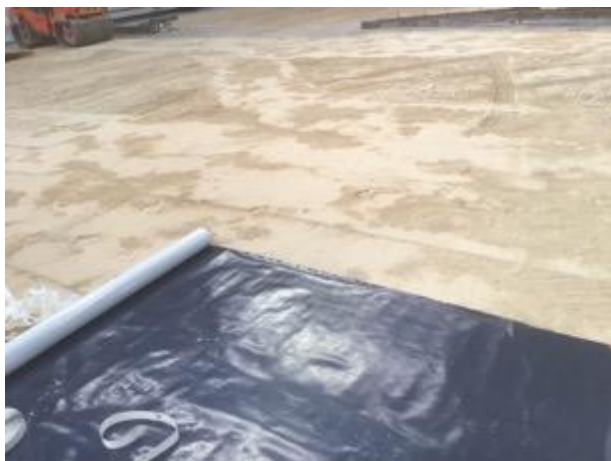
Membrane being rolled out

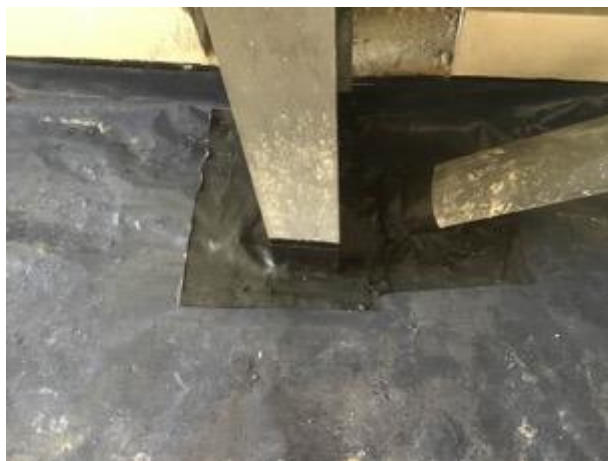
Stanchion seal using SAGM

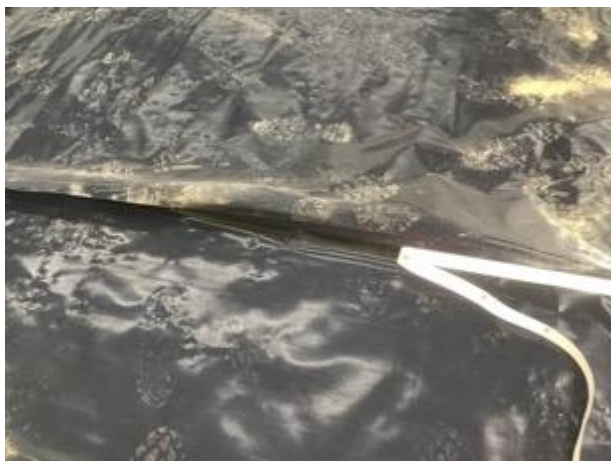
Joint using double sided joint tape

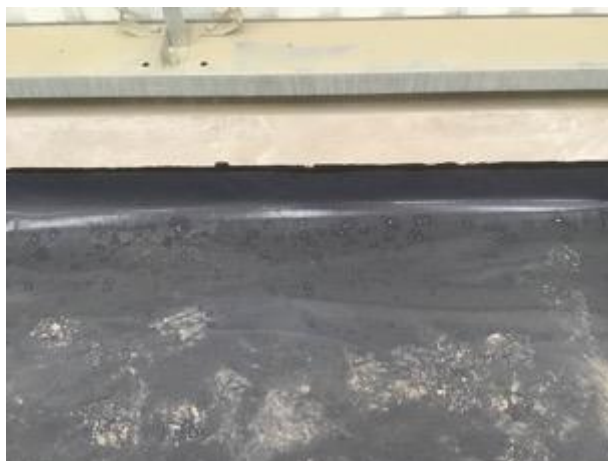
Perimeter edge seal

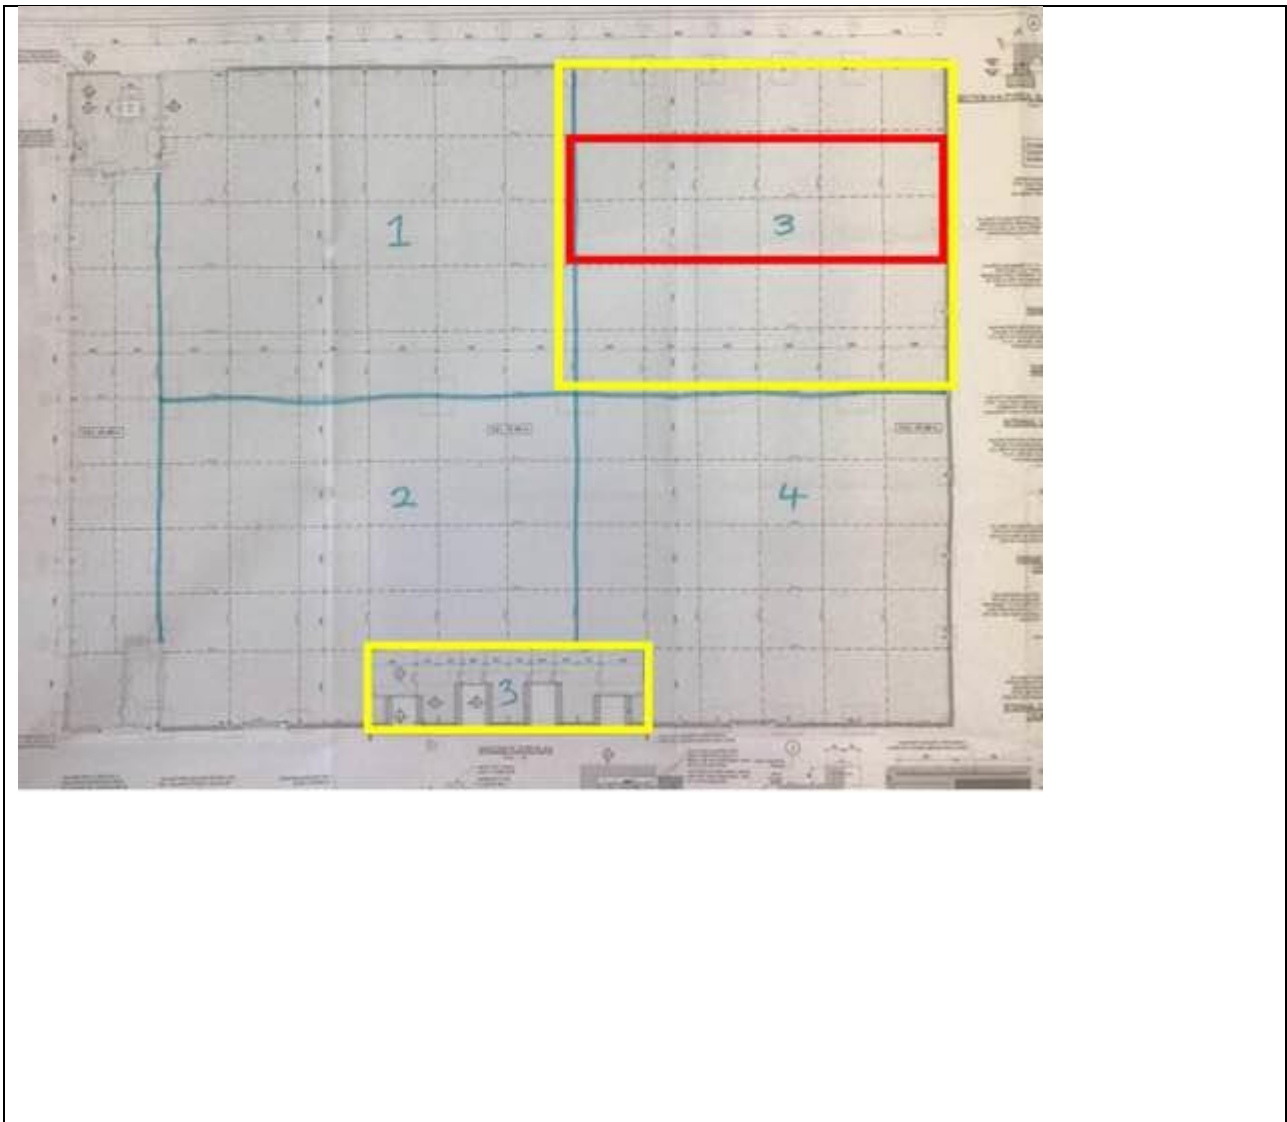
Area Inspected

| | Installation Notes | <p><b><u>(brief description of area/plots and list of defects/repairs identified to the main membrane sheet, excluding detailing and joints)</u></b></p> <p>MEC Environmental carried out a thorough visual inspection of the membrane that was laid as a full line in preparation for the first pump pour. The membrane is lined across the main footprint and is joined together and sealed to the perimeter walls using double sided Butyl tape. All penetrations and patch repairs sealed using SAGM.</p> <p>Site installed miothene strips surrounding all pipes and stanchions prior to the concrete pour.</p> <p>Marked drawing key</p> <p>Red - area of membrane inspected<br/>Yellow - full pour area</p> | |

| | <p><b><u>(List any defects to detailing work and joints):</u></b></p> <p>During our inspection the following defects and repairs were carried out: 15no patch repairs made by the installers using SAGM.</p> <p>Have any defects identified above been satisfactorily rectified <input checked="" type="checkbox"/> Yes <input type="checkbox"/> No <input type="checkbox"/> N/A</p> <p>The Area has passed inspection <input checked="" type="checkbox"/></p> <p>The Area has failed inspection and a corrective action sheet has been left with the contractor <input type="checkbox"/></p> <p>The Area is incomplete as detailed above <input type="checkbox"/></p> <p>Signed: <b>Dan Squire</b> Date: <b>02/09/2022</b></p> | | | |

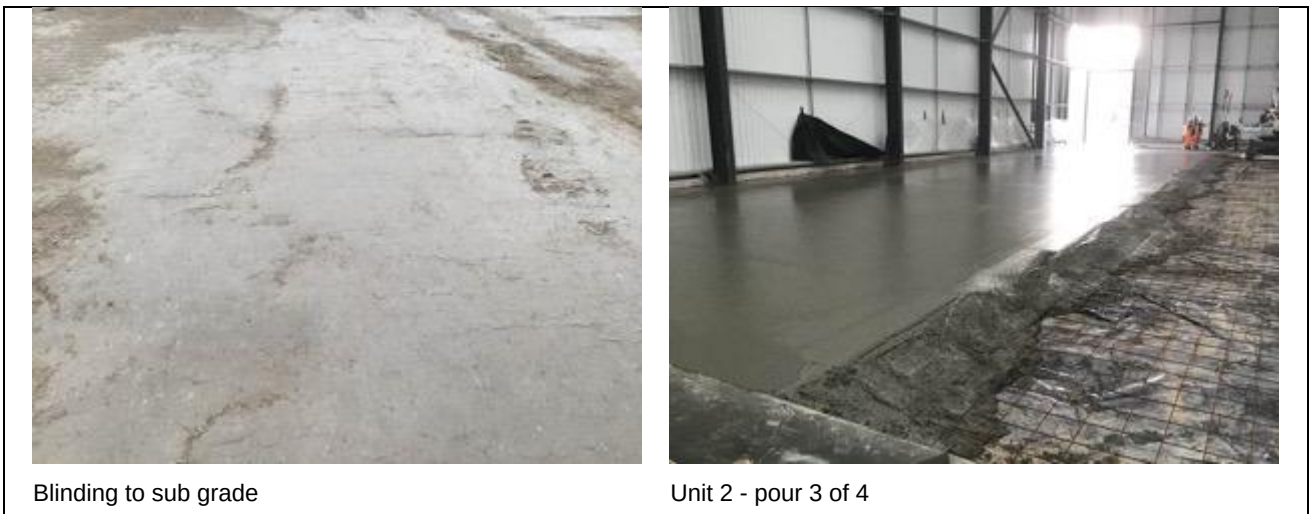
Unit 2 - pour 3 of 4

Blinding to sub grade

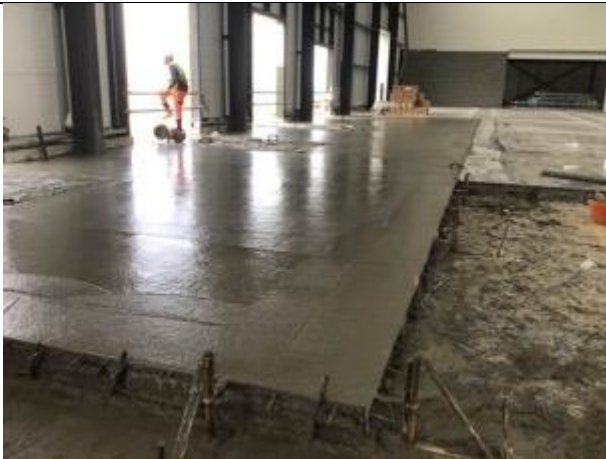
Dock levellers poured prior to our arrival

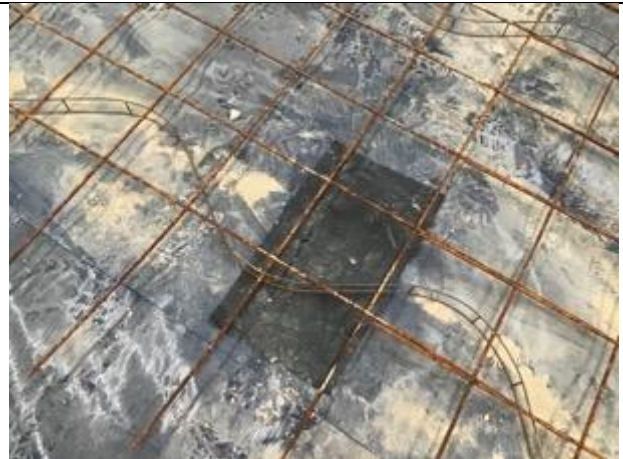
Sealed SAGM patch repair

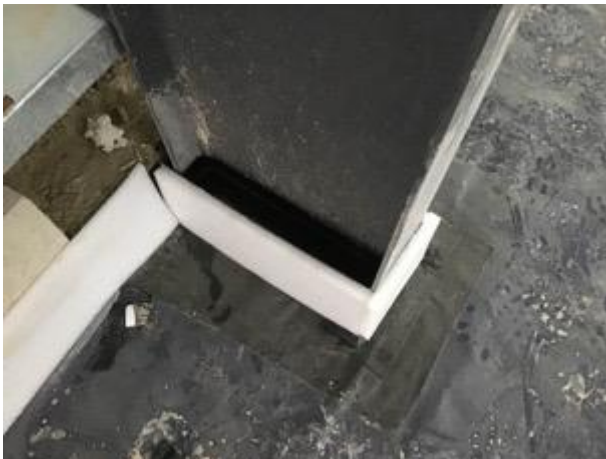
Sealed stanchion detail with miothene installed by others

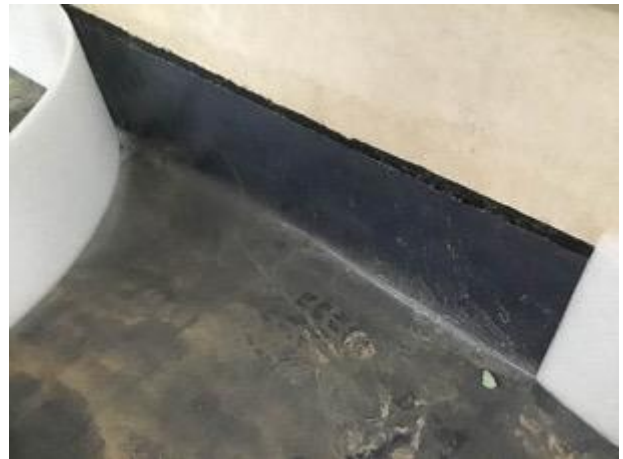
Sealed perimeter detailing

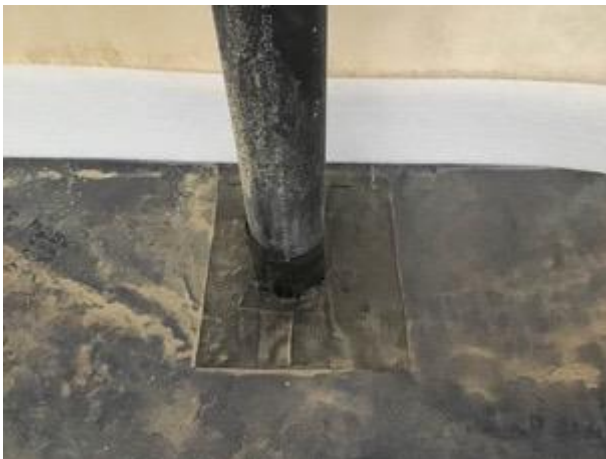
Sealed pipe penetration

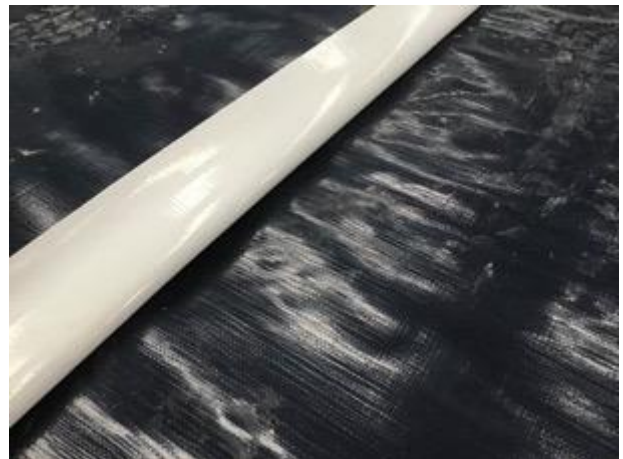
Sealed membrane tape joint
