# DRAINAGE INVESTIGATION REPORT

CLIENT BGP CONSULTING LLP

SITE SAUNDERSON ROAD -  
PENISTONE

DATE 12/10/2012 JOB No. 4771

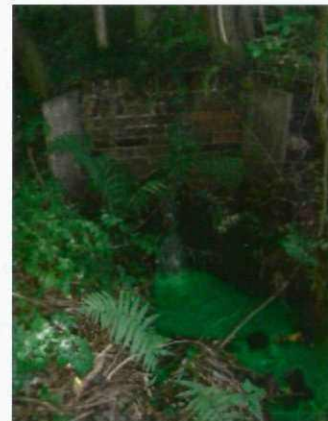
Title: GP8

Description: RIVER DON - OUTFALL FROM  
HIGHWAY GULLY ON SAUNDERSON RD.

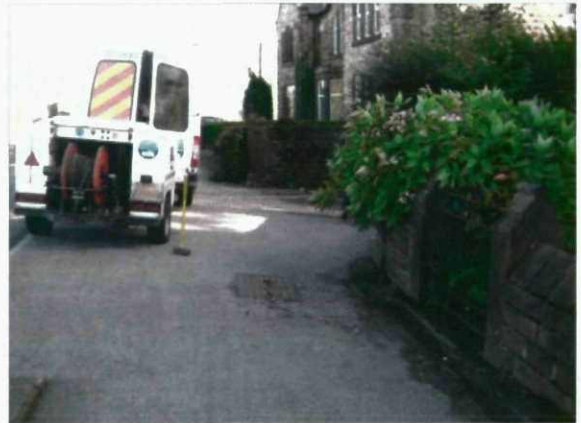
Title: GP12

Description: MANHOLE NOT RAISED - RAISING  
TARMAC

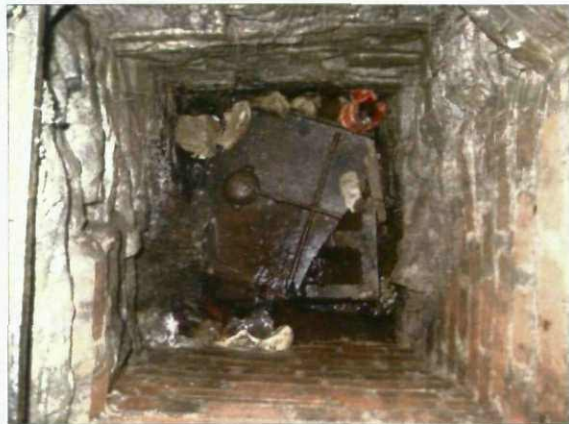
Title: GP15

| REMARKS<br>(Photos etc) | FULL OF DEBRIS - NOT OUTLET VISIBLE | |

Description: EDS3

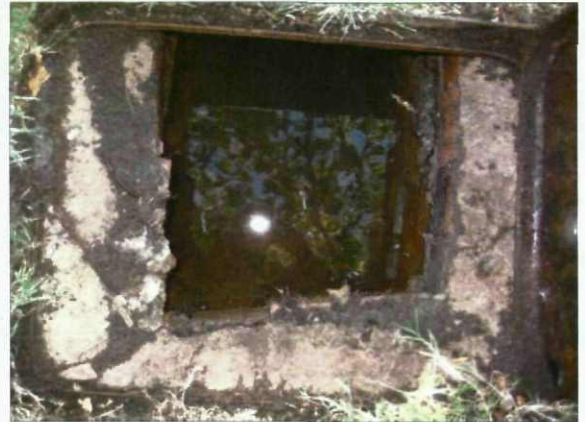
Title: GP18

| REMARKS<br>(Photos etc) | FULL OF WATER - NO PIPEWORK VISIBLE | |

Description: EDS4

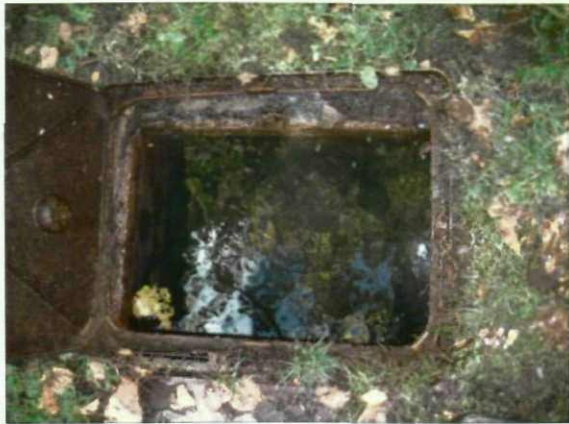
| REMARKS<br>(Photos etc) | FULL OF WATER - NO PIPEWORK VISIBLE | |

Title: GP21  
Date: 12/10/12  
Description: EDS5

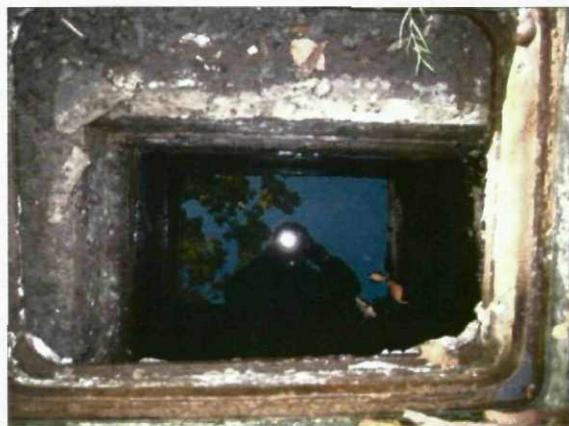
| REMARKS<br>(Photos etc) | FULL OF WATER - NO PIPEWORK VISIBLE | |

Title: GP23  
Date: 12/10/12  
Description: EDS6

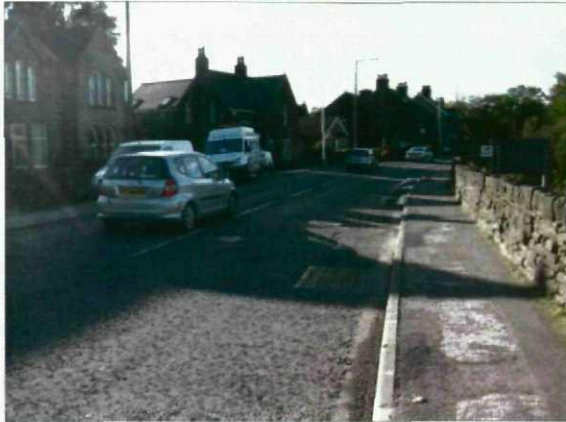
Title: GP25

Description: EDS7 - UNABLE TO RAISE

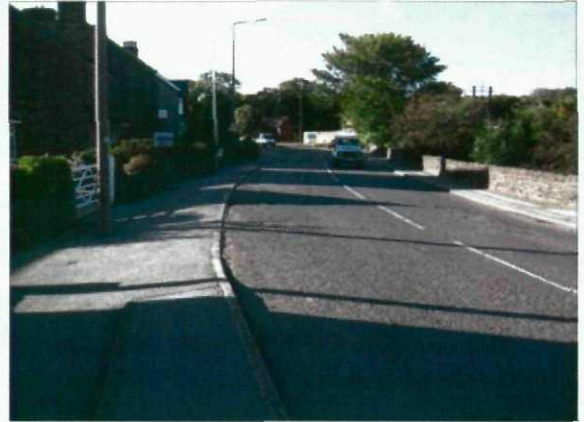
Title: GP26

Description: EDS8 - UNABLE TO RAISE
