# BS 5837: 2012 Arboricultural Survey & Impact Assessment

| Site Address: | 4 West View,<br>Beacon Hill,<br>Silkstone Common<br>S75 4QE | Client: | F.A.O Chris Race |
| Report Ref: | WVBH02-23 | Report Date &<br>Revision: | 26th of June 2023<br>Revision: I |

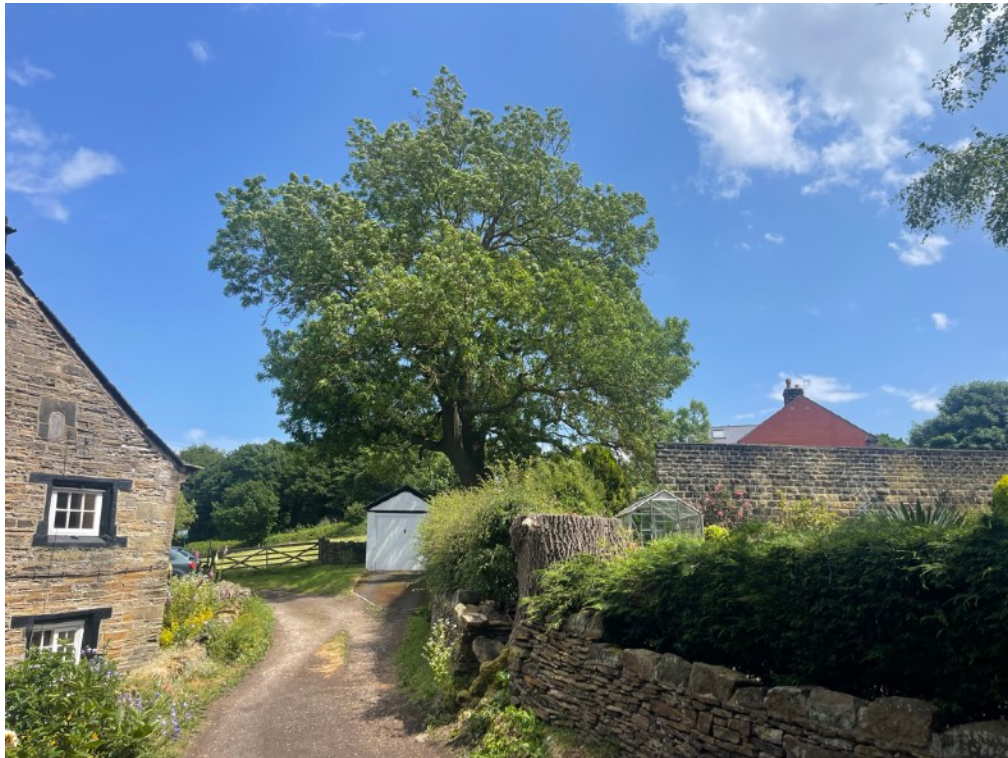
**Figure 1.** T1 covered by a TPO. Ash stump in the foreground previously a further TPO tree.

| Group / Tree No. | Age & Species | Cat. | Removal due to: | | Mitigation required for | | Details of how proposed build layout affects trees and recommendations for mitigation. |
|---|---|---|---|---|---|---|---|
| T1 | Mature Ash<br>( <i>Fraxinus</i> ) | B2 | | | | ✓ | Proposal in close proximity to RPA.<br><br>Protect unmade ground with temporary ground protection. |

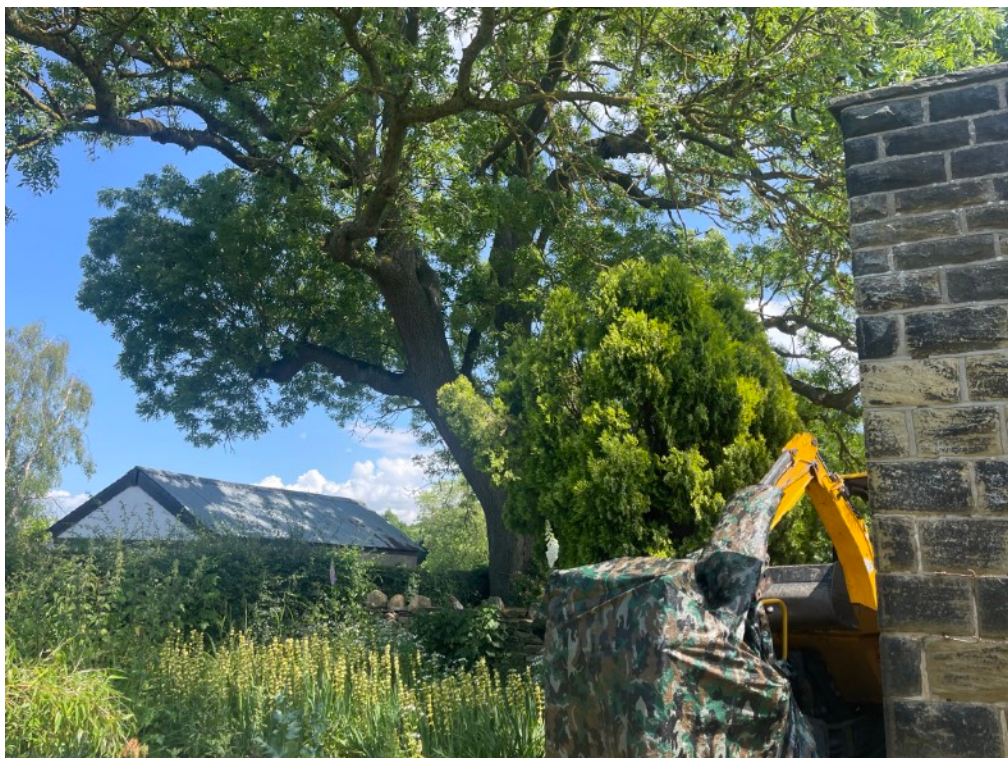
**Figure 2.** T1 in the background with T2 in the foreground.

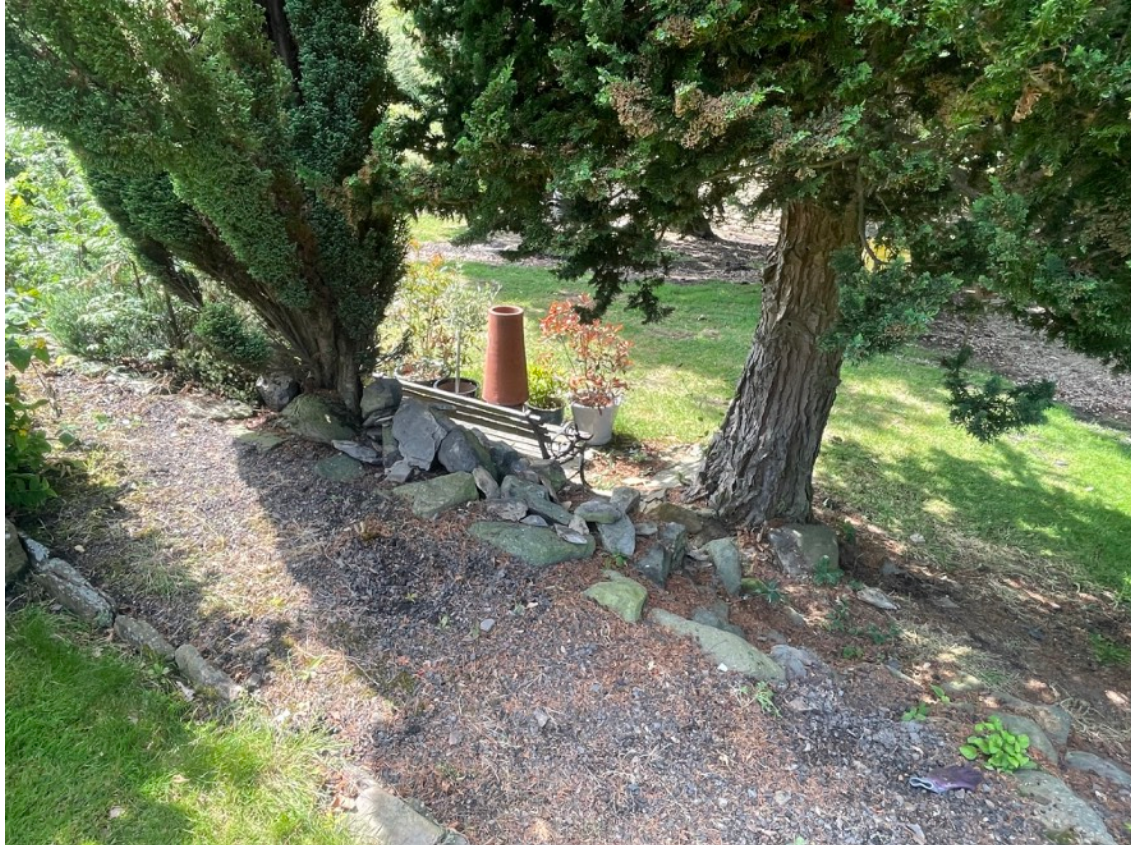
| Group / Tree No. | Age & Species | Cat. | Removal due to: | | Mitigation required for | | Details of how proposed build layout affects trees and recommendations for mitigation. |
|---|---|---|---|---|---|---|---|
| T3/G4 | Early Mature Cypress<br>( <i>cupressus</i> ) | B2/C2 | | | | ✓ | hard landscaping around the proposal impacts over the RPA, however, impact is likely to be negligible due to a change in levels between stem location and development.<br><br>No mitigation considered necessary. |

**Figure 4.** Stems of T3/G4 located below the proposed development site.

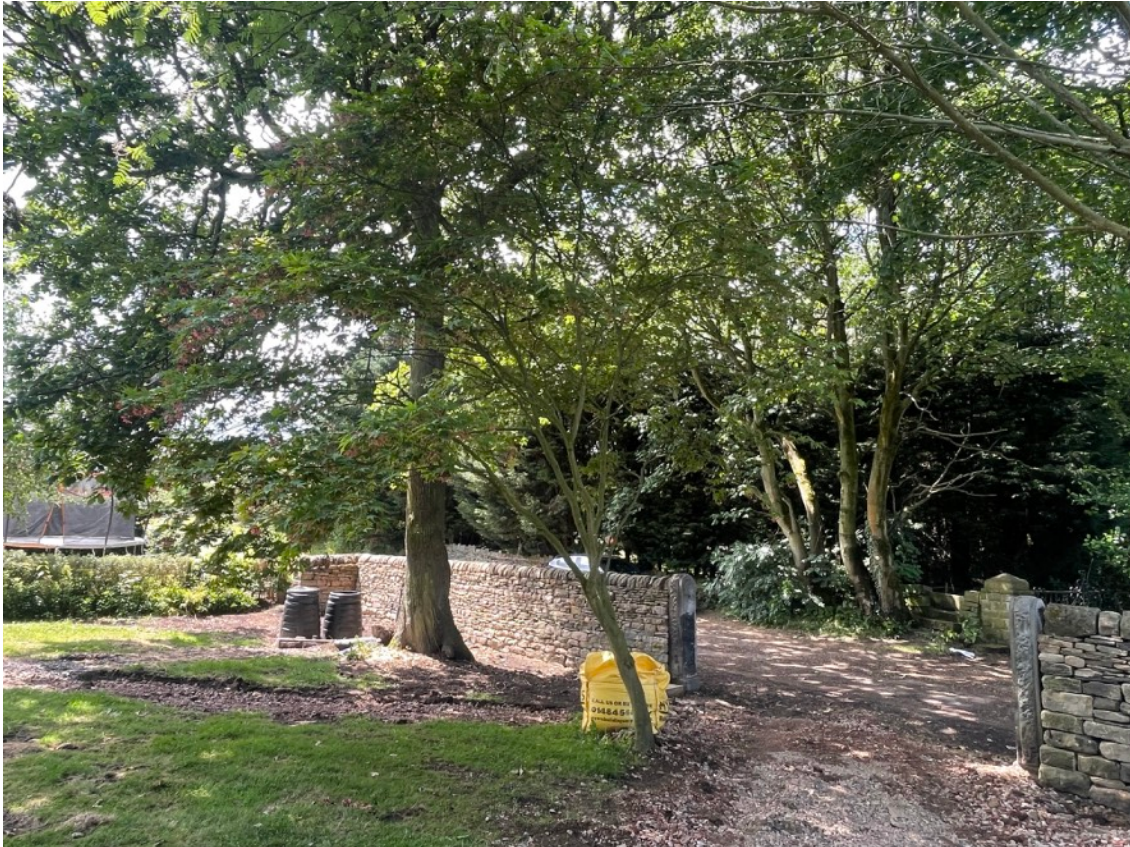
| ID | Age Class | Species | Height (m) | Stem Diameter (mm) | Branch Spread (m) N E S W | First Main Branch Height (m) / Direction | Canopy Height (m) | Vitality | General Observations | Preliminary Management Recommendations | Estimated Remaining Contribution | Category Grading | Root Protection Area Radius (m) |
|---|---|---|---|---|---|---|---|---|---|---|---|---|---|
| T9 | Mature | Japanese maple | 5 | 100, 90 | 2, 4, 2.5, 2 | 2 E | 1.5 | Normal | Heavily suppressed but generally good condition. | None | 20> | B2 | 1.5 |

**Figure 7.** Trees from left to right: T10, T9 and G11 on the opposing side of the road.

| Group / Tree No. | Age & Species | Cat. | Removal due to: | | Mitigation required for | | Details of how proposed build layout affects trees and recommendations for mitigation. |
|---|---|---|---|---|---|---|---|
| T7, T8, T9, T10, T12 | Mix | N/A | | | | ✓ | Soil rooting volumes which are not already covered by hard standing should be protected during the development by way of temporary ground protection.<br><br>Fencing is not considered suitable for this project as it would significantly limit the workspace within the site. |
