# **ARBORICULTURAL REPORT & Impact Assessment to BS 5837:2012 at:**

***Cross Keys Lane,  
Hoyland,  
Barnsley,  
South Yorkshire  
S74 0QA***

Prepared for:  
***FDA Landscape***

Reference: AWA3983

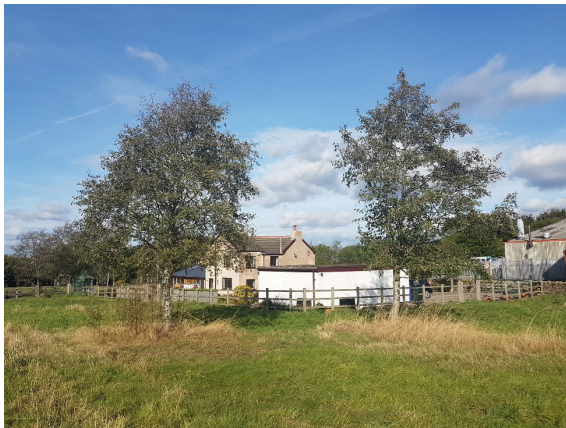
Photo 1: T1 and T2 from south west

| | Tree Species | | | Measurements | | | | Crown (m) | | | | | Tree Condition | | | | | | | | Value | | Management |
|---|---|---|---|---|---|---|---|---|---|---|---|---|---|---|---|---|---|---|---|---|---|---|---|
| T1 | Alder | <i>Alnus incana</i> | Semi-mature | 7 | 1 | 250 | No | 2 | 3 | 3 | 3 | 3 | No visual defects | Single stemmed. Vertical. Epicormic growths | Minor deadwood. Alder Leaf Beetle symptoms. Birds nest | | Good | Good | 20 to 40 yrs | Low | C | Removal required to facilitate development | |
| T2 | Alder | <i>Alnus incana</i> | Semi-mature | 8 | 1 | 210 | No | 1.5 | 2 | 3 | 2.5 | 2 | No visual defects | Single stemmed. Slight lean north east. Epicormic growths | Minor deadwood. Alder Leaf Beetle symptoms | | Good | Good | >40 yrs | Low | C | Removal required to facilitate development | |

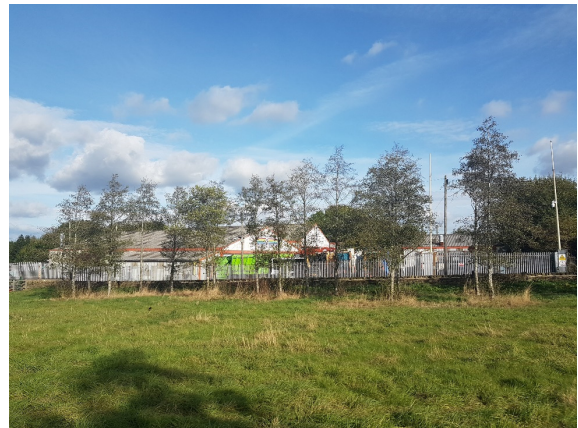
Photo 2: T3 to T17 from west

| | Tree Species | | | Measurements | | | | Crown (m) | | | | | Tree Condition | | | | | | | | Value | | Management |
|---|---|---|---|---|---|---|---|---|---|---|---|---|---|---|---|---|---|---|---|---|---|---|---|
| T3 | Alder | <i>Alnus incana</i> | Semi-mature | 11 | 1 | 200 | No | 1.5 | 2 | 2 | 2.5 | 2.5 | No visual defects | Single stemmed. Vertical. Epicormic growths | Minor deadwood. Alder Leaf Beetle symptoms | | Good | Good | >40 yrs | Low | C | Removal required to facilitate development | |
| T4 | Alder | <i>Alnus incana</i> | Semi-mature | 10 | 1 | 170 | No | 1.5 | 2 | 2.5 | 1.5 | 2 | No visual defects | Single stemmed. Slight lean north east. Epicormic growths | Minor deadwood. Alder Leaf Beetle symptoms | | Good | Good | >40 yrs | Low | C | Removal required to facilitate development | |
| T5 | Alder | <i>Alnus incana</i> | Semi-mature | 10 | 1 | 200 | No | 1.5 | 2 | 2 | 2 | 2.5 | No visual defects | Single stemmed. Vertical. Old pruning wounds | Minor deadwood. Alder Leaf Beetle symptoms | | Good | Good | >40 yrs | Low | C | Removal required to facilitate development | |
| T6 | Alder | <i>Alnus incana</i> | Semi-mature | 11 | 1 | 180 | No | 1.5 | 2.5 | 2.5 | 0.5 | 1.5 | No visual defects | Single stemmed. Vertical. Bark damage. Old pruning wounds | Minor deadwood. Alder Leaf Beetle symptoms | | Good | Good | >40 yrs | Low | C | Removal required to facilitate development | |

| Tree Species | | | | Measurements | | | | Crown (m) | | | | Tree Condition | | | | | | | | Value | | Management | |
|---|---|---|---|---|---|---|---|---|---|---|---|---|---|---|---|---|---|---|---|---|---|---|---|
| | T7 | Alder | <i>Alnus incana</i> | Semi-mature | 10 | 1 | 190 | No | 1.5 | 2 | 3 | 0.5 | 0.5 | No visual defects | Single stemmed. Vertical. Epicormic growths | Minor deadwood. Alder Leaf Beetle symptoms | | Good | Good | >40 yrs | Low | C | Removal required to facilitate development |
| | T8 | Alder | <i>Alnus incana</i> | Semi-mature | 10 | 1 | 180 | No | 1.5 | 2 | 2.5 | 1 | 2.5 | No visual defects | Single stemmed. Vertical. Old pruning wounds | Minor deadwood. Alder Leaf Beetle symptoms | | Good | Good | >40 yrs | Low | C | Removal required to facilitate development |
| | T9 | Alder | <i>Alnus incana</i> | Semi-mature | 10 | 1 | 170 | No | 1.5 | 2 | 1.5 | 1.5 | 2.5 | No visual defects | Single stemmed. Vertical | Minor deadwood. Alder Leaf Beetle symptoms | | Good | Good | >40 yrs | Low | C | Removal required to facilitate development |
| | T10 | Alder | <i>Alnus incana</i> | Semi-mature | 10 | 1 | 170 | No | 1.5 | 2.5 | 2.5 | 1.5 | 1.5 | No visual defects | Single stemmed. Slight lean north east. Epicormic growths. Old pruning wounds | Minor deadwood. Alder Leaf Beetle symptoms | | Good | Good | >40 yrs | Low | C | Removal required to facilitate development |
| | T11 | Alder | <i>Alnus incana</i> | Semi-mature | 10 | 1 | 130 | No | 1.5 | 2 | 1 | 1 | 2 | No visual defects | Single stemmed. Vertical. Epicormic growths | Minor deadwood. Alder Leaf Beetle symptoms | | Good | Good | >40 yrs | Low | C | Removal required to facilitate development |

| Tree Species | | | | Measurements | | | | Crown (m) | | | | | Tree Condition | | | | | | | Value | | Management | |
|---|---|---|---|---|---|---|---|---|---|---|---|---|---|---|---|---|---|---|---|---|---|---|---|
| | T12 | Alder | <i>Alnus incana</i> | Semi-mature | 11 | 1 | 190 | No | 1.5 | 2 | 1 | 1 | 2.5 | No visual defects | Single stemmed. Vertical. Old pruning wounds. Epicormic growths | Minor deadwood. Alder Leaf Beetle symptoms | | Good | Good | >40 yrs | Low | C | Removal required to facilitate development |
| | T13 | Alder | <i>Alnus incana</i> | Semi-mature | 11 | 1 | 210 | No | 1.5 | 2.5 | 3 | 2 | 1.5 | No visual defects | Single stemmed. Vertical | Minor deadwood. Alder Leaf Beetle symptoms | | Good | Good | >40 yrs | Low | C | Removal required to facilitate development |
| | T14 | Alder | <i>Alnus incana</i> | Semi-mature | 11 | 1 | 190 | No | 1.5 | 2.5 | 2.5 | 1 | 1.5 | No visual defects | Single stemmed. Vertical | Minor deadwood. Alder Leaf Beetle symptoms | | Good | Good | >40 yrs | Low | C | Removal required to facilitate development |
| | T15 | Alder | <i>Alnus incana</i> | Semi-mature | 10 | 1 | 220 | No | 1.5 | 2.5 | 2.5 | 2 | 2.5 | No visual defects | Single stemmed. Vertical. Epicormic growths. Staining. Bark damage | Minor deadwood. Alder Leaf Beetle symptoms | Black staining to stem, possible <i>Phytophthora</i> sp. symptoms | Fair | Good | 20 to 40 yrs | Low | C | Removal required to facilitate development |
| | T16 | Alder | <i>Alnus incana</i> | Semi-mature | 10 | 1 | 210 | No | 1.5 | 2 | 2 | 2 | 2 | No visual defects | Single stemmed. Vertical. Epicormic growths | Minor deadwood. Alder Leaf Beetle symptoms | | Good | Good | >40 yrs | Low | C | Removal required to facilitate development |

| Tree ID | Tree Species | | Maturity | Measurements | | | | Crown (m) | | | | Tree Condition | | | | | | | | Value | | Management |
|---|---|---|---|---|---|---|---|---|---|---|---|---|---|---|---|---|---|---|---|---|---|---|
| T17 | Alder | <i>Alnus incana</i> | Semi-mature | 10 | 1 | 200 | No | 6 | 2 | 2.5 | 1.5 | 1 | No visual defects | Single stemmed. Vertical. Epicormic growths. Bark damage. Old pruning wounds | Minor deadwood. Alder Leaf Beetle symptoms | Extensive bark damage to stem | Good | Good | >40 yrs | Low | C | Removal required to facilitate development |

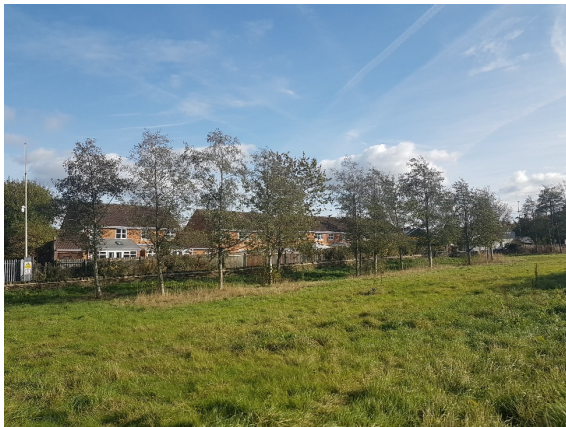
Photo 3: T18 to T30 from north west

| Tree ID | Tree Species | | Maturity | Measurements | | | | Crown (m) | | | | Tree Condition | | | | | | | | Value | | Management |
|---|---|---|---|---|---|---|---|---|---|---|---|---|---|---|---|---|---|---|---|---|---|---|
| T18 | Alder | <i>Alnus incana</i> | Semi-mature | 10 | 1 | 210 | No | 2 | 2.5 | 2 | 1 | 2 | No visual defects | Single stemmed. Slight lean north east. Epicormic growths. Bark damage | Minor deadwood. Alder Leaf Beetle symptoms | | Good | Good | >40 yrs | Low | C | Removal required to facilitate development |
| T19 | Alder | <i>Alnus incana</i> | Semi-mature | 10 | 1 | 180 | No | 1.5 | 2 | 1 | 1.5 | 2.5 | No visual defects | Single stemmed. Vertical. Epicormic growths. Old pruning wounds | Minor deadwood. Alder Leaf Beetle symptoms | | Good | Good | >40 yrs | Low | C | Removal required to facilitate development |
| T20 | Alder | <i>Alnus incana</i> | Semi-mature | 11 | 1 | 210 | No | 1.5 | 1.5 | 1 | 2 | 3 | No visual defects | Single stemmed. Vertical. Old pruning wounds | Minor deadwood. Alder Leaf Beetle symptoms | | Good | Good | >40 yrs | Low | C | Removal required to facilitate development |
| T21 | Alder | <i>Alnus incana</i> | Semi-mature | 11 | 1 | 220 | No | 1.5 | 2 | 2 | 3 | 2.5 | No visual defects | Single stemmed. Vertical. Old pruning wounds | Minor deadwood. Alder Leaf Beetle symptoms | | Good | Good | >40 yrs | Low | C | Removal required to facilitate development |

| Tree Species | | | | Measurements | | | | Crown (m) | | | | | Tree Condition | | | | | | | Value | | Management | |
|---|---|---|---|---|---|---|---|---|---|---|---|---|---|---|---|---|---|---|---|---|---|---|---|
| | T22 | Cherry | Prunus sp. | Semi-mature | 12 | 1 | 240 | No | 2 | 3.5 | 2.5 | 4 | 3 | No visual defects | Single stemmed. Slight lean south | Minor deadwood | Northern stem appears to have been historically damaged. Southern stem now dominant. | Good | Good | >40 yrs | Low | C | Removal required to facilitate development |
| | T23 | Alder | Alnus incana | Semi-mature | 11 | 1 | 210 | No | 1.5 | 2.5 | 2 | 1 | 2.5 | No visual defects | Single stemmed. Vertical. Epicormic growths. Old pruning wounds. Bark damage | Minor deadwood. Alder Leaf Beetle symptoms | Good | Good | >40 yrs | Low | C | Removal required to facilitate development | |
| | T24 | Alder | Alnus incana | Semi-mature | 10 | 1 | 220 | No | 1.5 | 2.5 | 1 | 2 | 3 | No visual defects | Single stemmed. Vertical. Epicormic growths. Old pruning wounds | Minor deadwood. Alder Leaf Beetle symptoms | Good | Good | >40 yrs | Low | C | Removal required to facilitate development | |
| | T25 | Alder | Alnus incana | Semi-mature | 10 | 1 | 170 | No | 1.5 | 2.5 | 2.5 | 1.5 | 1 | No visual defects | Single stemmed. Vertical | Minor deadwood. Alder Leaf Beetle symptoms | Good | Good | >40 yrs | Low | C | Removal required to facilitate development | |
| | T26 | Alder | Alnus incana | Semi-mature | 11 | 1 | 160 | No | 1.5 | 2 | 2 | 1 | 3 | No visual defects | Single stemmed. Vertical | Minor deadwood. Alder Leaf Beetle symptoms | Good | Good | >40 yrs | Low | C | Removal required to facilitate development | |
| | T27 | Alder | Alnus incana | Semi-mature | 12 | 1 | 270 | No | 1.5 | 2.5 | 2.5 | 2.5 | 3.5 | No visual defects | Single stemmed. Vertical. Epicormic growths. Old pruning wounds | Minor deadwood. Alder Leaf Beetle symptoms | Good | Good | >40 yrs | Low | C | Removal required to facilitate development | |

| | Tree Species | | | Measurements | | | | Crown (m) | | | | | Tree Condition | | | | | | | | Value | | Management |
|---|---|---|---|---|---|---|---|---|---|---|---|---|---|---|---|---|---|---|---|---|---|---|---|
| T28 | Alder | <i>Alnus incana</i> | Semi-mature | 11 | 1 | 270 | No | 1.5 | 3 | 3 | 3.5 | 3.5 | No visual defects | Single stemmed. Vertical. Epicormic growths | Minor deadwood. Alder Leaf Beetle symptoms | | Good | Good | >40 yrs | Low | C | Removal required to facilitate development | |
| T29 | Alder | <i>Alnus incana</i> | Semi-mature | 10 | 1 | 210 | No | 1.5 | 2.5 | 2.5 | 2.5 | 2.5 | No visual defects | Single stemmed. Vertical. Old pruning wounds | Minor deadwood. Alder Leaf Beetle symptoms | | Good | Good | >40 yrs | Low | C | Removal required to facilitate development | |
| T30 | Alder | <i>Alnus incana</i> | Semi-mature | 10 | 1 | 170 | No | 1.5 | 2.5 | 2.5 | 2 | 2.5 | No visual defects | Single stemmed. Vertical. Old pruning wounds | Minor deadwood. Alder Leaf Beetle symptoms | | Good | Good | >40 yrs | Low | C | Removal required to facilitate development | |

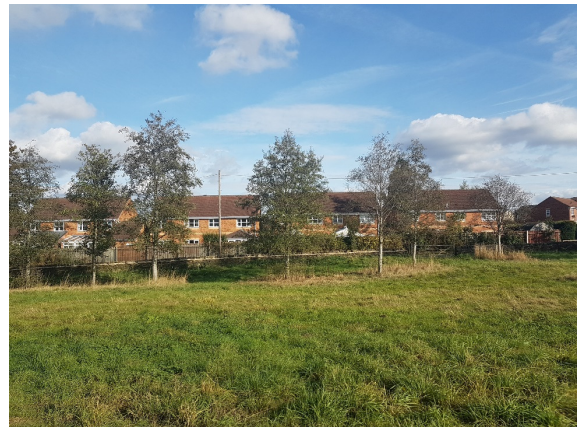
Photo 4: T25 to T31 from west

| | Tree Species | | | Measurements | | | | Crown (m) | | | | | Tree Condition | | | | | | | | Value | | Management |
|---|---|---|---|---|---|---|---|---|---|---|---|---|---|---|---|---|---|---|---|---|---|---|---|
| T31 | Alder | <i>Alnus incana</i> | Semi-mature | 8 | 1 | 180 | No | 1.5 | 2.5 | 1.5 | 2 | 2.5 | No visual defects | Single stemmed. Vertical | Minor deadwood. Alder Leaf Beetle symptoms | Telephone line to east | Good | Good | >40 yrs | Low | C | Removal required to facilitate development | |

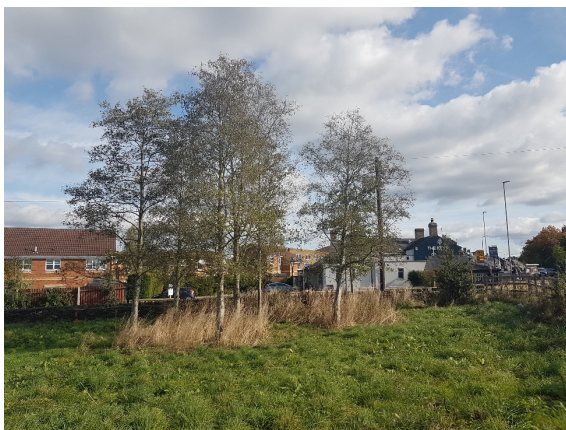
Photo 5: T32 to T39 from north west

| | Tree Species | | | Measurements | | | | Crown (m) | | | | | Tree Condition | | | | | | | | Value | | Management |
|---|---|---|---|---|---|---|---|---|---|---|---|---|---|---|---|---|---|---|---|---|---|---|---|
| T32 | Alder | <i>Alnus incana</i> | Semi-mature | 11 | 1 | 230 | No | 1.5 | 3.5 | 2.5 | 1.5 | 3 | No visual defects | Single stemmed. Slight lean north east | Minor deadwood. Alder Leaf Beetle symptoms | | Good | Good | >40 yrs | Low | C | Removal required to facilitate development | |
| T33 | Alder | <i>Alnus incana</i> | Semi-mature | 10 | 1 | 240 | No | 1.5 | 2.5 | 3.5 | 2 | 2 | No visual defects | Single stemmed. Vertical. Old pruning wounds | Minor deadwood. Alder Leaf Beetle symptoms | Telephone line to east | Good | Good | >40 yrs | Low | C | Removal required to facilitate development | |

| | Tree Species | | | Measurements | | | | Crown (m) | | | | | Tree Condition | | | | | | | | Value | | Management |
|---|---|---|---|---|---|---|---|---|---|---|---|---|---|---|---|---|---|---|---|---|---|---|---|
| T34 | Alder | <i>Alnus incana</i> | Semi-mature | 11 | 1 | 180 | No | 1.5 | 2.5 | 3 | 2 | 1 | No visual defects | Single stemmed. Slight lean north east | Minor deadwood. Alder Leaf Beetle symptoms | Telephone line to east | Good | Good | >40 yrs | Low | C | Removal required to facilitate development | |
| T35 | Alder | <i>Alnus incana</i> | Semi-mature | 9 | 1 | 140 | No | 1.5 | 2.5 | 2.5 | 1.5 | 1 | No visual defects | Single stemmed. Slight lean north east. Bark damage | Minor deadwood. Alder Leaf Beetle symptoms | Telephone line to east | Good | Good | >40 yrs | Low | C | Removal required to facilitate development | |
| T36 | Alder | <i>Alnus incana</i> | Semi-mature | 11 | 1 | 230 | No | 1.5 | 2.5 | 2 | 2 | 3 | No visual defects | Single stemmed. Vertical. Old pruning wounds | Minor deadwood. Alder Leaf Beetle symptoms | | Good | Good | >40 yrs | Low | C | Removal required to facilitate development | |
| T37 | Alder | <i>Alnus incana</i> | Semi-mature | 11 | 1 | 260 | No | 1.5 | 2.5 | 3 | 2 | 2.5 | No visual defects | Single stemmed. Vertical. Old pruning wounds. Bark damage | Minor deadwood. Alder Leaf Beetle symptoms | | Good | Good | >40 yrs | Low | C | Removal required to facilitate development | |
| T38 | Alder | <i>Alnus incana</i> | Semi-mature | 10 | 1 | 240 | No | 1.5 | 2.5 | 3 | 2.5 | 3 | No visual defects | Single stemmed. Slight lean east | Minor deadwood. Alder Leaf Beetle symptoms | | Good | Good | >40 yrs | Low | C | Removal required to facilitate development | |
| T39 | Holly | <i>Ilex aquifolium</i> | Young | 5 | 1 | 80 | No | 0 | 1 | 1 | 1 | 1.5 | No visual defects | Single stemmed. Slight lean east | Minor deadwood | | Good | Good | 20 to 40 yrs | Low | C | Removal required to facilitate development | |

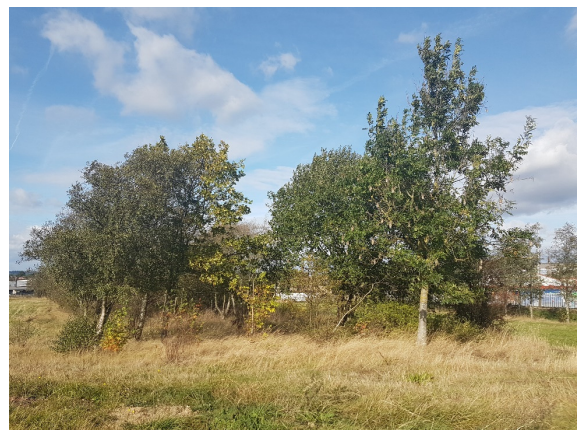
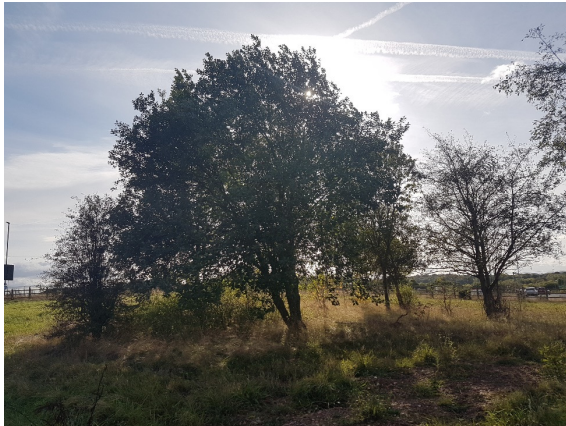
Photo 6: T40 to T45 from south

| Tree ID | Tree Species | | Maturity | Measurements | | | | Crown (m) | | | | Tree Condition | | | | | | | | Value | | Management |
|---|---|---|---|---|---|---|---|---|---|---|---|---|---|---|---|---|---|---|---|---|---|---|
| T40 | Goat Willow | <i>Salix caprea</i> | Semi-mature | 9 | 5 | 150, 200, 150, 90, 180 | No | 0.5 | 5 | 5.5 | 4 | 2.5 | Exposed roots | Multiple stemmed at base. Slight lean north east. Old pruning wounds. Tight unions. Minor cavities. Minor decay. Partially included bark | Minor deadwood. Minor snapouts | | Good | Fair | 20 to 40 yrs | Low | C | Removal required to facilitate development |
| T41 | Ash | <i>Fraxinus excelsior</i> | Semi-mature | 10 | 1 | 210 | No | 1.5 | 2 | 3 | 2.5 | 3 | No visual defects | Single stemmed. Vertical | Minor dieback. Minor deadwood. Minor snapouts | Minor dieback in crown | Fair | Good | 10 to 20 yrs | Low | C | Removal required to facilitate development |
| T42 | Oak | <i>Quercus robur</i> | Semi-mature | 8 | 1 | 170 | No | 2.5 | 1.5 | 3 | 2 | 0.5 | No visual defects | Single stemmed. Slight lean north east | Minor deadwood | | Good | Good | >40 yrs | Low | C | Removal required to facilitate development |
| T43 | Birch | <i>Betula pendula</i> | Semi-mature | 7.5 | 2 | 120, 110 | No | 1.5 | 2.5 | 2.5 | 2.5 | 2 | No visual defects | Twin stemmed at 1m. Slight lean north east. Epicormic growths. Tight unions | Minor deadwood | | Good | Good | 20 to 40 yrs | Low | C | Removal required to facilitate development |
| T44 | Alder | <i>Alnus incana</i> | Semi-mature | 6 | 3 | 120, 140, 80 | No | 2 | 2 | 2.5 | 3 | 1.5 | No visual defects | Multiple stemmed at 0.5m. Slight lean north east. Bark damage. Tight unions | Minor deadwood. Alder Leaf Beetle symptoms | Large bark wounds at base | Fair | Fair | 20 to 40 yrs | Low | C | Removal required to facilitate development |

| | Tree Species | | | Measurements | | | | Crown (m) | | | | | Tree Condition | | | | | | | | Value | | Management |
|---|---|---|---|---|---|---|---|---|---|---|---|---|---|---|---|---|---|---|---|---|---|---|---|
| T45 | Alder | <i>Alnus incana</i> | Semi-mature | 7 | 1 | 220 | No | 1.5 | 3 | 3 | 2 | 2 | No visual defects | Single stemmed. Slight lean north east. Epicormic growths. Stubs | Minor deadwood. Alder Leaf Beetle symptoms | Significant snapout at base | Fair | Fair | 20 to 40 yrs | Low | C | Removal required to facilitate development | |

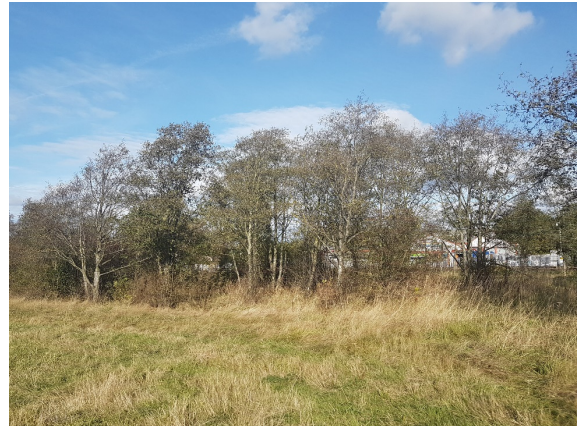
Photo 8: T46 to T54 from south west

| | Tree Species | | | Measurements | | | | Crown (m) | | | | | Tree Condition | | | | | | | | Value | | Management |
|---|---|---|---|---|---|---|---|---|---|---|---|---|---|---|---|---|---|---|---|---|---|---|---|
| T46 | Alder | <i>Alnus incana</i> | Semi-mature | 6.5 | 2 | 170, 130 | No | 2 | 2 | 2.5 | 2 | 2.5 | No visual defects | Twin stemmed at 0.5m. Vertical. Epicormic growths | Minor deadwood. Minor snapouts. Alder Leaf Beetle symptoms | | Fair | Fair | 20 to 40 yrs | Low | C | Removal required to facilitate development | |
| T47 | Alder | <i>Alnus incana</i> | Semi-mature | 6.5 | 3 | 130, 110, 50 | No | 2 | 2 | 2 | 2 | 2 | No visual defects | Twin stemmed at 0.5m. Vertical. Epicormic growths | Minor deadwood. Minor snapouts. Alder Leaf Beetle symptoms | | Fair | Fair | 20 to 40 yrs | Low | C | Removal required to facilitate development | |
| T48 | Rowan | <i>Sorbus sp.</i> | Semi-mature | 6.5 | 2 | 130, 60 | Yes | 2 | 2 | 2.5 | 2 | 1.5 | No visual defects | Twin stemmed at 1m. Slight lean east | Minor deadwood | | Good | Good | 10 to 20 yrs | Low | C | Removal required to facilitate development | |
| T49 | Alder | <i>Alnus incana</i> | Semi-mature | 7 | 1 | 240 | No | 2 | 2.5 | 2.5 | 2.5 | 2.5 | No visual defects | Single stemmed. Vertical. Epicormic growths | Minor deadwood. Minor snapouts. Alder Leaf Beetle symptoms | | Fair | Good | 20 to 40 yrs | Low | C | Removal required to facilitate development | |
| T50 | Alder | <i>Alnus incana</i> | Semi-mature | 7.5 | 3 | 100, 130, 210 | No | 2 | 3 | 3 | 3 | 3 | No visual defects | Multiple stemmed at base. Vertical. Epicormic growths | Minor deadwood. Minor snapouts. Alder Leaf Beetle symptoms | | Fair | Good | 20 to 40 yrs | Low | C | Removal required to facilitate development | |

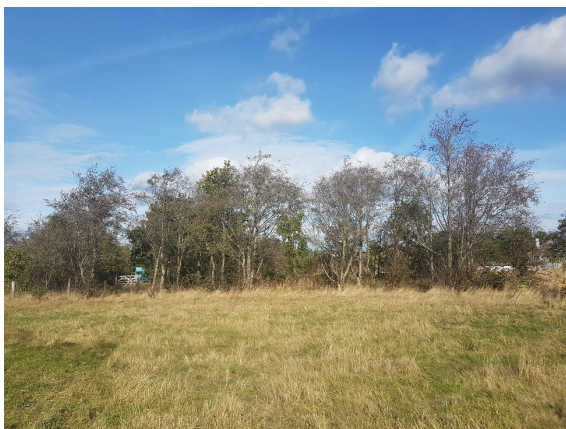
Photo 11: T70 to T85 from west

| Tree ID | Tree Species | | Maturity | Measurements | | | | Crown (m) | | | | Tree Condition | | | | | | | | Value | | Management |
|---|---|---|---|---|---|---|---|---|---|---|---|---|---|---|---|---|---|---|---|---|---|---|
| T85 | Alder | <i>Alnus incana</i> | Semi-mature | 8 | 2 | 170, 110 | No | 2 | 2.5 | 3 | 2 | 2 | No visual defects | Twin stemmed at 0.5m. Vertical. Stubs. Bark damage | Minor deadwood. Alder Leaf Beetle symptoms | | Good | Good | 20 to 40 yrs | Low | C | Removal required to facilitate development |

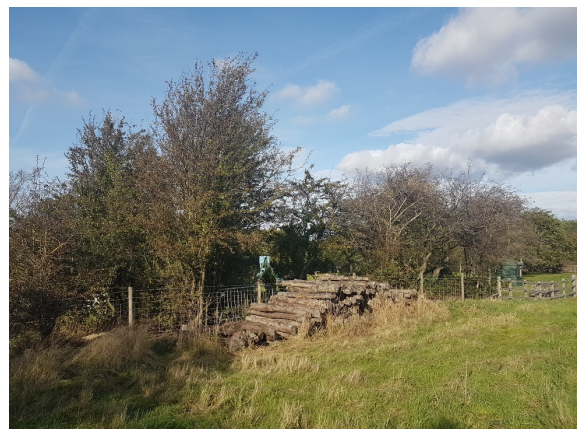
Photo 12: G86 from south west

- 3.2.6 G86 forms an adjacent tree group situated in adjacent land beyond the site's northern boundary. The group is comprised predominantly of shrubby Hawthorn with occasional young to semi mature Alder. The tree group was only given a cursory inspection with measurements estimated and condition values indicative only.

| Tree ID | Tree Species | | Maturity | Measurements | | | | Crown (m) | | | | Tree Condition | | | | | | | | Value | | Management |
|---|---|---|---|---|---|---|---|---|---|---|---|---|---|---|---|---|---|---|---|---|---|---|
| G86 | Hawthorn. Alder. | <i>Crataegus sp.</i><br><i>Alnus sp.</i> | Semi-mature | 7 | 10 | 80 | Yes | 1 | See plan | | | | Limited access around base | Single and Multiple stemmed | Minor deadwood | Adjacent, no access. Young to semi mature tree group. Predominantly shrubby Hawthorn with occasional Alder. Sporadic. | Fair | Fair | 20 to 40 yrs | Low | C | No works required |
