* inc. architecture ltd		the barn, mock hall farm, 63 leads road, mirfield, wf14 6da, west yorkshire tel: 07831 275394, e-mail: mail@inc-architecture.co.uk, www.inc-architecture.com		© 2022	
project	HARRAL BUILDING, 32-38 ELDON STREET, BARNSELY	status	PLANNING PERMISSION		
client	SIMON SANGHA	date	APRIL 2022	scale	1:50 @ A1
dwg title	PROPOSED REPAIR ELEVATIONS (SHEET 1)	dwg no.	132/P/203	rev.	
revision notes:

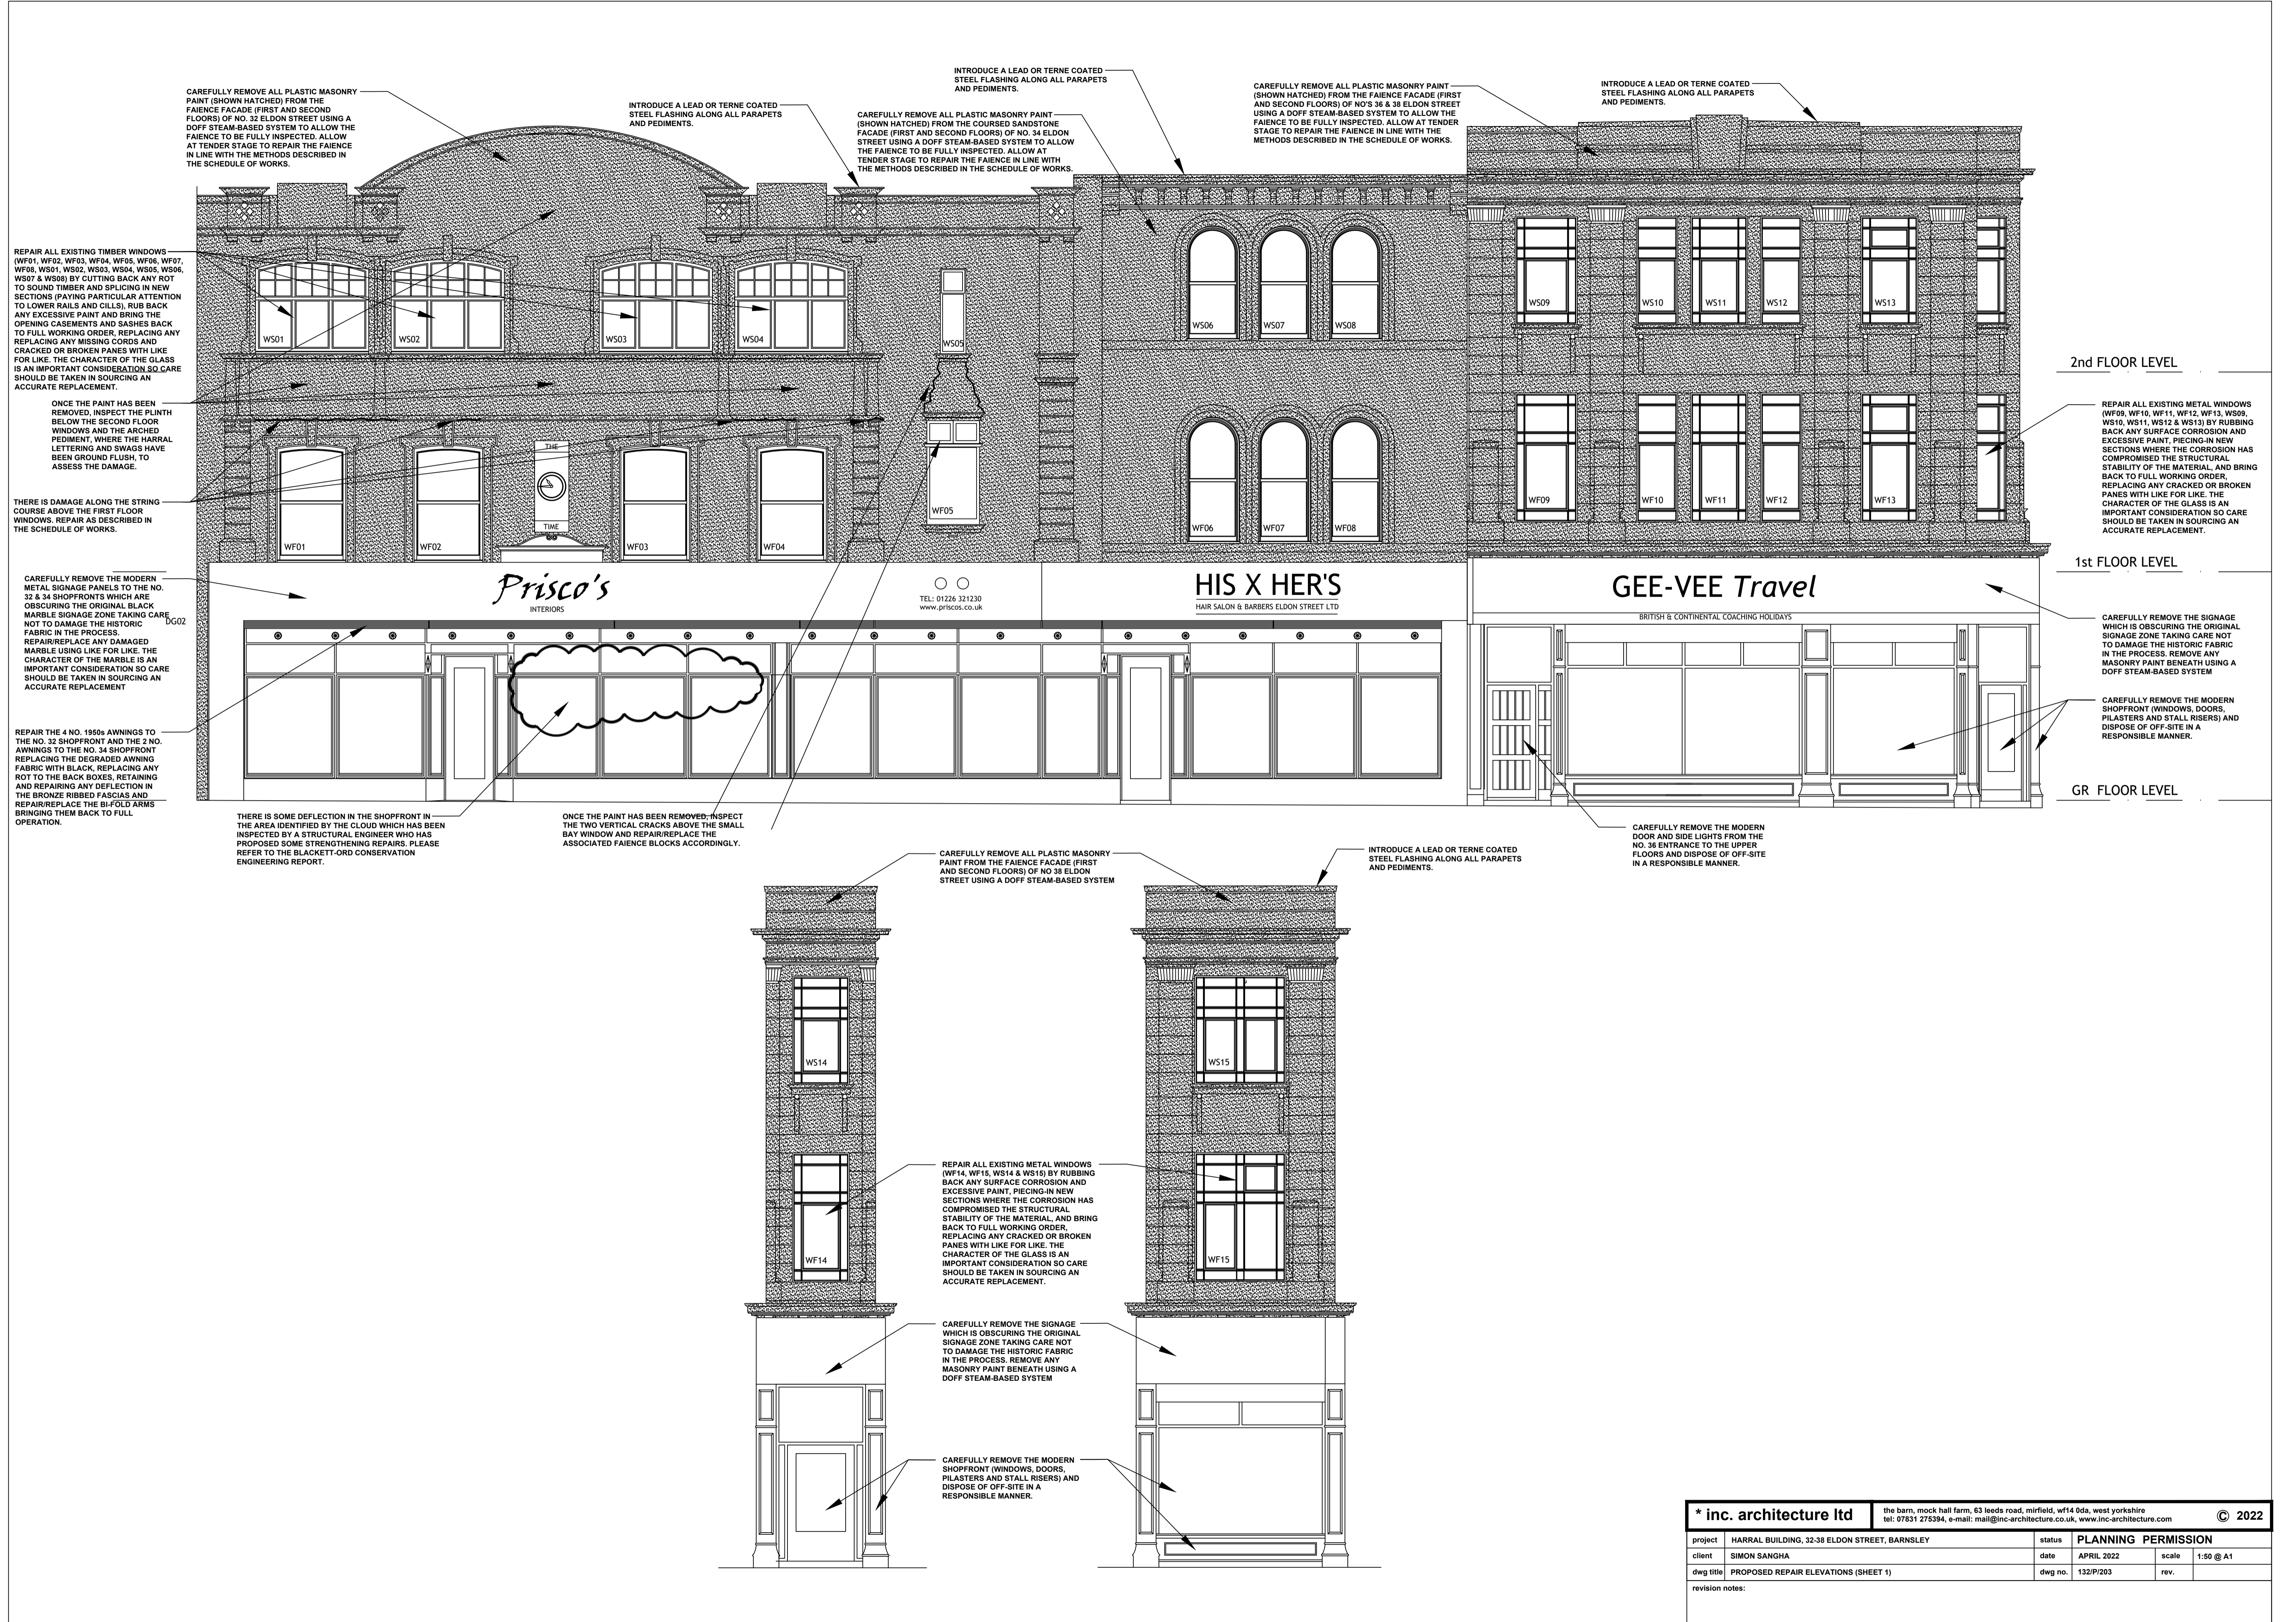
ONCE THE PAINT HAS BEEN REMOVED, INSPECT THE PLINTH BELOW THE SECOND FLOOR WINDOWS AND THE ARCHED PEDIMENT, WHERE THE HARRAL LETTERING AND SWAGS HAVE BEEN GROUND FLUSH, TO ASSESS THE DAMAGE.

THERE IS DAMAGE ALONG THE STRING COURSE ABOVE THE FIRST FLOOR WINDOWS. REPAIR AS DESCRIBED IN THE SCHEDULE OF WORKS.

THERE IS SOME DEFLECTION IN THE SHOPFRONT IN THE AREA IDENTIFIED BY THE CLOUD WHICH HAS BEEN INSPECTED BY A STRUCTURAL ENGINEER WHO HAS PROPOSED SOME STRENGTHENING REPAIRS. PLEASE REFER TO THE BLACKETT-ORD CONSERVATION ENGINEERING REPORT.

ONCE THE PAINT HAS BEEN REMOVED, INSPECT THE TWO VERTICAL CRACKS ABOVE THE SMALL BAY WINDOW AND REPAIR/REPLACE THE ASSOCIATED FAIENCE BLOCKS ACCORDINGLY.

CAREFULLY REMOVE ALL PLASTIC MASONRY PAINT (SHOWN HATCHED) FROM THE FAIENCE FACADE (FIRST AND SECOND FLOORS) OF NO. 32 ELDON STREET USING A DOFF STEAM-BASED SYSTEM TO ALLOW THE FAIENCE TO BE FULLY INSPECTED. ALLOW AT TENDER STAGE TO REPAIR THE FAIENCE IN LINE WITH THE METHODS DESCRIBED IN THE SCHEDULE OF WORKS.

INTRODUCE A LEAD OR TERNE COATED STEEL FLASHING ALONG ALL PARAPETS AND PEDIMENTS.

CAREFULLY REMOVE ALL PLASTIC MASONRY PAINT (SHOWN HATCHED) FROM THE COURSED SANDSTONE FACADE (FIRST AND SECOND FLOORS) OF NO. 34 ELDON STREET USING A DOFF STEAM-BASED SYSTEM TO ALLOW THE FAIENCE TO BE FULLY INSPECTED. ALLOW AT TENDER STAGE TO REPAIR THE FAIENCE IN LINE WITH THE METHODS DESCRIBED IN THE SCHEDULE OF WORKS.

CAREFULLY REMOVE ALL PLASTIC MASONRY PAINT (SHOWN HATCHED) FROM THE FAIENCE FACADE (FIRST AND SECOND FLOORS) OF NO'S 36 & 38 ELDON STREET USING A DOFF STEAM-BASED SYSTEM TO ALLOW THE FAIENCE TO BE FULLY INSPECTED. ALLOW AT TENDER STAGE TO REPAIR THE FAIENCE IN LINE WITH THE METHODS DESCRIBED IN THE SCHEDULE OF WORKS.

REPAIR ALL EXISTING TIMBER WINDOWS (WF01, WF02, WF03, WF04, WF05, WF06, WF07, WF08, WS01, WS02, WS03, WS04, WS05, WS06, WS07 & WS08) BY CUTTING BACK ANY ROT TO SOUND TIMBER AND SPICING IN NEW SECTIONS (PAYING PARTICULAR ATTENTION TO LOWER RAILS AND CILLS), RUB BACK ANY EXCESSIVE PAINT AND BRING THE OPENING CASEMENTS AND SASHES BACK TO FULL WORKING ORDER, REPLACING ANY MISSING CORDS AND CRACKED OR BROKEN PANEES WITH LIKE FOR LIKE. THE CHARACTER OF THE GLASS IS AN IMPORTANT CONSIDERATION SO CARE SHOULD BE TAKEN IN SOURCING AN ACCURATE REPLACEMENT.

CAREFULLY REMOVE THE MODERN METAL SIGNAGE PANELS TO THE NO. 32 & 34 SHOPFRONTS WHICH ARE OBSCURING THE ORIGINAL BLACK MARBLE SIGNAGE ZONE TAKING CARE NOT TO DAMAGE THE HISTORIC FABRIC IN THE PROCESS. REPAIR/REPLACE ANY DAMAGED MARBLE USING LIKE FOR LIKE. THE CHARACTER OF THE MARBLE IS AN IMPORTANT CONSIDERATION SO CARE SHOULD BE TAKEN IN SOURCING AN ACCURATE REPLACEMENT.

REPAIR THE 4 NO. 1950s AWNINGS TO THE NO. 32 SHOPFRONT AND THE 2 NO. AWNINGS TO THE NO. 34 SHOPFRONT REPLACING THE DEGRADED AWNING FABRIC WITH BLACK, REPLACING ANY ROT TO THE BACK BOXES, RETAINING AND REPAIRING ANY DEFLECTION IN THE BRONZE RIBBED FASCIAS AND REPAIR/REPLACE THE BI-FOLD ARMS BRINGING THEM BACK TO FULL OPERATION.

CAREFULLY REMOVE ALL PLASTIC MASONRY PAINT FROM THE FAIENCE FACADE (FIRST AND SECOND FLOORS) OF NO 38 ELDON STREET USING A DOFF STEAM-BASED SYSTEM

CAREFULLY REMOVE THE MODERN DOOR AND SIDE LIGHTS FROM THE NO. 38 ENTRANCE TO THE UPPER FLOORS AND DISPOSE OF OFF-SITE IN A RESPONSIBLE MANNER.

REPAIR ALL EXISTING METAL WINDOWS (WF09, WF10, WF11, WF12, WF13, WS09, WS10, WS11, WS12 & WS13) BY RUBBING BACK ANY SURFACE CORROSION AND EXCESSIVE PAINT, PIECING-IN NEW SECTIONS WHERE THE CORROSION HAS COMPROMISED THE STRUCTURAL STABILITY OF THE MATERIAL, AND BRING BACK TO FULL WORKING ORDER, REPLACING ANY CRACKED OR BROKEN PANEES WITH LIKE FOR LIKE. THE CHARACTER OF THE GLASS IS AN IMPORTANT CONSIDERATION SO CARE SHOULD BE TAKEN IN SOURCING AN ACCURATE REPLACEMENT.

CAREFULLY REMOVE THE SIGNAGE WHICH IS OBSCURING THE ORIGINAL SIGNAGE ZONE TAKING CARE NOT TO DAMAGE THE HISTORIC FABRIC IN THE PROCESS. REMOVE ANY MASONRY PAINT BENEATH USING A DOFF STEAM-BASED SYSTEM

CAREFULLY REMOVE THE MODERN SHOPFRONT (WINDOWS, DOORS, PILASTERS AND STALL RISERS) AND DISPOSE OF OFF-SITE IN A RESPONSIBLE MANNER.
