**Tree Survey:** The Crown and Anchor,  
Barugh Lane, Barugh Green,  
Barnsley, S75 1LL.

**Client:** True North Brew Co.  
via Tracy-Jane Neal, Melling Ridgeway.

**Date of Survey:** February 13<sup>th</sup> 2025.

**File reference:** Crown & Anchor 01

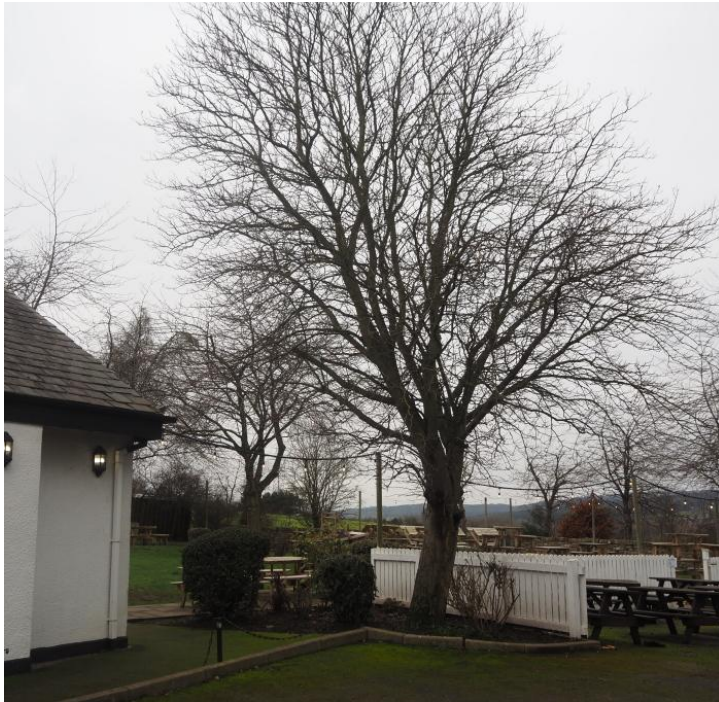
Photograph 1.

| Tree No. | Species. | Ht | TD | Age class | Category | Comments. | RPA |
|---|---|---|---|---|---|---|---|
| 1. | Whitebeam | 9 | 450 | M | C1 | Crown reaches 4 metres in all directions. Some old pruning wounds have decay that's insignificant at this time. Only 4 metres from the building. An untidy specimen. Will be only a couple of metres from the extension. | 92 |

Photograph 1 shows tree 1 the Whitebeam. It was a dull day and the picture is rather dark, but it's clear that if the extension is erected the new building will be only a couple of metres from the trunk of the tree. This is well within the BS5837-suggested RPA, which would be 6 metres radius.

All things considered I think it would be wisest to remove this tree and plant a new one when construction work is complete. The tree is not a particularly good specimen and as it's rather hidden from view by the existing building, not many passers-by are likely to notice it missing. It certainly isn't the sort of tree that should stand in the way of development proposal. In terms of the Government's Guidance on Tree Preservation Orders (TPO) it has low amenity value, so its management is entirely up to the owners. I also note here that

1. I see no reason for trees to stand in the way of this proposal.
2. I recommend tree 1 is removed and a new tree planted when construction work is finished.

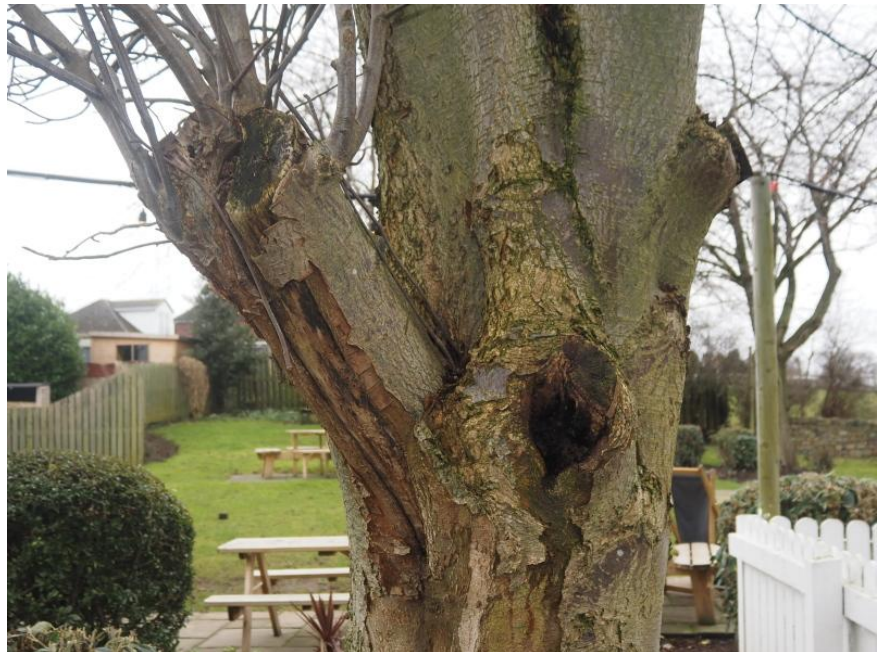
Photograph 2.

Photograph 2 is a view of tree 1's trunk showing some old pruning wounds and superficial decay that's resulted from the pruning.

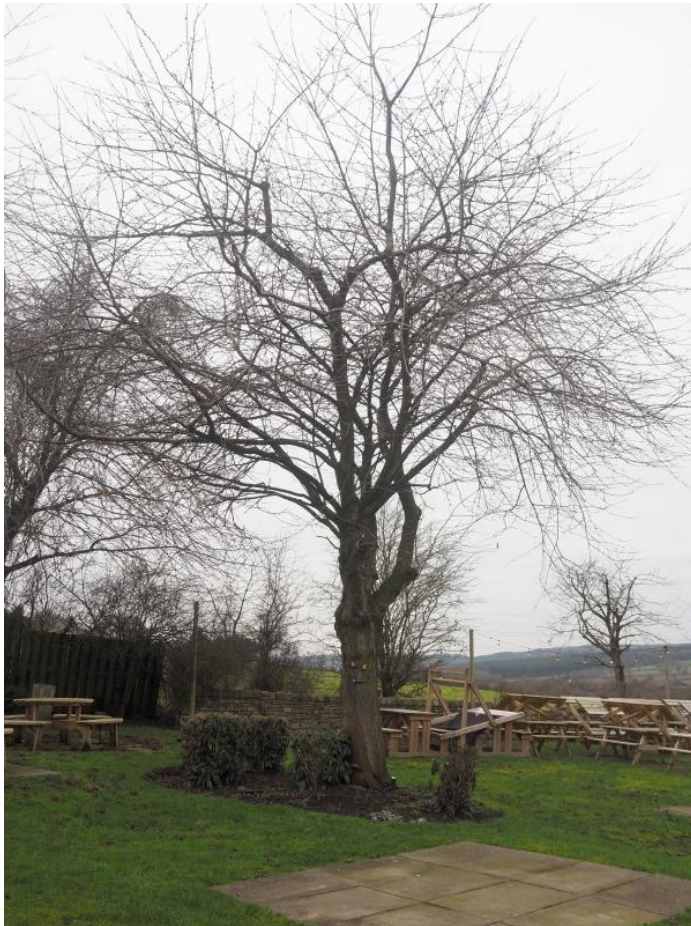
Photograph 3.

Photograph 3 shows tree 2 a Cherry. I estimate (from the proposal drawing) that this tree will be 7 metres from the rear of the proposed building, although there will be a patio somewhat closer. Assuming the patio does not require any substantial soil level changes within this tree's RPA (6 metres radius) then I think it's unlikely to be affected adversely by the proposal.

Whatever the situation, this is another tree with low amenity value. It's not a major feature in the local landscape.

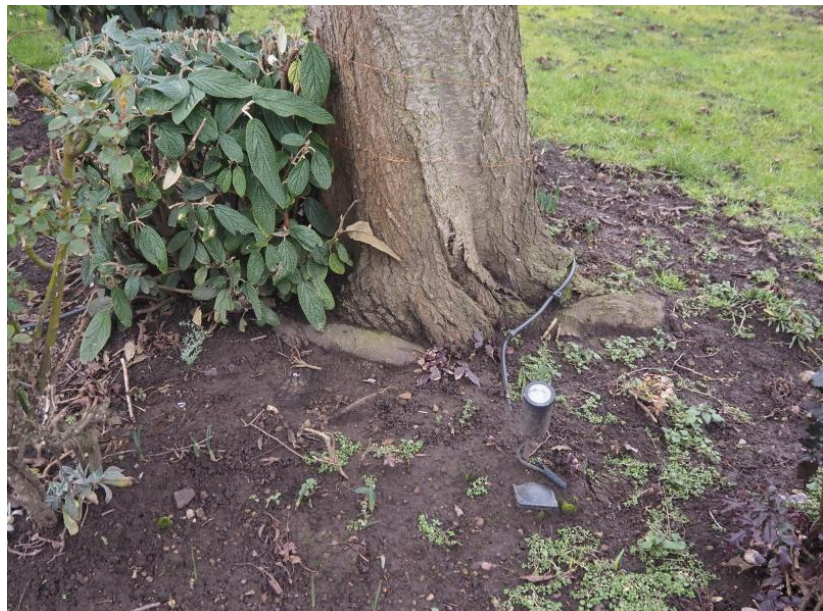
Photograph 4.

Photograph 4 shows the base of tree 2; it's got floodlights and their cables nailed to the roots and to the trunk. This is bad practice, even though I don't think it's doing too much harm at the moment.

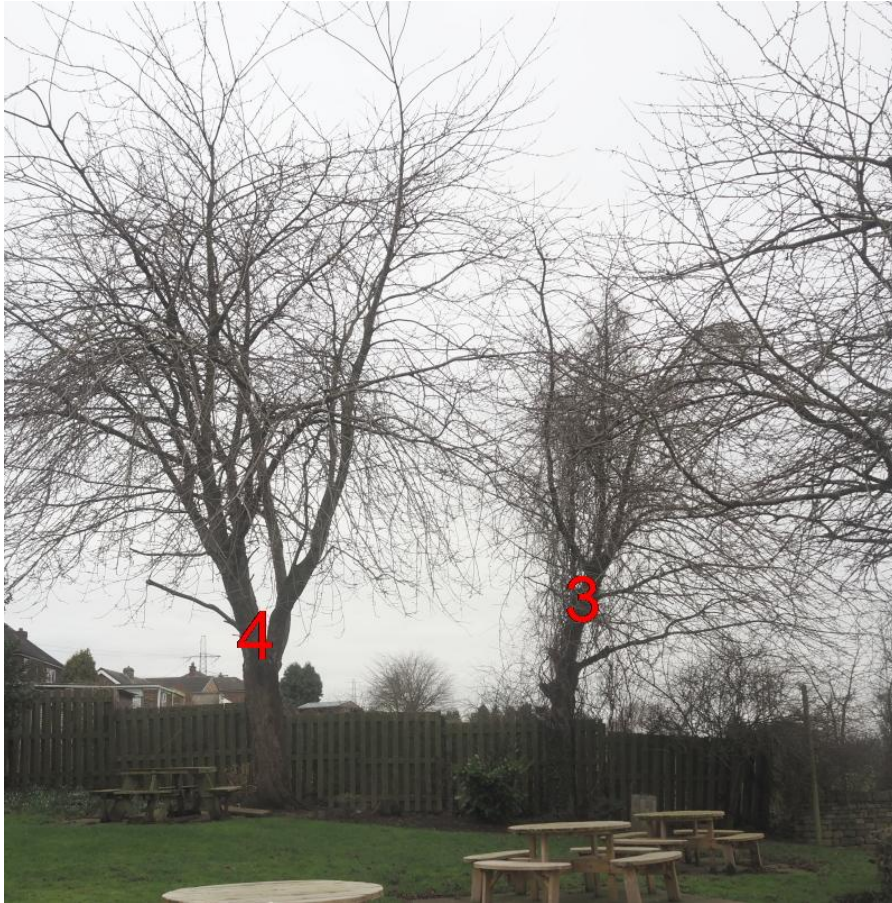
Photograph 5.

Photograph 5 is a view of trees 3 & 4 on the north west boundary. this is taken looking roughly west. These trees are well away from the proposal.

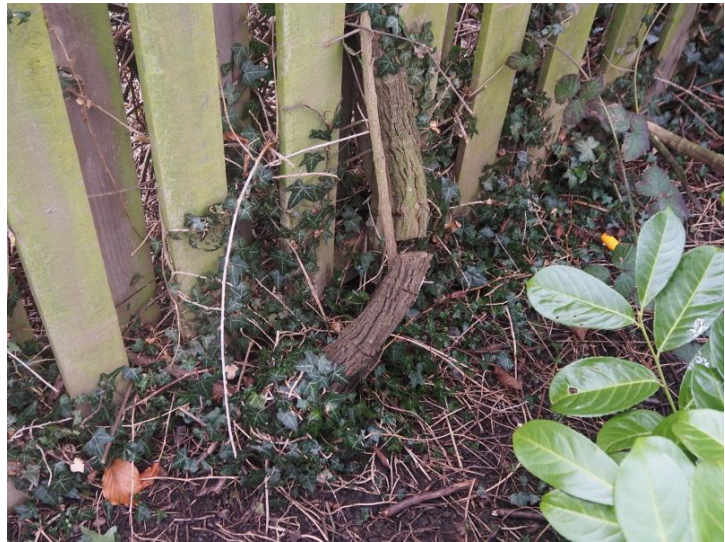
Photograph 6.

Photograph 6 shows the cut stem of the climbing Rose that festoons tree 3. The reason I'm not sure whether the Rose is dead is because there may be more than one stem.

I'm not sure why the Rose stem has been cut; it's possible that somebody was anticipating climbing the tree to prune it and therefore decided it would be wise to kill the rose. Unfortunately climbers like this take some years to rot away and fall from the tree, and the thorns are no less sharp in the meantime! (Some people plant such roses along fences to deter intruders. I don't know if that's why this was planted here. Horticulture students used to be taught that such plants were a sort-of natural barbed wire.)

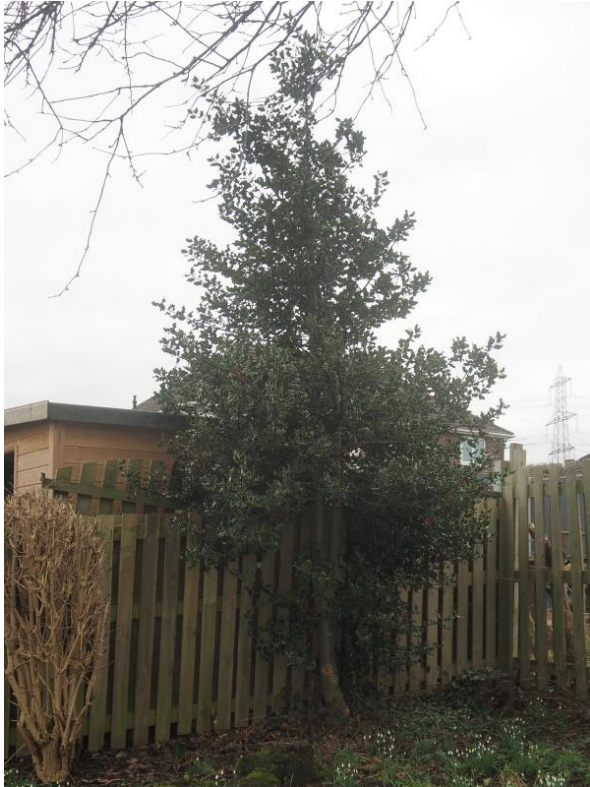
Photograph 7.

Photograph 7 is a view of the Holly tree 5. It's little more than a sapling really

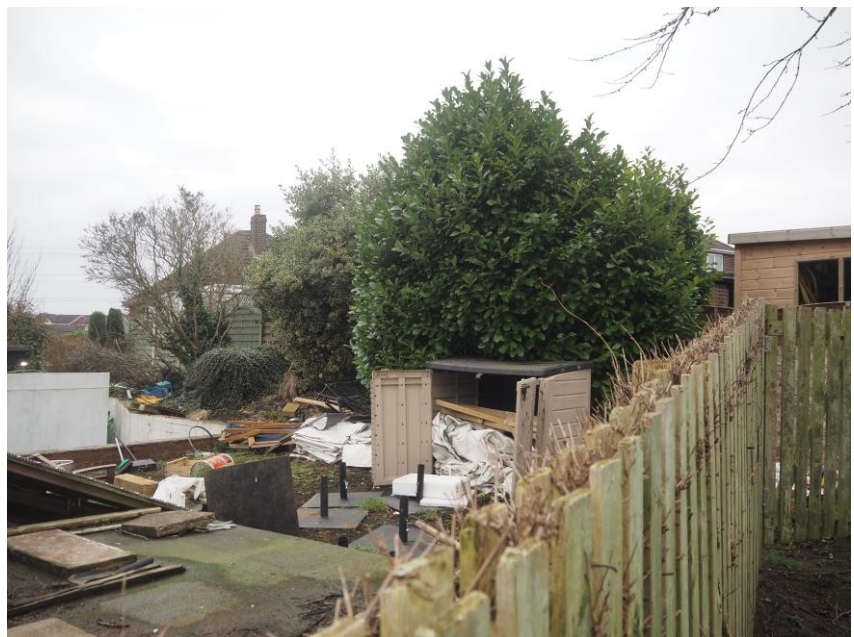
Photograph 8.

Photograph 8 is a view of the shrubs in the yard area to the rear of the pub. Cherry Laurel is considered something of an invasive pest nowadays; it's displacing native species from woodlands. Much like Rhododendron.

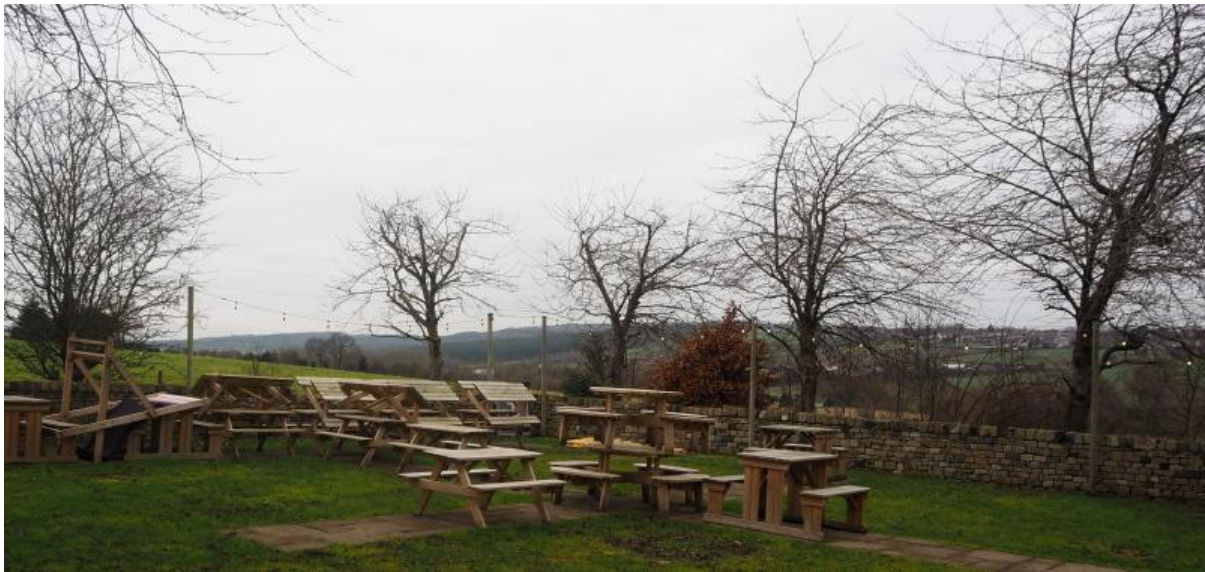
Photograph 9.

Photograph 9 is a view looking north west from the garden. All the trees in this photo, group 8 in the schedule, are outside the site.

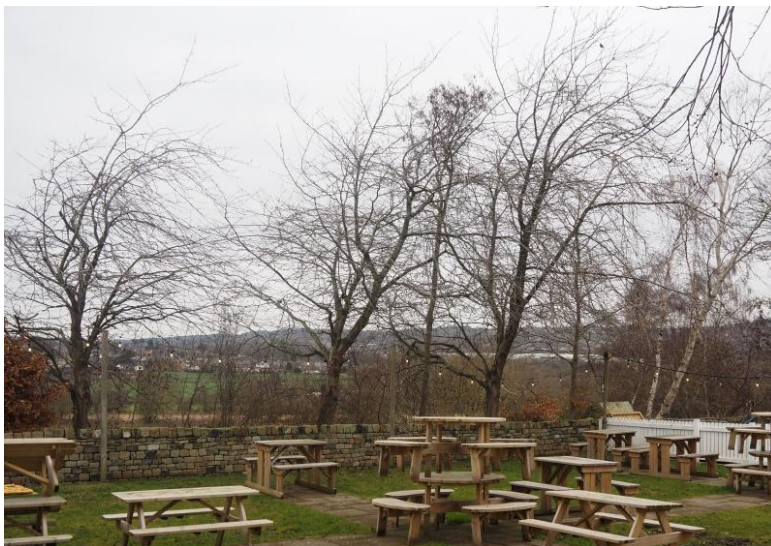
Photograph 9.

Photograph 9 shows the eastern end of group 8, also outside the site.

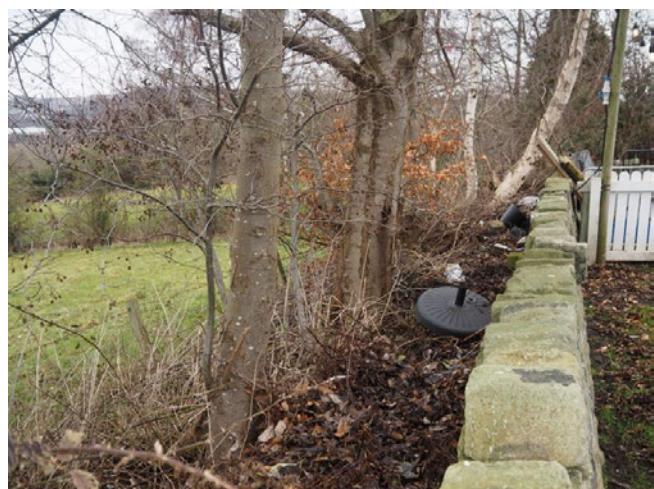
Photograph 10 is a view of the situation at the base of the trees in photo 9. It seems that whoever rakes up the leaves from the pub garden simply tips them over the wall. While this is not highly damaging it does lead to other people tipping other things, as can be seen in this photo. It seems livestock is excluded from the base of the trees, but I think this is a practice that should be discontinued.

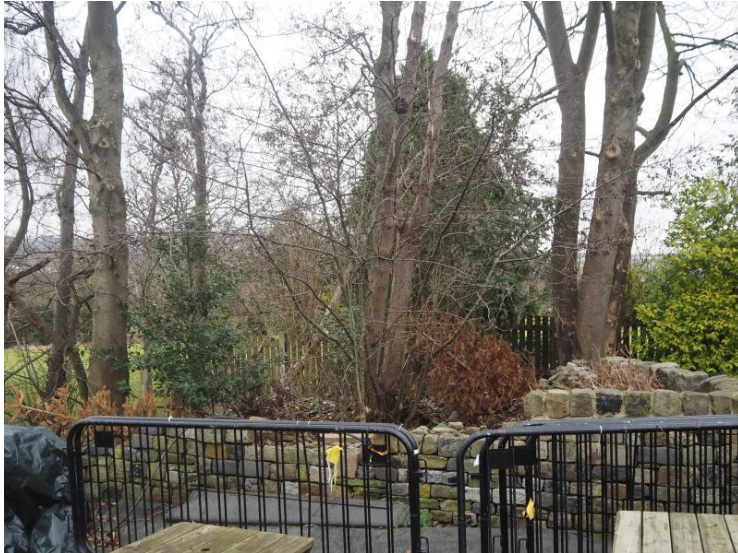
Photograph 11.

Photograph 11 shows group 8 looking roughly west from the garden. This area is used to store “stuff” that is bound-to-come-in-hand, and also as a staging post for other stuff waiting to be removed. (Note the inevitable old Christmas tree!)

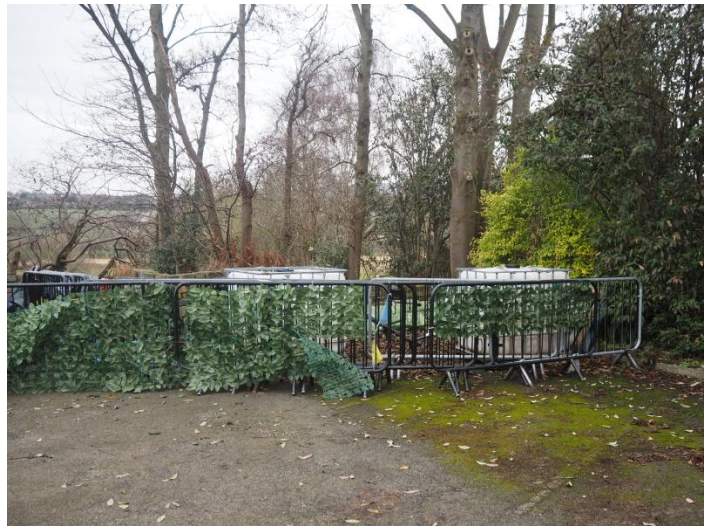
Photograph 12.

Photograph 12 is another view of group 8 taken looking north from the car park. The stuff is relatively benign, but there is potential for damage to be done to trees. The Alder in this group appears to have been scorched by a fire.

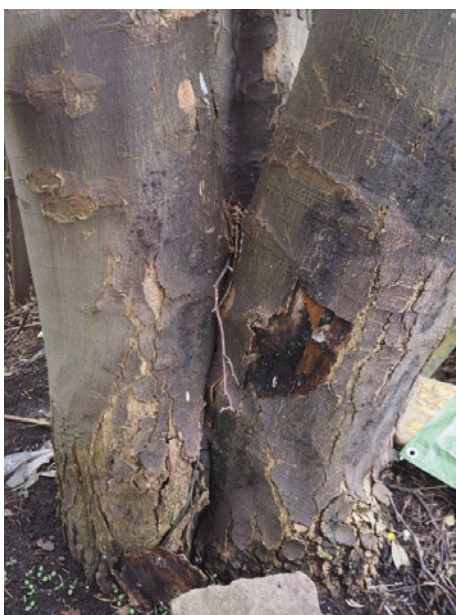
Photograph 13.

| Tree No. | Species. | Ht | TD | Age class | Category | Comments. | RPA |
|---|---|---|---|---|---|---|---|
| 8. | Group | 14 max | 800 max | M | C2 | A couple of Sycamore and an Alder tree in an area that seems to be the pub's stackyard/storage area for unused "stuff." One Sycamore, with three stems (possibly coppice growth) has some damage at the base, which may be the onset of "sooty bark disease." This tree needs to be inspected when in leaf. | 290 |

Photograph 13 shows the base of the Sycamore tree at the right of photo 12. This damage may have been caused by a fire, although there may be some disease involved. This tree needs to be inspected in the summer when in leaf.

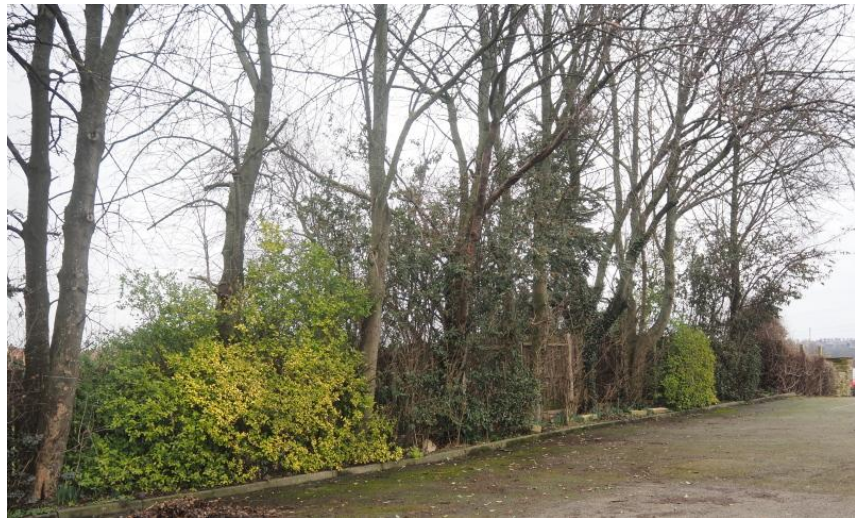
Photograph 14.

Photograph 14 is a view of the trees at the side of the car park, group 9. These are unlikely to be a consideration in the proposal, but steps should be taken to ensure they are not damaged by the site works.

Some trees in group 9 have long lower branches over the car park, so pruning them to ensure site deliveries do not strike them would be prudent.

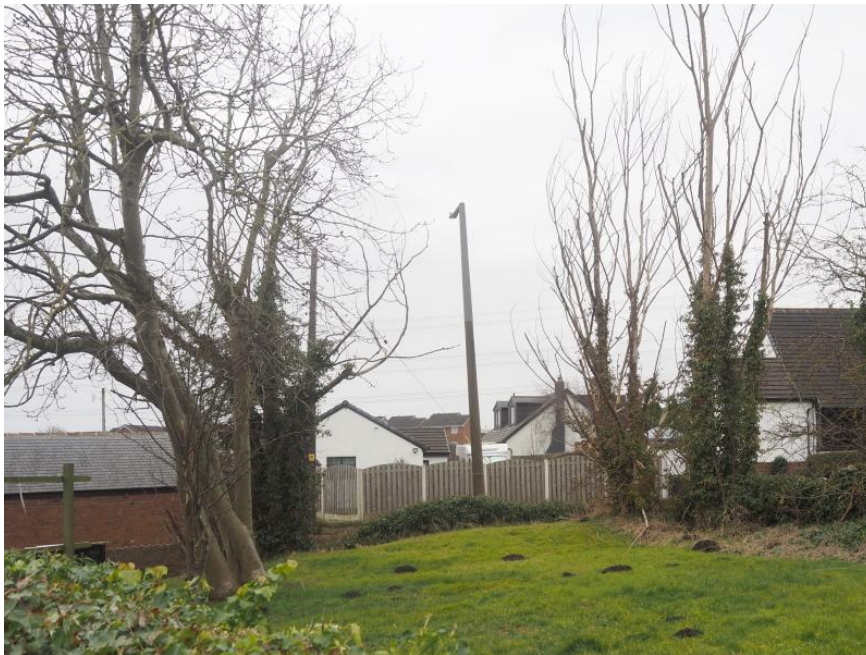
Photograph 15.

Photograph 15 shows the group of trees at the front of the Crown & Anchor. The tree at the left is the Ash and alive, the trees at the right are Elms and dead. the Elms really need to be removed. This is nothing to do with the proposal.

I'm not entirely sure that these trees belong to the pub but they really need to be sorted out sooner rather than later.
