Hoyland, Barnsley – Visit 2

VCS Report

Project: Hoyland, Barnsley – Visit 2

Job No: PTS22335-05

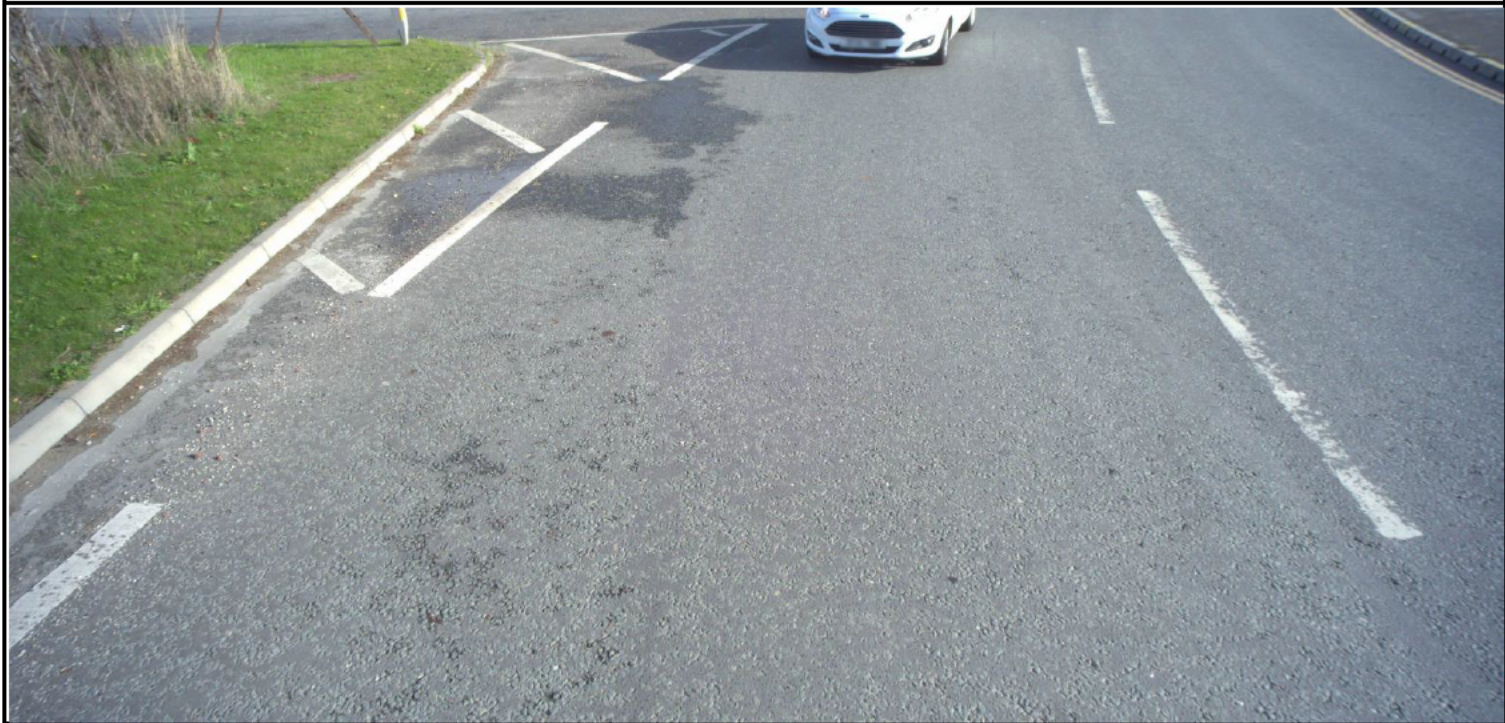
Photo Ref : 2	Section : A6195 Exit
Chainage : 0	Feature / Defect : Minor Surface Defectiveness

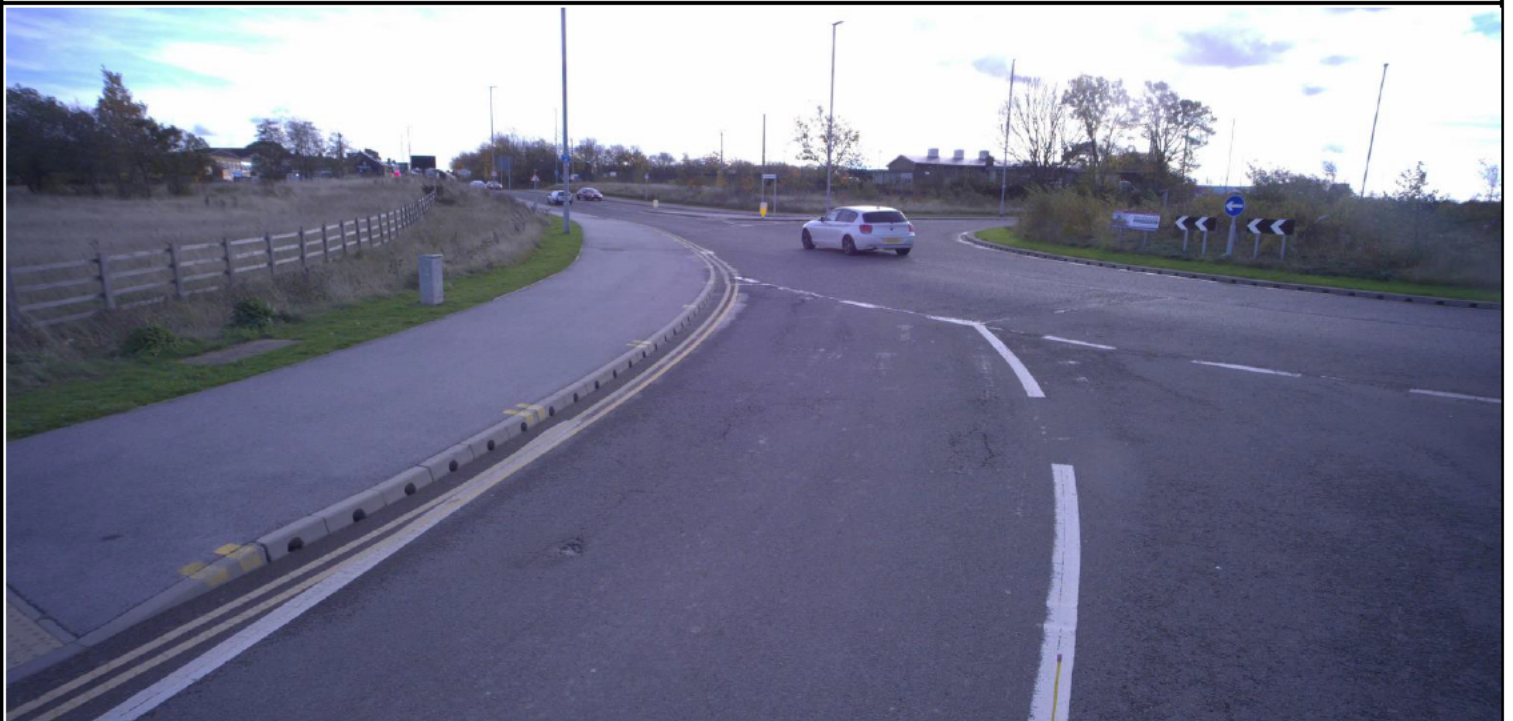
Photo Ref : 6

Section : Sheffield Road Entry

Chainage : 12

Feature / Defect : Pothole/Major Cracking/Minor Cracking

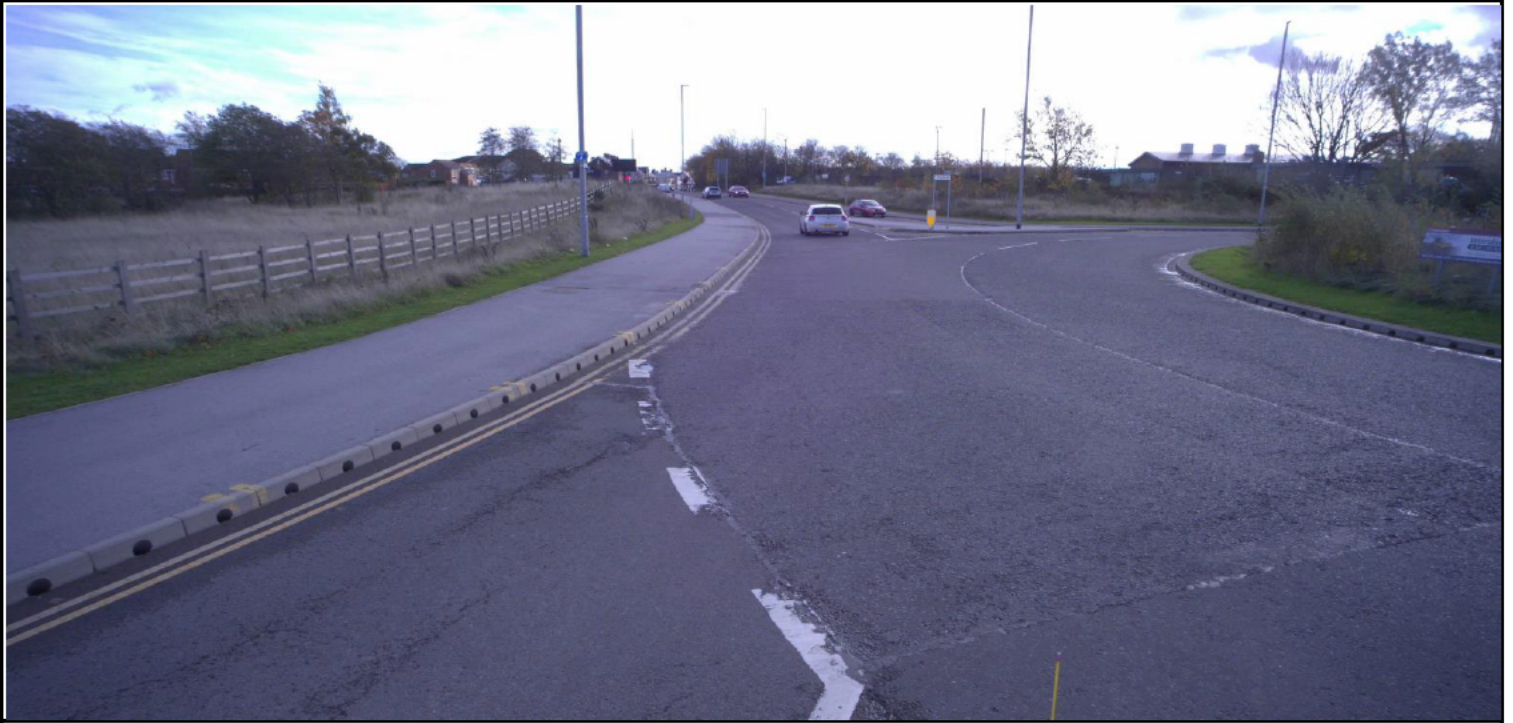
Photo Ref : 7

Section : Sheffield Road Entry

Chainage : 19

Feature / Defect : Major Cracking

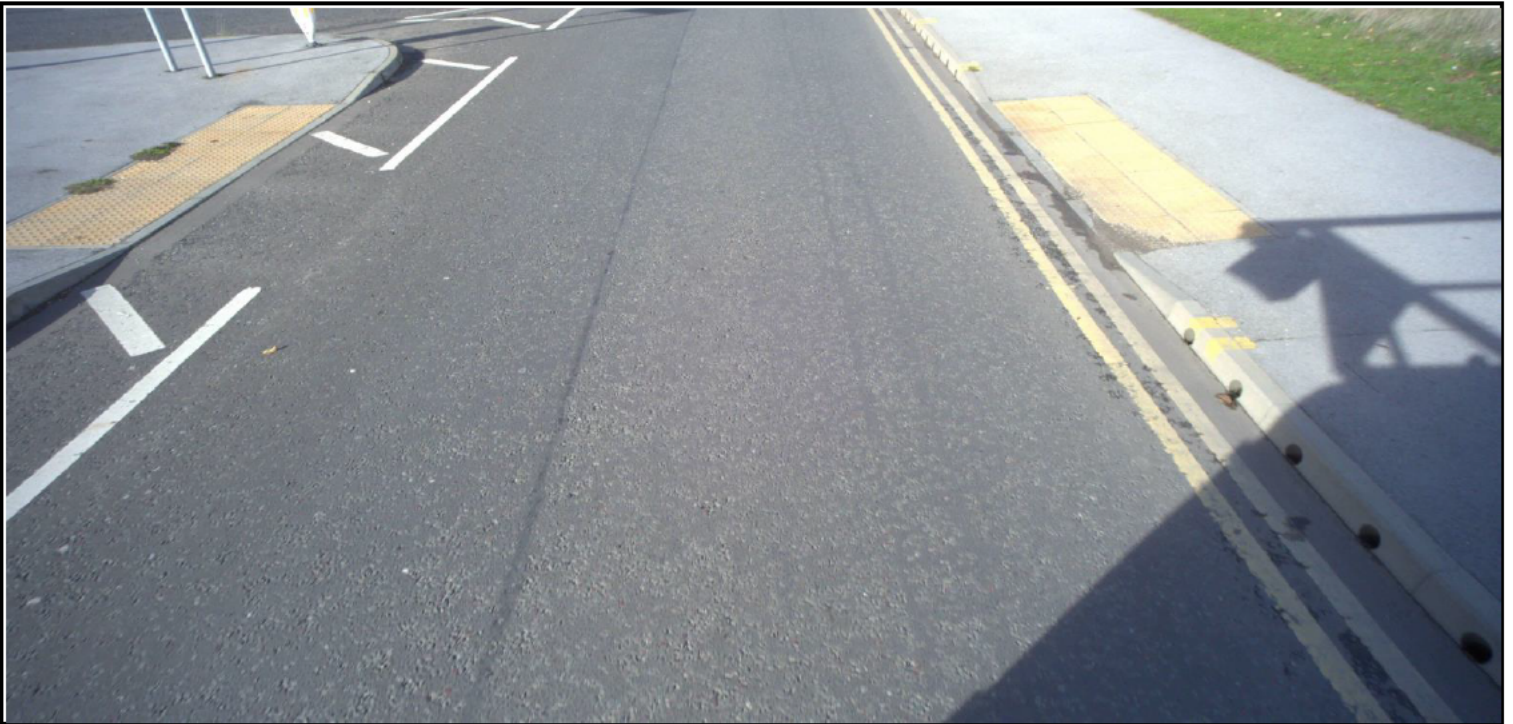
Photo Ref : 9

Section : Sheffield Road Exit

Chainage : 0

Feature / Defect : Minor Fattig

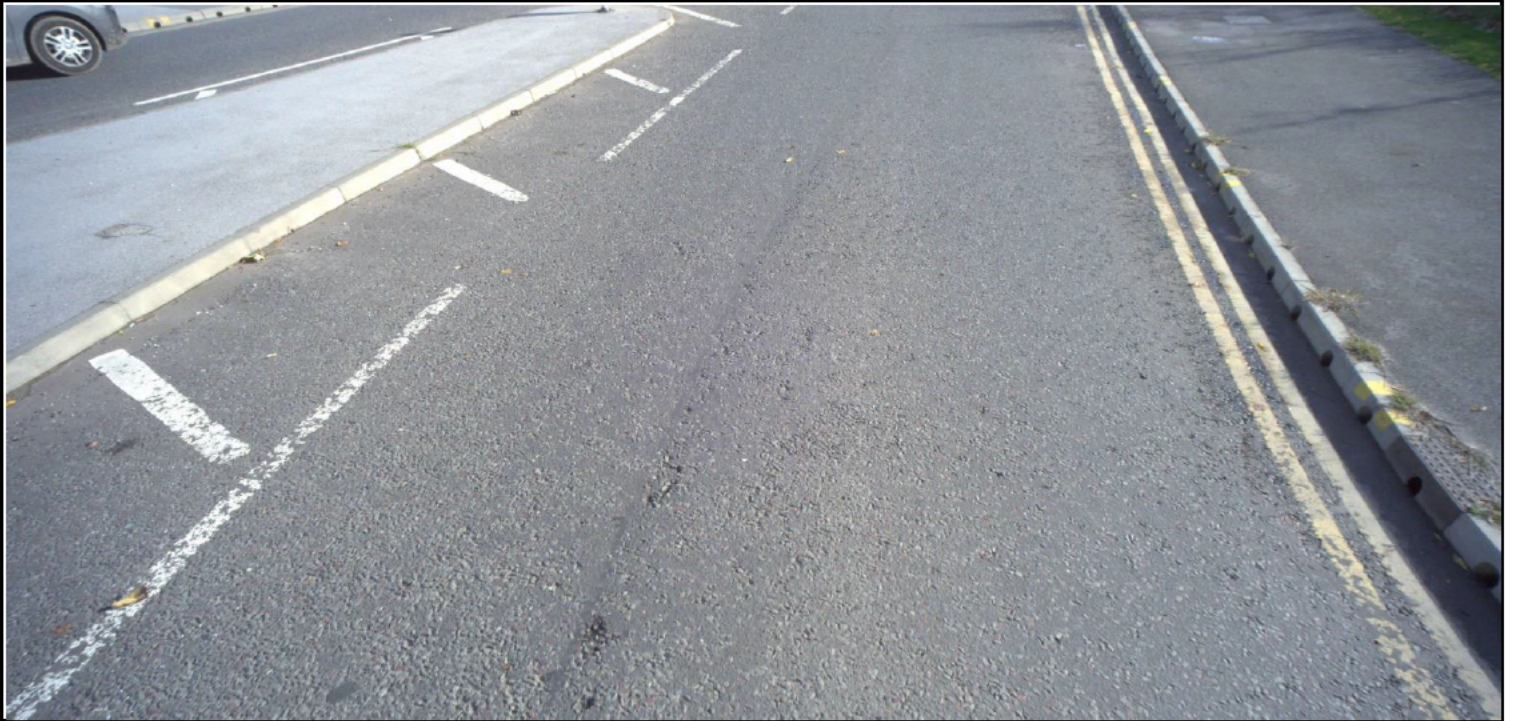
Photo Ref : 11

Section : Sheffield Road Entry

Chainage : 0

Feature / Defect : Minor Surface Defectiveness

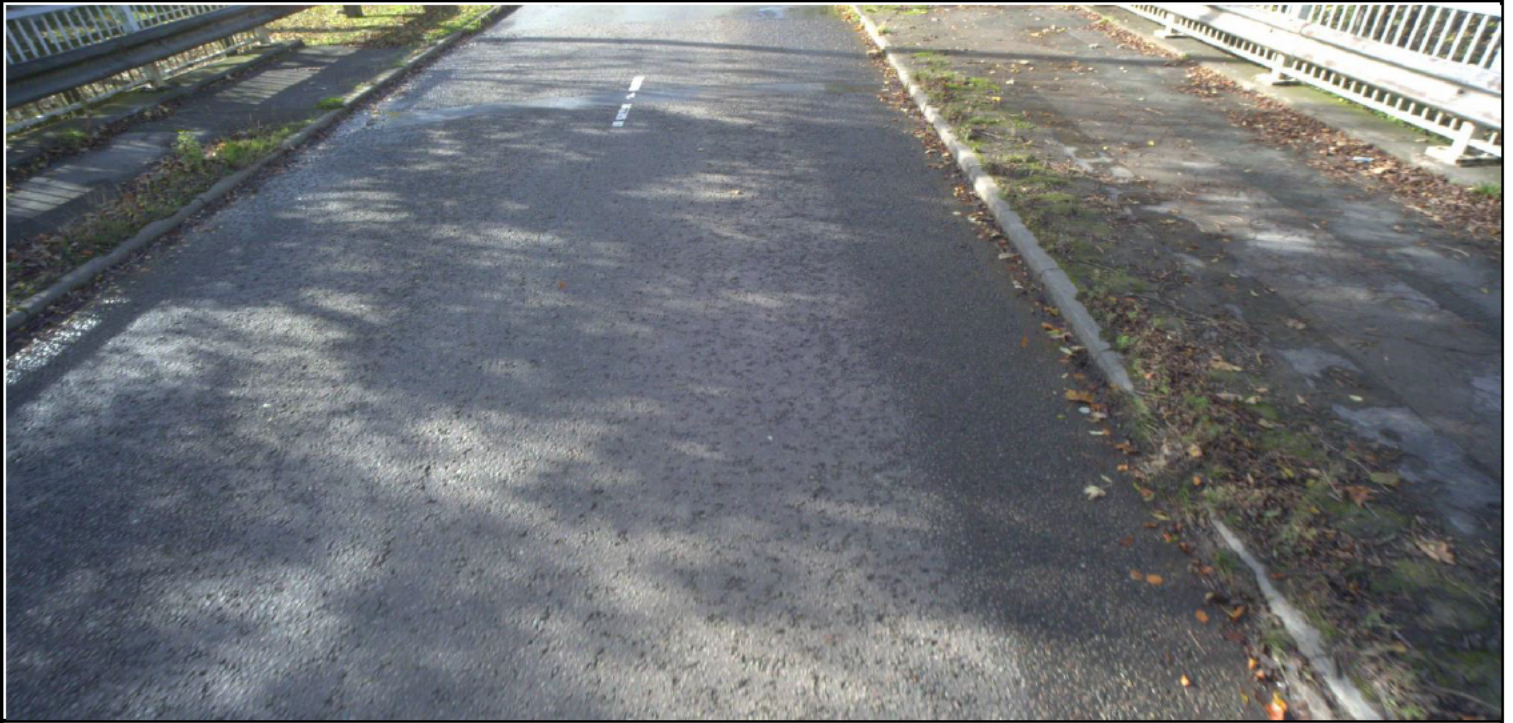
Photo Ref : 15

Section : Tankersley Lane - EB

Chainage : 0

Feature / Defect : Minor Surface Defectiveness

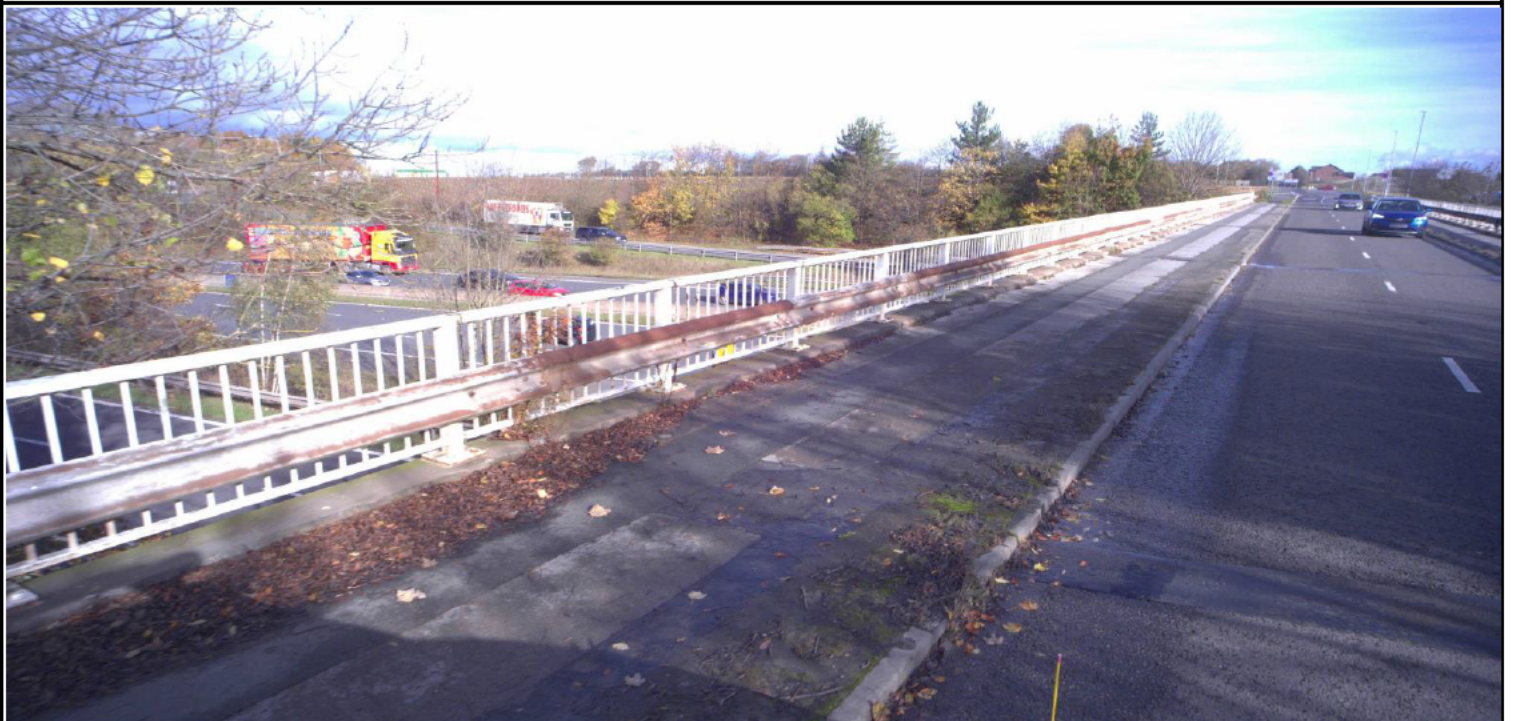
Photo Ref : 16

Section : Tankersley Lane - EB

Chainage : 0

Feature / Defect : Major Surface Defectiveness

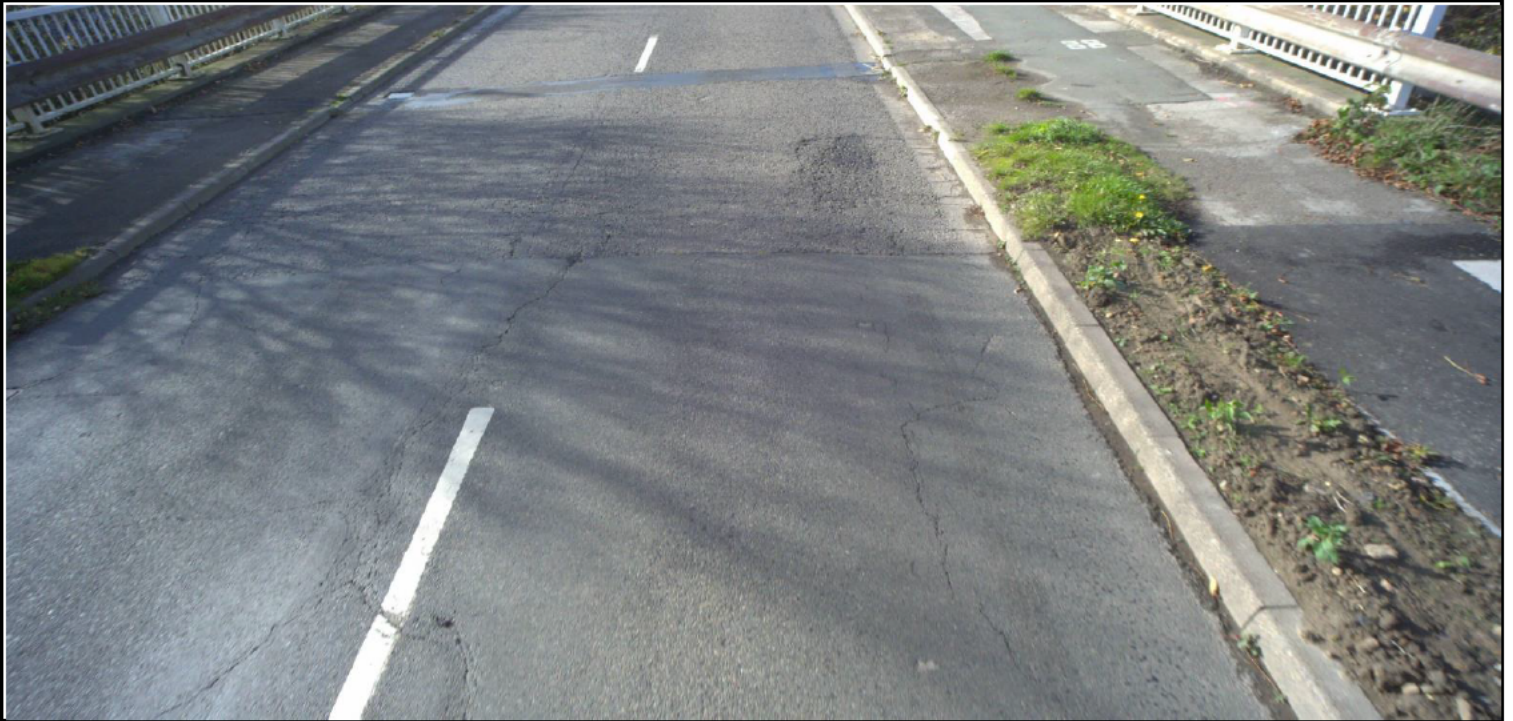
Photo Ref : 17

Section : Tankersley Lane - EB

Chainage : 107

Feature / Defect : Major Cracking/SD(2)/Cracking

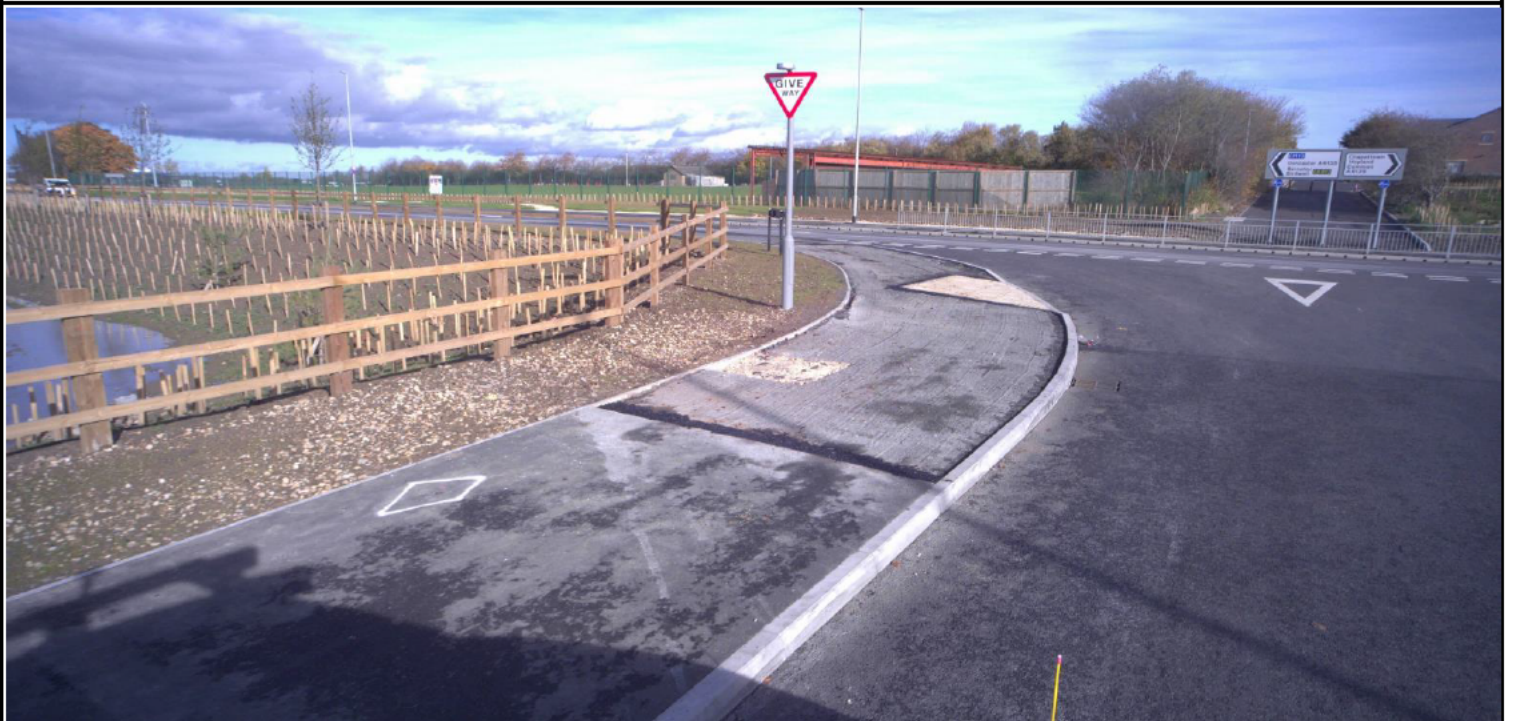
Photo Ref : 18

The visual condition survey indicates that the carriageway surface is Thin Surfacing (TSSC) and Hot Rolled Asphalt (HRA) and the Footpath Surface is Asphalt Concrete (AC). Tankersley Lane is generally in good condition. However, there are some areas of major and minor surface defectiveness, small areas of major crazing and some cracking. The area of footpath with no surface construction should be noted.

Section : Tankersley Lane - EB

Chainage : 291

Feature / Defect : No surface on Footpath

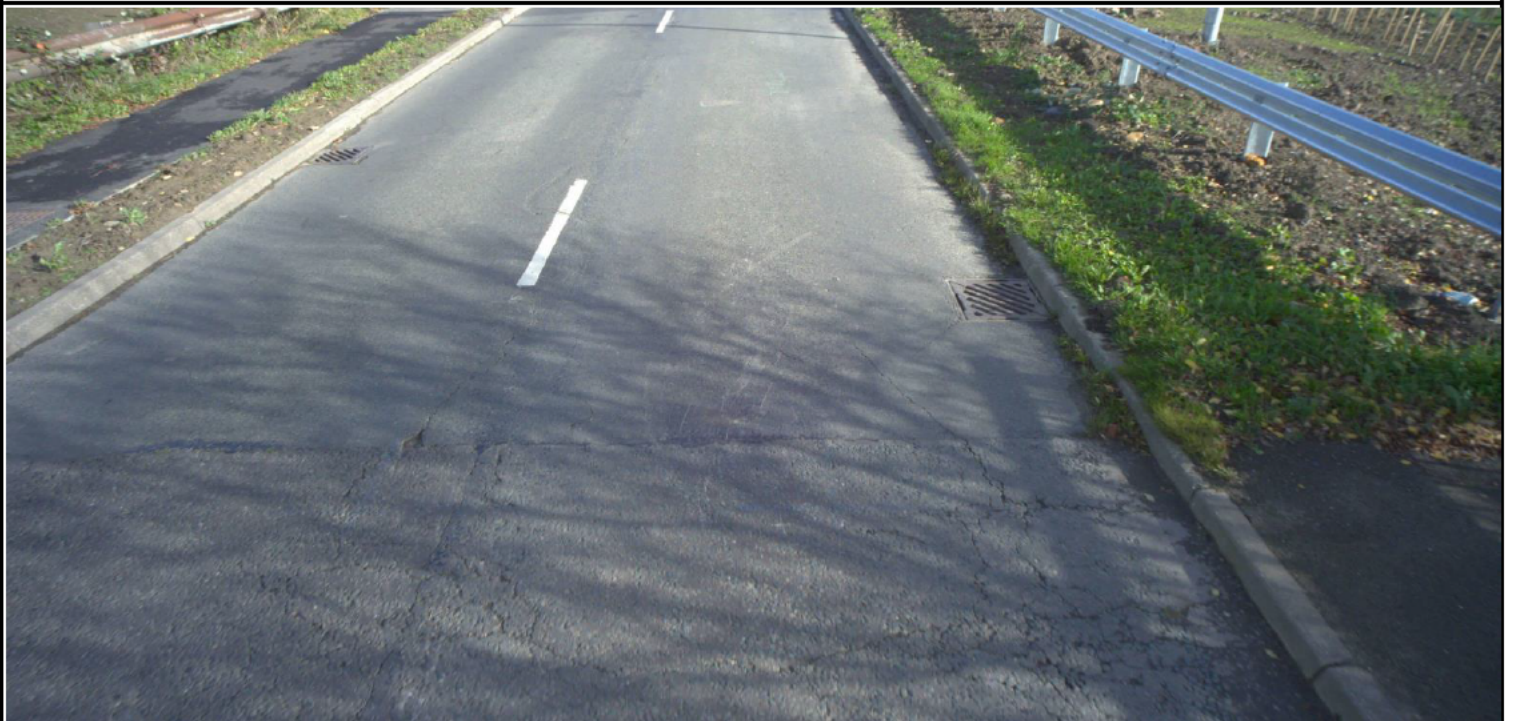
Photo Ref : 20

Section : Tankersley Lane - WB

Chainage : 185

Feature / Defect : SD(2)/Minor Cracking/Major Cracking

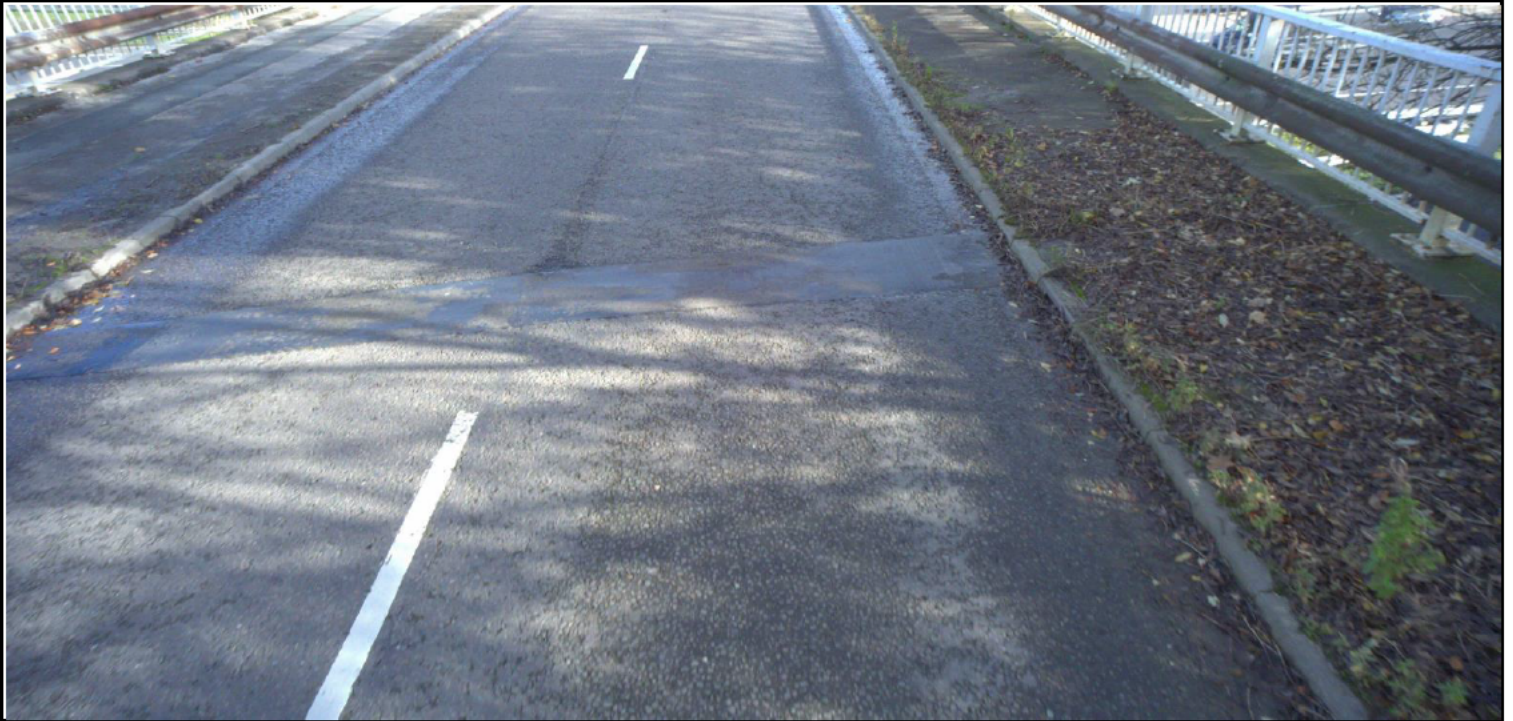
Photo Ref : 21

Section : Tankersley Lane - WB

Chainage : 284

Feature / Defect : Minor Surface Defectiveness

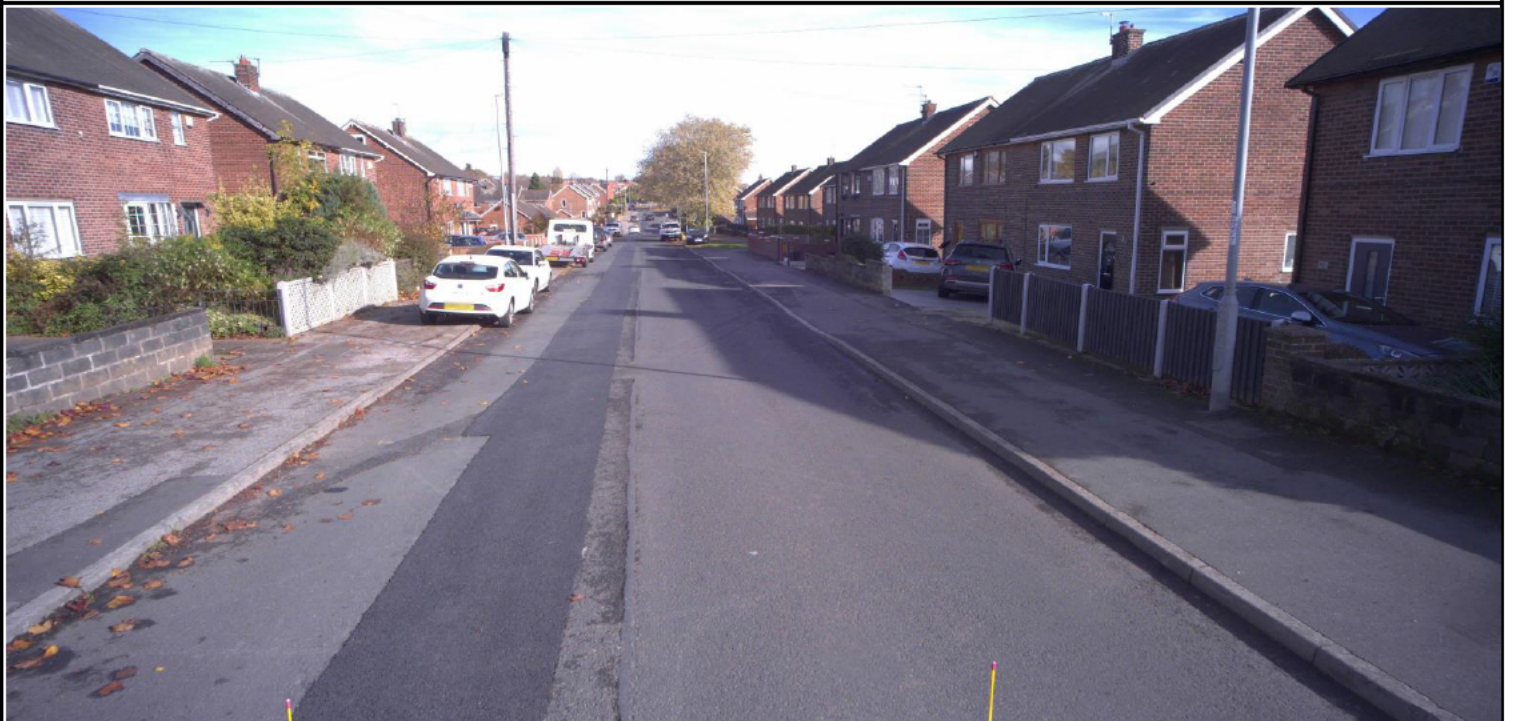
Photo Ref : 26

The visual condition survey indicates that the surface is Thin Surfacing (TSSC) and is in good condition. Parkside Road from mini Rbt (NB) has a small area of minor surface defectiveness. The rest of the survey found no defects including the mini roundabout.

Section : Parkside Road from mini Rbt

Chainage : 31

Feature / Defect : Minor Surface Defectiveness

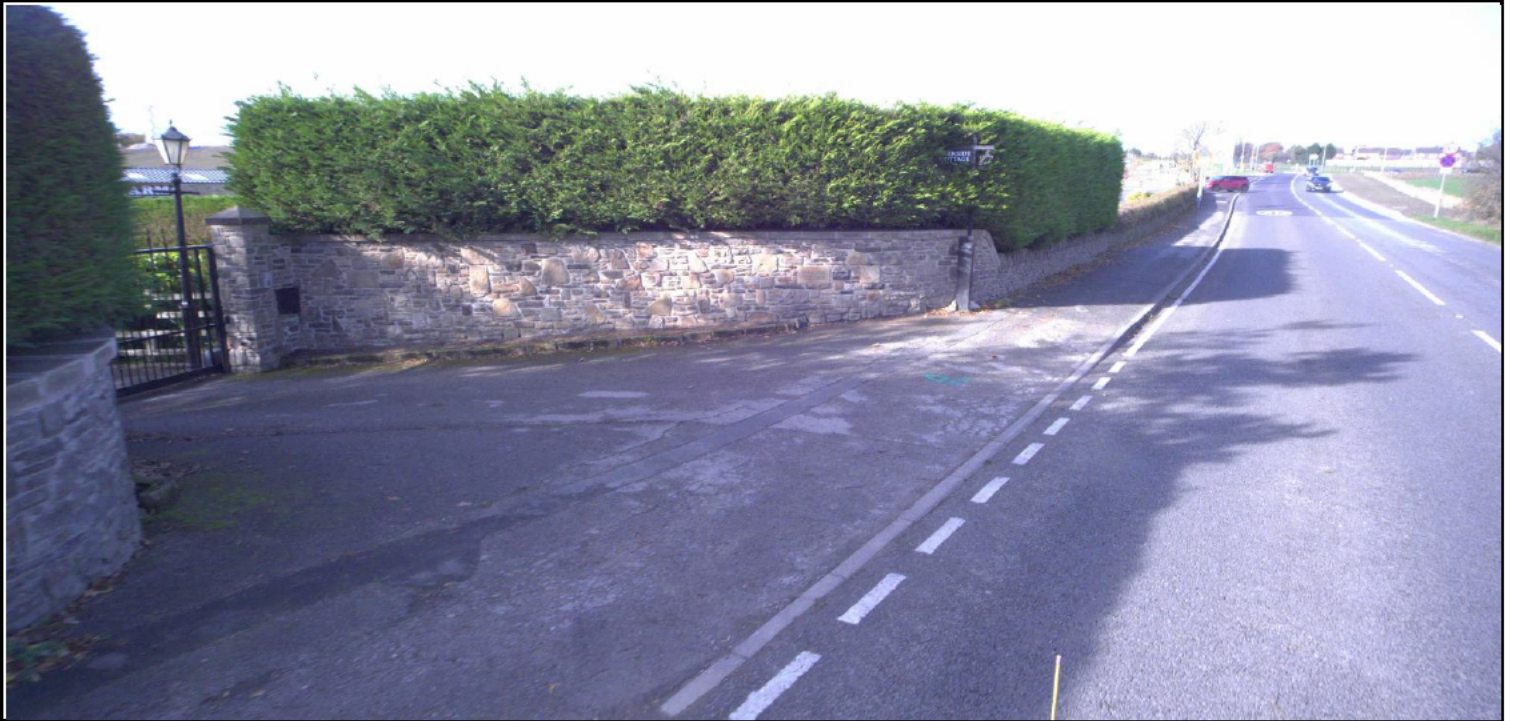
Photo Ref : 29

Section : Sheffield Road - NB

Chainage : 31

Feature / Defect : SD(2)/Minor Cracking

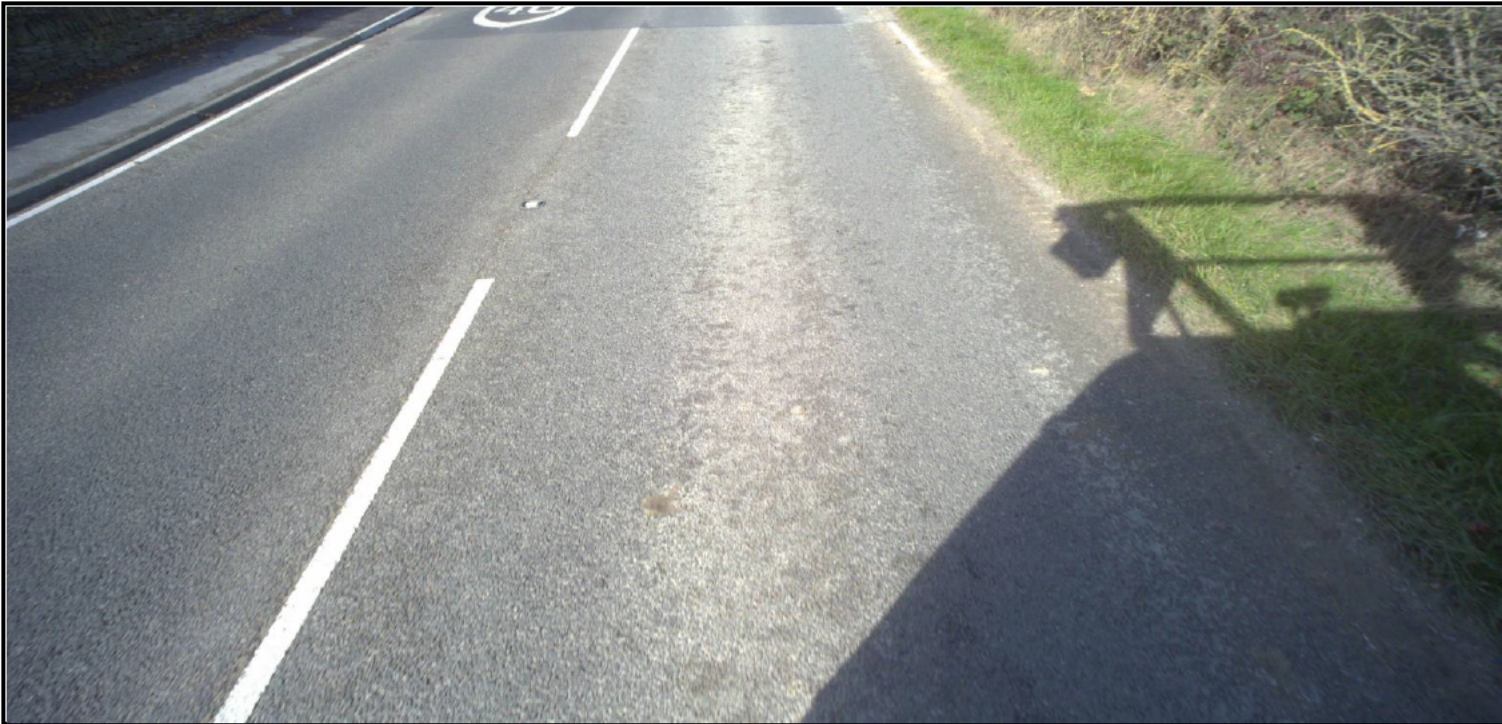
The visual condition survey indicates that the carriageway surface is Thin Surfacing (TSSC) and the footpath surface is Asphalt Concrete (AC). Sheffield Road (NB) is generally in good condition but has a small area of minor surface defectiveness and crazing on the footpath. Sheffield Road (SB) is generally in poor condition due to a large area of the section being minor surface defectiveness.

Photo Ref : 31	Section : Sheffield Road - SB
Chainage : 62	Feature / Defect : Minor Surface Defectiveness
