# **High Street, Shafton– BS5837:2012 Tree Survey, Arboricultural Impact Assessment and Arboricultural Method Statement**

**Vistry Partnerships Yorkshire  
Limited, Homes England**

Version: **V3.0**  
Issue Date: **June 2022**  
Report Ref: **19268**

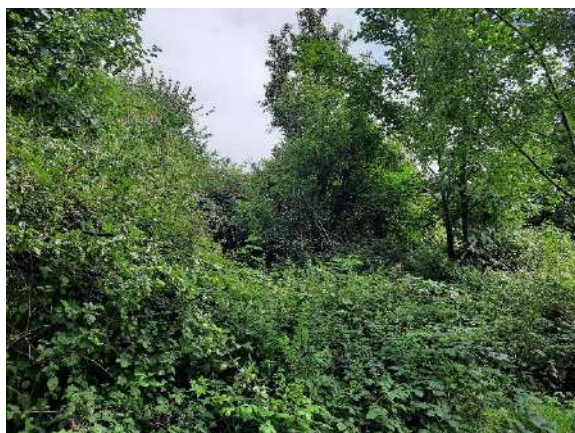
- 3.2.6 To the south of these boundary trees is an area of dense bramble with tree group G048. In parts the vegetation is impenetrable and some trees are not accessible. The core of this tree group appears to have been an orchard, or area of fruit trees. Many remain, though all are unmanaged and many are in poor condition. The area has now become dominated by early mature sycamore, willow *Salix sp.* and hawthorn *Crataegus monogyna*.

**Plate 1:** General view of G048 looking east

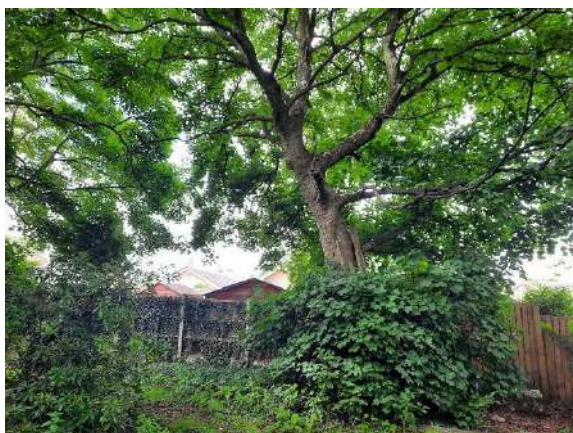
- 3.2.7 The larger individuals plotted on the topographical survey have been recorded as part of this survey. Most are of little merit, being typical of trees which rapidly colonise fallow sites. T008 is a sycamore of good form and vigour and has been given a B category. Similarly T018, a wild cherry has good form and vigour and has been given a B category both trees are found on the northern edge of G048.

**Plate 2:** Sycamore T008 looking north west

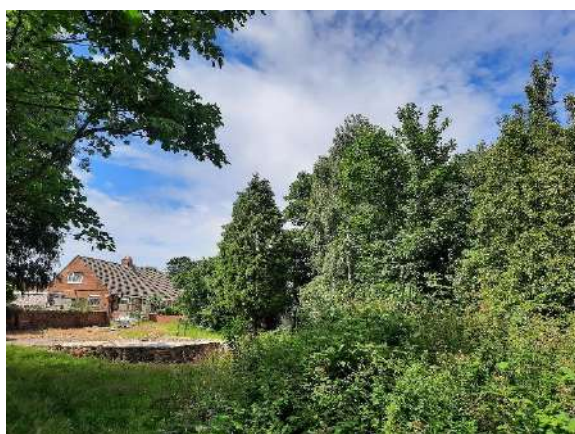
**Plate 3:** Looking towards north west corner. T003 middle

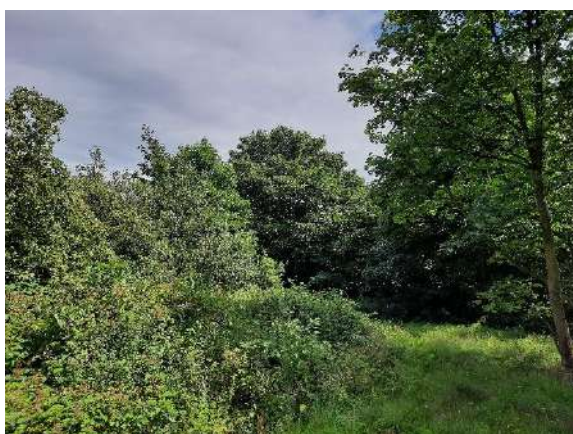
**Plate 4:** southern edge of G048 looking east

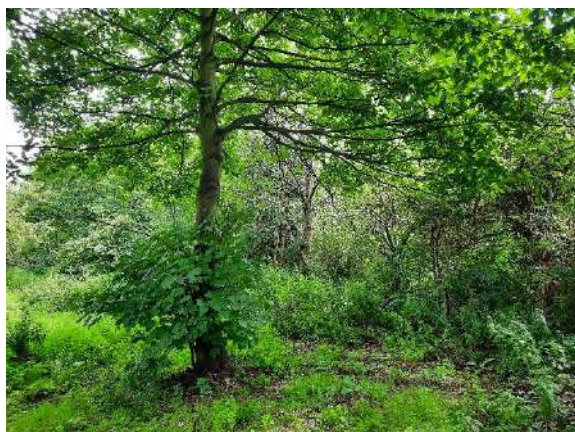
- 3.2.4 Two of the highest quality trees on the site are located on the northern boundary which actually runs south west to north east. Sycamores *Acer pseudoplatanus* T004 and T007 are, A category trees. Showing excellent health and vigour, the trees have high and well developed canopies. Both have dense epicormics growth at their base, and this should be removed to allow the basal flair of both trees to be inspected for any defects.

**Plate 5:** Sycamore T007 looking south

| Tree number | Tree work required | Reason |
|---|---|---|
| T007 | Remove epicormics from base and inspect basal area | Inspect tree for any defects |

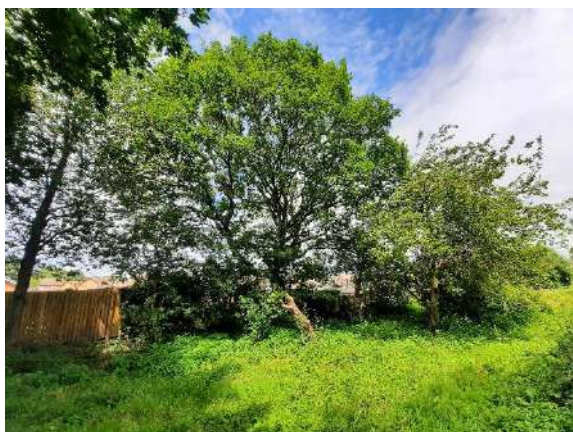
**Plate 6:** Sessile oak T011 centre looking north east

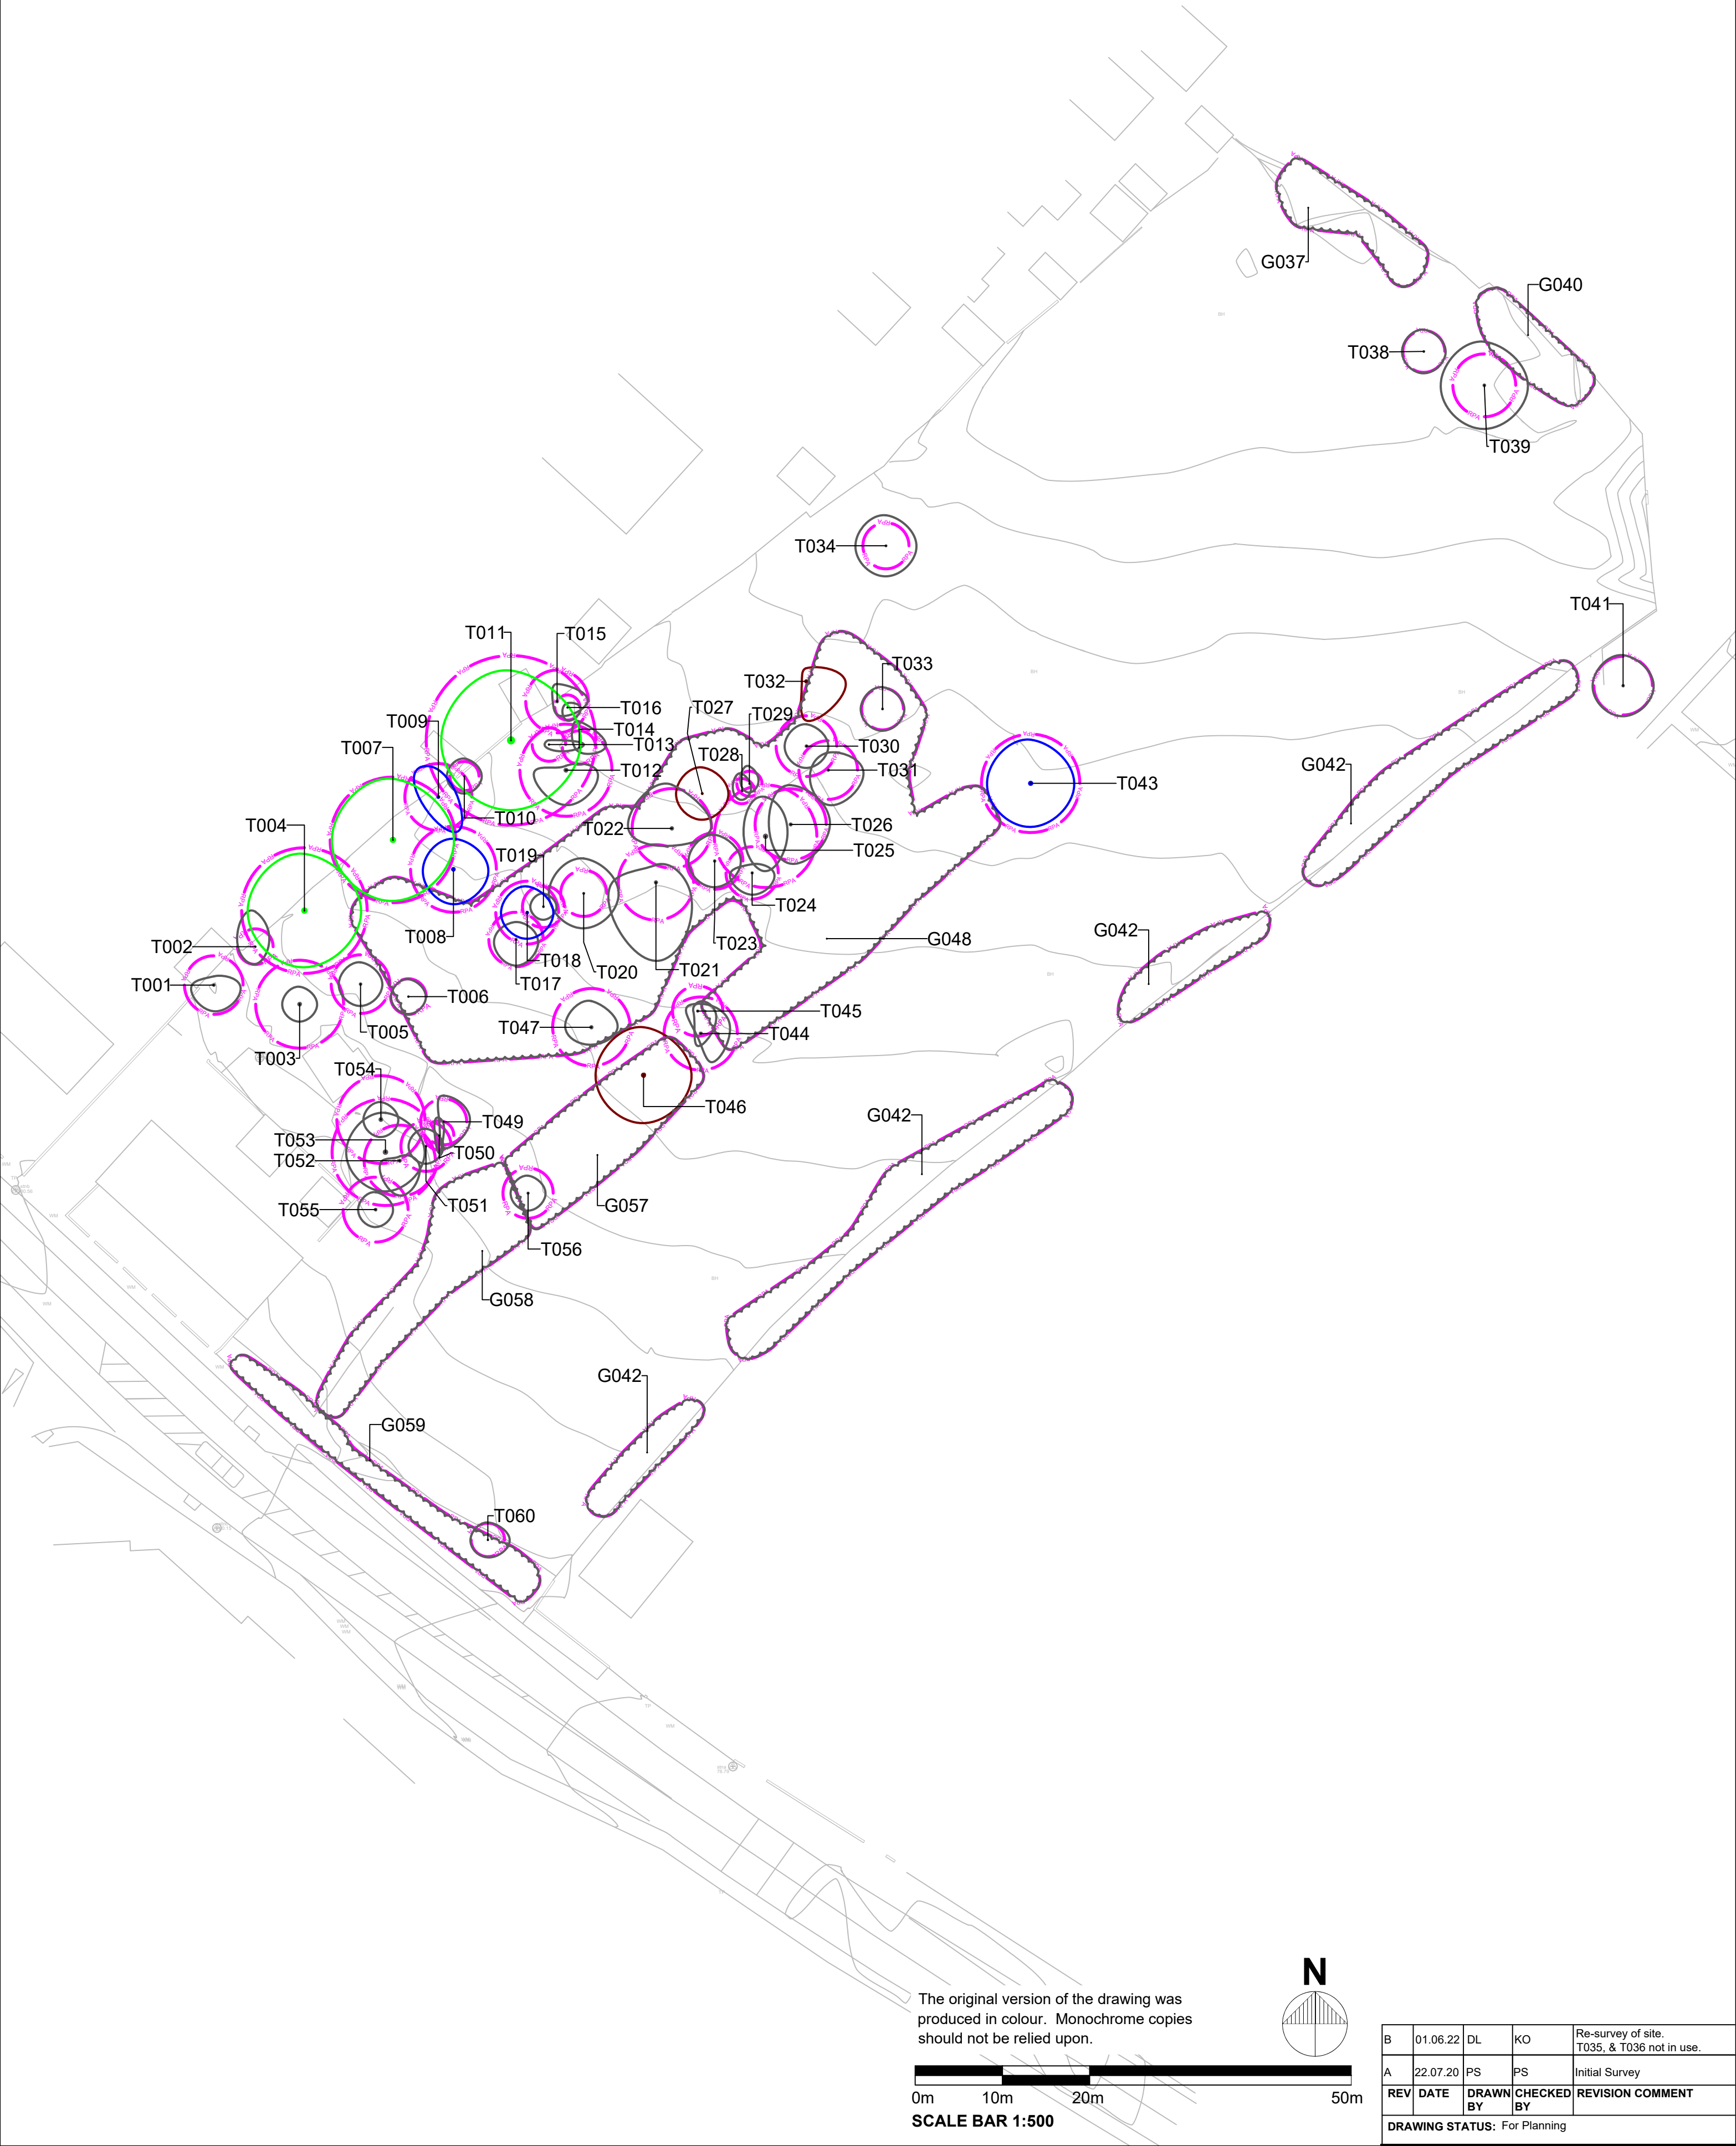
Title  
Figure 3.1  
Tree Survey and Tree Constraints Plan

- 3.2.1 The Tree Survey Schedule in Table 3.1 (Appendix 1) describes the results of the tree survey and includes preliminary management recommendations. The table should be read in conjunction with Figure 3.1 Tree Survey and Tree Constraints Plan (Appendix 3). This drawing illustrates the location of the trees surveyed, the extent of their canopies as well as the RPA of each tree and tree group.

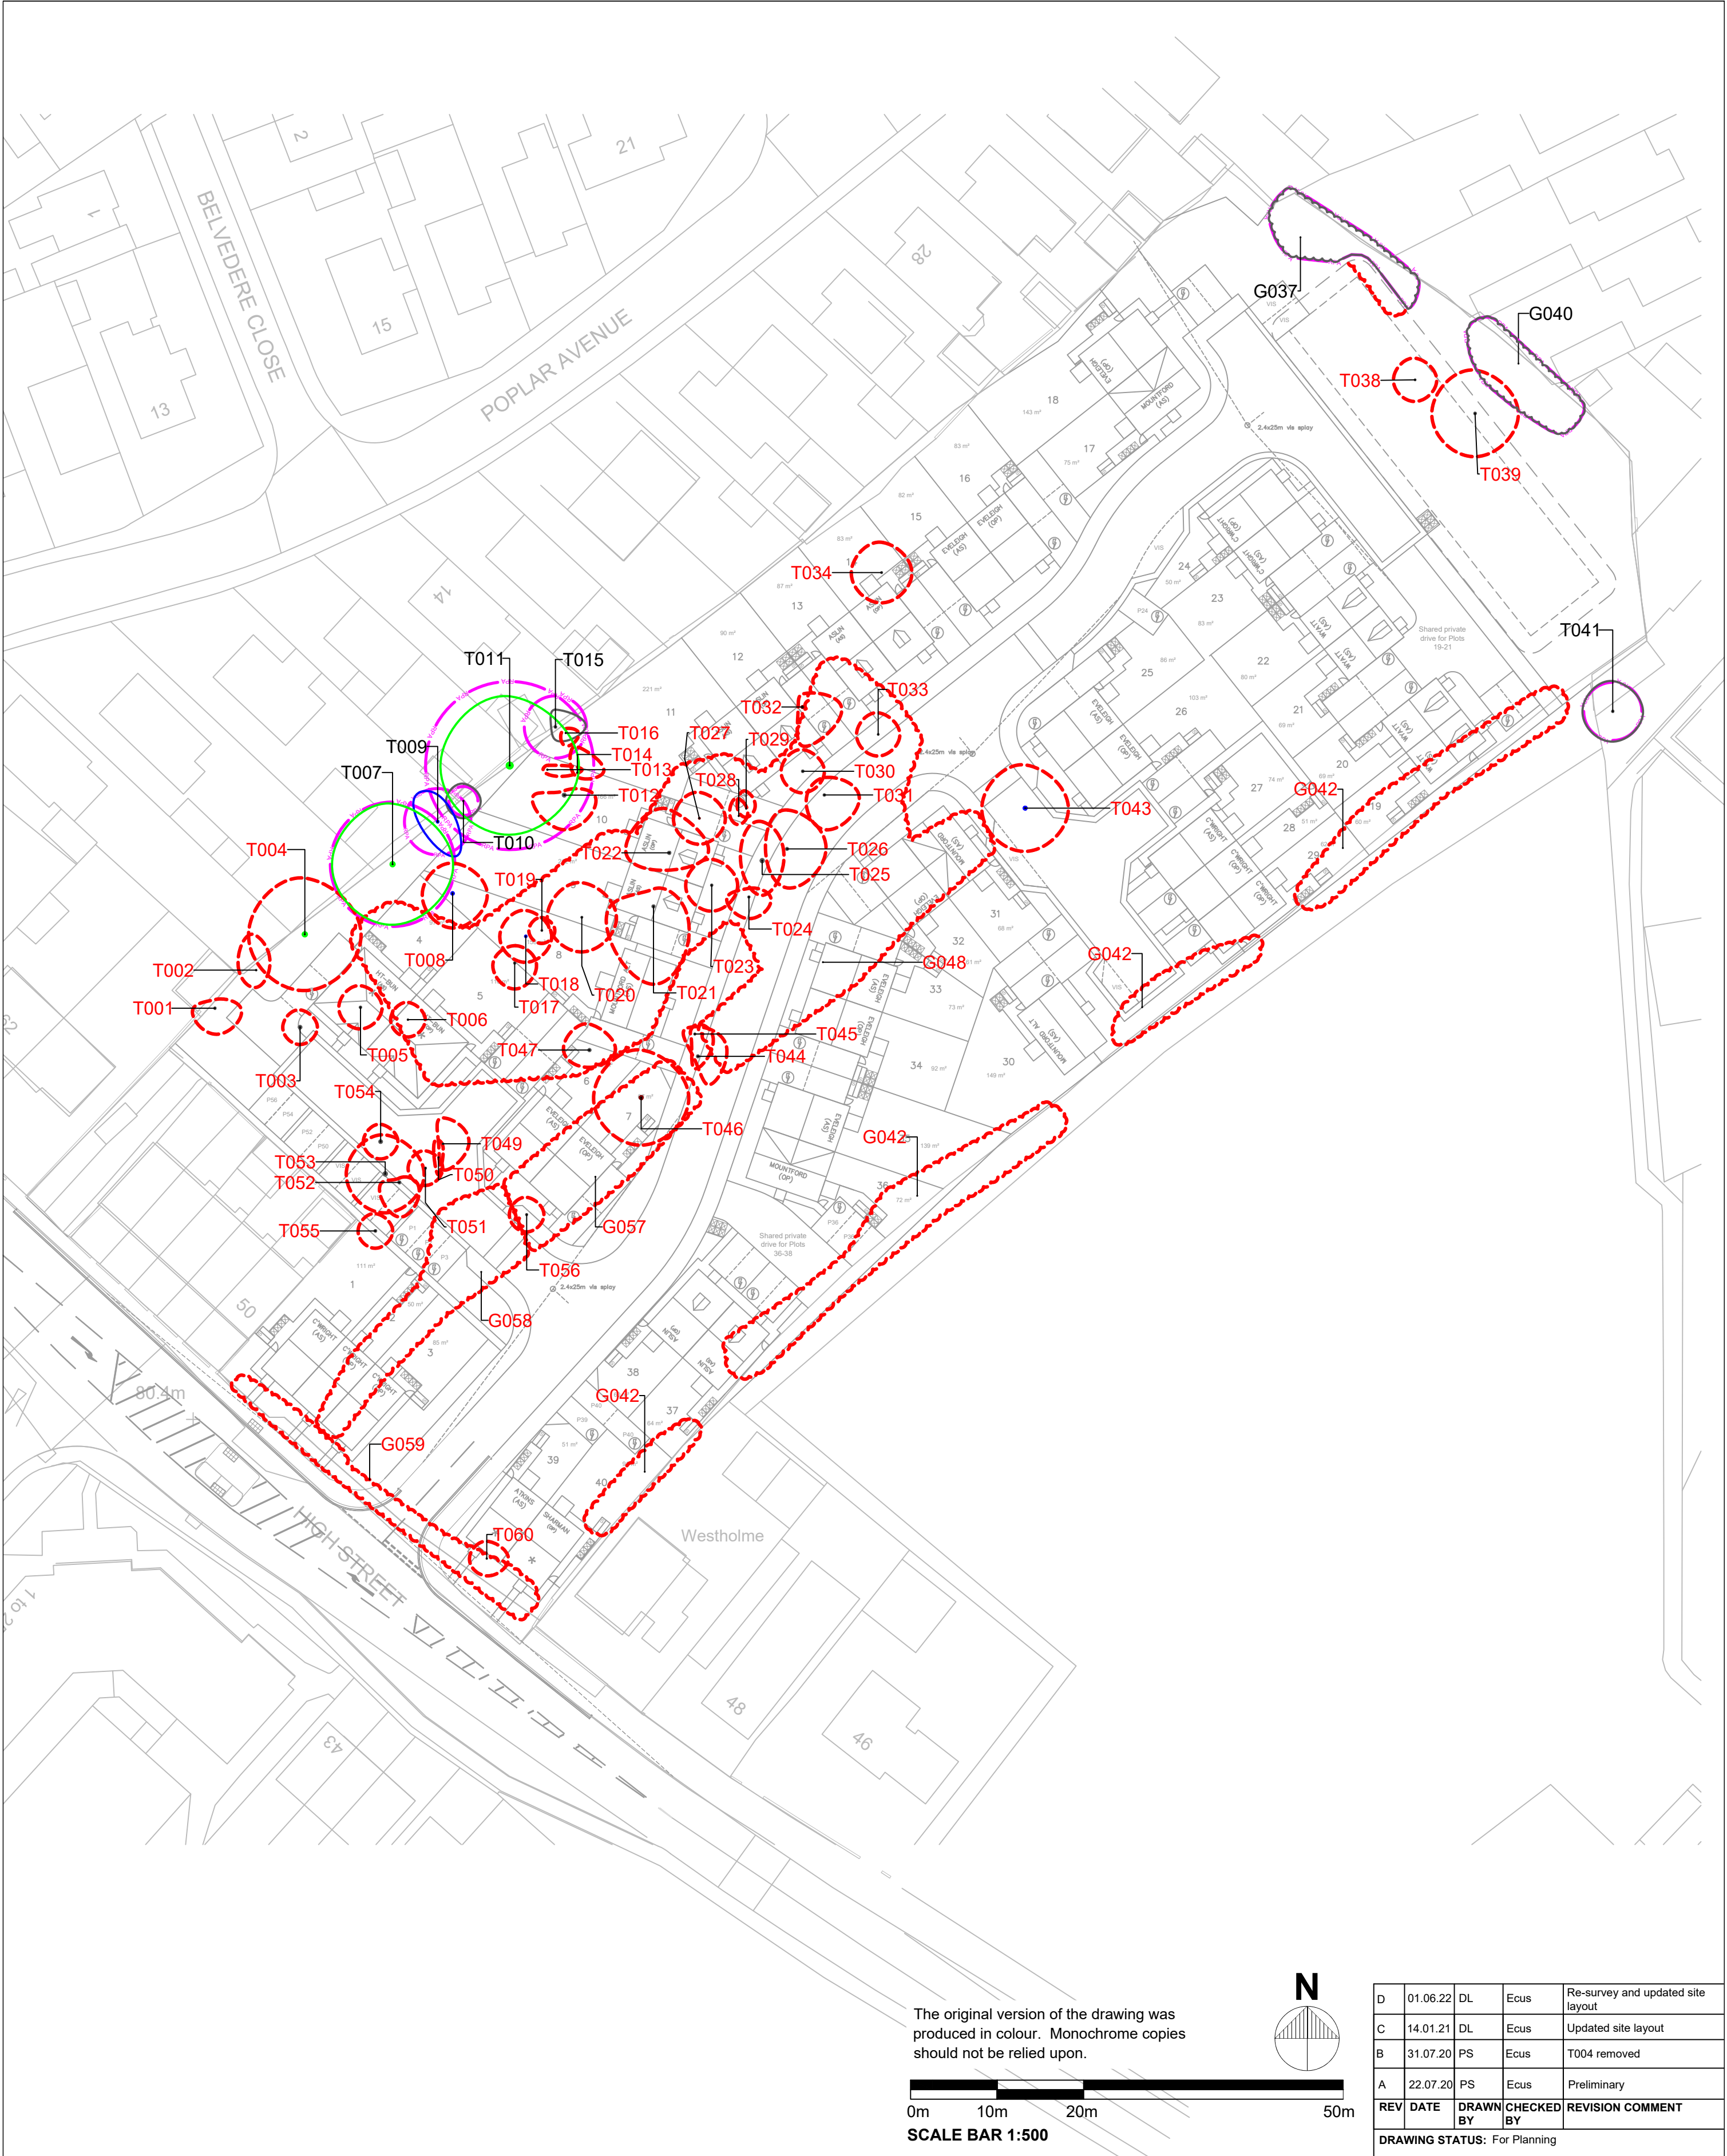
| Title<br><b>Figure 4.1<br/>Arboricultural Impact Assessment</b> | | | |

- 4.3.3 The tree removals represent a loss of 82% of all the trees and groups on the site. This represents a significant loss of tree cover at a site level. However it should be noted that the majority of the trees lost are concentrated within a small area of the site, with the remainder of the site consisting of open grassland. The layout of the scheme does allow for two A category trees to be retained, as well as one of the four B category trees to be retained.
