Active Tree Risk Assessment-

**5 Chedworth Close,
Darton,
Barnsley**

Report Reference: TCC1712-1

Report Title:	Active Tree Risk Assessment
Report Reference:	TCC-1712
Written by:	Joe Hardaker FdSc Arb BSc Hort
Client:	Mr & Mrs Race
Date:	May 2024

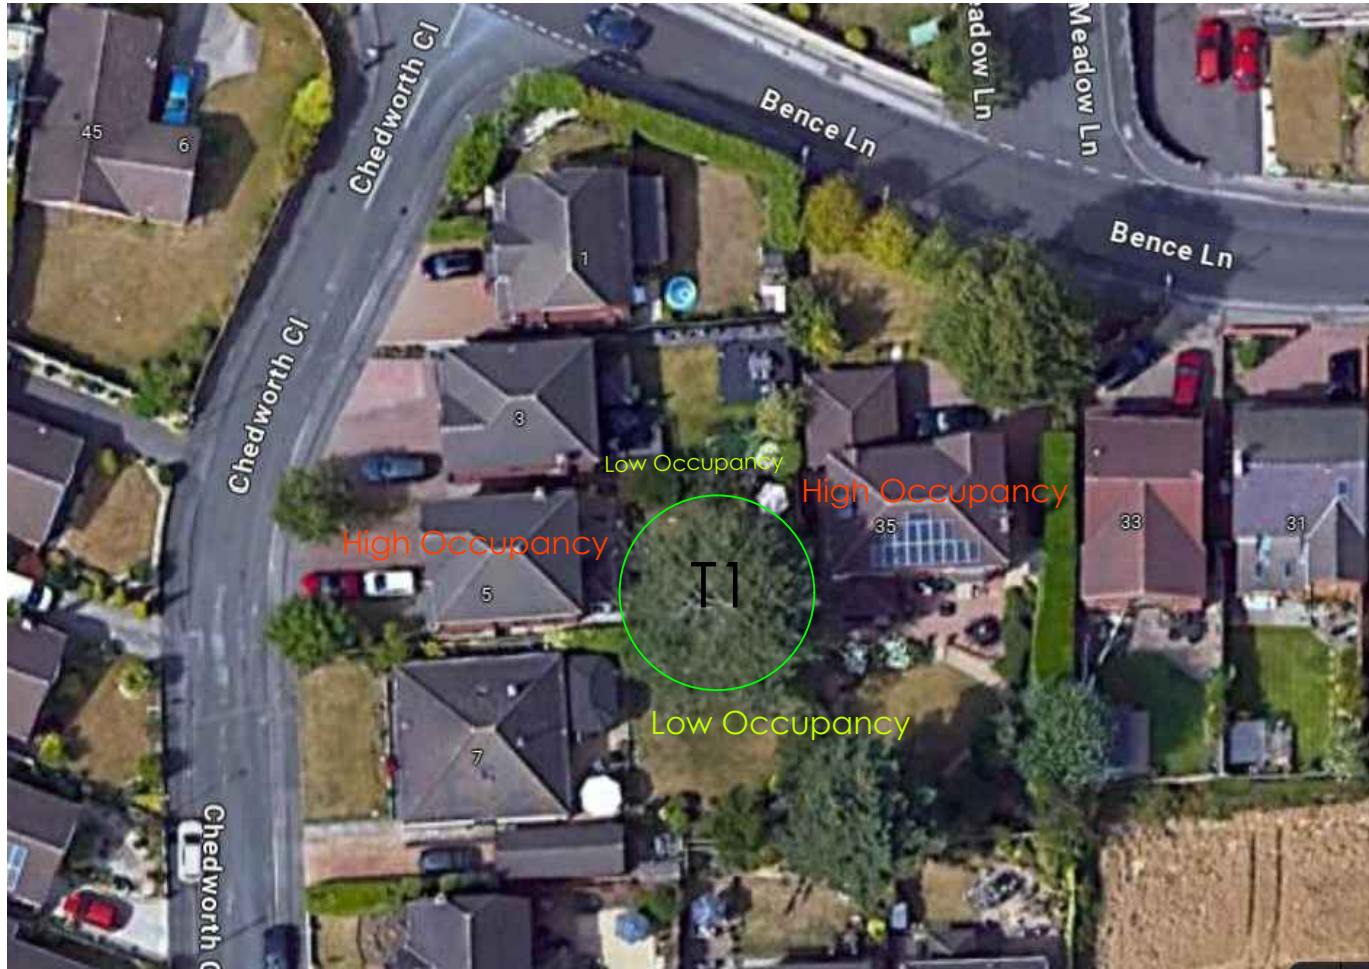
TREE SURVEY PLAN

14. The tree is a mature Corsican Pine (*Pinus nigra*) of approximately 13m in height. It has a spreading form and slight crown bias to the south-east.

16. Anatomy – Good height to diameter ratio, providing good strength to its main stem. Lower peripheral branches have developed phototropic characteristics in order to gain access to light beyond the trees upper canopy dripline, and as such have become overextended.

17. Load – An adjoining sister tree was removed in March 2023, which has changed wind load characteristics to the tree. Consequentially this marginally increases the chances of gale damage.

20. Given the recent load change, the presence of over overextending limbs and the tree and its near neighbours previous susceptibility to wind and snow damage, it is deemed appropriate to reduce the lower lateral overextending branches by 2-4m (depending on weight characteristics) up to a height of 8m.
21. This effect of the recommended work will reduce end weight and surface area of lower limbs in an effort to lower risk of branch breakages by wind or snowfall.
