Arboricultural Constraints Appraisal & Impact Assessment

Site
Address: **53 Keresforth Hall
Barnsley
S70 6NL**

Report
Ref: **KFHB01-26**

Non-Technical Summary

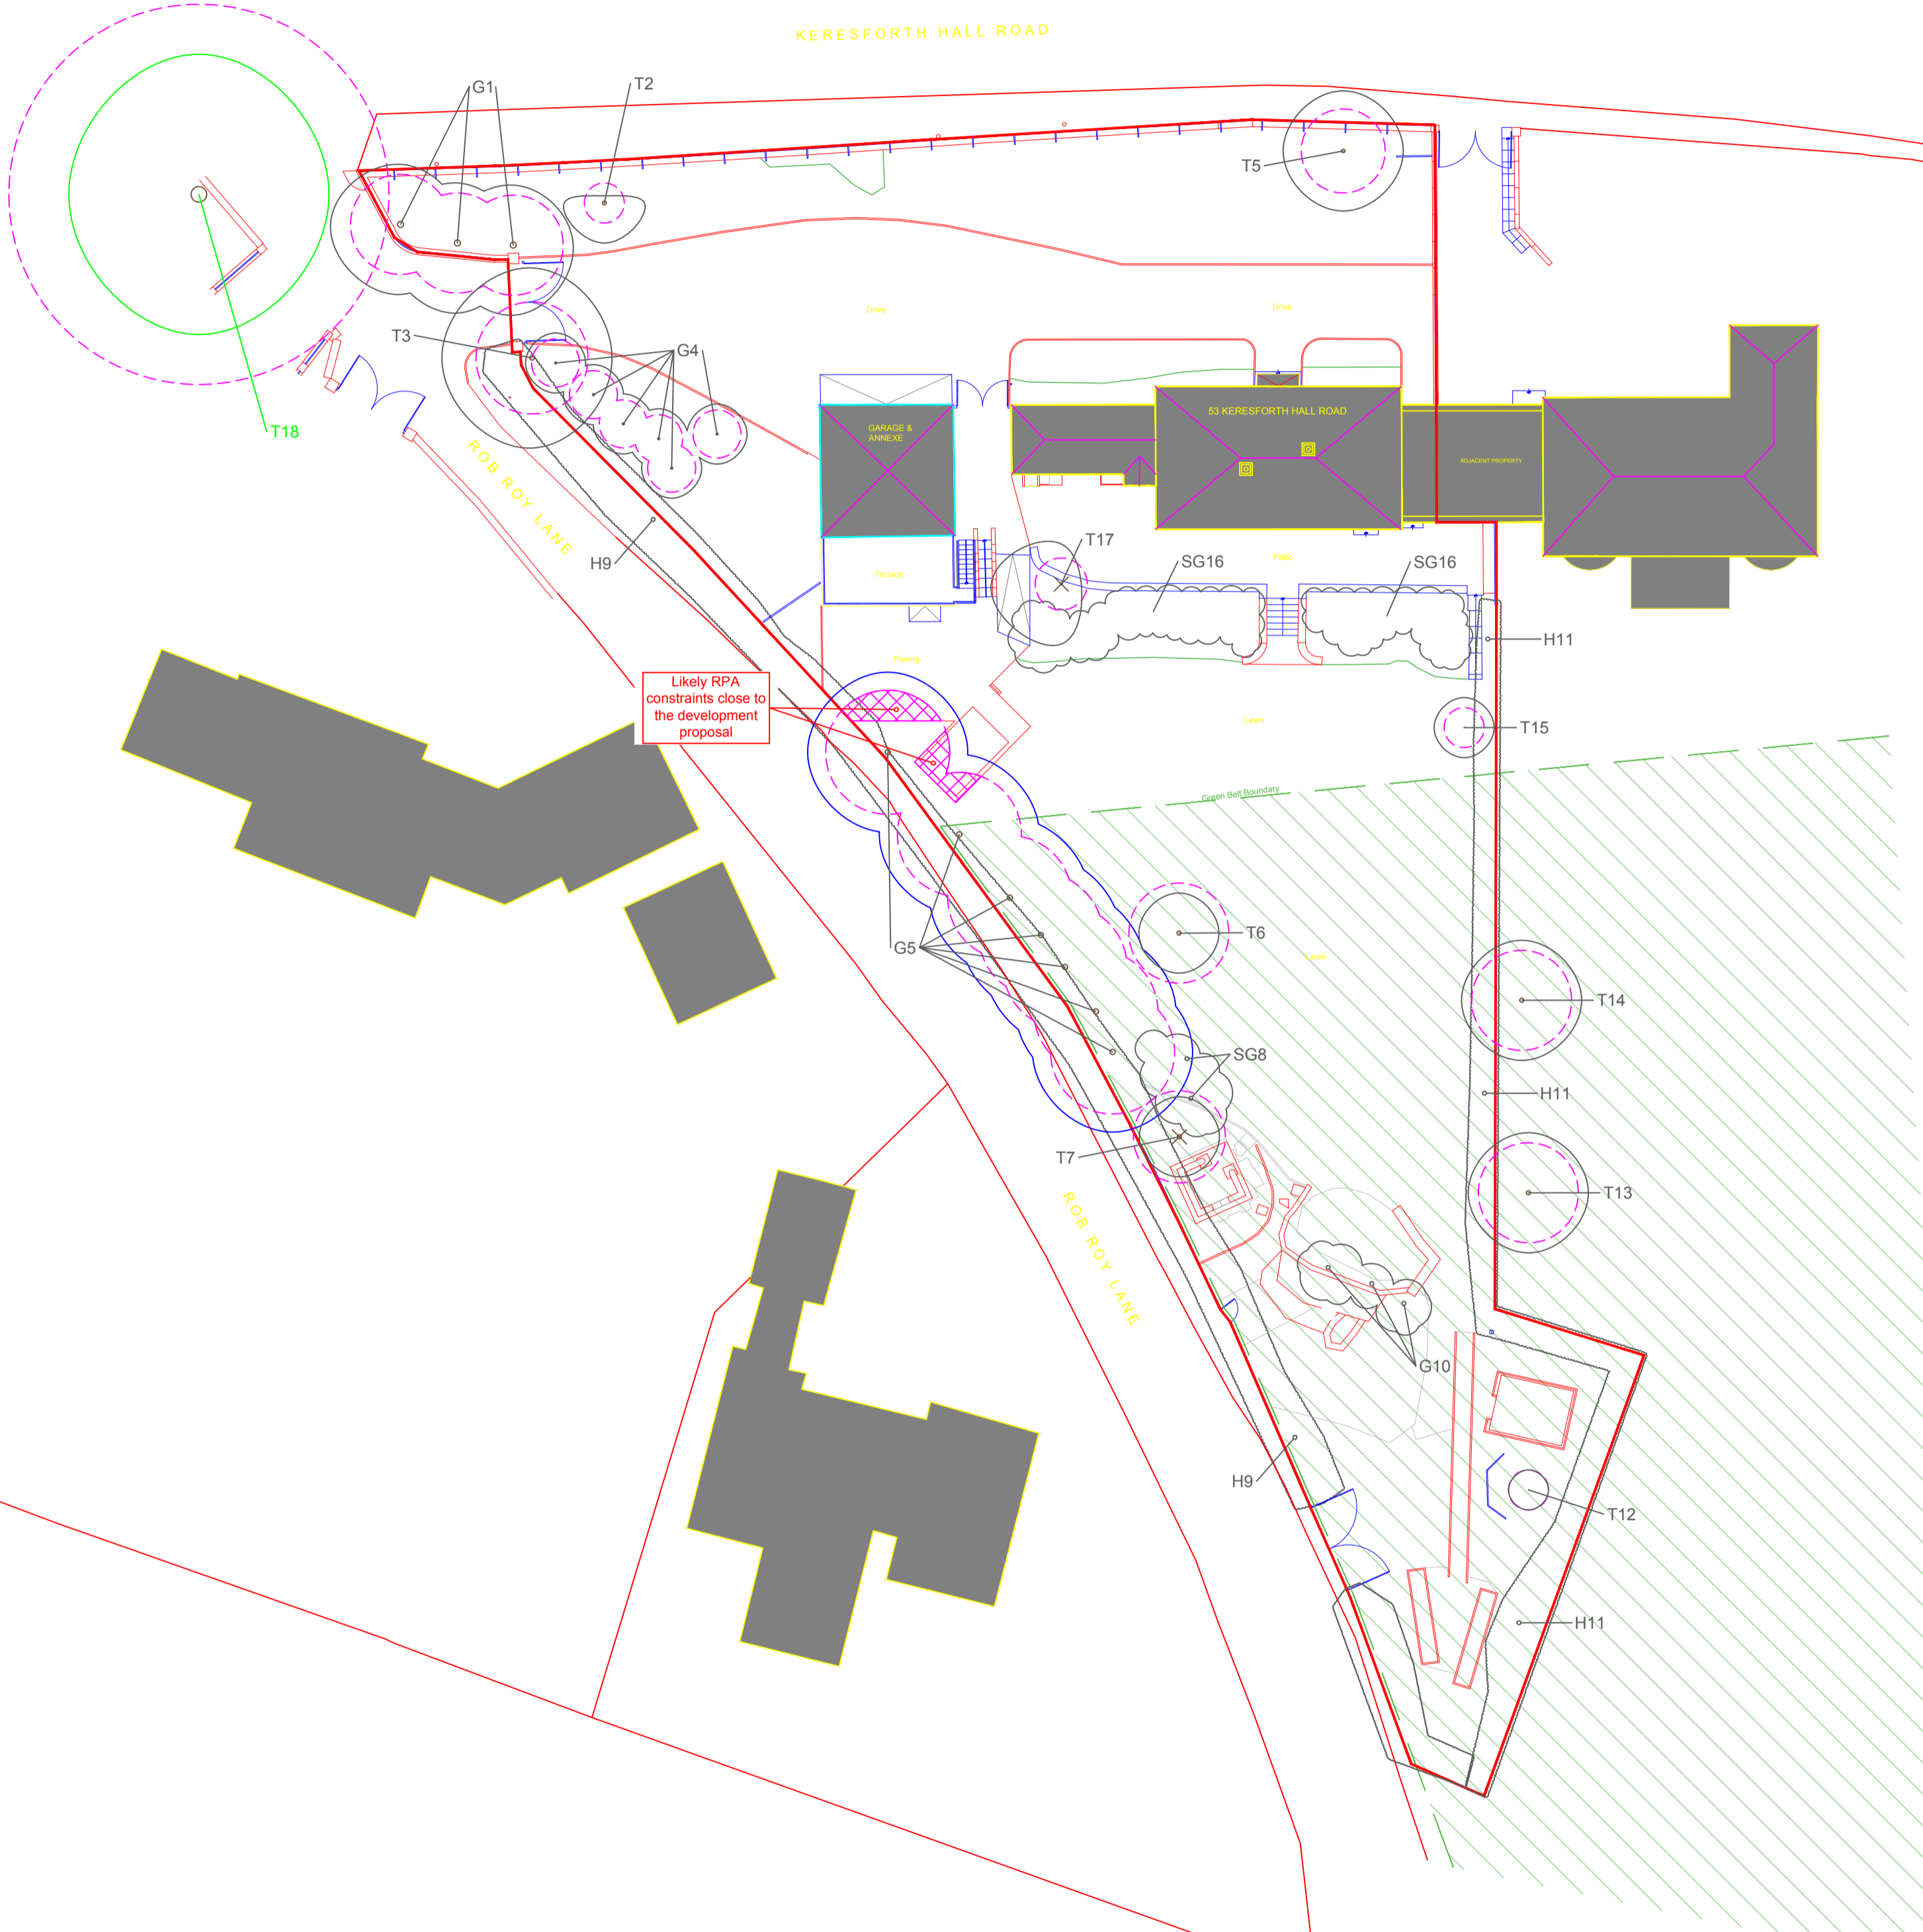
Likely RPA constraints close to the development proposal

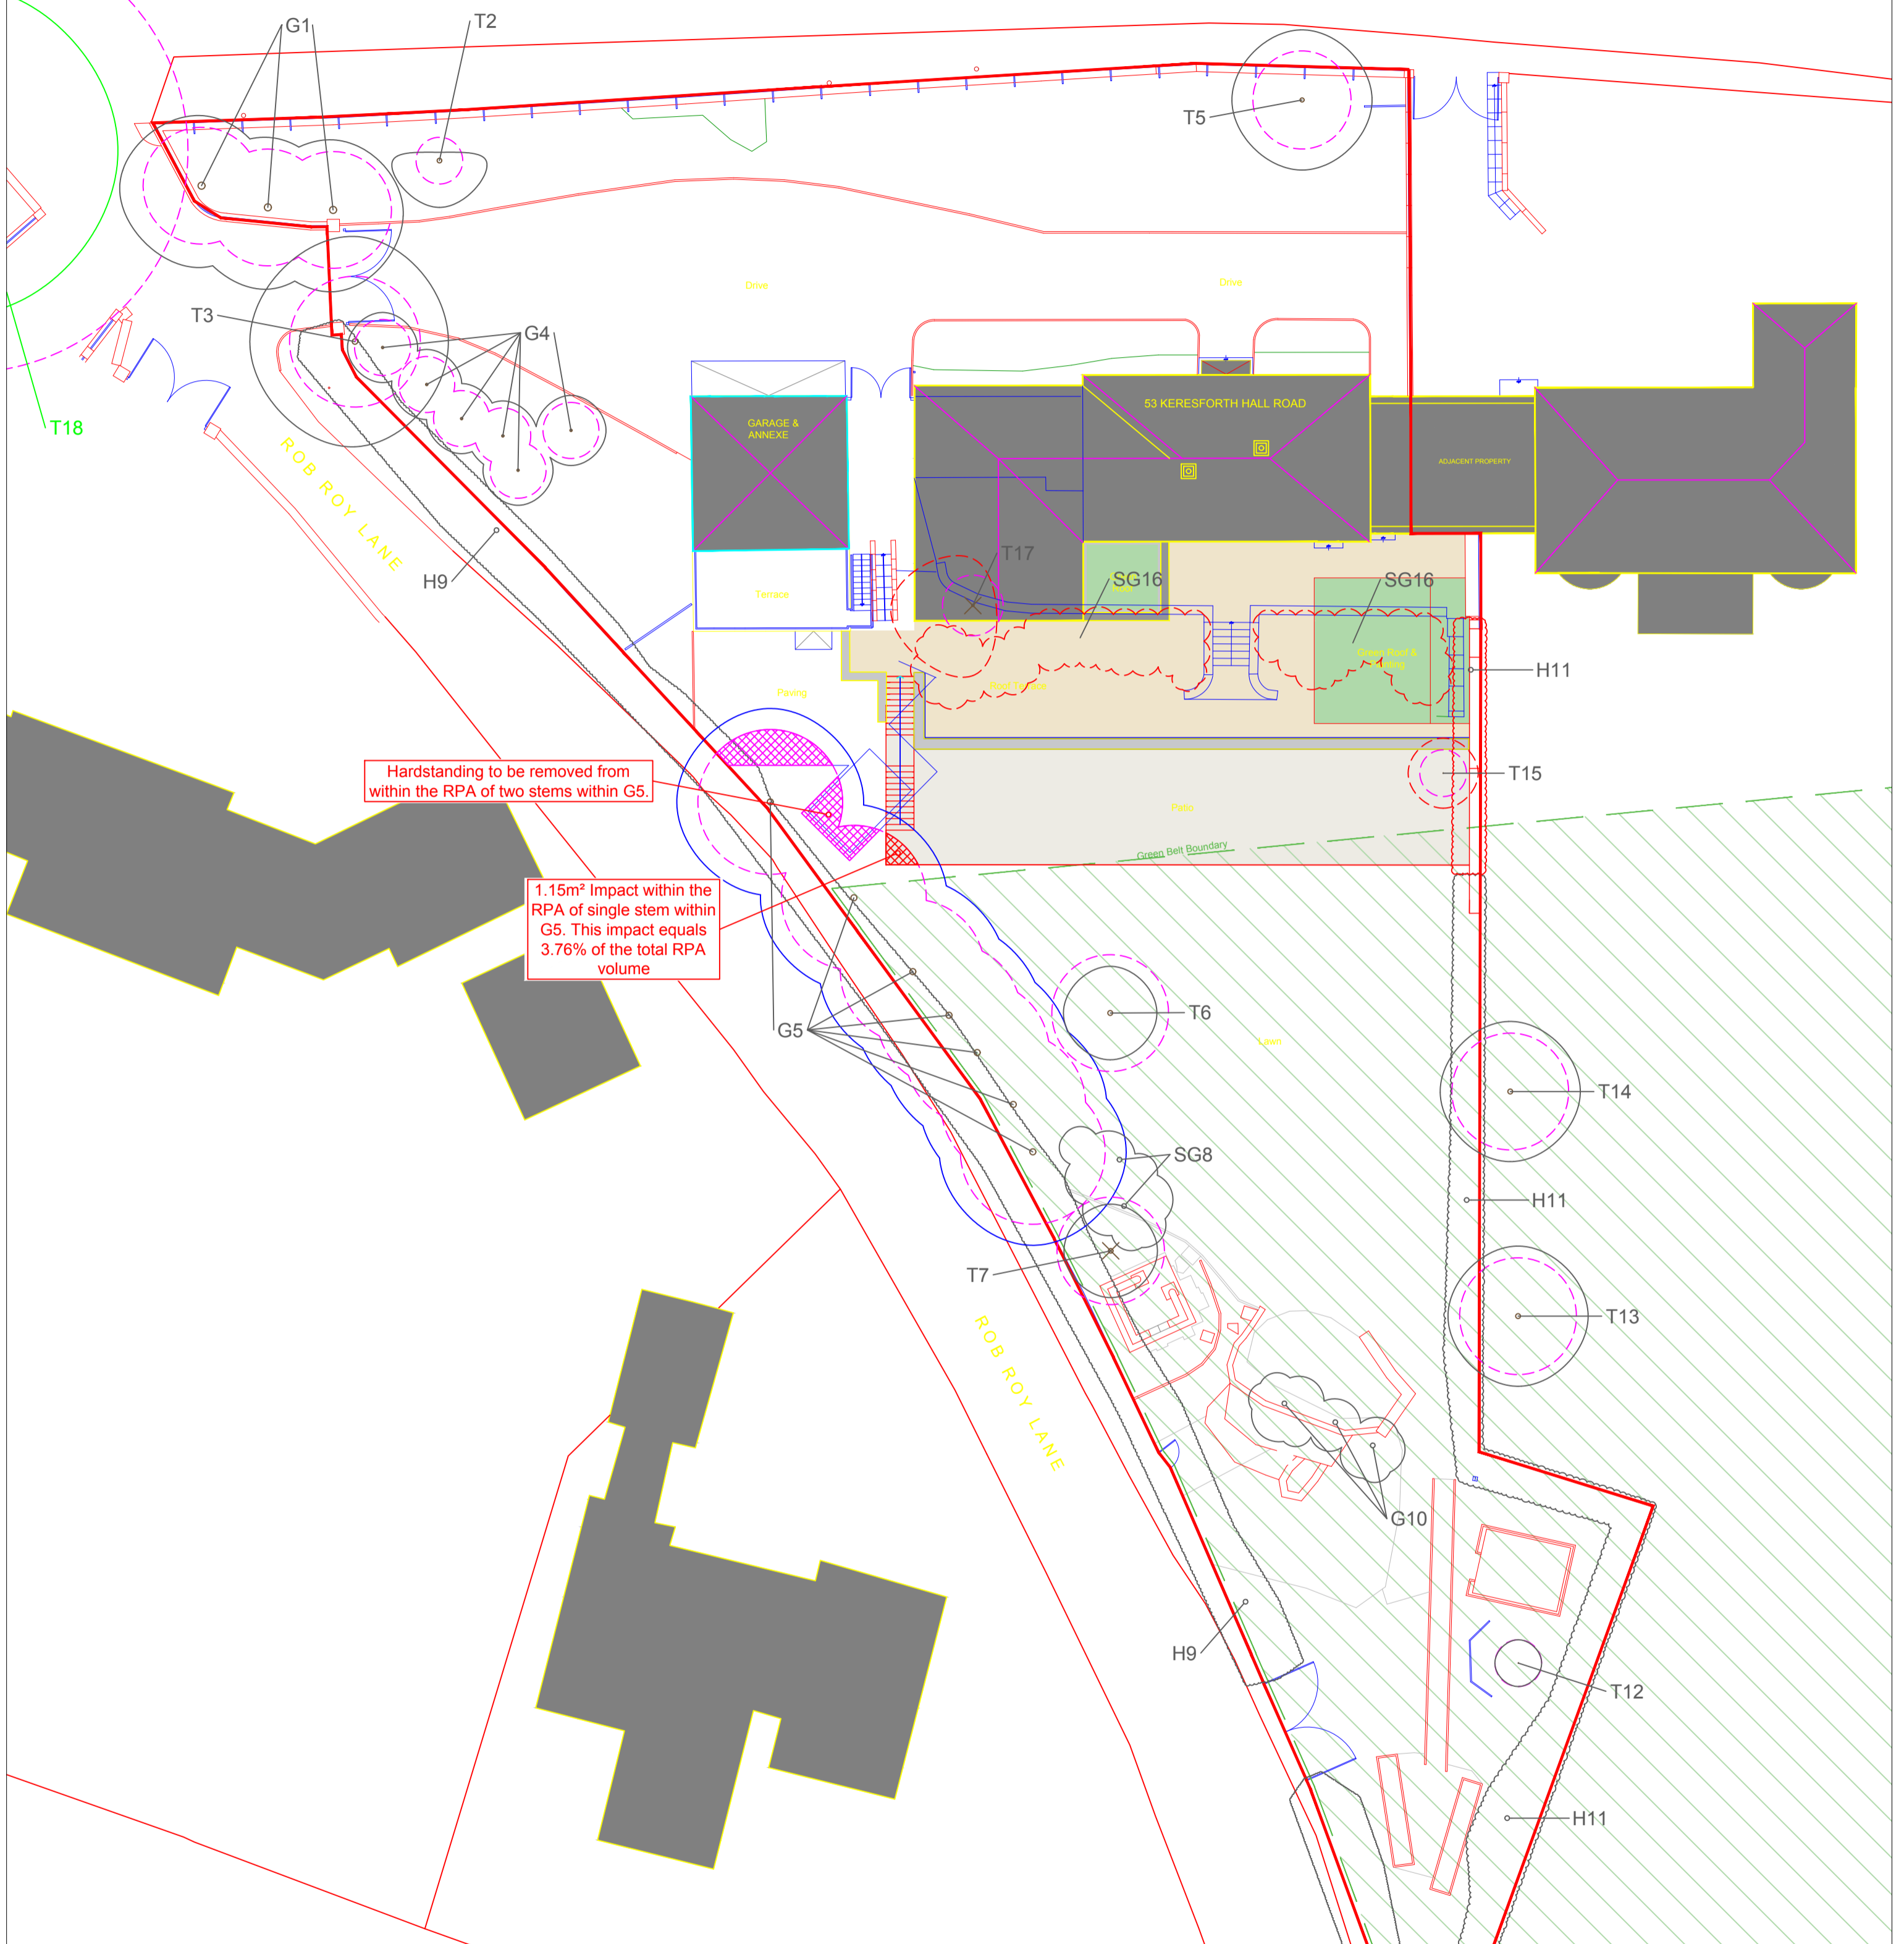
Hardstanding to be removed from within the RPA of two stems within G5.

1.15m² Impact within the RPA of single stem within G5. This impact equals 3.76% of the total RPA volume

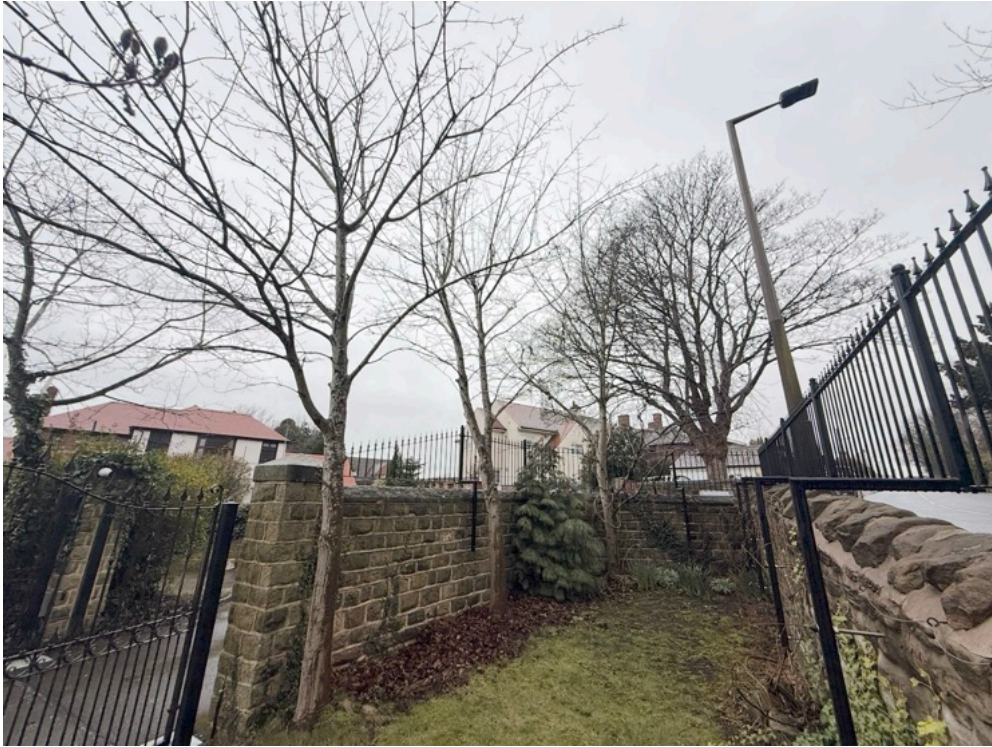
Figure 1. G1 with T18 in the background.

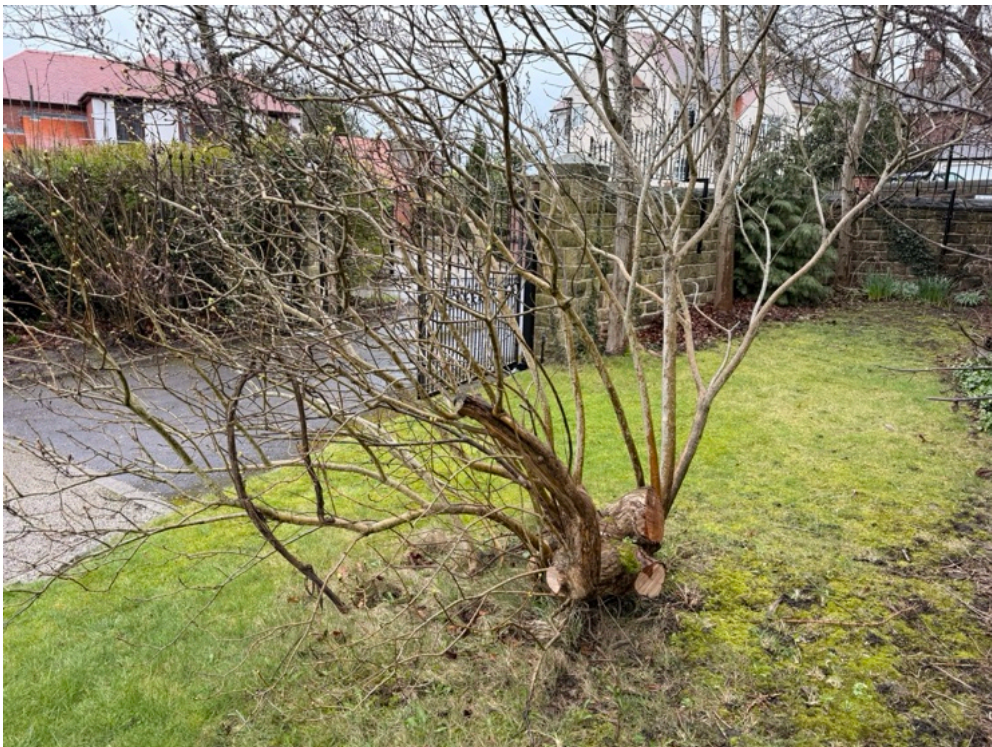
Figure 2. T2.

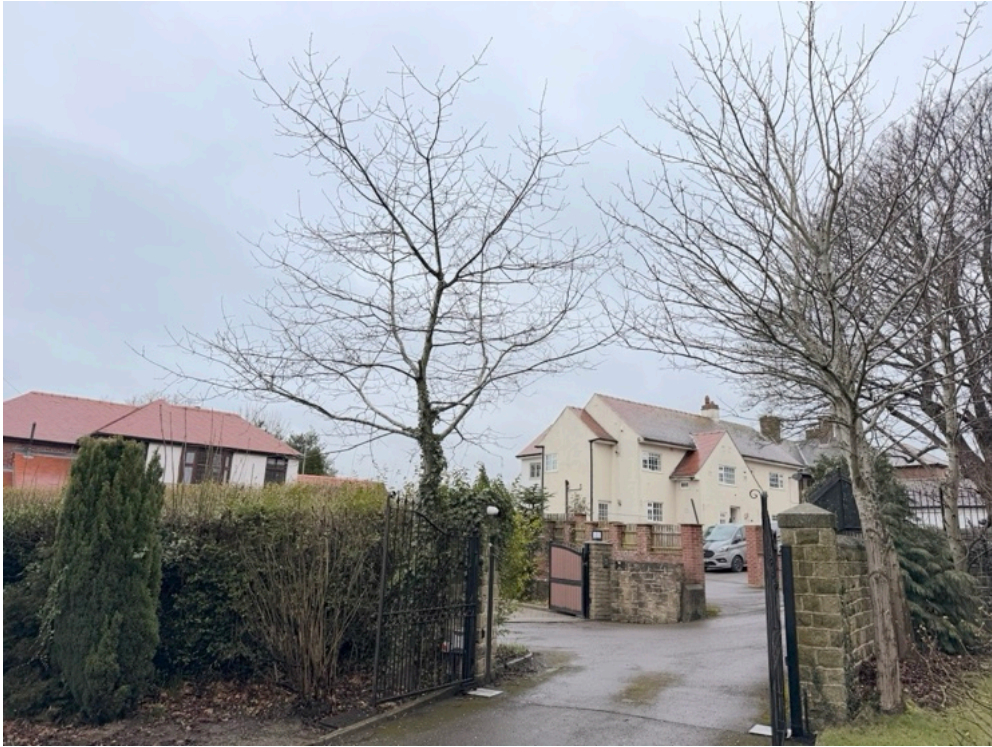
T3	Semi Mature	Cherry (<i>Prunus</i>)	8.5	230	4.5, 4, 4.5, 4.5	3	2.5	Fair	The tree stem is located next to the main entrance pillar and partially within the boundary hedgerow. Ivy is becoming established on the lower part of the stem, with the tree displaying overall good health and structure.	Sever and remove Ivy	10>	C1	2.8
G4	Semi Mature	Mixed	3	100	1.5, 1.5, 1.5, 1.5	-	0	Normal	A mixed Cypress and Cedar group, which also includes one Laurel and one Holly. Trees are relatively young and in reasonable condition, forming a cohesive group with some trees height managed at approximately 3 m.	-	10>	C2	1.2
T5	Early Mature	Cherry (<i>Prunus</i>)	7	150, 150	3, 3, 3, 3	3	1.5	Normal	The tree is located under the utility lines and appears to have been historically managed at approximately 4 m. Regrowth from pruning cuts appears vigorous suggesting the tree is in good health.	Potential to prune back to historic pruning points to ensure clearance from the utility lines.	10>	C1	2.1

Figure 3. T3 with part of G4 and H9 below.

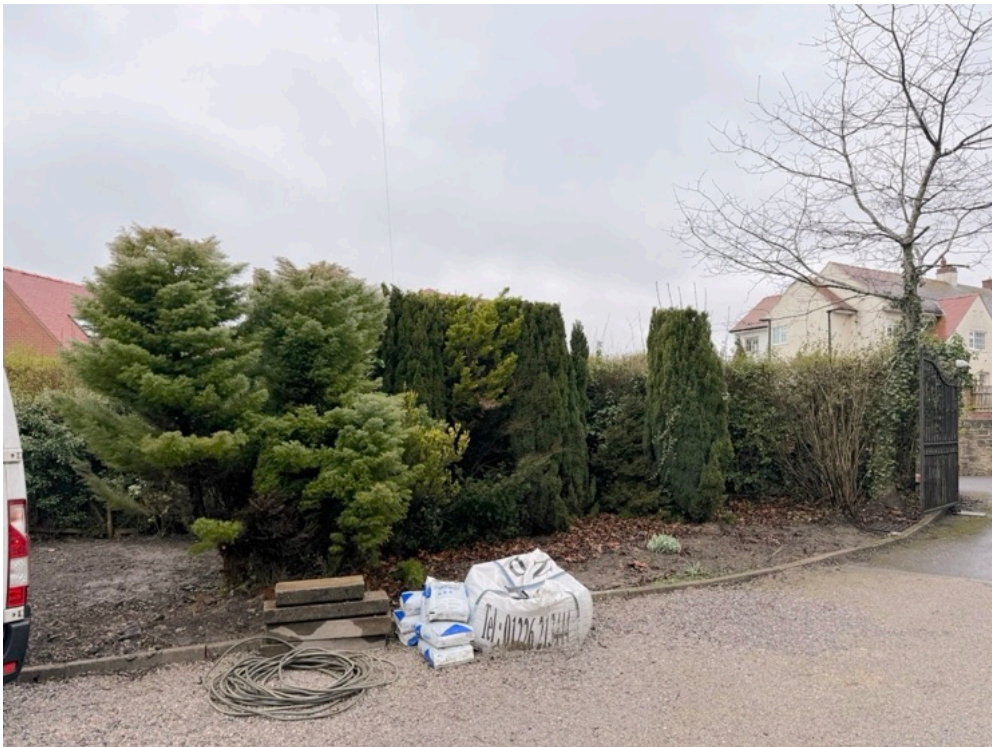
Figure 4. G4 with H9 behind.

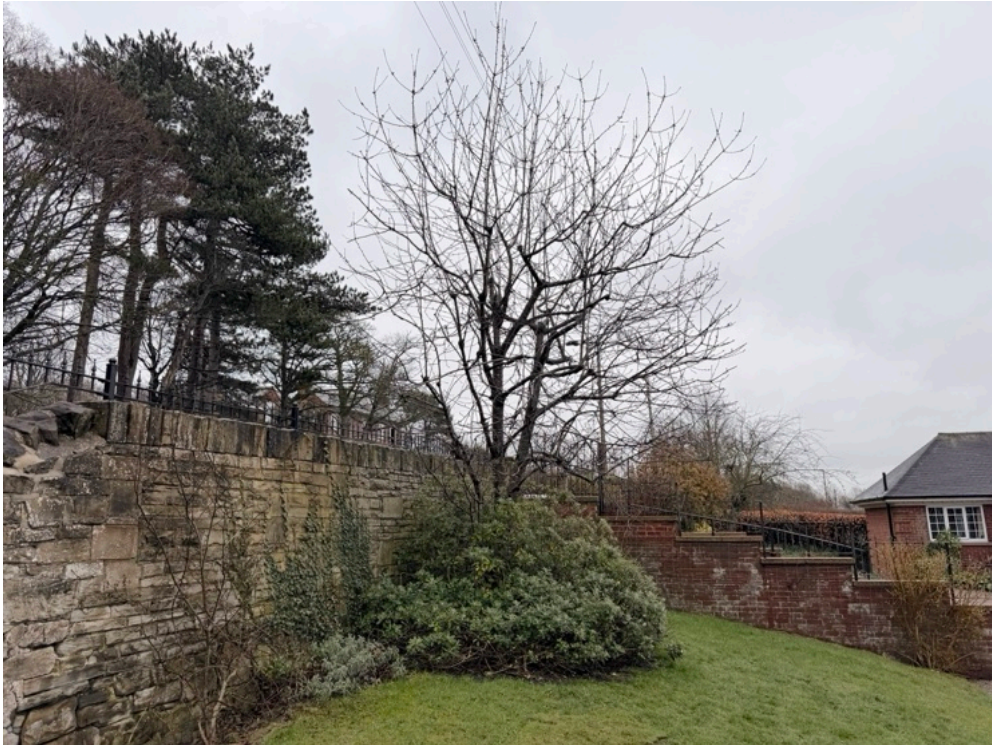
T5 is situated in the eastern corner of the plot, beneath overhead utility lines, where historic pruning has previously been undertaken to manage the clearance.

Figure 5. T5.

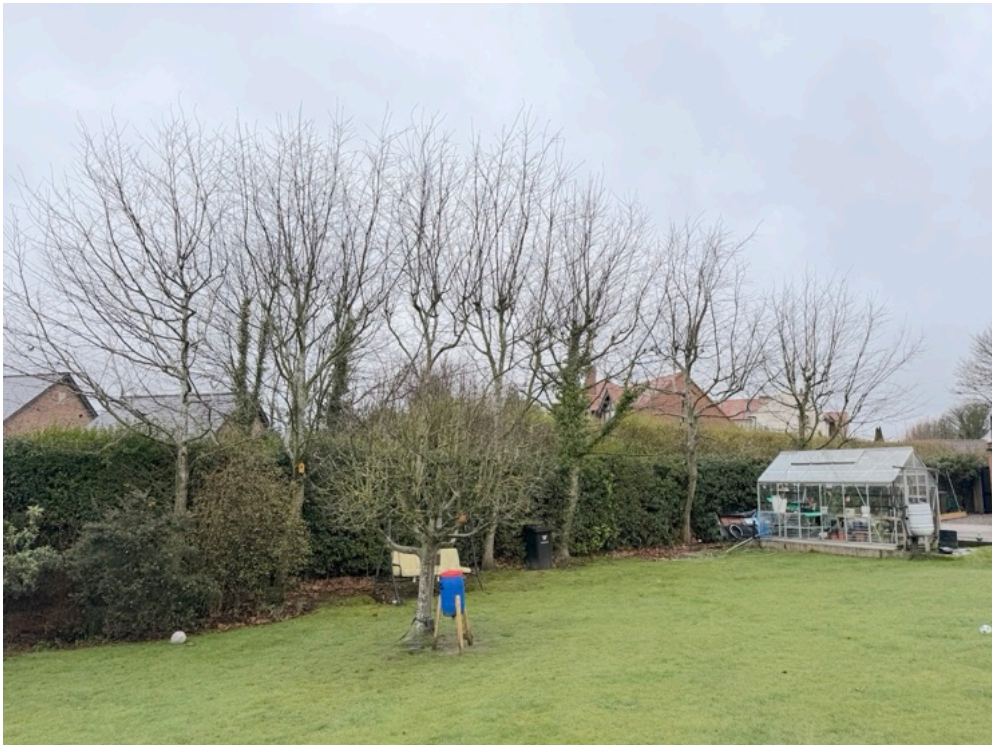
Group / Tree No.	Age & Species	Cat.	Removal due to:		Mitigation required for		Details of how proposed build layout affects trees and recommendations for mitigation.
			Cons.	Cond.	Canopy	RPA	
G5	Semi Mature Red Oak (<i>Quercus</i>)	B2				✓	<p>Removal of existing greenhouse hardstanding (4.35 m²) within the RPA of G5 and a minor patio incursion of 1.15 m² (circa 4% of the RPA area associated with one stem).</p> <p>Existing hardstanding to be removed carefully to minimise soil disturbance. Patio construction to utilise shallow excavation where practicable, retaining roots where possible and pruning only where unavoidable in accordance with arboricultural best practice. Soil beneath the removed hardstanding should be loosened and improved.</p> <p>Although a minor RPA incursion will occur, the removal of the hardstanding will reinstate approximately 2 m² of rooting area, resulting in an overall net gain of approximately 0.85 m² of permeable soil within the RPA of the affected stem.</p>

G5	Semi Mature	Red Oak (<i>Quercus rubra</i>)	9.5	260	4, 4, 4, 4	3	3.5	Normal	A row of seven trees of roughly equal age, size and health characteristics. All trees within the row have historically been reduced to 5 m and are now displaying young, vigorous, upright shoots extending from the pruning points. Given the young age of the trees, they are free from any age-related defect, although they have multiple pruning wounds on the lower 2 m of the stems. Pollard points are likely to have been entrance points for decay, which will make ongoing height management important.	-	20>	B2	3.1
T6	Early Mature	Rowan (<i>Sorbus aucuparia</i>)	4	210	2, 2, 2, 2	1.5	1.5	Normal	The tree has been cyclically pruned to form a compact domed canopy.	-	10>	C2	2.5

Figure 6. G5 with H9 below and T6 in the foreground.

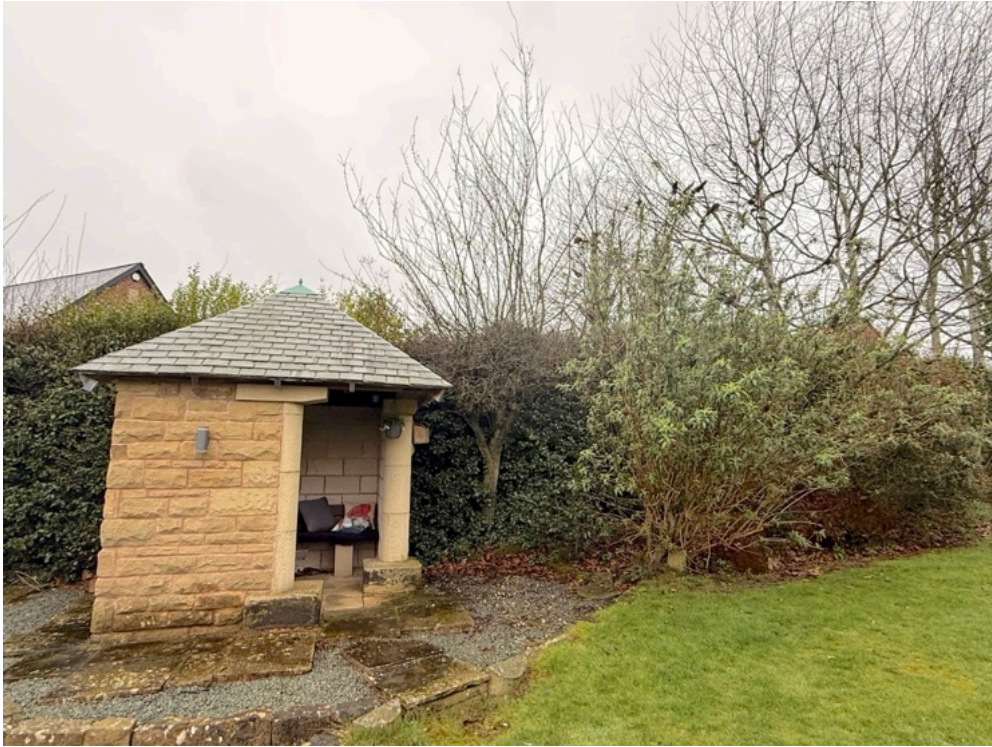
Figure 7. T7 is to the right of the stone building, with aspects of SG8 to the right of the image.

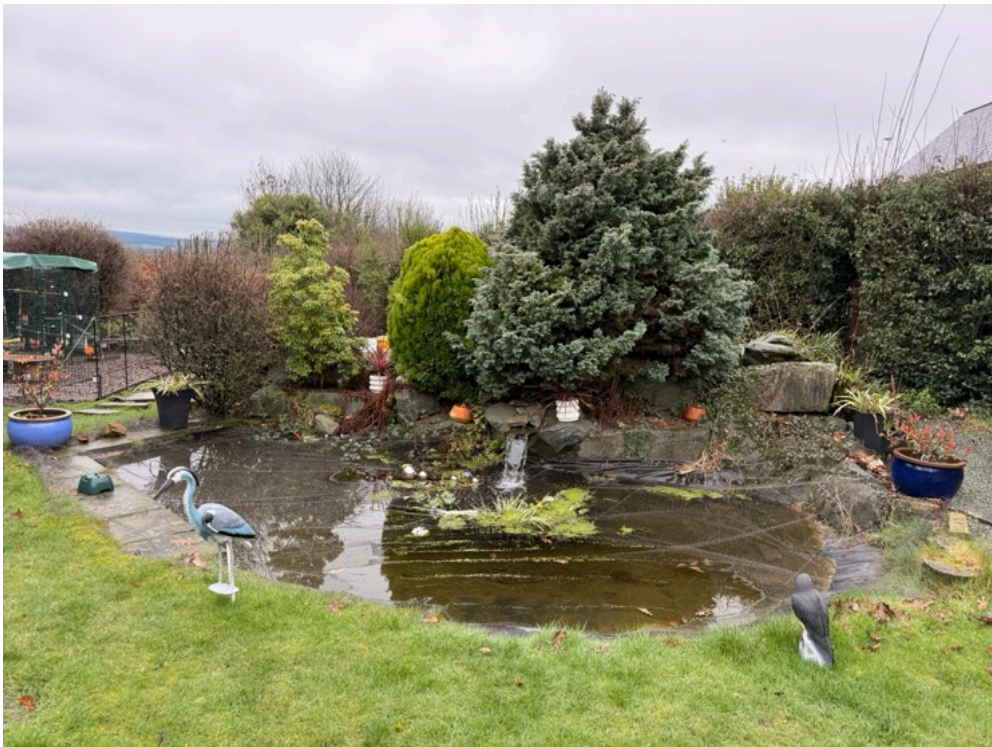
An exception to this perimeter arrangement is G10, which is located toward the narrowing southern end of the garden. This group forms a vegetated backdrop to the existing pond and provides a degree of visual screening within the lower part of the garden.

Figure 8. G10 behind the pond.

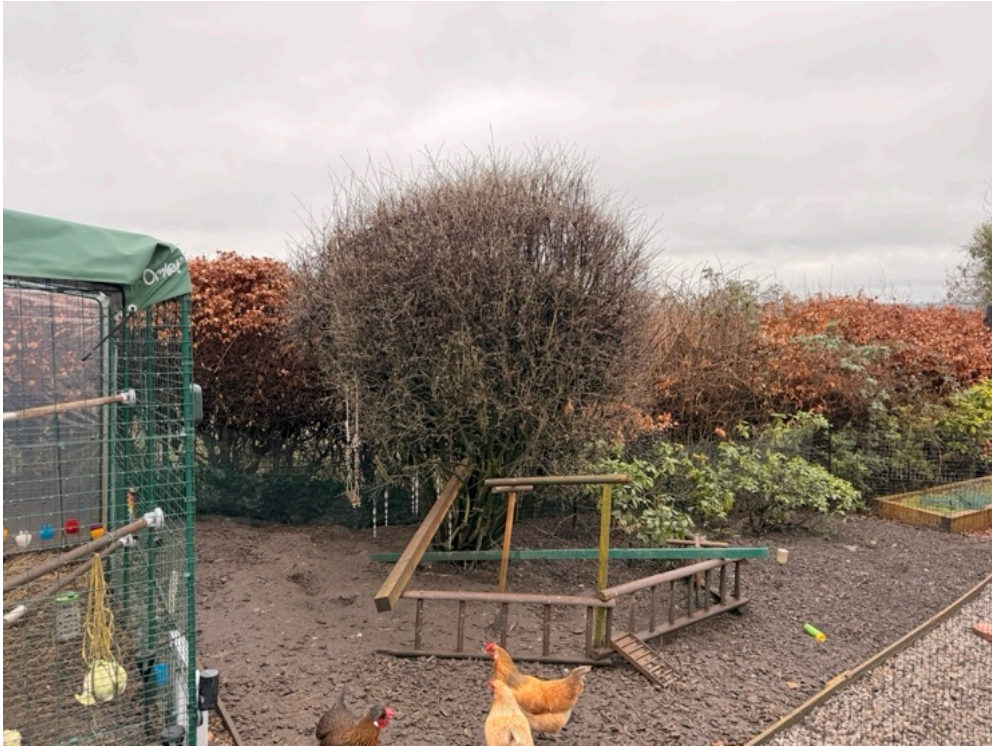
Figure 9. T12 with H11 behind.

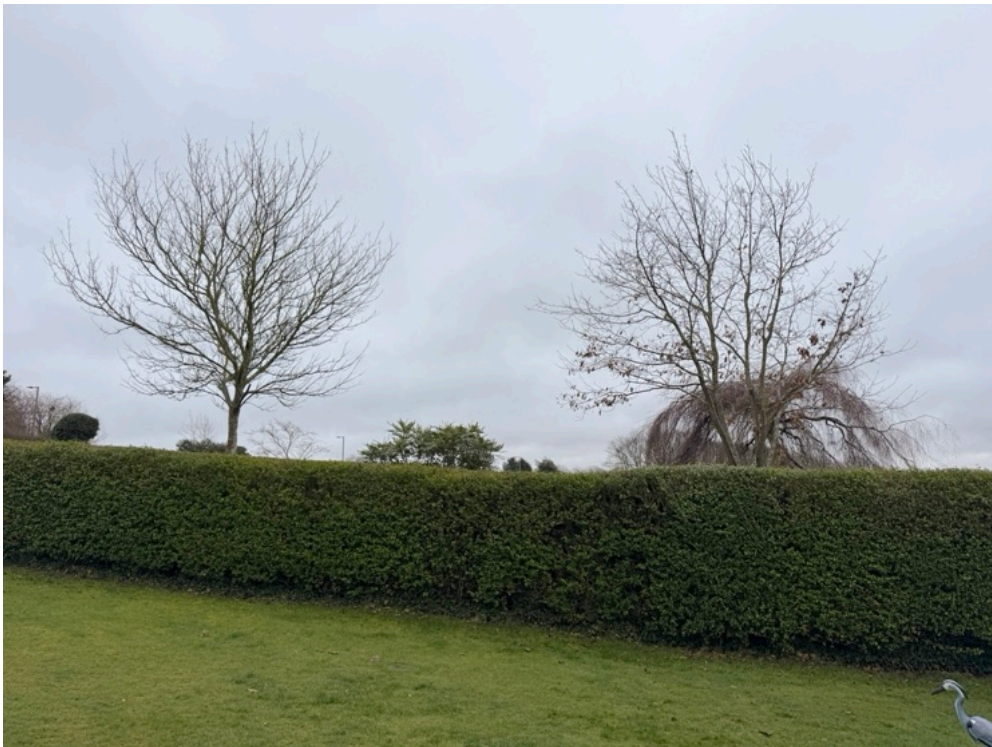
Figure 10. T14 (left) and T13 (right) behind the boundary feature (H11).

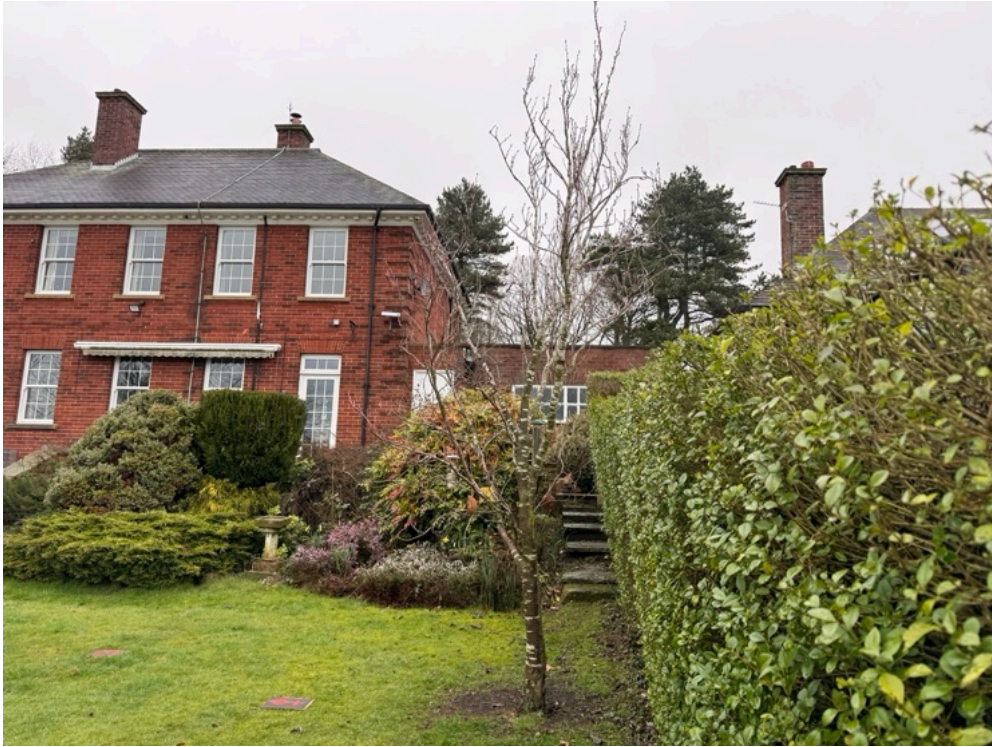
Figure 12. T15 with part of SG16 in the background and H11 to the right of the image.

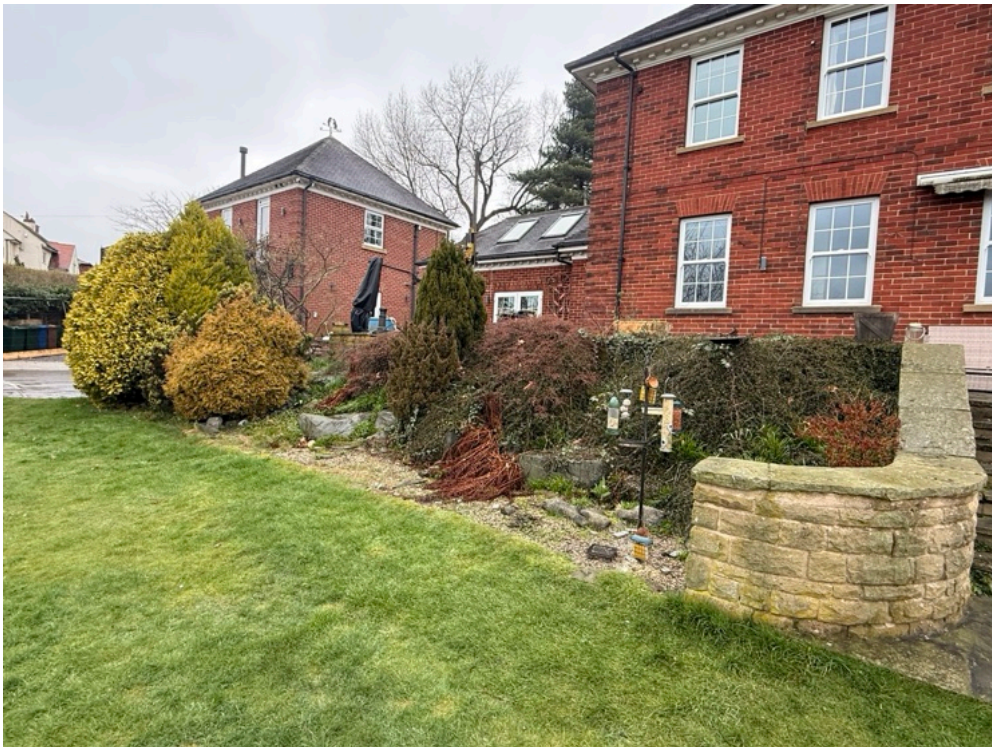
Group / Tree No.	Age & Species	Cat.	Removal due to:		Mitigation required for		Details of how proposed build layout affects trees and recommendations for mitigation.
			Cons.	Cond.	Canopy	RPA	
SG16	Mixed Shrubs	C2	✓				Woody shrub border in conflict with the development proposal. The loss of this border will be partially mitigated through the provision of the two proposed green roof areas , which will contribute to replacement vegetation and biodiversity value.
T17	Early Mature Japanese Maple (<i>Acer palmatum</i>)	C2	✓				Tree in direct conflict with the proposed development footprint. The loss of this tree will be mitigated through replacement planting within the landscape design and the provision of two green roof areas which contribute to biodiversity enhancement.
<p>Group / Tree No. - ID referenced within the arboricultural survey. Age & Species - Age classification and common name for specimen. Cat - BS 5837 category rating. Removal due to - 'Cons' = Construction. 'Cond' = Condition. Mitigation required for - Canopy or for RPA (Root Protection Area).</p>

Figure 13. An additional part of SG16.

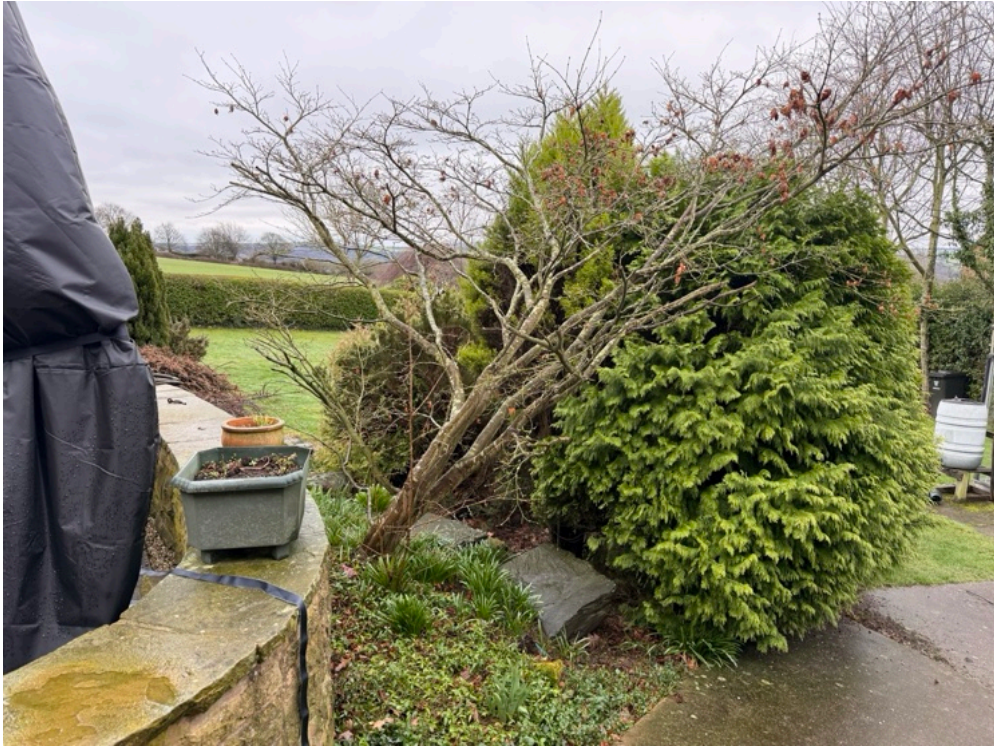
Figure 14. T17 with SG16 behind.
