Fall Head Farm, Fall Head Lane, Silkstone, Barnsley S75 4LB

You have asked that I make a structural inspection of redundant farm buildings at Fall Head Farm to advise on their condition in connection with proposed conversion/renovation plans.

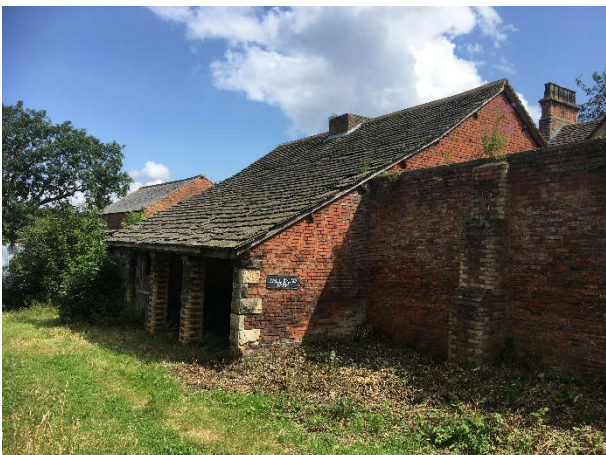
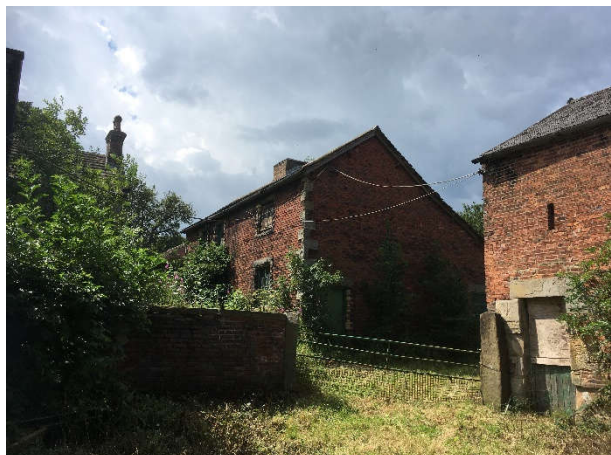
Building A

Building A. Detached two storey barn or former dwelling house with single storey lean-to at the rear, possibly a former carriage shed. Solid brick walls with stone heads and cills at openings. The roof is covered in stone slates.

Walls appeared to be in a satisfactory condition for their age and usage, with acceptable line and level of coursing and reasonably plumb alignment. Carriage shed quoin and stone heads and cills all weathered/eroded to a degree.

Ground floor walls appeared satisfactory. Upstairs, access was not gained to the north end room due to unsafe condition of floor, but no major defects were noted. King post roof trusses likely reusable if desired, subject to specialist timber treatment report.

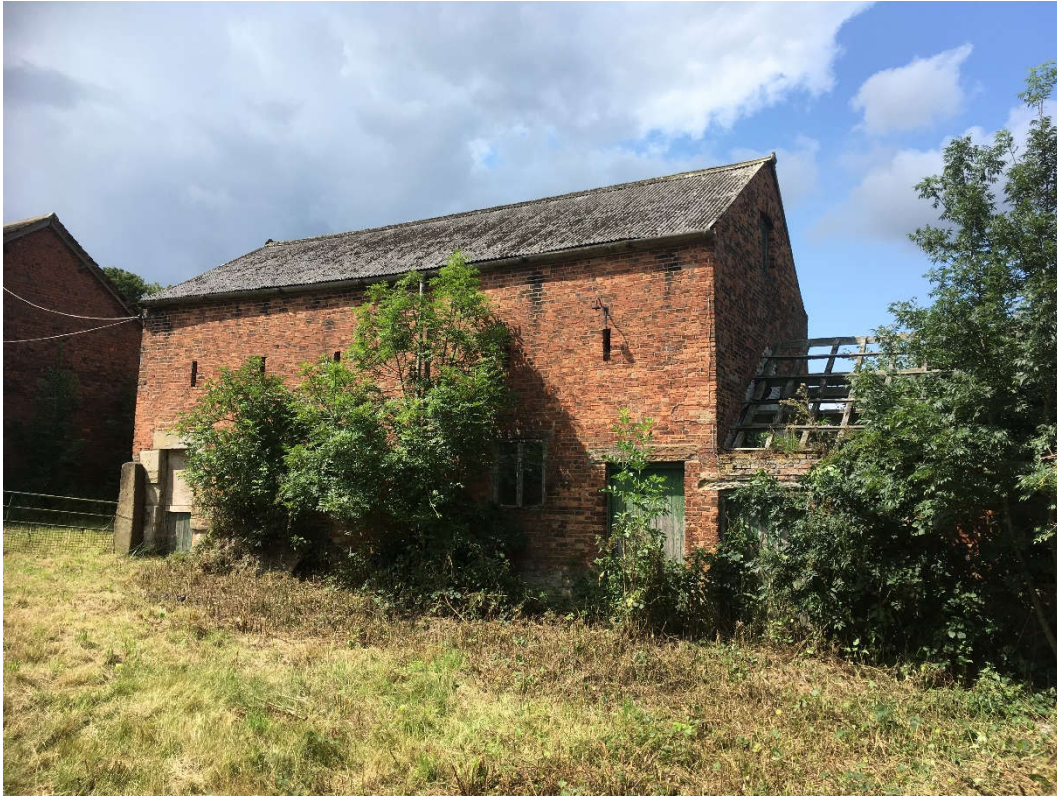
Building B

Building B. Two storey barn attached to building C. Solid brick walls, stone heads and cills. Roof covered in corrugated sheeting, possibly asbestos-cement.

Walls displayed a number of defects but none requiring major rebuilding:

SE elevation. Lateral in-out movement of perhaps 150mm over the full height. Brickwork joints eroded central base area. Quoin stone at door opening missing.

SW elevation. A bowing outwards over ground floor height of perhaps 100 to 150mm but no major cracks visible. Stone heads and cills weathered.

NW elevation. Stone walling below internal ground floor level eroded. Slight bowing outwards centrally of perhaps 100mm over full height but no major cracks visible.

NE elevation. Slight twist outwards at western end of verge.

Southern compartment, ground floor, SE wall leaning, mirroring external view. SW wall, joints have opened up around the infilling of a large ground floor opening and movement of the redundant lintel over has caused the eastern door pier to lean. These defects mirror those noted externally. Floor over unsafe.

Northern compartment. Some slight separation between the internal cross wall and the rear wall. First floor examined from northern compartment only, showing rear external wall bowing out perhaps 75mm with a general lean out towards the top of about 50mm. No major cracks noted. King post roof trusses may be capable of reuse if desired, subject to timber report etc.

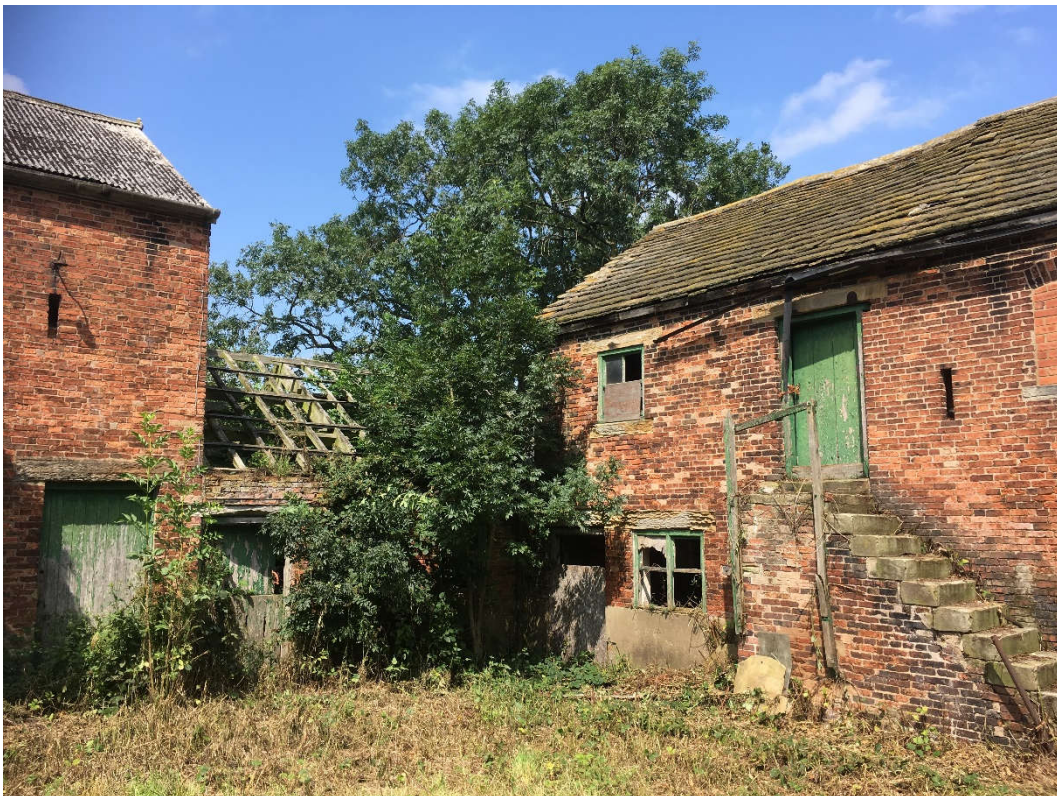
Building C. Single storey barn attached to buildings B and D, of brick and stone construction. Roof coverings missing and roof structure largely open to the elements.

Building C – Corner single storey link building.

SE elevation (single storey), stone heads and cills eroded. SE elevation (gable shared with building D), loose masonry along verge with some bricks missing. Slight lean inwards at ground floor.

NW elevation. stone walling below ground floor badly eroded. Wall leans outwards possibly 150mm.

NE elevation. Lower stonework badly eroded.

NW wall leans out as noted

NE wall, condition generally obscured by plaster but with some minor cracking and a slight lean outwards.

Roof trusses have been exposed to the weather for some time with consequent deterioration. Hip truss has major splice repair to principal tie. Intermediate truss has water damage at the ends.

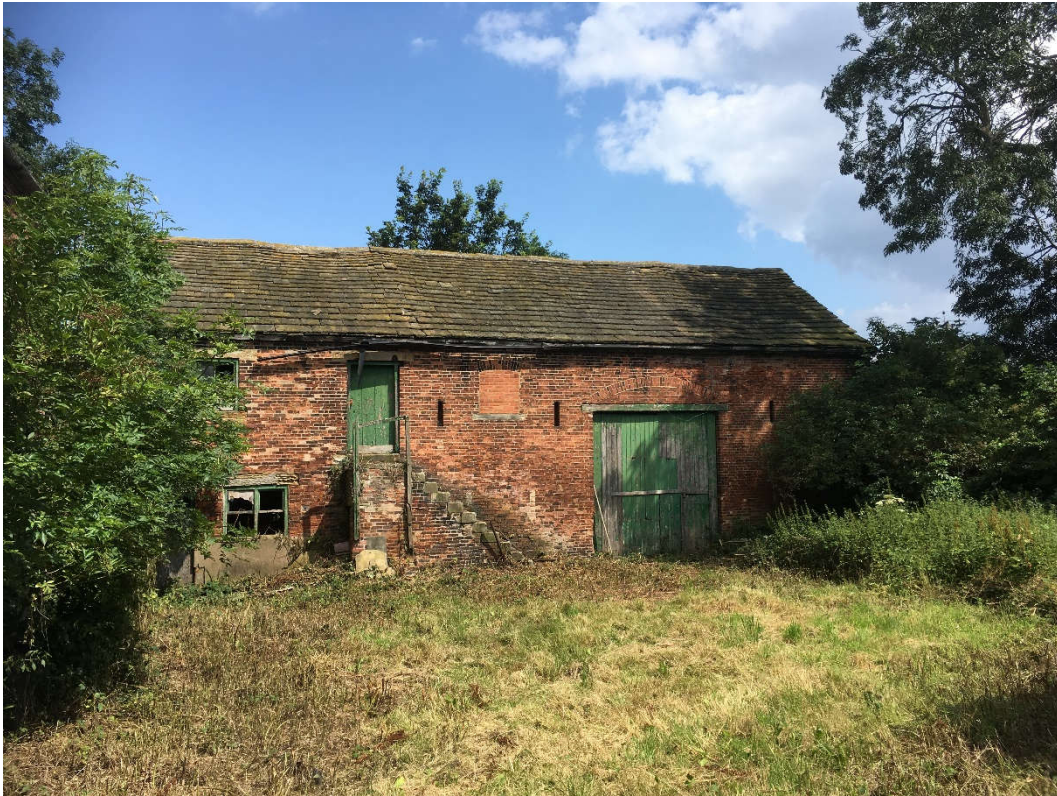
Building D

Building D. Tall single storey barn but with western end compartment having two storeys. Attached to building C. Solid brick walls, stone heads and cills and stone slate roof.

SE elevation. Gable verge brickwork loose and some bricks missing. Local bulge outwards approximately 50mm in upper half, southern end. Mortar joints above eaves level eroded.

SW elevation. Brickwork in reasonable condition but with areas of joint erosion above entrance and at foot of external staircase. Stone heads and cills eroded.

NE elevation. Cracking and opening of joints around infilled former arched opening, approximately up to 20mm width. Western end is of stone construction with significant erosion to upper storey.

Walls generally reasonably plumb but with general minor unevenness in brick coursing. NE wall shows diagonal cracks over infilled arch, mirroring external view.

First floor structure in two storey western compartment was unsafe, preventing access. Ground and first floor walls appeared satisfactory with no major defects noted. First floor timber beams currently propped near mid span.

Queen post roof truss may be capable of reuse if desired subject to satisfactory timber report etc.

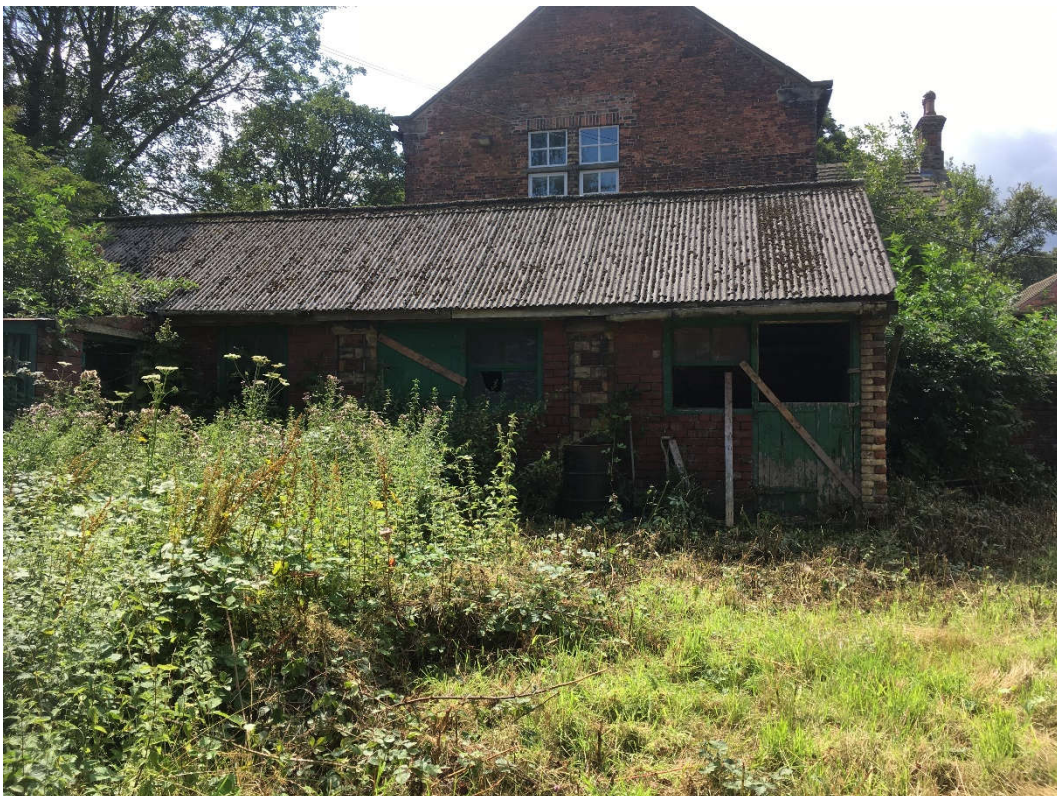
Building E

Building E. Single storey barn, possibly former carriage shed, with bays demarcated by feature brick piers and the bays largely infilled subsequently with brickwork. Roof covered in corrugated sheeting, possibly asbestos-cement.

NW and SE gables appeared to be in satisfactory condition though southern corner quoin is eroded.

NE elevation. Slight lean outwards of dividing piers with a slight bulge outwards of the infill brickwork near mid length of wall.
