Tree Survey; **Burntwood Hall Care Centre,  
Brierley Common, Barnsley, S72 9HB.**

Client; **Tim A Stubbins, Mitchell and Proctor Architects,  
on behalf of Guardian Care.**

Date of Survey; **January 26<sup>th</sup> 2010**

File reference **Burntwood Hall 01**

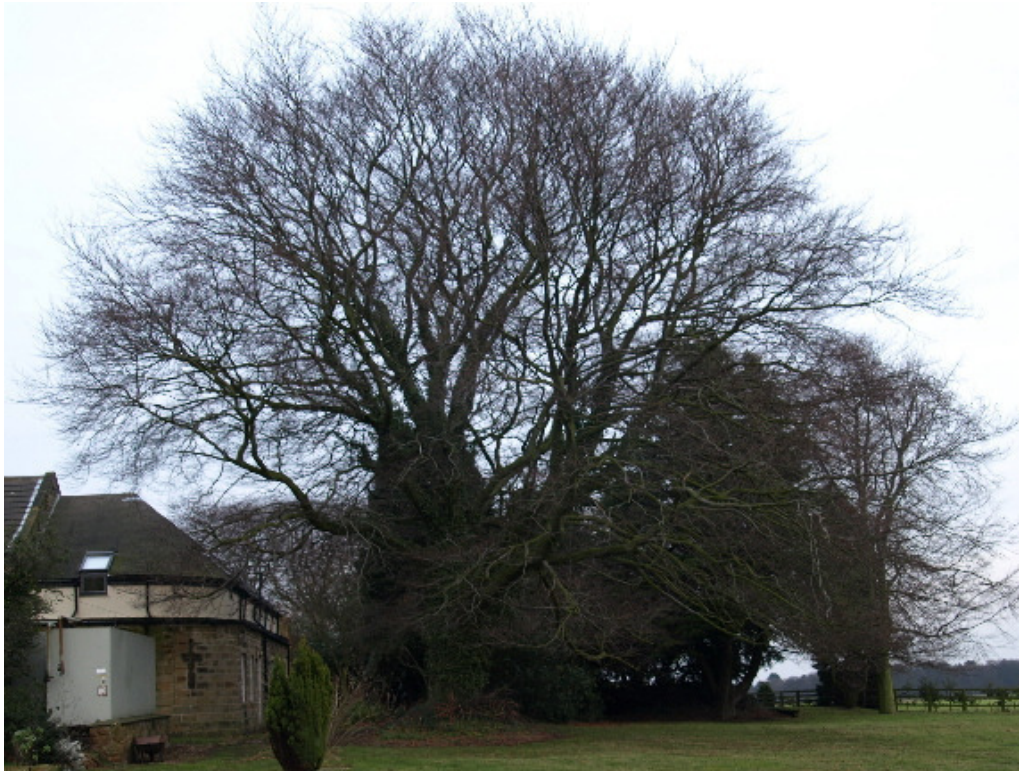
Figure 1.

| Tree No. | Species. | Ht | TD | Age class | Category | Comments. | RPA |
|---|---|---|---|---|---|---|---|
| 1. | Beech | 18 | 1100 | M | B1 | 22 metre spread. An imposing specimen, Ivy clad. Some lower branches are close to the ground. Dead wood and debris heaped around the base of the trunk prevented a detailed inspection. Some minor dead wood in the crown. | 548 |

Figure 1 is a photograph of tree 1, the Beech. It is an imposing specimen and in better condition than might be anticipated. There is some minor dead wood in the crown, less than might have been anticipated for a tree in this position and of this size. Figure 2 shows that where dead twigs and branches have fallen from the tree they have been simply stacked at the base. While this is not particularly a problem it did prevent me from thoroughly inspecting the tree's trunk at ground level. I mention this merely to emphasise that I have not thoroughly examined the tree. I did note that the crown appears quite healthy and there is no sign of any die-back. I also noted that the soil profile at the base of the tree might have been altered so there could have been some root damage in the past.

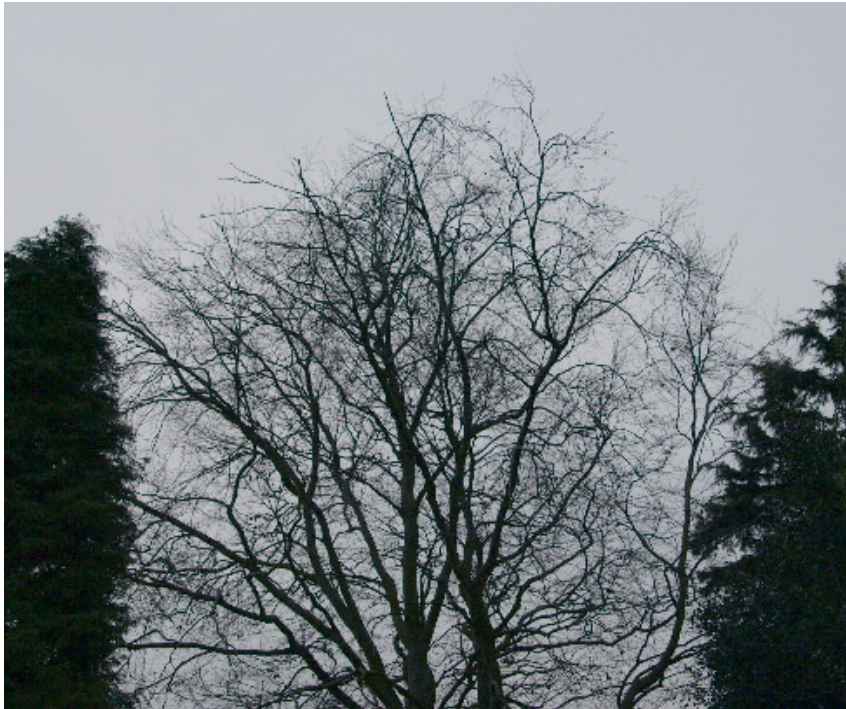
Figure 3.

| Tree No. | Species. | Ht | TD | Age class | Category | Comments. | RPA |
|---|---|---|---|---|---|---|---|
| 9. | Beech | 16 | 720 | M | C1 | Superficially a reasonable specimen, but some die-back and an extensive infestation of Felted Beech Coccus; a sap sucking insect that is often the vector for Beech Bark Disease. | 235 |

Figure 3 above shows the crown of Beech tree 9. In contrast to tree 1 we can see some die-back in the crown. (Tree 10 is to the left and tree 6 to the right) Figure 4 shows the trunk of tree 9; the white striations are actually masses of the sap-sucking insect Felted Beech Coccus (*Cryptococcus fagisuga*). This is not much of an insect in that it's very small and has no legs or wings, it's just a mouth and a stomach, but it is frequently a precursor to the development of Beech Bark Disease. The die-back may be related to this insect or it may be that the tree has had the soil level altered over its roots.

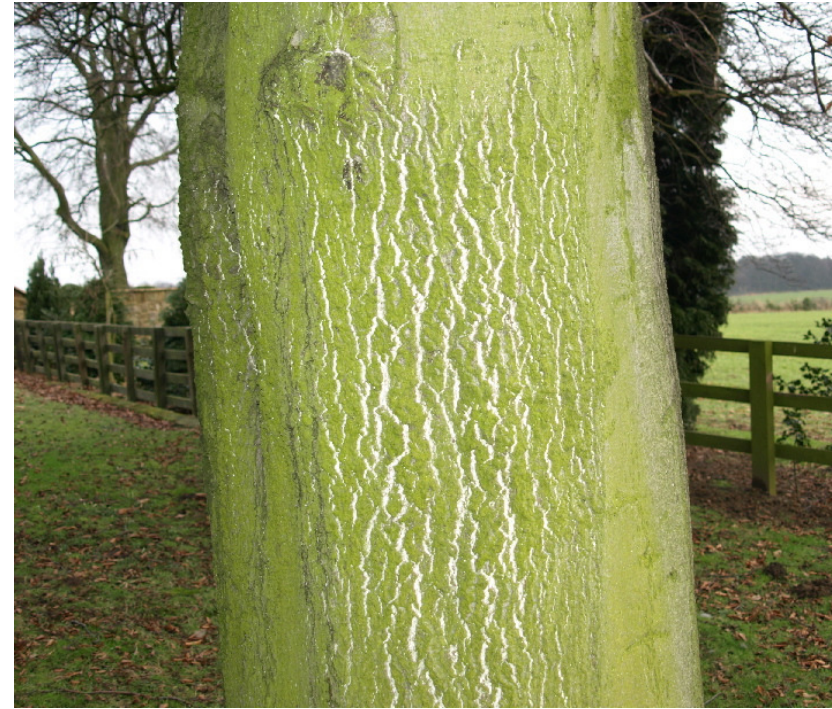
Figure 4.

Infestations with insect pests pose something of a conundrum in that we're never completely sure whether the insect pest has become established because a tree is in decline or whether it's the infestation that leads to decline. With many tree problems the primary cause is the tree becoming damaged by, say, lightning or mechanical damage. Opportunist infections and infestations then hasten the tree along its "mortality spiral." This is obviously a subject beyond the scope of this report, suffice to say this tree is not in as good a condition as it might be, certainly not as good as tree 1.

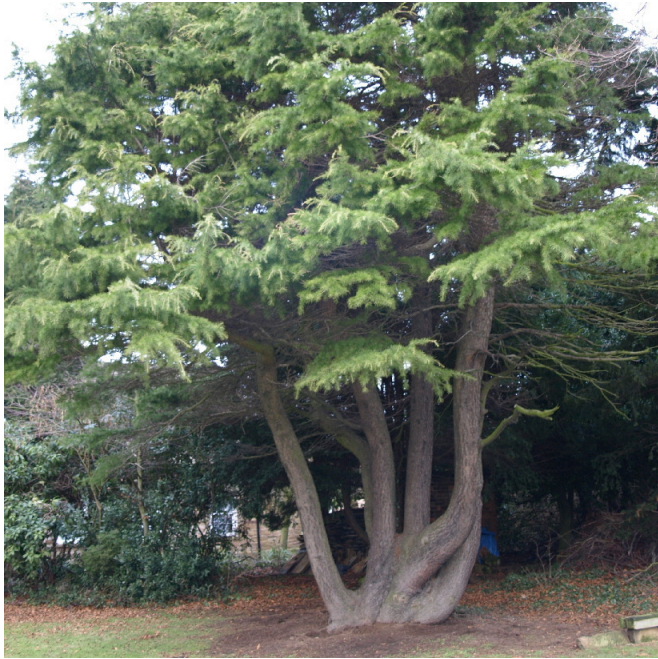
Figure 5.

| Tree No. | Species. | Ht | TD | Age class | Category | Comments. | RPA |
|---|---|---|---|---|---|---|---|
| 6. | Deodar Cedar | 15 | 720 <sup>1</sup> | M | B1 | 5 stems. An interesting specimen. Reasonable condition, soil level may have been raised at one side of the trunk. | 231 |

Figure 5 shows tree 6 with its interesting, architectural trunks. Figure 6 shows tree 14, the Walnut coppice-growth. Tree 14 will require removal for the proposed extension and while I consider it to be an unusual feature I have to accept that my tastes are not particularly mainstream, and visually this is not an impressive feature. It also has no special value to wildlife and is not particularly rare. The Romans are thought to have introduced it and now it's widespread but I'm not aware of it having become naturalised anywhere.

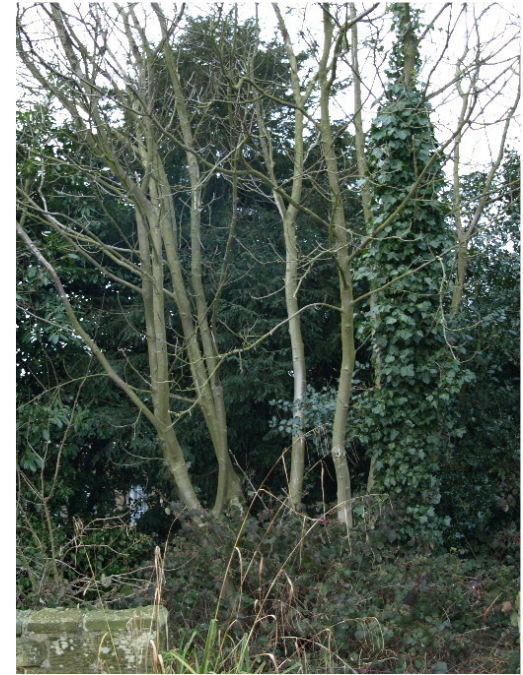
Figure 6.

| Tree No. | Species. | Ht | TD | Age class | Category | Comments. | RPA |
|---|---|---|---|---|---|---|---|
| 14. | Walnut | 7 | 170 x 8 | M | C1 | This is very unusual in that we do not often see multi-stemmed Walnuts. This tree has 8 stems all growing from a decayed stump. It is coppice growth and while it is an interesting feature it does not have much future as the individual stems are weakly attached to the remnants of the decayed stump. | 105 |

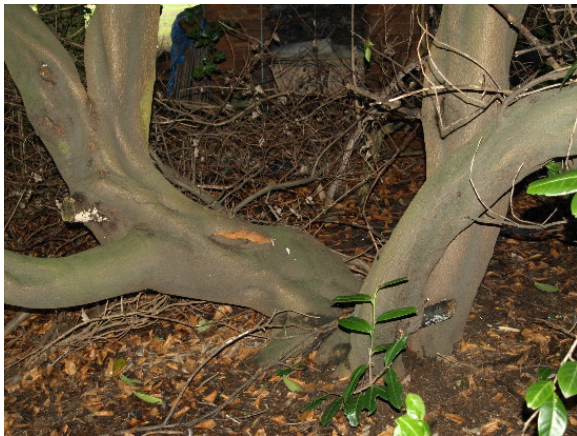
Figure 7.

| Tree No. | Species. | Ht | TD | Age class | Category | Comments. | RPA |
|---|---|---|---|---|---|---|---|
| 12. | Laurel | 6 | 500af | M | R | This is a very large shrub. Without getting into a debate about when a shrub becomes a tree I would simply remove it as Laurel is an invasive pest that suppresses our native flora. Otherwise there's nothing at all wrong with it, but other nearby trees would grow better were it not there. | 0 |

Figure 7 shows the base of tree 12. As I pointed out it is hardly a tree at all and I only mention it because it is so large. I also would not normally condemn (categorise it as 'R') a tree unless it was actually some sort of danger, however in this case I make an exception as it is clearly interfering with the growth of better and much more desirable trees. Laurel has a reputation for being invasive and while not as notorious as Rhododendron it is a similar-sized problem at many locations.

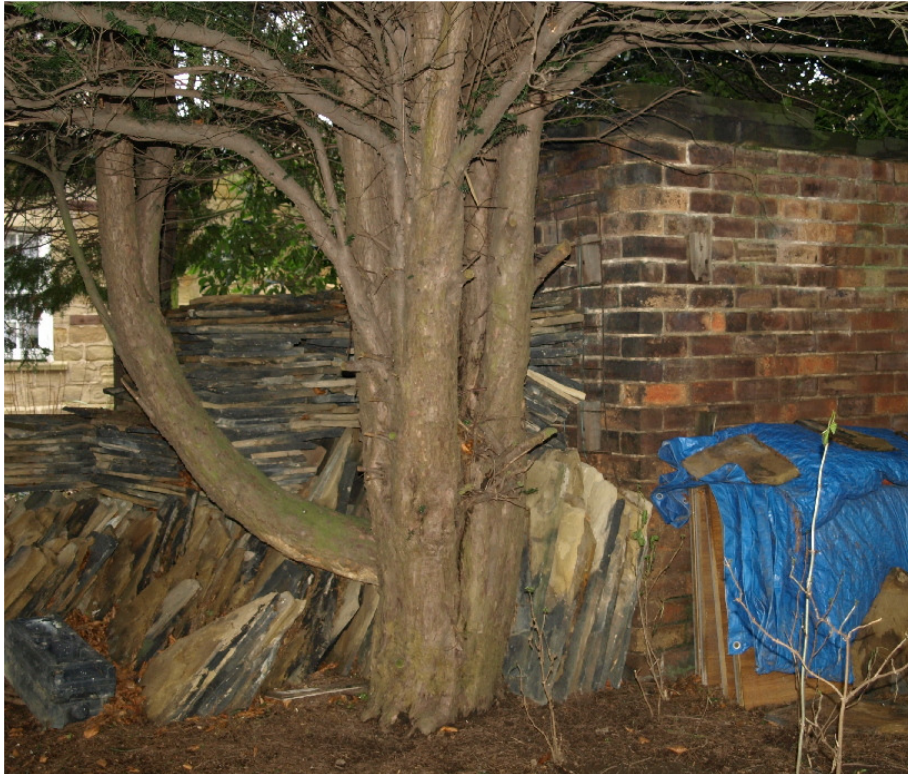
Figure 8.

| Tree No. | Species. | Ht | TD | Age class | Category | Comments. | RPA |
|---|---|---|---|---|---|---|---|
| 5. | Yew | 6 | 400af | M | C1 | As tree 4. | 51 |

Figure 8 shows the base of tree 5. Behind the brick wall is an area used for burning garden (presumably) refuse. It is apparent that lower branches of this tree and others get scorched on a regular basis. The picture shows a quantity of stone roof tiles stacked against the tree. While it is not immediately apparent that they are causing any problems it is obvious that this is no way to treat trees. I don't know if it is intended to remove the outbuilding but this is all but impossible without causing extensive root damage.

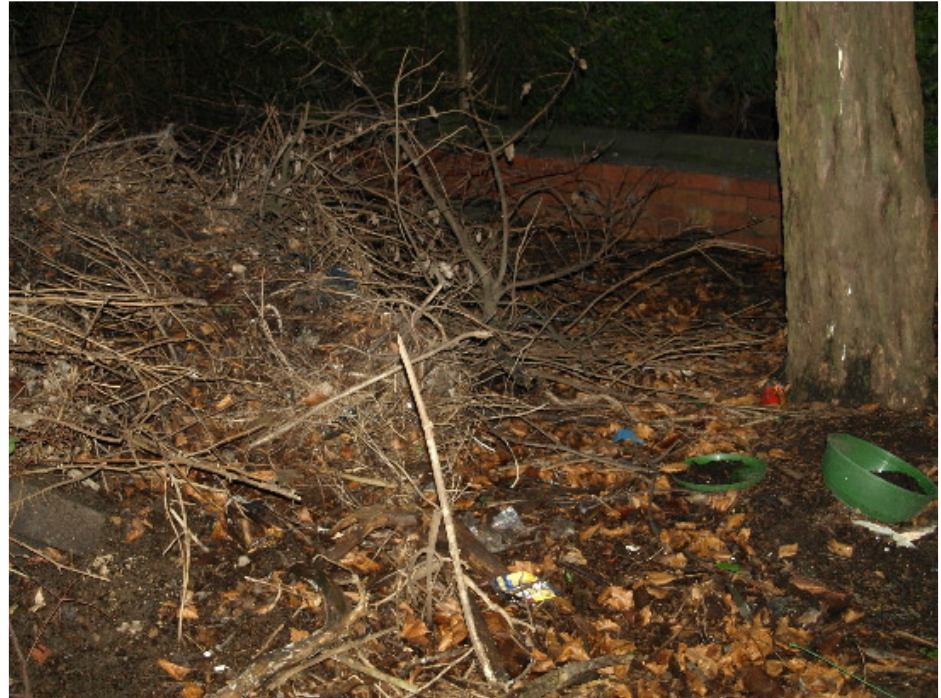
Figure 9.

| Tree No. | Species. | Ht | TD | Age class | Category | Comments. | RPA |
|---|---|---|---|---|---|---|---|
| 13. | Yew | 8 | 400 | M | C1 | A reasonable specimen but one-sided due to suppression from the above-mentioned Laurel. | 73 |

Figure 9 shows a pile of garden refuse at the base of tree 13. Again it appears that an out-of-sight, out-of-mind situation has prevailed. While it is not immediately obvious that damage is being done, the situation is unlikely to be beneficial to this or any other tree.

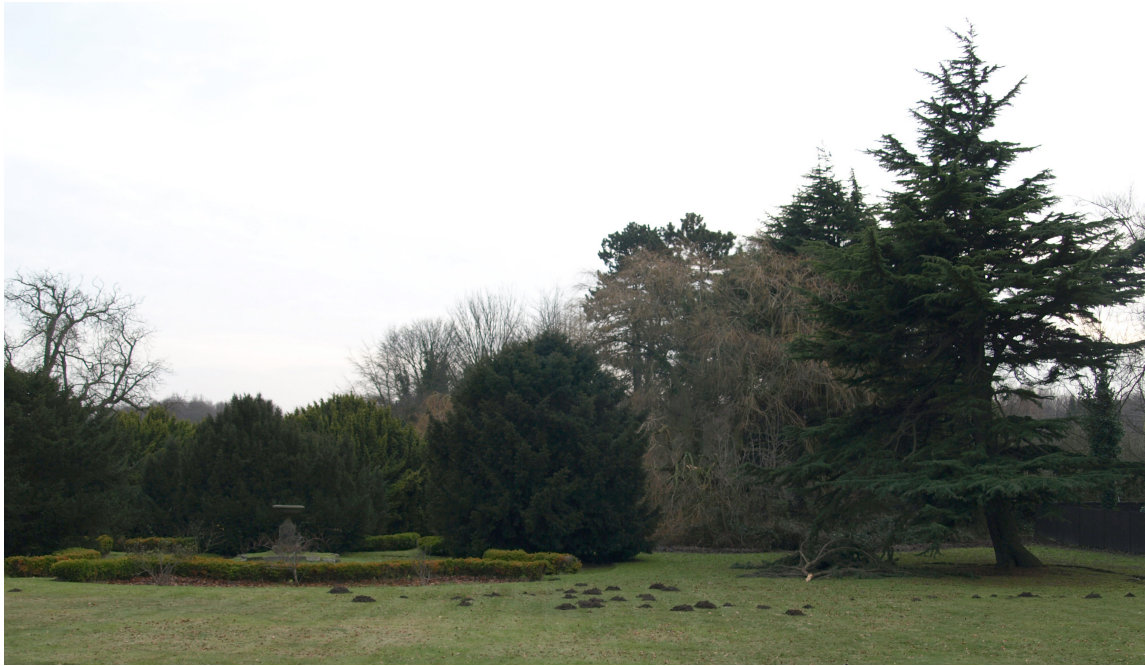
Figure 10.

Figure 10 is a view of the garden to the southwest. It is reasonably well kept and obviously an asset to the Burntwood Hall's business. This part of the garden will be completely unaffected by the proposal.
