**ARBORICULTURAL IMPACT ASSESSMENT
to BS 5837:2012
at
Land at Green Road
Dodworth
Barnsley
South Yorkshire
S75 3RR**

Client:
Newett Homes

JCA Ref:
18317-A/AJB

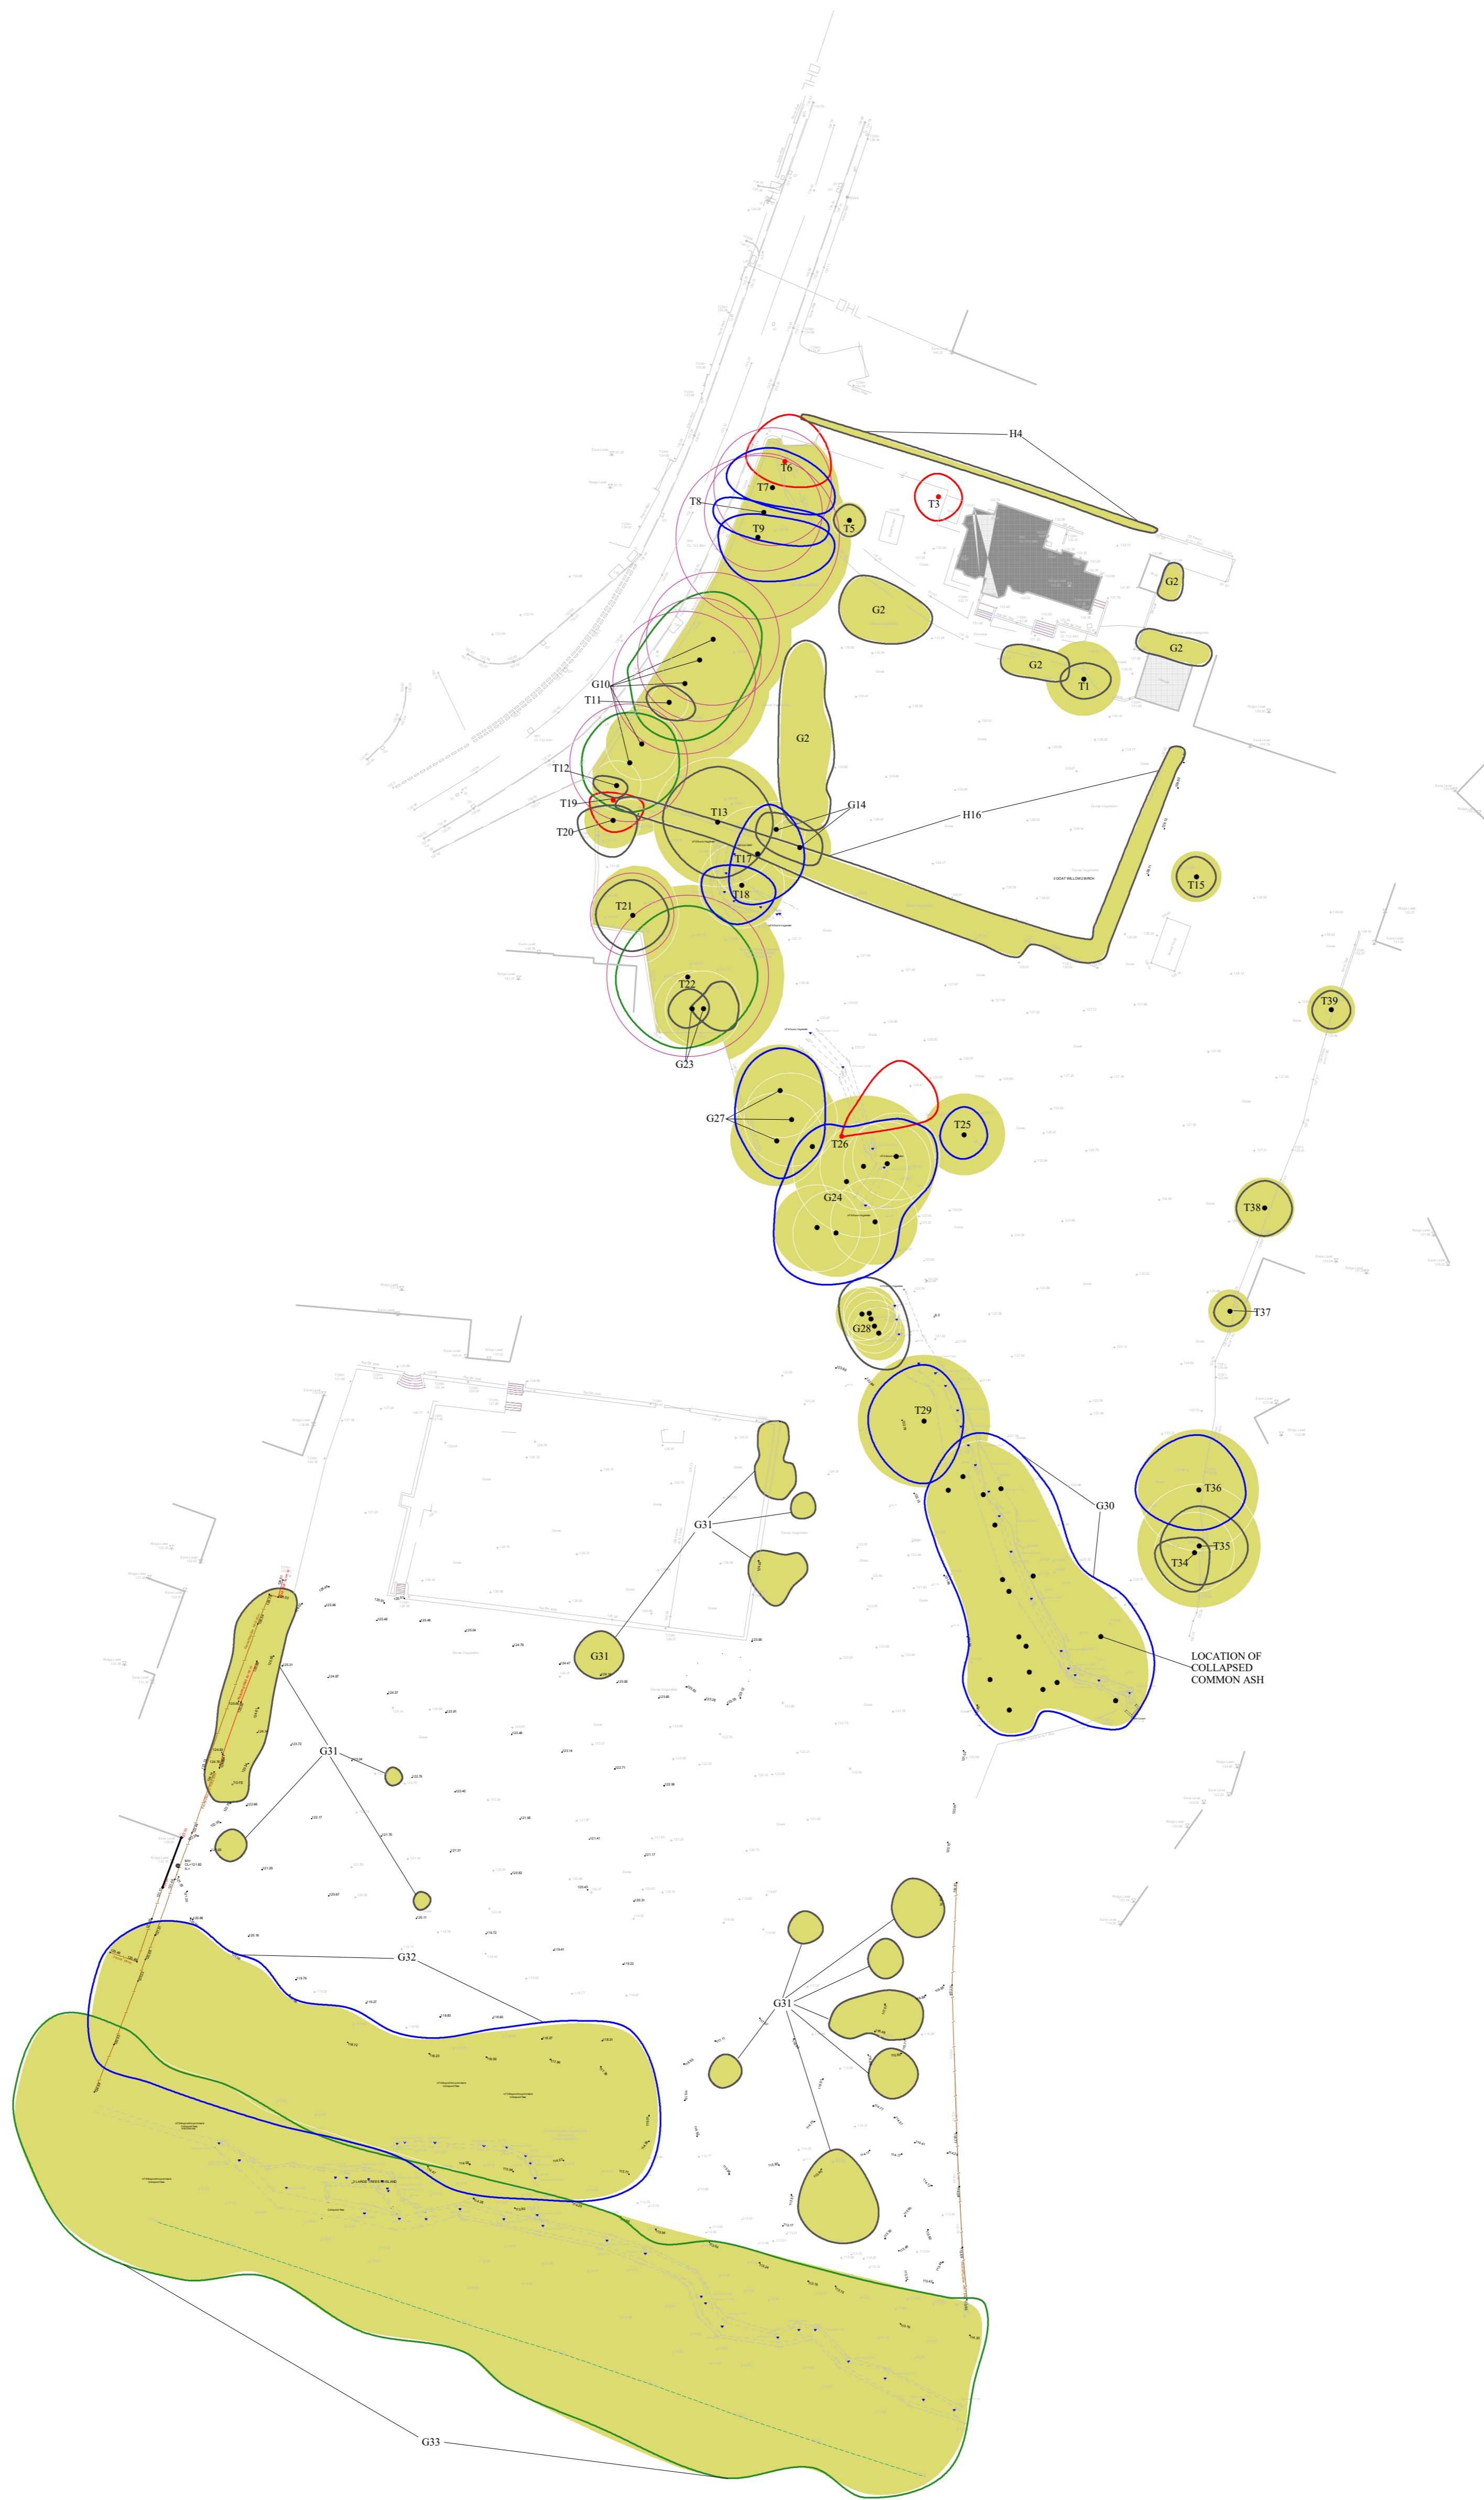
Appendix 6: Tree Constraints Plan

- 4.7 The protection of retained trees can be achieved by the creation of a Construction Exclusion Zone based on the Root Protection Area of a tree. The Root Protection Area of each tree or group is marked on the Tree Constraints Plan at **Appendix 5**.

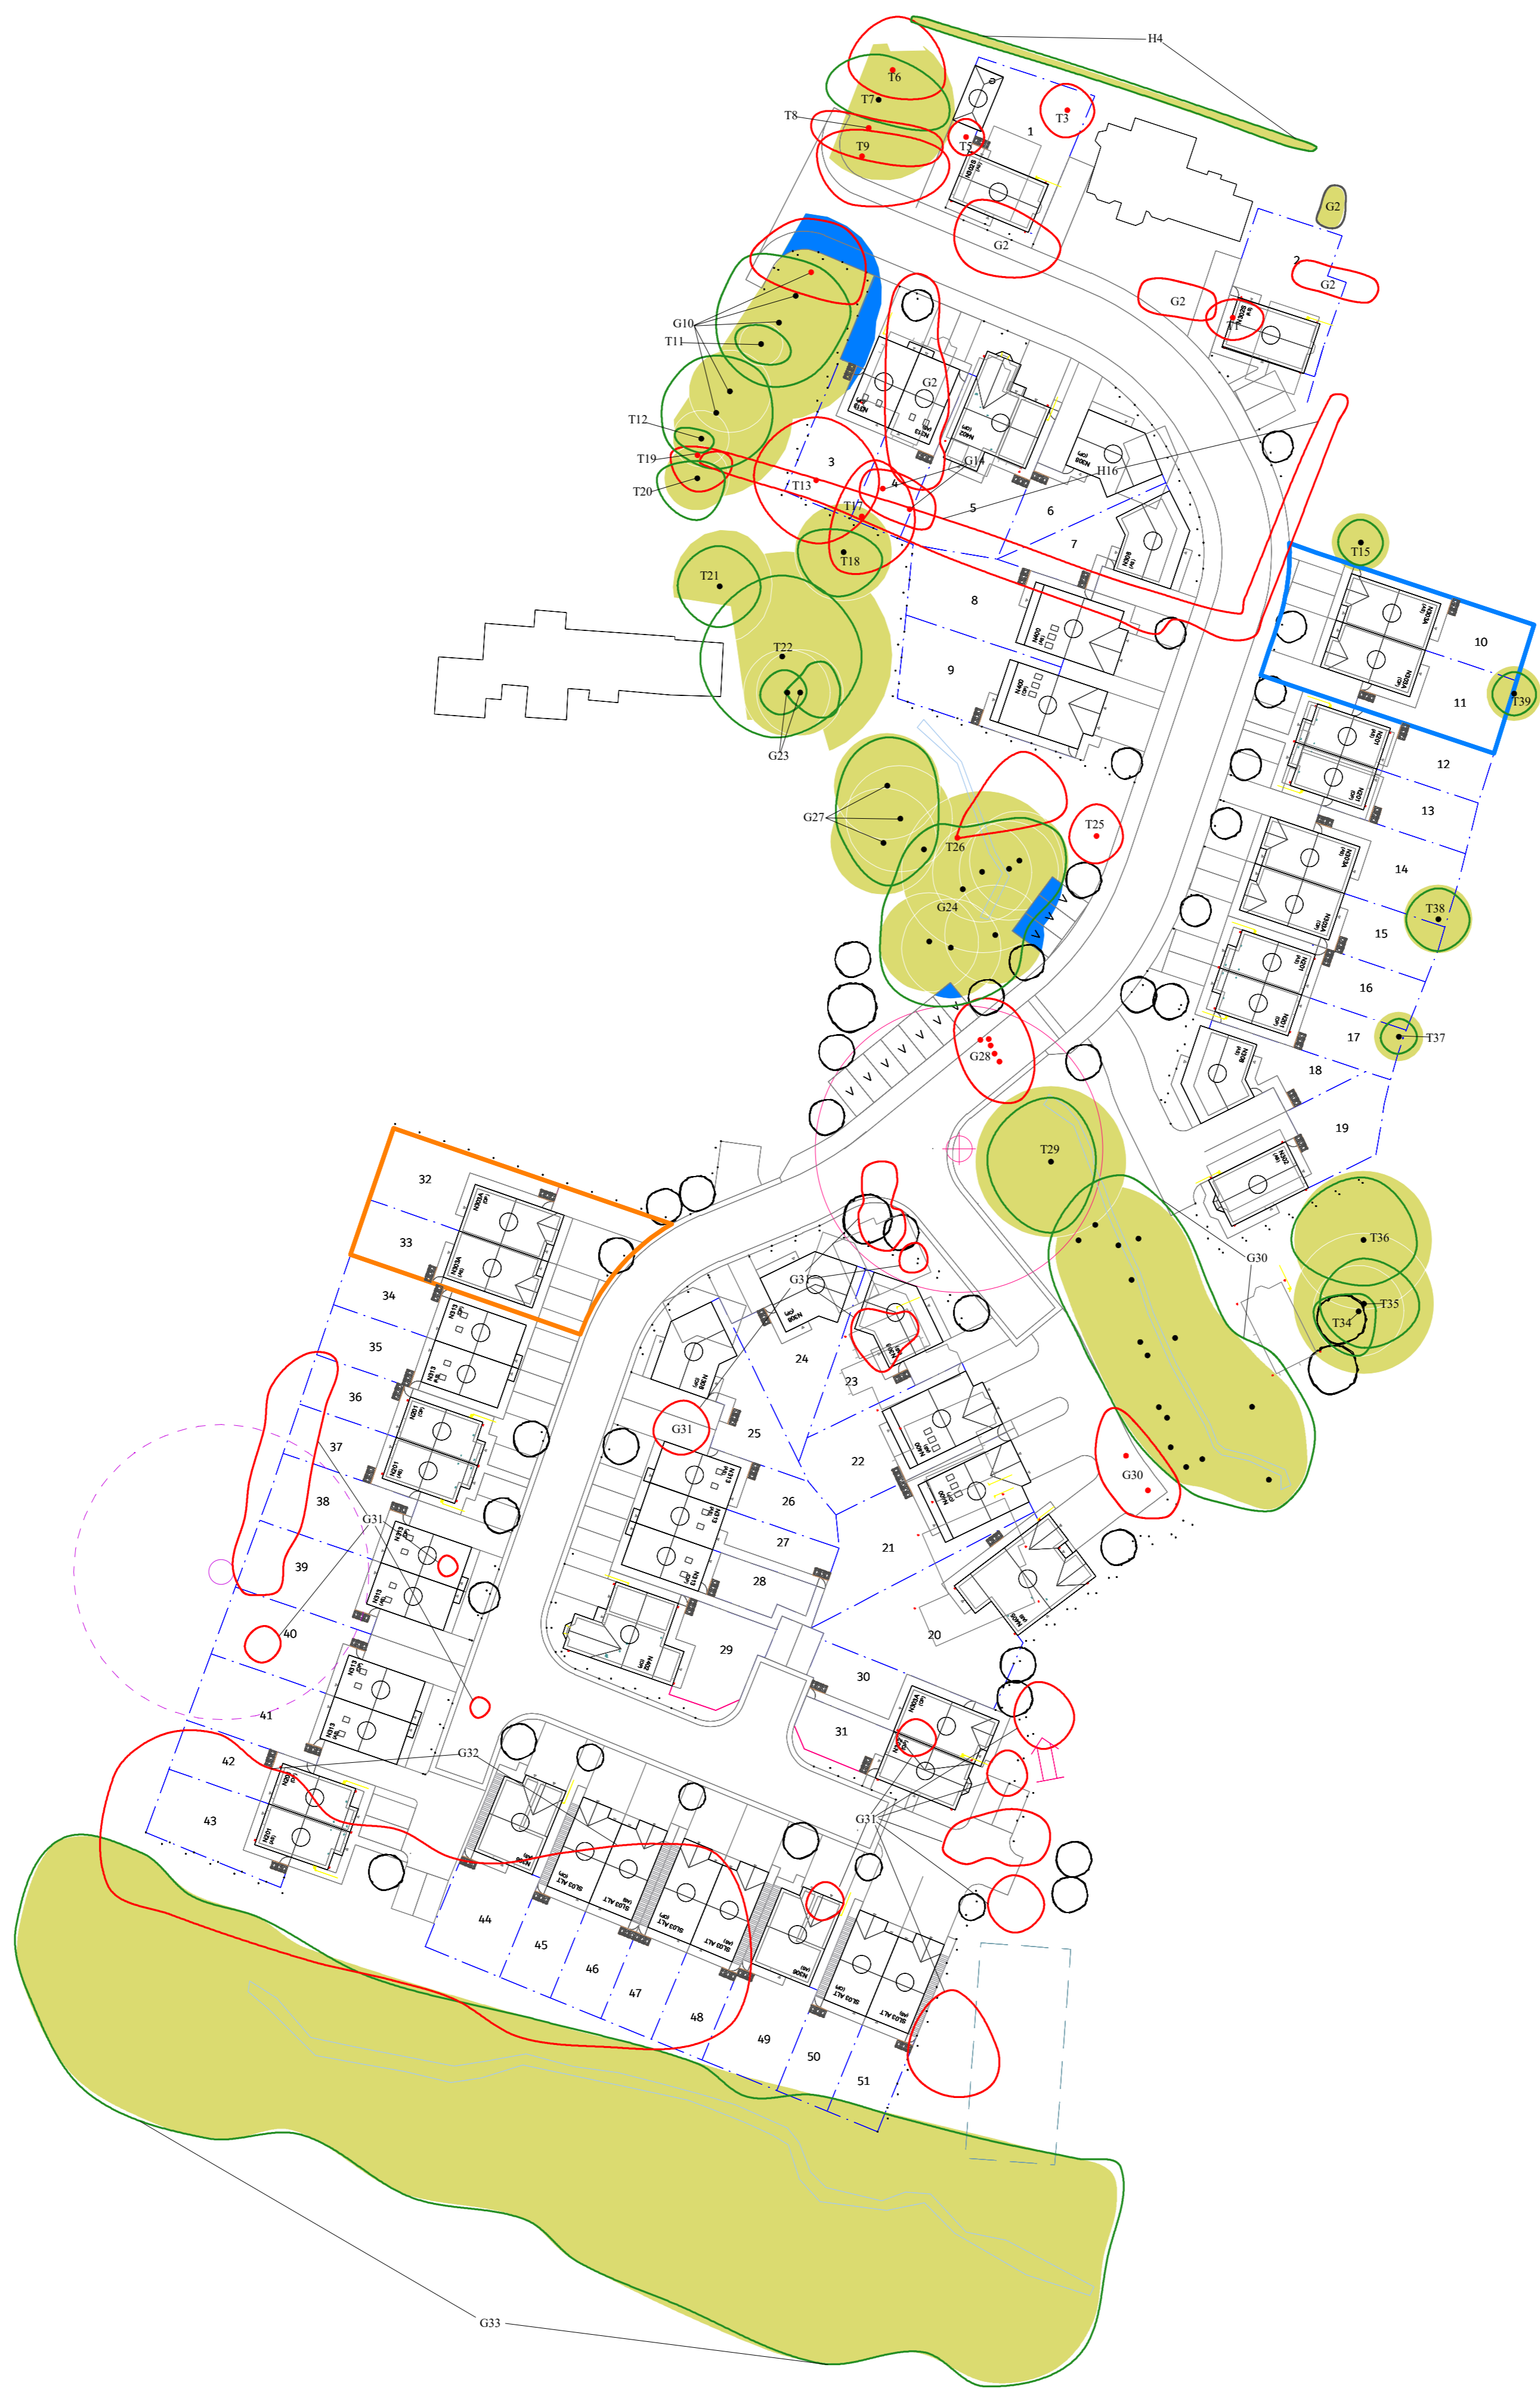
Appendix 6: Arboricultural Implications Plan

- 3.2.1 In order to facilitate the proposed development, it will be necessary to remove **T1**, four sections of **G2** (as shown in red on the plan at **Appendix 6**), **T5**, **T8**, **T9**, one tree within **G10** (as shown in red on the plan at **Appendix 6**), **T13**, **G14**, **H16**, **T17**, **T25**, **G28**, two trees within **G30** (as shown in red on the plan at **Appendix 6**), **G31** and **G32**. Of these, the one tree within **G10** falls into retention category 'A', **T8**, **T9**, **T17**, **T25**, **G30** and **G32** fall into retention category B and **T1**, **G2**, **T13**, **G14**, **H16**, **G28** and **G31** fall into retention category 'C'.

- 3.5.1.1 Where the proposals require work to be undertaken within the RPA of a tree which is to be retained, specialist measures must be adopted during the construction phase to avoid ground compaction and minimise root damage.
- 3.5.1.2 Such areas are highlighted in **blue** shade on the Arboricultural Implications Plan at **Appendix 6**.

- 3.5.3.1 Proposed hard surfacing is located within the RPA of **G10** and **G24**, as shown in blue shade on the plan at **Appendix 6**. Due to the nature of the incursion, it is not considered necessary to install specialised surfaces. Instead, root pruning will be undertaken under the supervision of an appointed arboriculturist to prevent 'ripping' damage, which is commonly associated with mechanical excavation.

3.6.1 Part of the proposed development will encroach into the RPAs of **G10** and **G24**, resulting in possible root loss. It would therefore be prudent to apply appropriate mycorrhizae fungi to the soils around these trees after the construction phase is complete. Certain mycorrhiza fungi form a symbiotic relationship with tree roots. A tree root associated with such mycorrhiza will take up nutrients more effectively and this will therefore help the tree to produce new roots more effectively, so benefitting their recovery.

- 3.3.1 Where the footprint of the proposed road, footpath and car parking spaces fall within the RPA of retained trees, root pruning will be required, under the supervision of an appointed arboriculturist in the location shown in blue shade on the plan at **Appendix 6**. Root pruning will accommodate the proposed road, footpath and car parking spaces whilst preventing any 'ripping' damage, a problem commonly associated with mechanical excavations.
