*BS5837:2012 Trees in relation to  
design, demolition and construction*

Barnsley College,  
Carrington Avenue,  
Barnsley S75 1AT

2<sup>nd</sup> June 2014

| <b>Title</b> | Carrington Avenue BS5837:2012 Tree Survey Report | | |

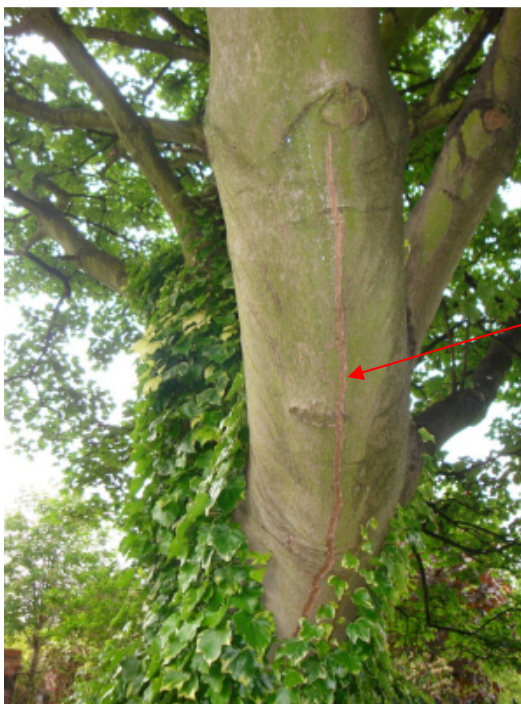
- 3.1.5 T13 was found to have evidence of structural crack on a scaffold limb while at present there does not appear to be a significant risk of failure it is recommended that this be monitored on a regular basis and the ivy be severed to improve visibility.

*Crack to bark on scaffold limb of T13*

| Tree / Group No | Recommended works | Work Priority |
|---|---|---|
| T13 | Sever ivy at the base of tree / monitor | 5 |

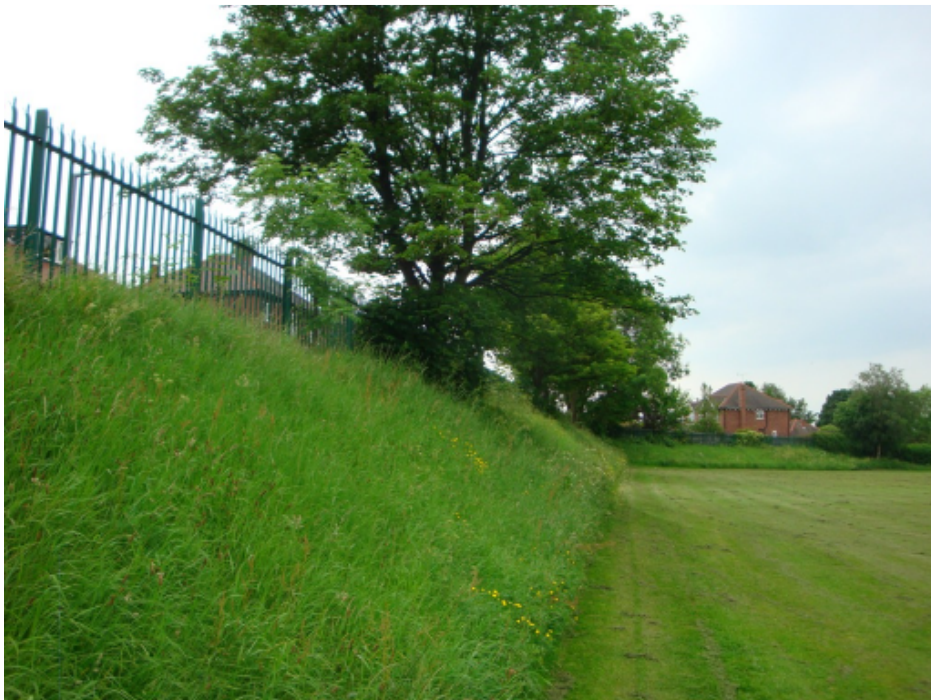
- 4.1.1 The impact assessment is based upon the design proposal supplied which is shown in Appendix B. Note if the finalised proposal is radically different from that previously supplied the impact assessment will need to be reviewed.
- 4.1.2 After studying the proposed layout, it is thought that all trees recorded within the site can be retained (with the exception of T19 which should be removed on the grounds of good Arboricultural management) without a significant impact on tree health. Temporary Protective Fencing (as shown in Appendix D) should be erected as shown on the Tree Protection Plan – the fencing need only be placed around T1-T12. Fencing around T13-G21 is not thought necessary as the trees are growing at the top of an embankment and this will afford the trees ground protection.

*Trees along East boundary growing at the top of embankment*
