# **LOCKWOOD ROAD, GOLDTHORPE**

## **for Gleeson Homes & Regeneration**

## 1.0 GENERAL

- 1.1 This tree survey was undertaken by Martin Popplewell (Landscape Architect) and Scott Reid (Arboriculturist) on 22 Jan 2021 on behalf of Gleeson Homes & Regeneration in conjunction with proposals for residential development on site.

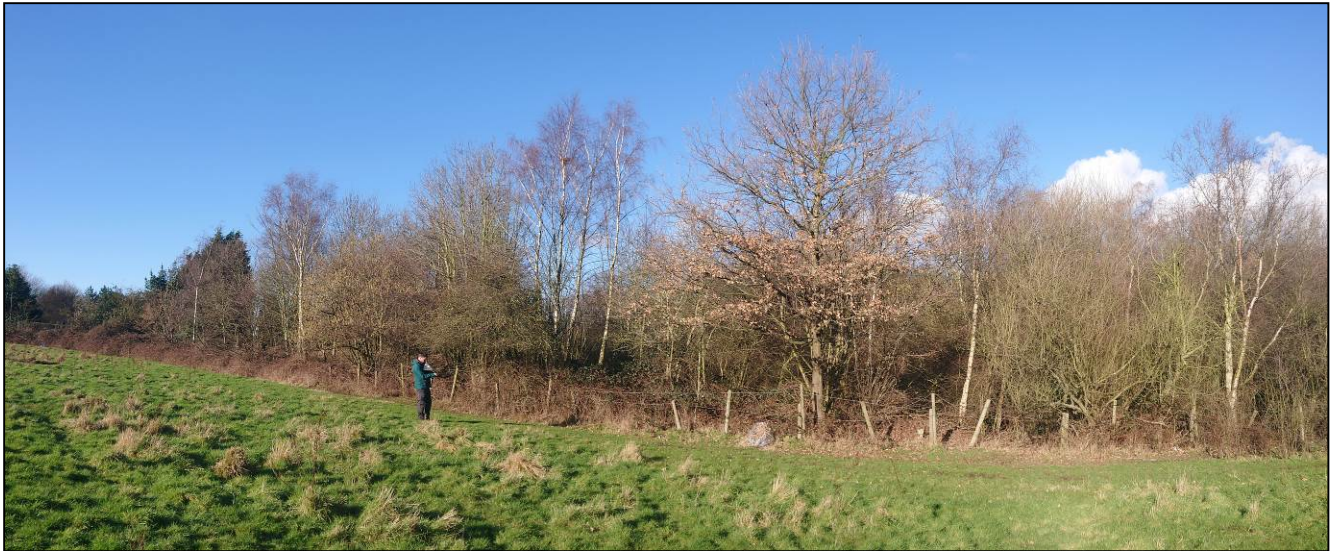
| Tree number on dwg | Species | Height (m) | Stem diameter (cm) | Branch spread (m) | Age class | Crown clearance + Ht/direction of lowest branch | Physiological condition | Estimated remaining contribution (years) | Category grading | Notes / Structural condition | Preliminary management recommendations |
|---|---|---|---|---|---|---|---|---|---|---|---|
| G3 | Silver Birch, Oak, Sycamore, Ash, Hawthorn, Hazel, Goat Willow | 12 | <18 | As plan | EM | 0 | Good | 40+ | B2 | Area of woodland planting lies offsite, but canopies extend over site boundary. Establishing well and good future potential. One ash (noted on plan thus: #) lying close to site boundary has a failed union and should be removed on safety grounds. | Remove poor quality ash. |

Photo 1: View north showing western part of woodland group G3 that abuts northern site boundary. ▲

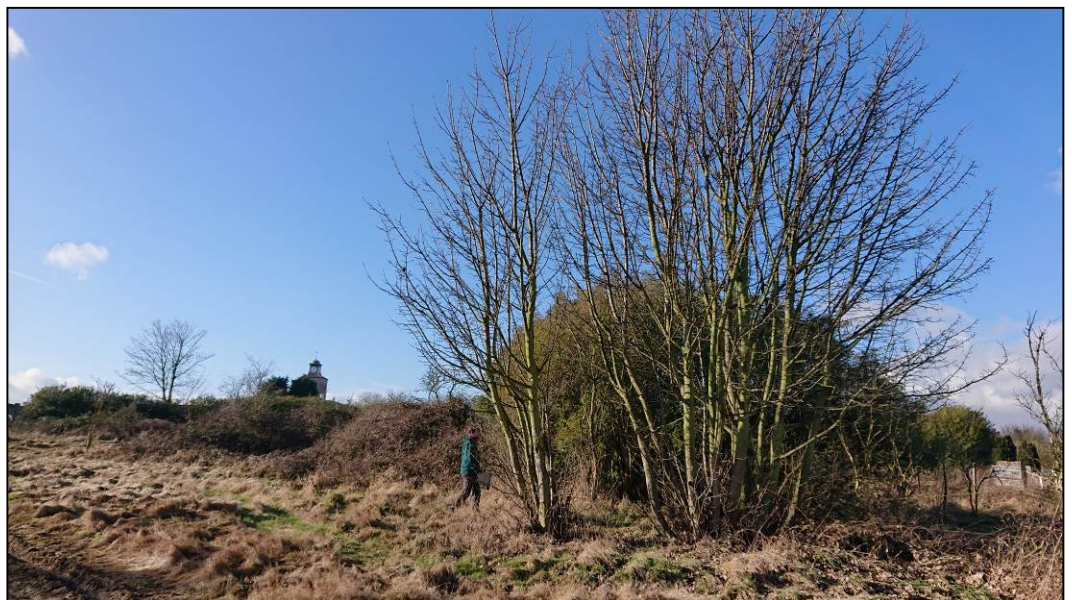
Photo 2: ▲

| Tree number on dwg | Species | Height (m) | Stem diameter (cm) | Branch spread (m) | Age class | Crown clearance + Ht/direction of lowest branch | Physiological condition | Estimated remaining contribution (years) | Category grading | Notes / Structural condition | Preliminary management recommendations |
|---|---|---|---|---|---|---|---|---|---|---|---|
| H16 | Privet | 6 | 7 | 4m wide | SM | 0 | Good | 20-40 | C2 | Well-established hedge unmaintained for some time. Dense foliage to ground level. | No action |

| Tree number on dwg | Species | Height (m) | Stem diameter (cm) | Branch spread (m) | Age class | Crown clearance + Ht/direction of lowest branch | Physiological condition | Estimated remaining contribution (years) | Category grading | Notes / Structural condition | Preliminary management recommendations |
|---|---|---|---|---|---|---|---|---|---|---|---|
| T17 | Sycamore | 12 | 30, 27 | As plan | SM | 3 | Good | 20-40 | B1 | Stem forks into 2 at 2m; evenly balanced rounded crown. Limited access prevents a detailed examination but appears to be in good condition at present. | No action |
| G19 | Sycamore | 10 | 25 | As plan | EM | 2.5 | Good | 40+ | C2 | Group of self-sown, multi-stemmed trees with dense, shrubby crowns that read as one. Epicormic growth and some decay at base; bark wounds to stems. | No action |

View west showing Sycamore group G19 in foreground with shrubby privet beyond. Privet hedge H16 and Sycamore T17 can be seen in middle distance (left of view).

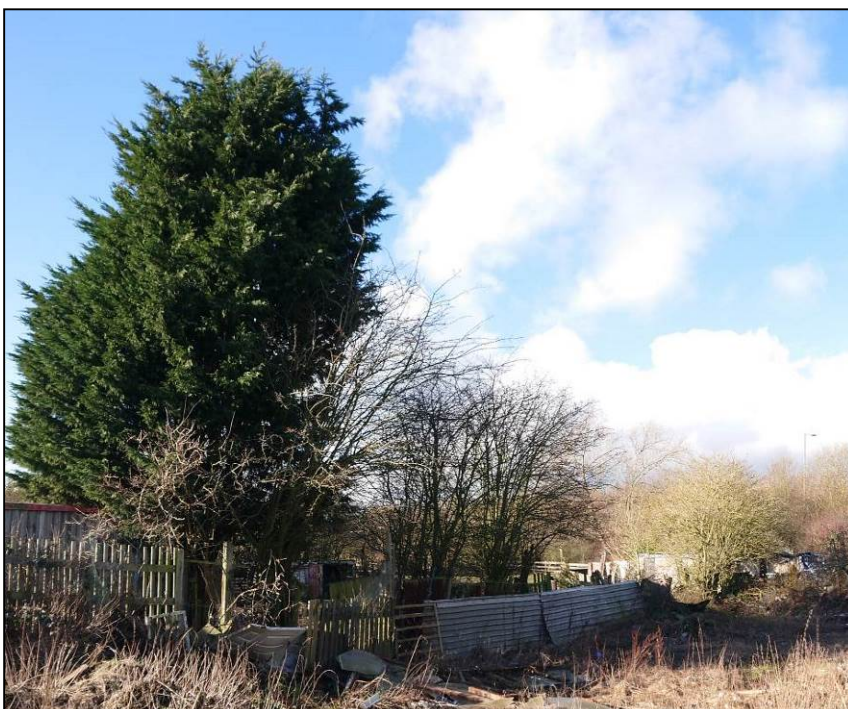
Photo 3:

| Tree number on dwg | Species | Height (m) | Stem diameter (cm) | Branch spread (m) | Age class | Crown clearance + Ht/direction of lowest branch | Physiological condition | Estimated remaining contribution (years) | Category grading | Notes / Structural condition | Preliminary management recommendations |
|---|---|---|---|---|---|---|---|---|---|---|---|
| T23 | Willow | 13 | 30 | As plan | EM | 3 | Good | 20-40 | C1 | Stem forks into 2 at 2m; wide spreading open crown. Limited access prevents a detailed examination but appears to be in acceptable condition at present | No action |
| H25 | Hawthorn | 5 | 8 | 4m wide | SM | 0 | Fair | 20-40 | C2 | Two short lengths of mature hedge; dense foliage to ground level. Limited arboricultural value. | No action |
| T26 | Leyland's Cypress | 12 | 34 | 4m rad. | EM | 2 | Good | 20-40 | C1 | Straight main stem and dense, conical crown. Previously topped at 2m but crown shows good vitality. | No action |

View north showing Cypress T26 on left, hawthorn / Elder hedge H25 centre / right and Willow T23 in middle distance (centre right)
