Date: 7th June 2022
Your ref: (S72 8UN)
My Ref: SI 00251

**COAL MINING RISK INTERPRETATION REPORT – FOLLOWING THE SITE
INVESTIGATION FOR PROPOSED RESIDENTIAL DEVELOPMENT OF FORMER GARAGE
SITE, BLOEMFONTEIN STREET, CUDWORTH, BARNLSLEY S72 8UN.**

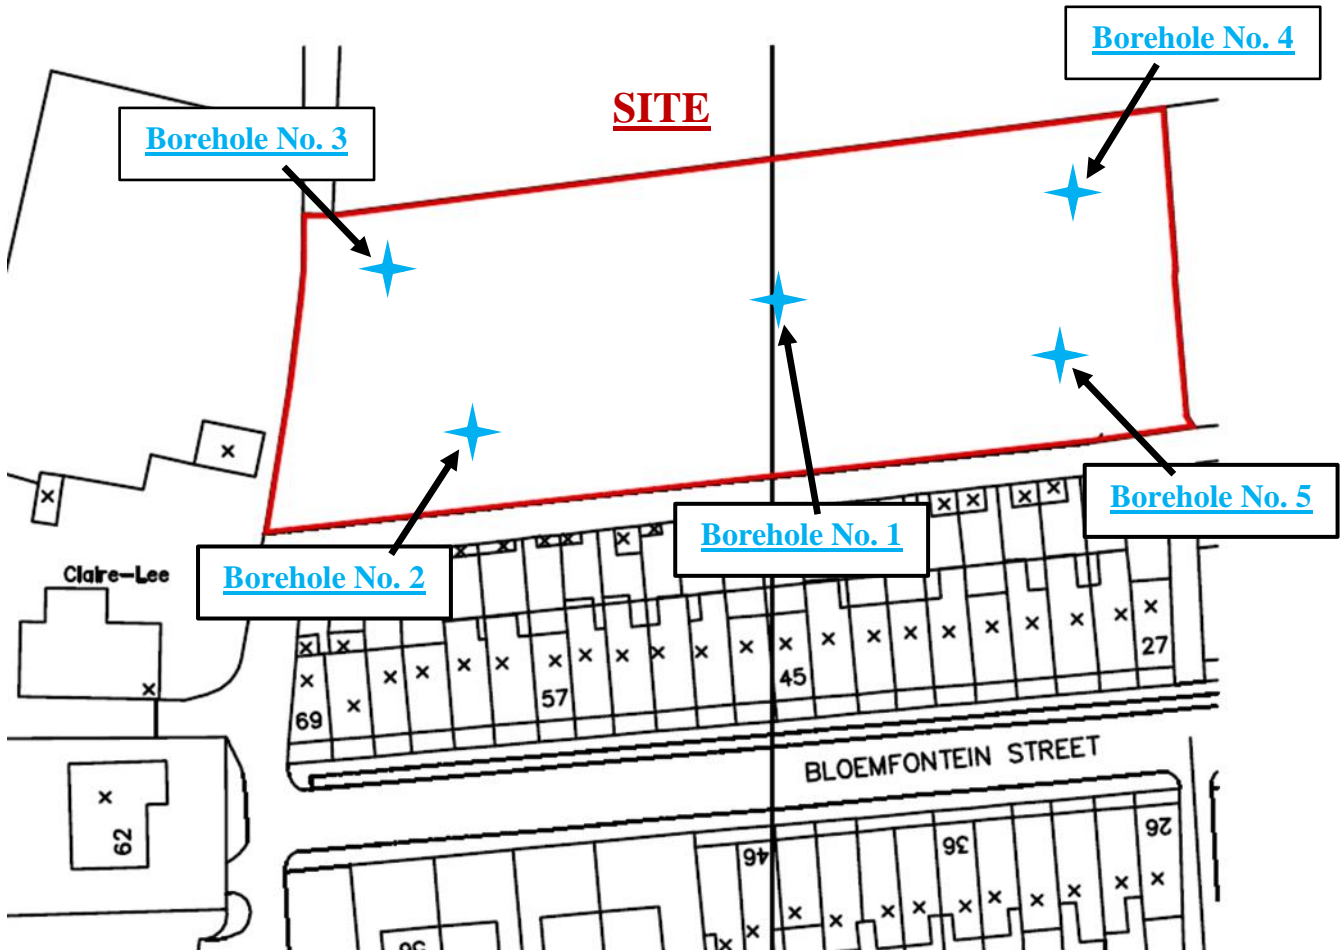
5.2 Borehole Location Plan No. 00251/B

All holes proved a similar section of strata, but with holes 4 and 5 (in the east) proving 1.3m of brown clay with sandstone lumps above the weathered sandstone bedrock. Firm brown silty sandstone, with occasional grey silty bands, were then encountered to 20m deep in all holes with borehole no. 3 proving an in-tact coal seam of 0.8m thickness at 18m deep. This is considered to be the Sharlston Low coal seam which, given the geological position, will be at its shallowest at borehole no. 3; thus, why not encountered in the other boreholes as it dips to greater depths in excess of 20m.

The logs appear to match well at a similar elevation which would infer no signs of any geological faulting between the borehole locations.

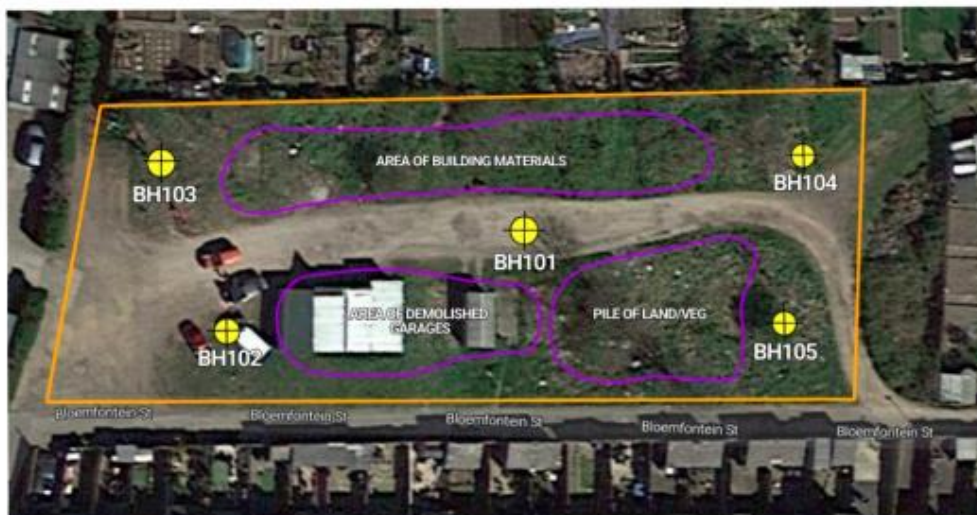
**LAND AT BLOEMFONTEIN STREET
CUDWORTH
BARNSELY**

An underground utility Survey and clearance was undertaken at the land at Bloemfontein Street, Cudworth.

5 positions were cleared with a 2m radius around each location.

Some areas were inaccessible with the Ground Penetrating Radar equipment due to various materials and vegetation (see diagram).
